# **CHARACTERIZING AND INSPECTING FOR PROGRESSIVE EPOXY DEBONDING IN BONDED INSULATED RAIL JOINTS**

**09-1793**

Submitted for consideration for presentation and publication  
88<sup>th</sup> Annual Meeting of the Transportation Research Board  
Washington, DC – January 2009

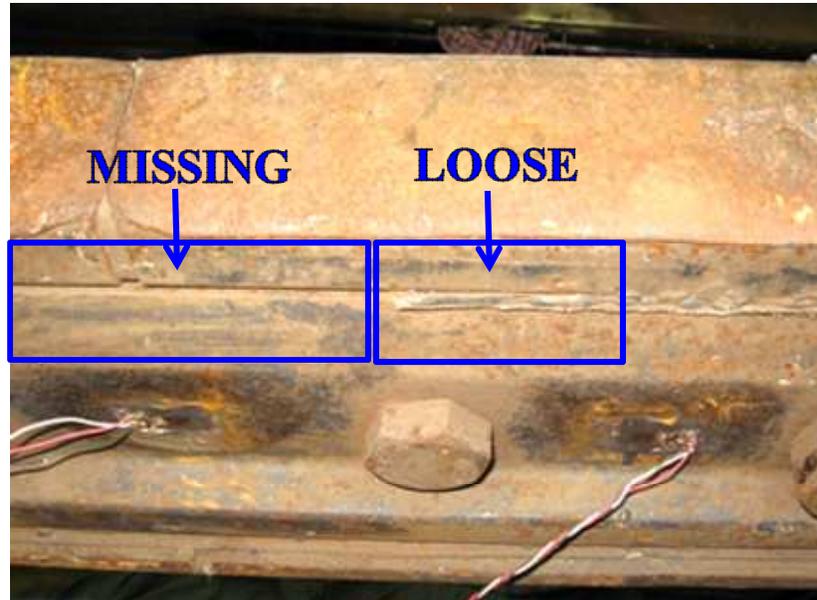
- 1.) **Loose:** some or all of the insulator and excess epoxy was still present, but it was no longer sealed to the metal surfaces. In other words, this section of the edge of the insulator layer was pulling away from the joint.
- 2.) **Missing:** no epoxy or insulator was visible at the top edge of the joint bar. This does not necessarily imply that the insulation between the rail and joint bar had worn away completely, only that the outside edge – the part that fills the space between the fillets on the top outer edge of the joint bar and the bottom outer edge of the rail head – had broken off.

**Figure 1: Classifications of damage to the top edge of the insulator layer.**  
(a) Loose and Missing. (b) Loose only.

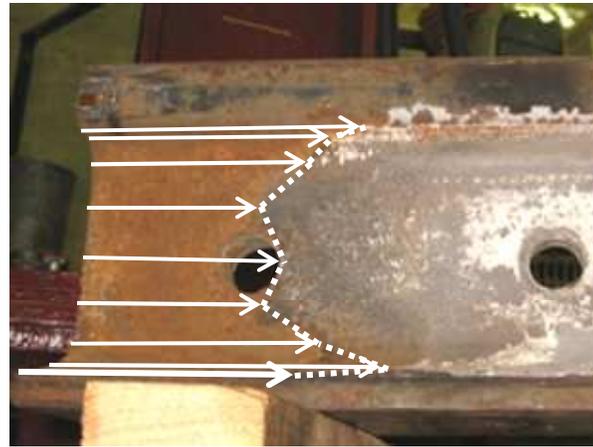
**Figure 2: Disassembled IJ's. (a) Measuring the debonded region. (b) Inclusive versus Strict debonding.**

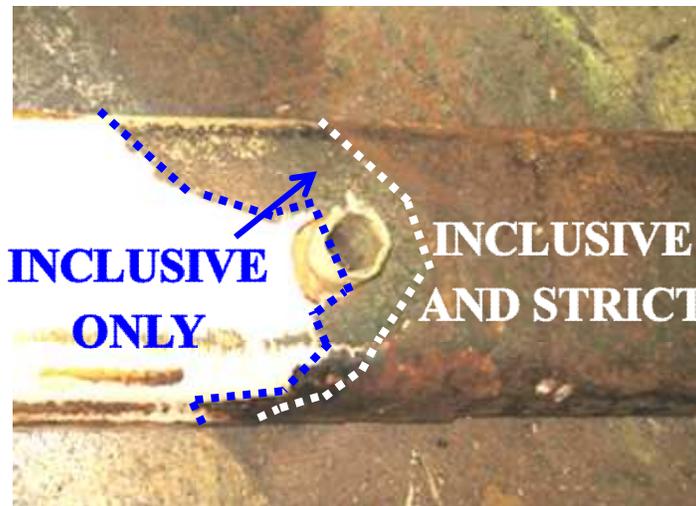
(b)

- 1.) Areas where small dark red or brown patches were speckled with other light-colored patches.
- 2.) Areas with dark brown or black, but not reddish, discoloration. All of the bonded metal surfaces should have remained clean and shiny while sealed beneath the epoxy. Given that such areas tend to occur in proximity to heavily rusted areas, they might show where the surface has debonded and been exposed to air and moisture, but not long enough for visible rust to form. On the other hand, a dark color could simply mean that some carbon or dirt was present when the joint was assembled. It could also indicate some chemical process in the curing epoxy, which might or might not affect bond strength.

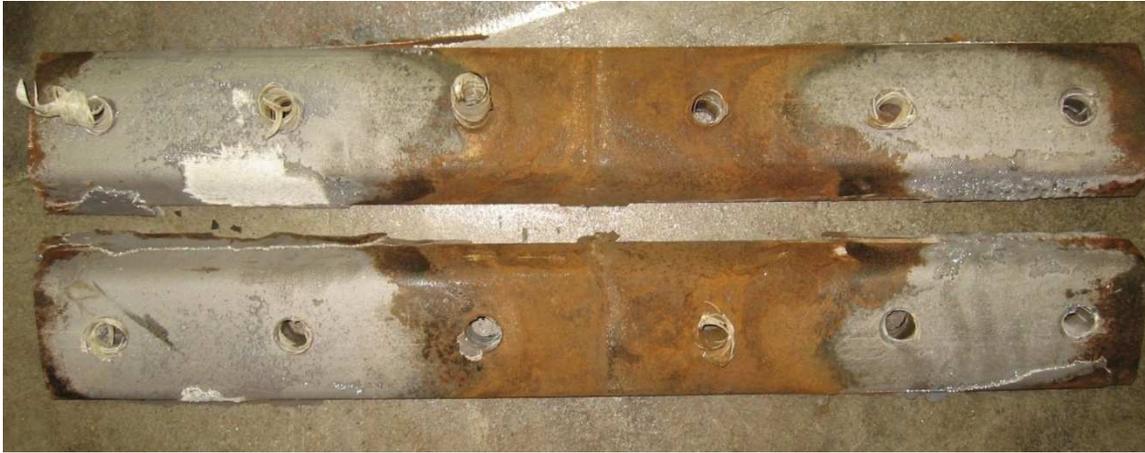
**Figure 3: Shape of debonded region. (a) Debonding (dark area) extends farther on head and base than on web. (b) Onset of debonding at endpost.**

The characteristic shape in Figure 3a corresponds to values of  $H$  and  $B$  that are larger than  $W$ . It appears that debonding tends to begin along the upper and lower edges of the interface (Figure 3b) – that is,  $H$  and  $B$  grow to a certain value while  $W$  remains small. It is assumed that after a certain amount of degradation all three measurements start to grow equally, so that  $H-W$  and  $B-W$  remain approximately constant.

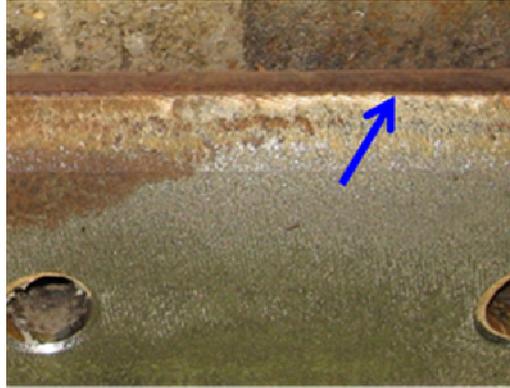
**Figure 4: Debonding behind visible edge of insulator without corresponding debonding on hidden surface.**
