Lessons Learned from a 60" CIPP Storm Sewer Liner Installation

Robert Stolt, PE
Christopher Beranek, PE

CIPP Project Scope: Norris Yard, Irondale, AL

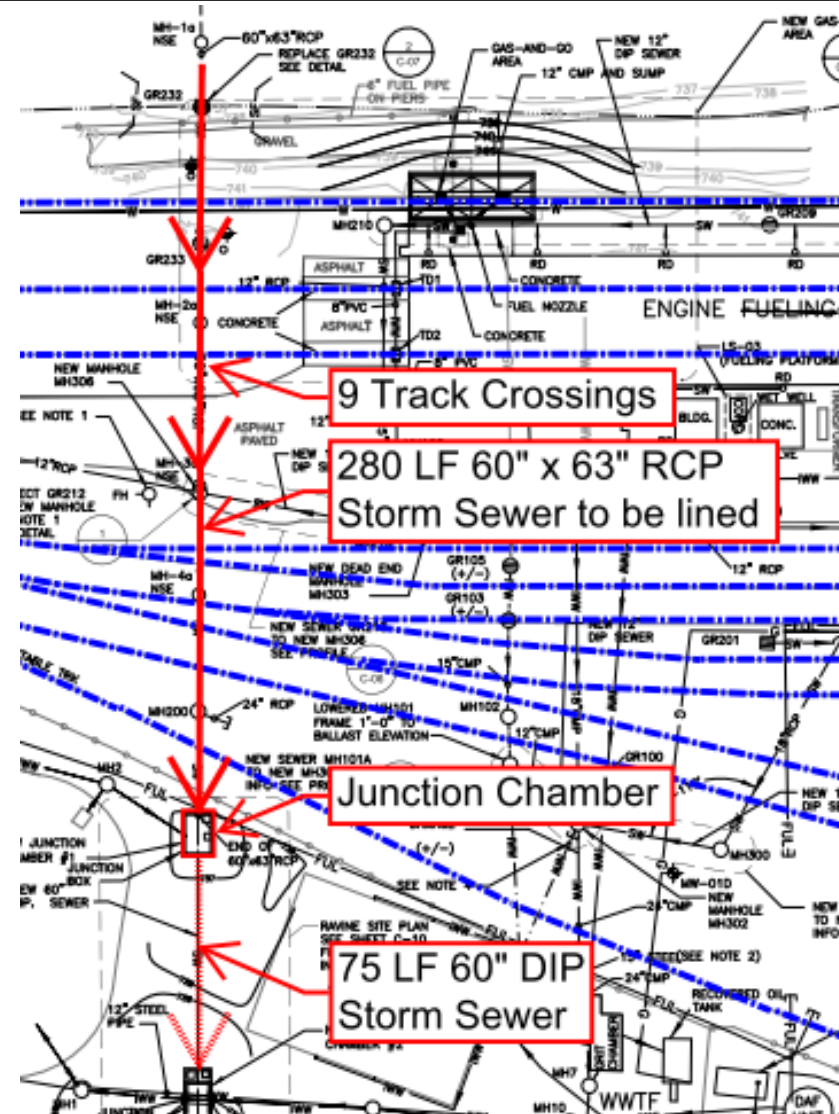
- 60" x 63" RCP storm sewer:
 - Multiple cracks and joint leaks (20+) allowing petroleum-impacted groundwater to seep into the pipe
- Clean pipe
- Plug upstream pipe
- Install bypass pumps, if required
- Grout soil behind pipe, if required
- Install a CIPP liner
- Cure CIPP liner
- Provide a 1-year liner warranty

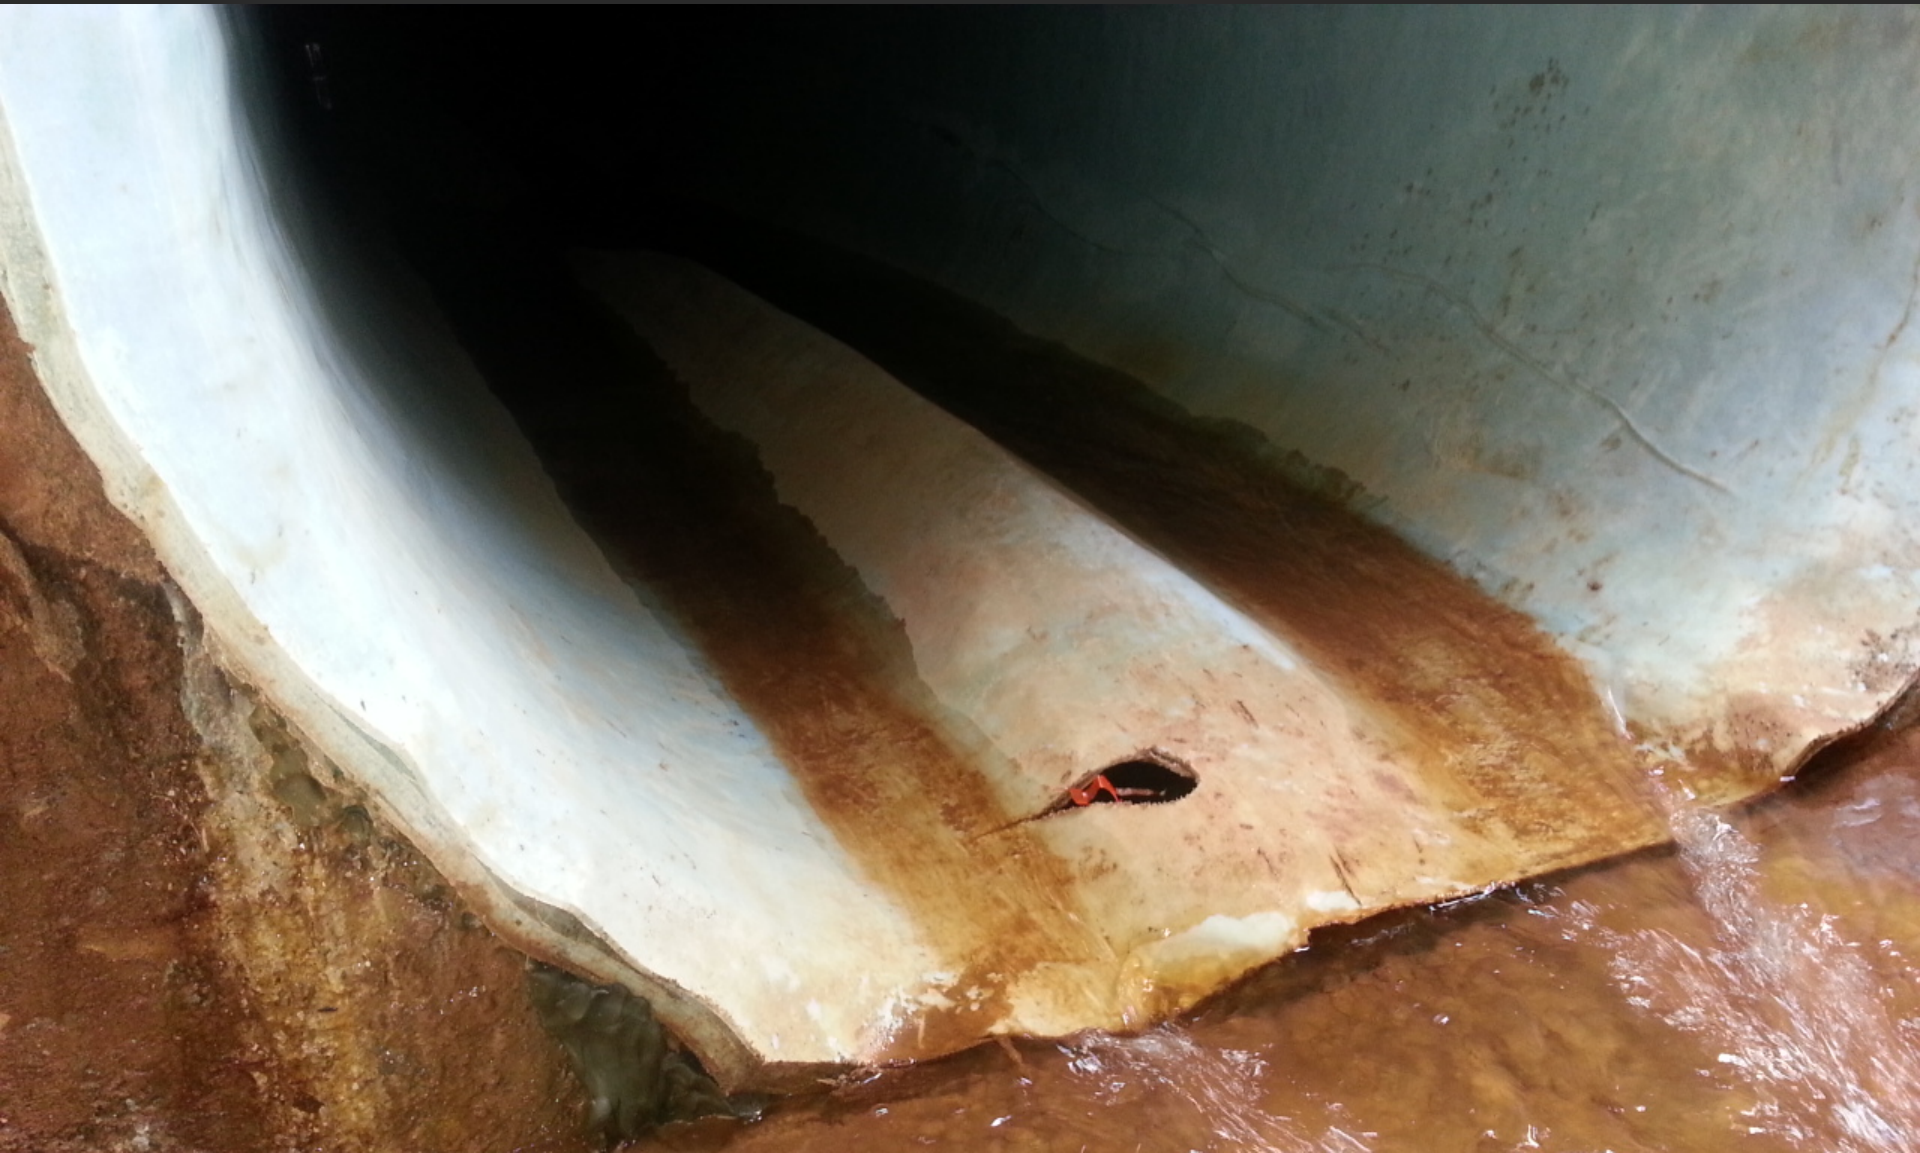
Defects Identified: Raised Invert or Bubble (1/15/2014)

- The project specification allowed the CIPP Liner Company to use their expertise of their product to select the following items:
 - Type of Resin (specification identified diesel fuel and petroleum in groundwater)
 - Resin Curing Method
 - Installation Conditions
- These three items are believed to be the main reasons for the liner defects.

- Type of Resin:
 - Polyester resin was chosen by the CIPP Liner Company.
 - Polyester resin is not as compatible with petroleum products and diesel fuels as vinyl ester resin.
 - The project specification stated groundwater was impacted by diesel fuel and oil.
 - Require the CIPP Liner Company to provide vinyl ester resin for any installations where the liner will come into contact with petroleum products such as oils and diesel fuels.

- Resin Curing Method:
 - The CIPP Liner Company decided to use steam to cure the liner resin as it is more cost effective.
 - For large pipe diameters, steam may not provide a uniform heating source.
 - Require the CIPP Liner Company to use hot water curing, as it provides a more uniform distribution of heat.

- The CIPP liner was installed after an extended dry period and no grouting was done before the liner was installed.
- Liner repairs were performed during a wet period with active leaks.
- The liner repair company was forced to stop leaks prior to actual liner repairs were made.
- Require the CIPP Liner Company to install the liner during a wet period and stop all active leaks prior to the liner installation.

- Removed raised top layer of CIPP liner (3/16" thick) with pneumatic tools from 4 o'clock to 8 o'clock from Junction Chamber to MH 306
- Several major water leaks identified, approx. 50 gpm
- Drilled holes through CIPP liner and RCP into surrounding soil; injected approx. 65 gal. of expanding, hydrophilic, polyurethane foam grout to stop leaks
- Filled remaining holes with hydraulic cement
- Applied 100 mils of Raven 405 primer on repaired surfaces
- Applied 300-700 mils of Raven 512 top coat
- Total liner repair thickness: 7/16"-9/16"

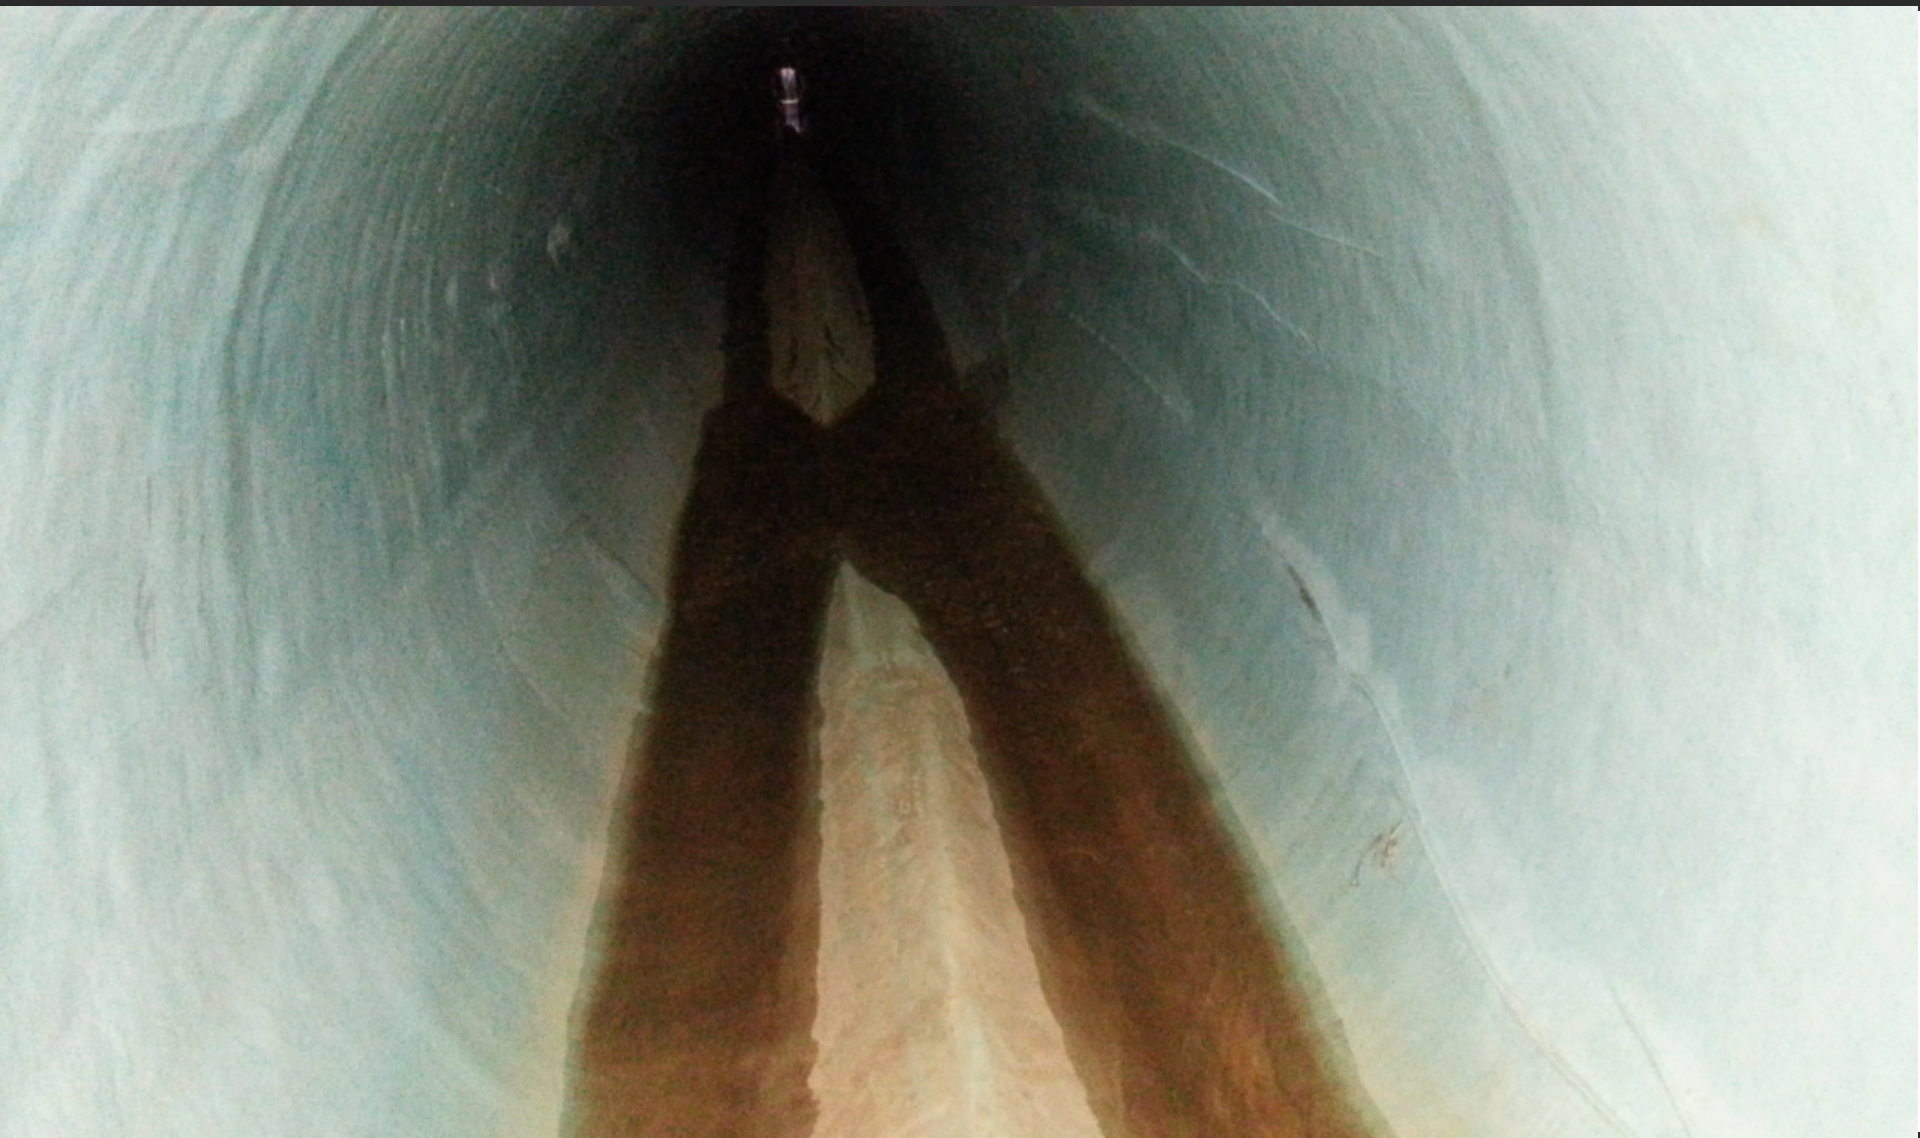
Defects Identified: Raised Invert or Bubble (1/15/2014)

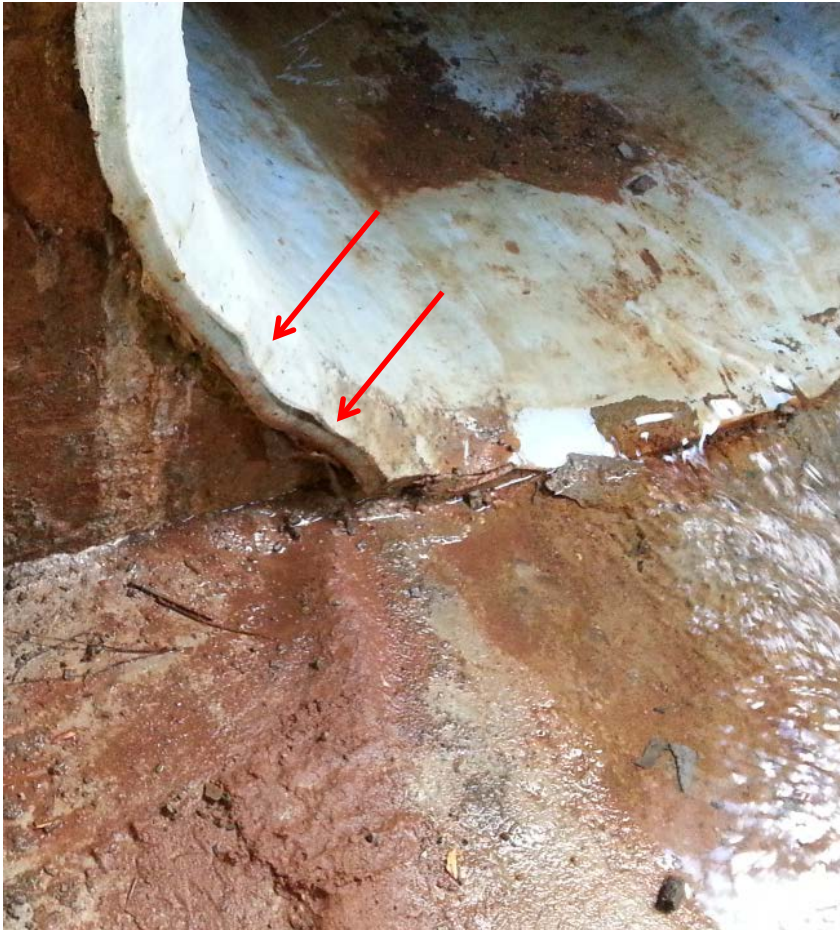
12/27/2013

Defects Identified: Comparison Before/After

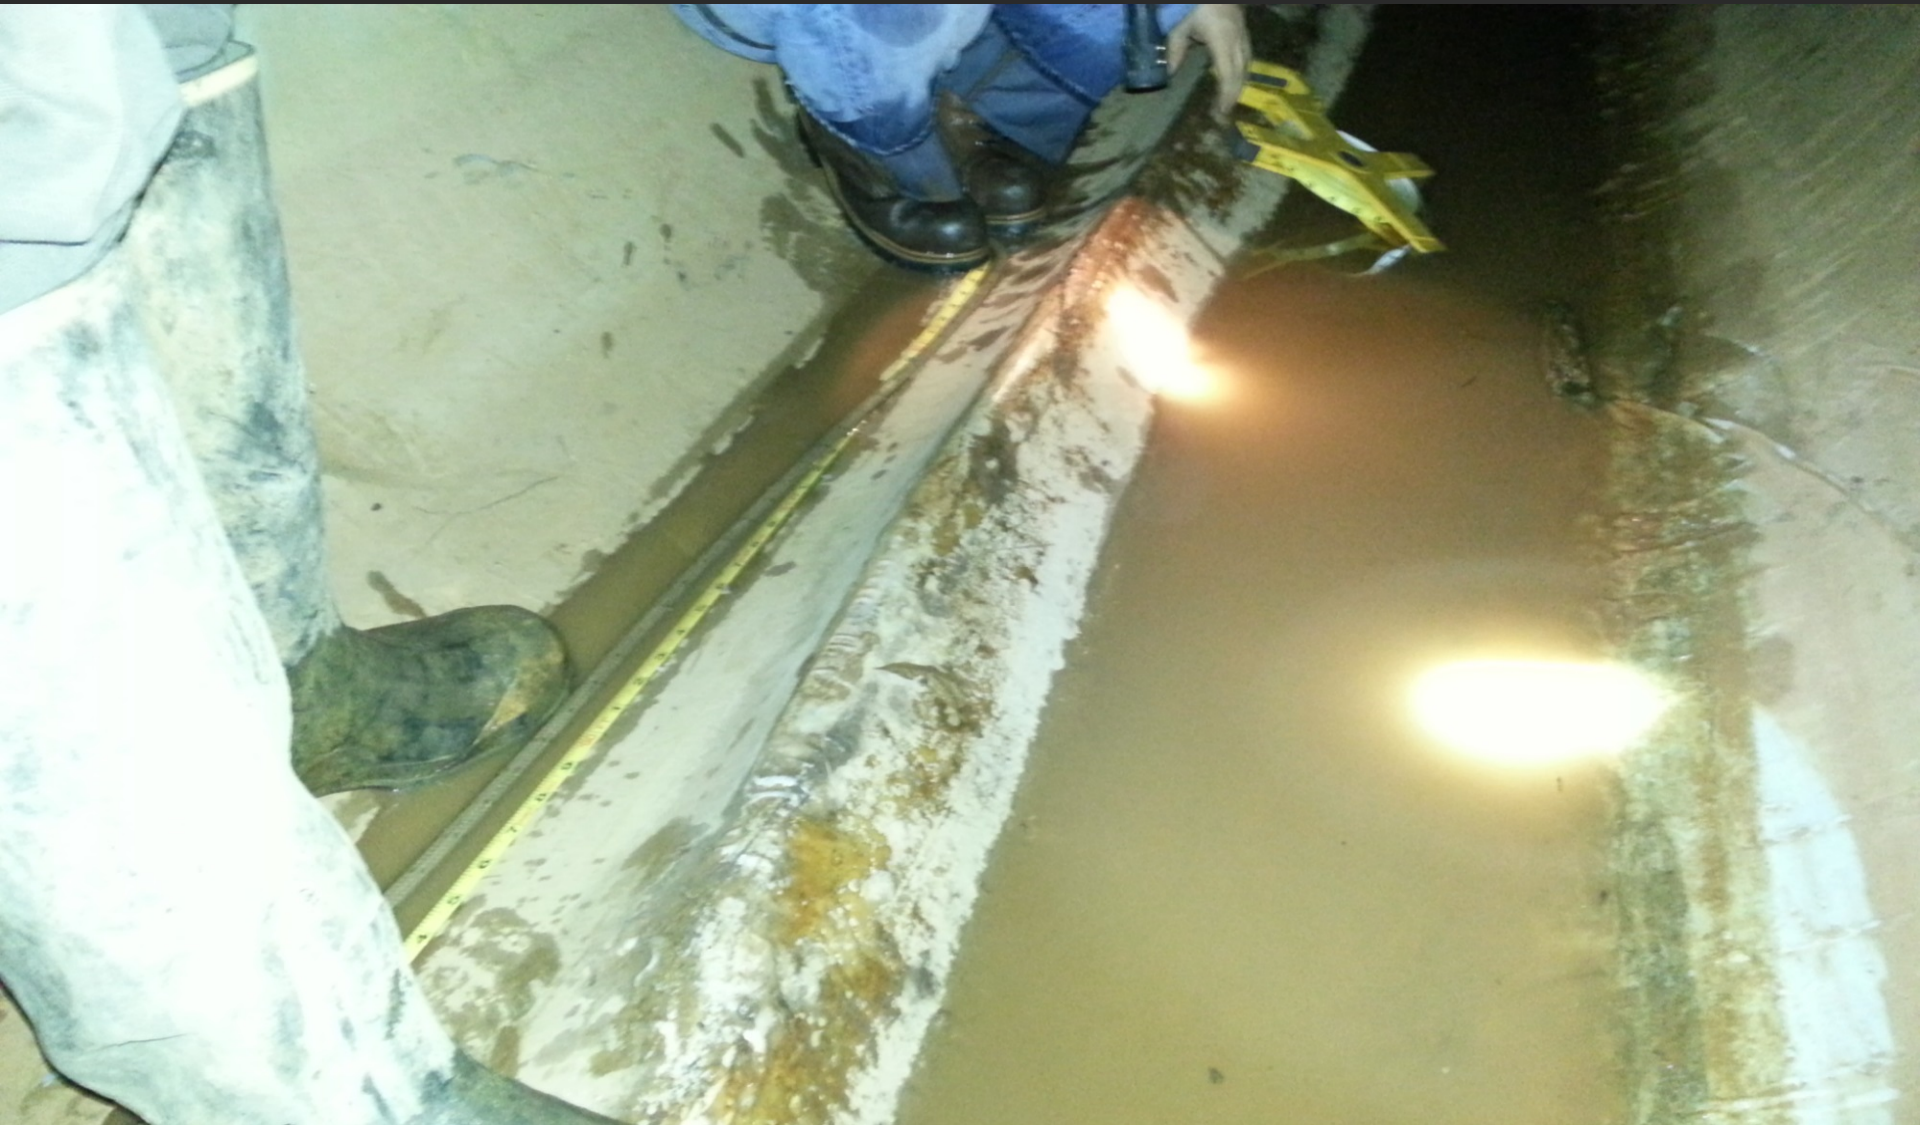
Defects Identified: CIPP Liner Inspection (6/6/2014)

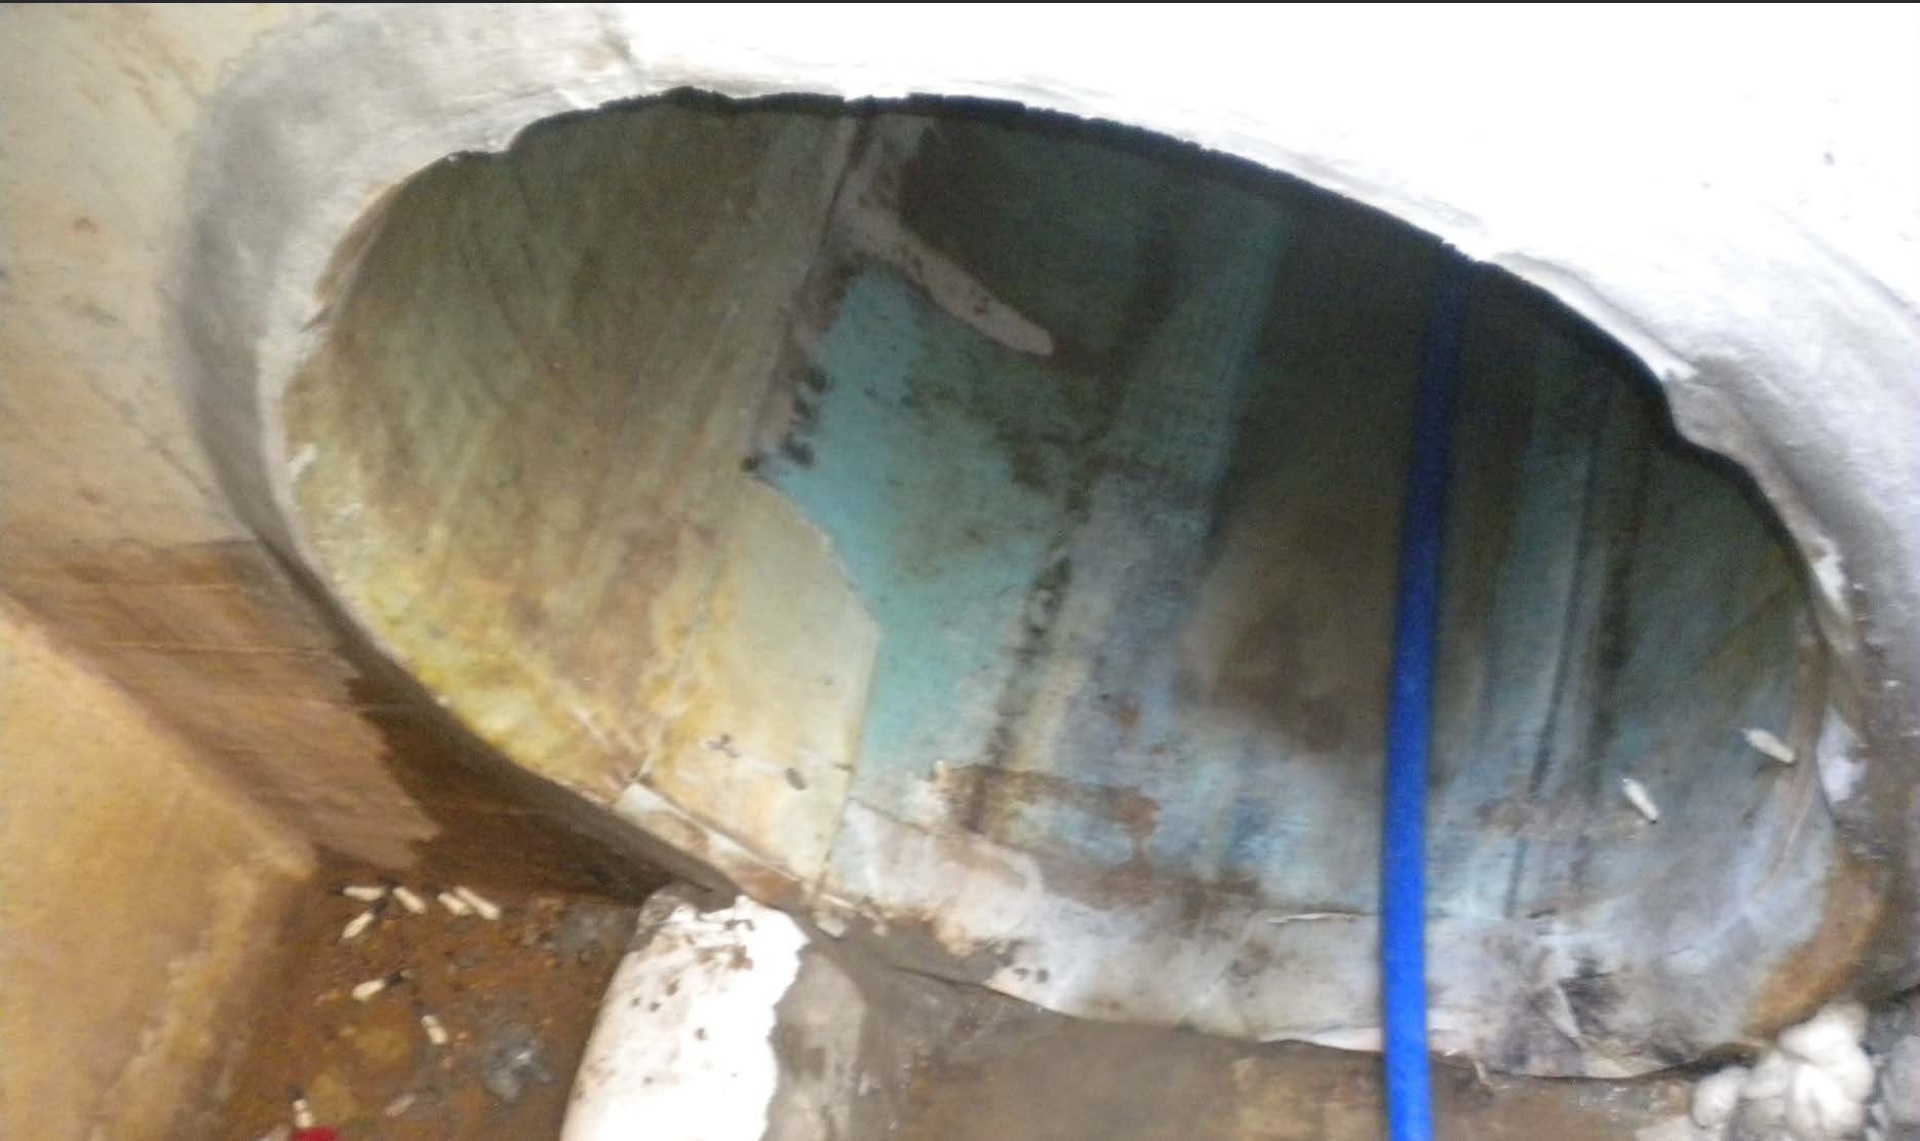
Warranty Repairs: Removal of defective top layer of liner

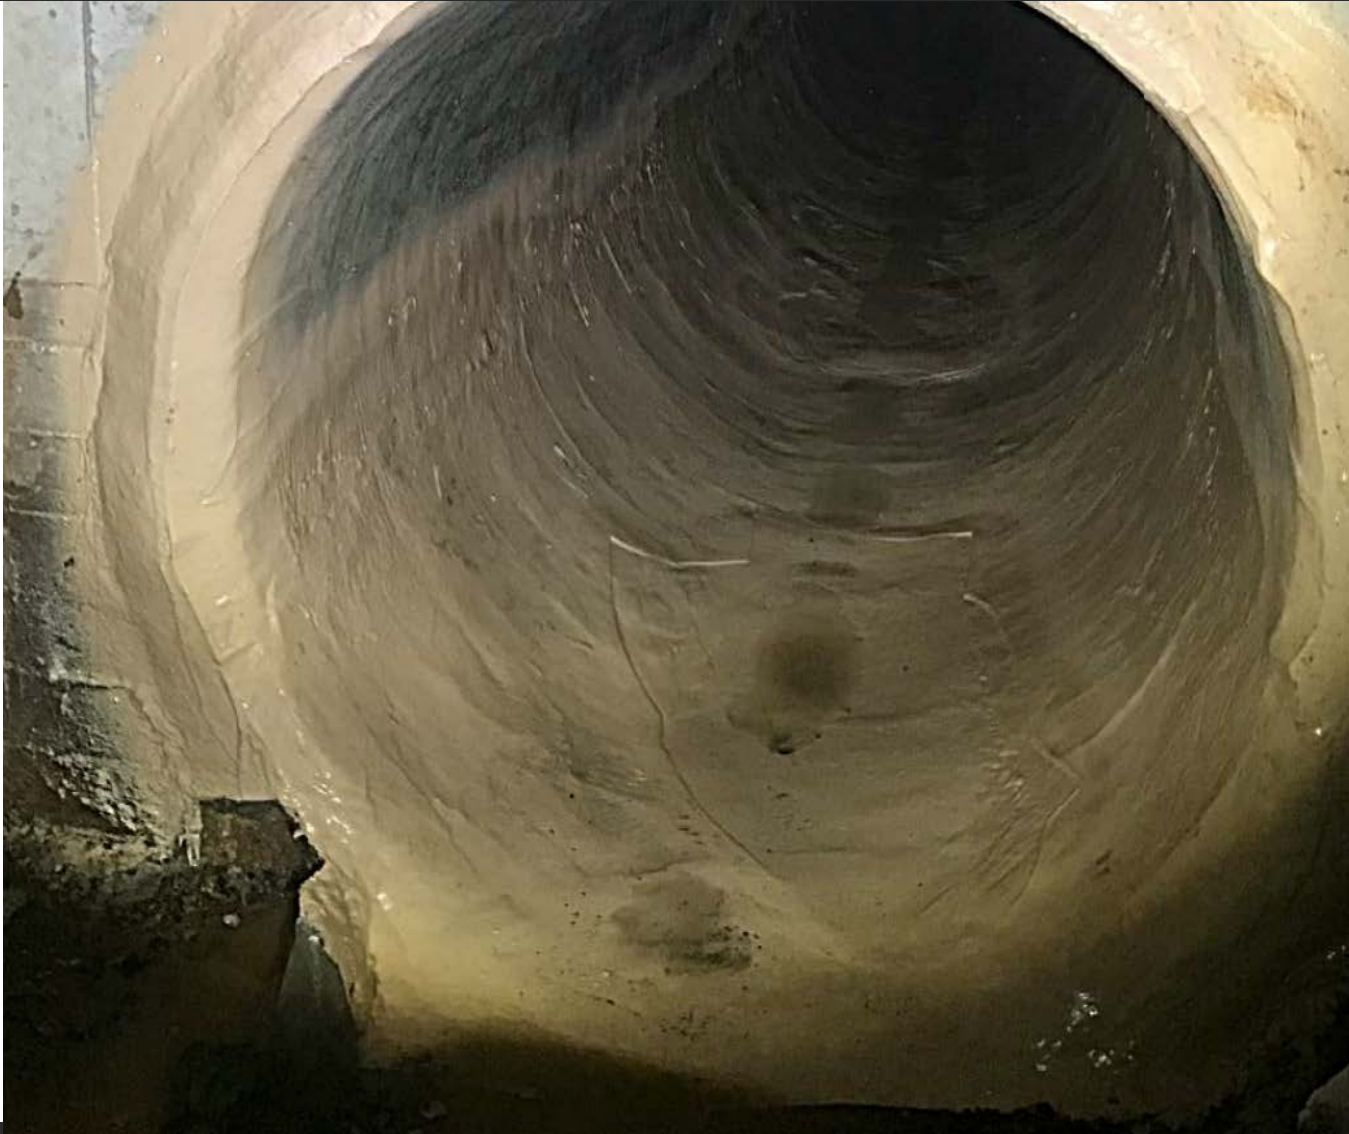
Warranty Repairs: Completed Liner Repair

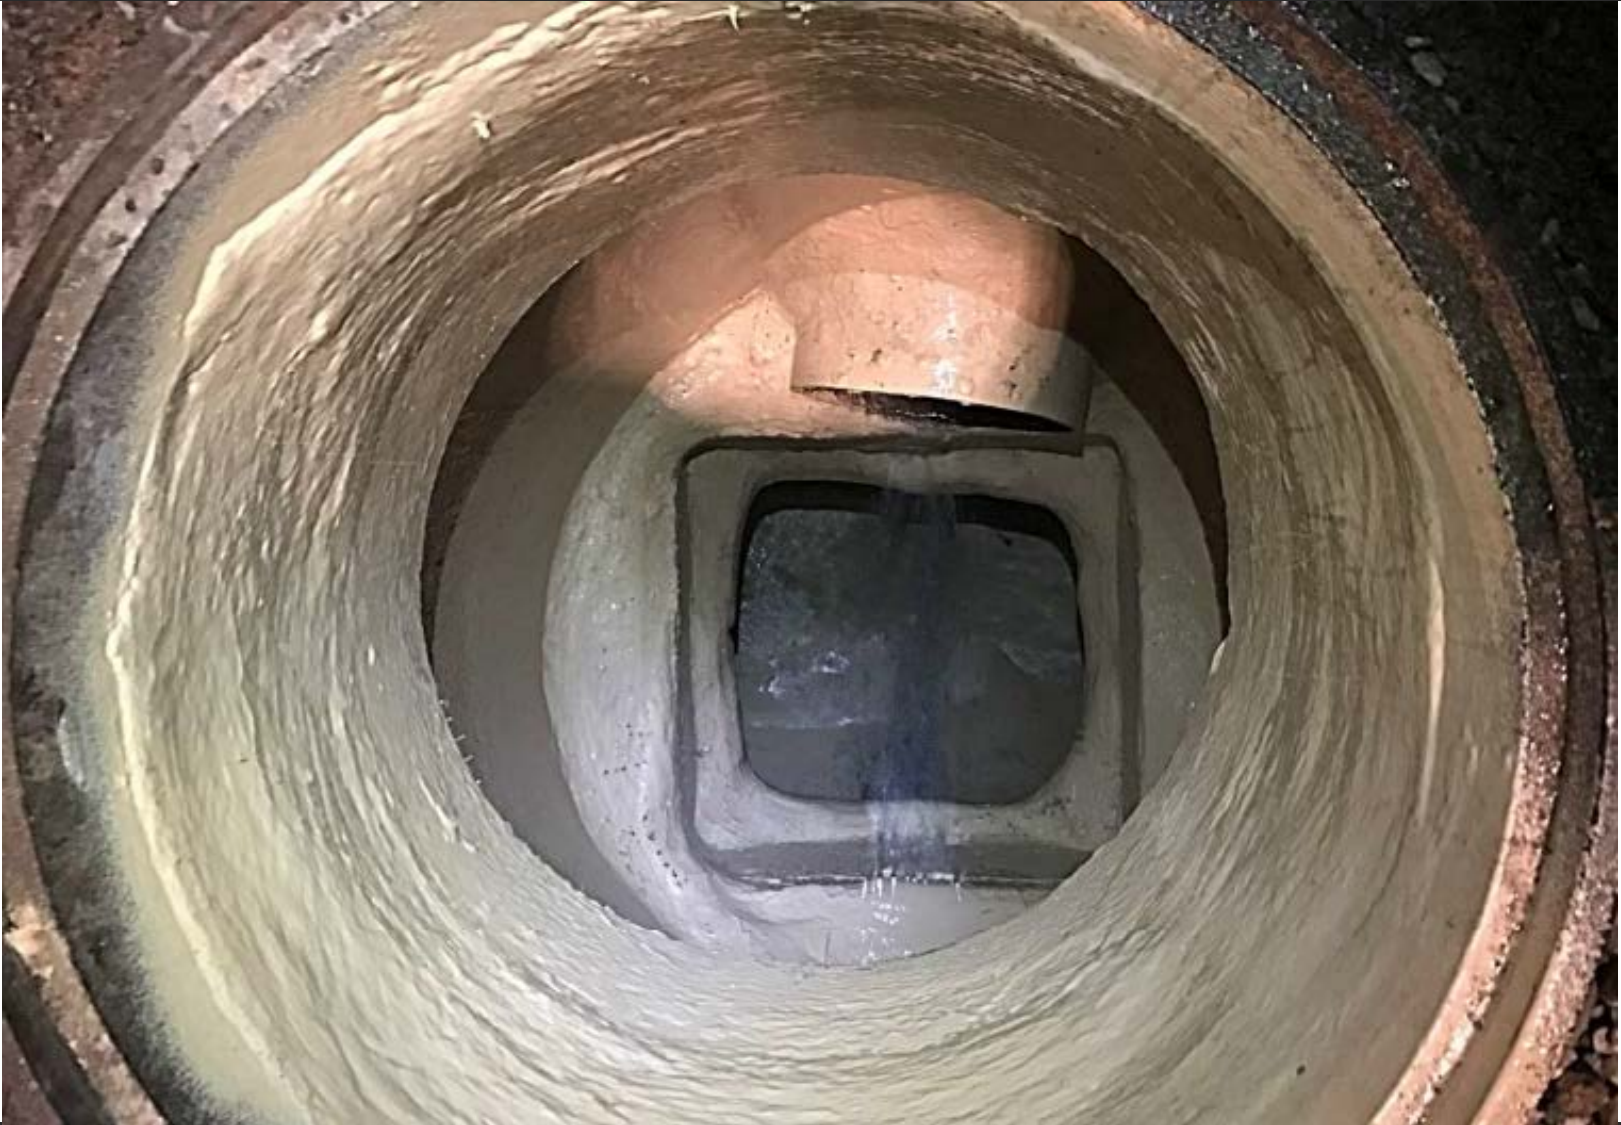
Warranty Repairs: Completed MH 306 Repair
