Rail Yard Case Study: Aging Subsurface Infrastructure and Environmental Issues

2015 Railroad Environmental Conference October 27 & 28, 2015

Stuart Boykin, CSX Transportation Mike Feamster, Ramboll Environ Tobias Parker, Ramboll Environ

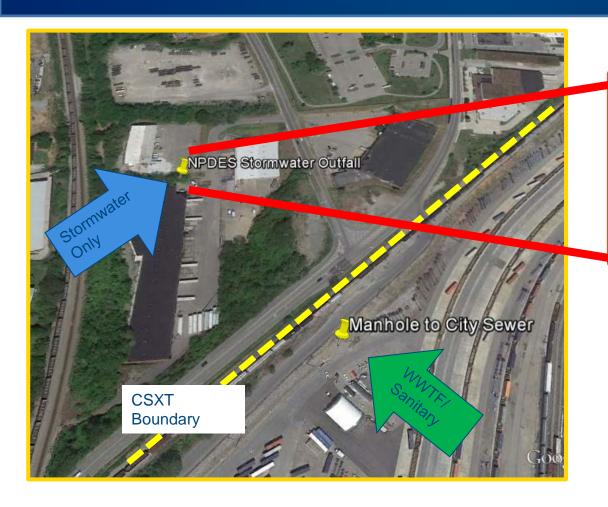
NPDES OUTFALL

Late February 2014, a sheen was identified at NPDES Outfall, not at SW plant

- There was no visible source of sheen from stormwater system
- Investigate outside CSXT property
- Reduced known flow to stormwater outfall
- Inaccurate/incomplete documentation led to involved investigation

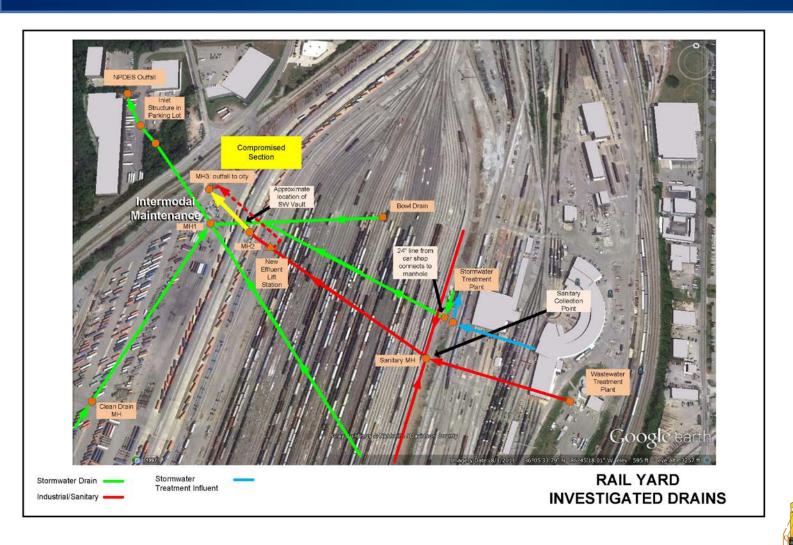
Identified compromised sanitary sewer pipe 50 feet below ground

The only pipe to city sewer was inoperable

Divert flow away from collapsed pipe

Sanitary wastewater- collected in frac

tanks; discharge to city

WWTF effluent-diverted to stormwater treatment plant; discharge to NPDES outfall

> Installed tertiary treatment at WWTF

Flushed stormwater treatment plant upstream piping

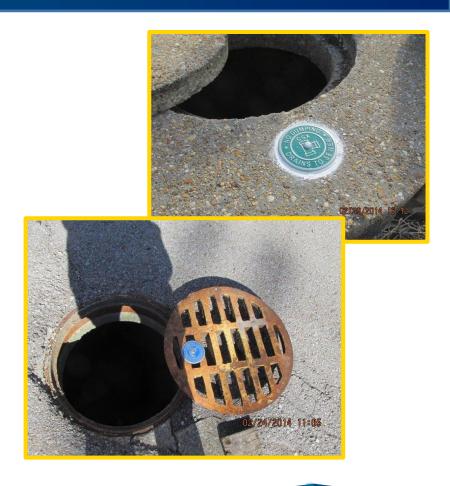
- Located previously unidentified influent and effluent piping
- Identified unique connections
- Identified properly labelled manholes
- Identified compromised pipe

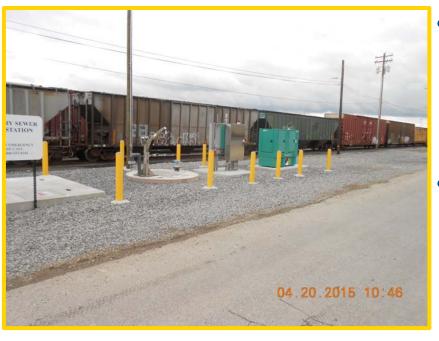
- Compromised pipe 50-ft deep under active tracks
- Pump station location
 - Near compromised pipe
 - Remote from WWTF
 - Accessible for construction and maintenance
- Remote location challenges:
 - Independent power and controls
 - Telemetry for remote monitoring and controls
 - Redundant (Fail Safe) pump, power and controls

Installed triplex pump station:

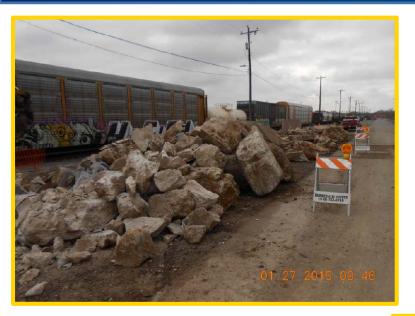
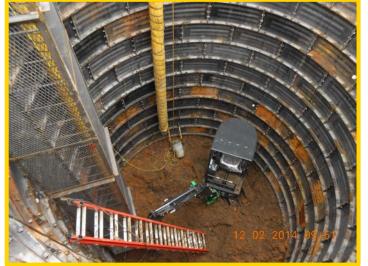
- Underground challenges: boulders, piping, cables, signal lines
- Active Rail Yard; (~50 feet between track and access road)
- Significant Depth (>40 feet)
