Concrete Ties – The Amtrak Experience

Alfred J. Cloutier
Assistant Deputy Chief Engineer - Track

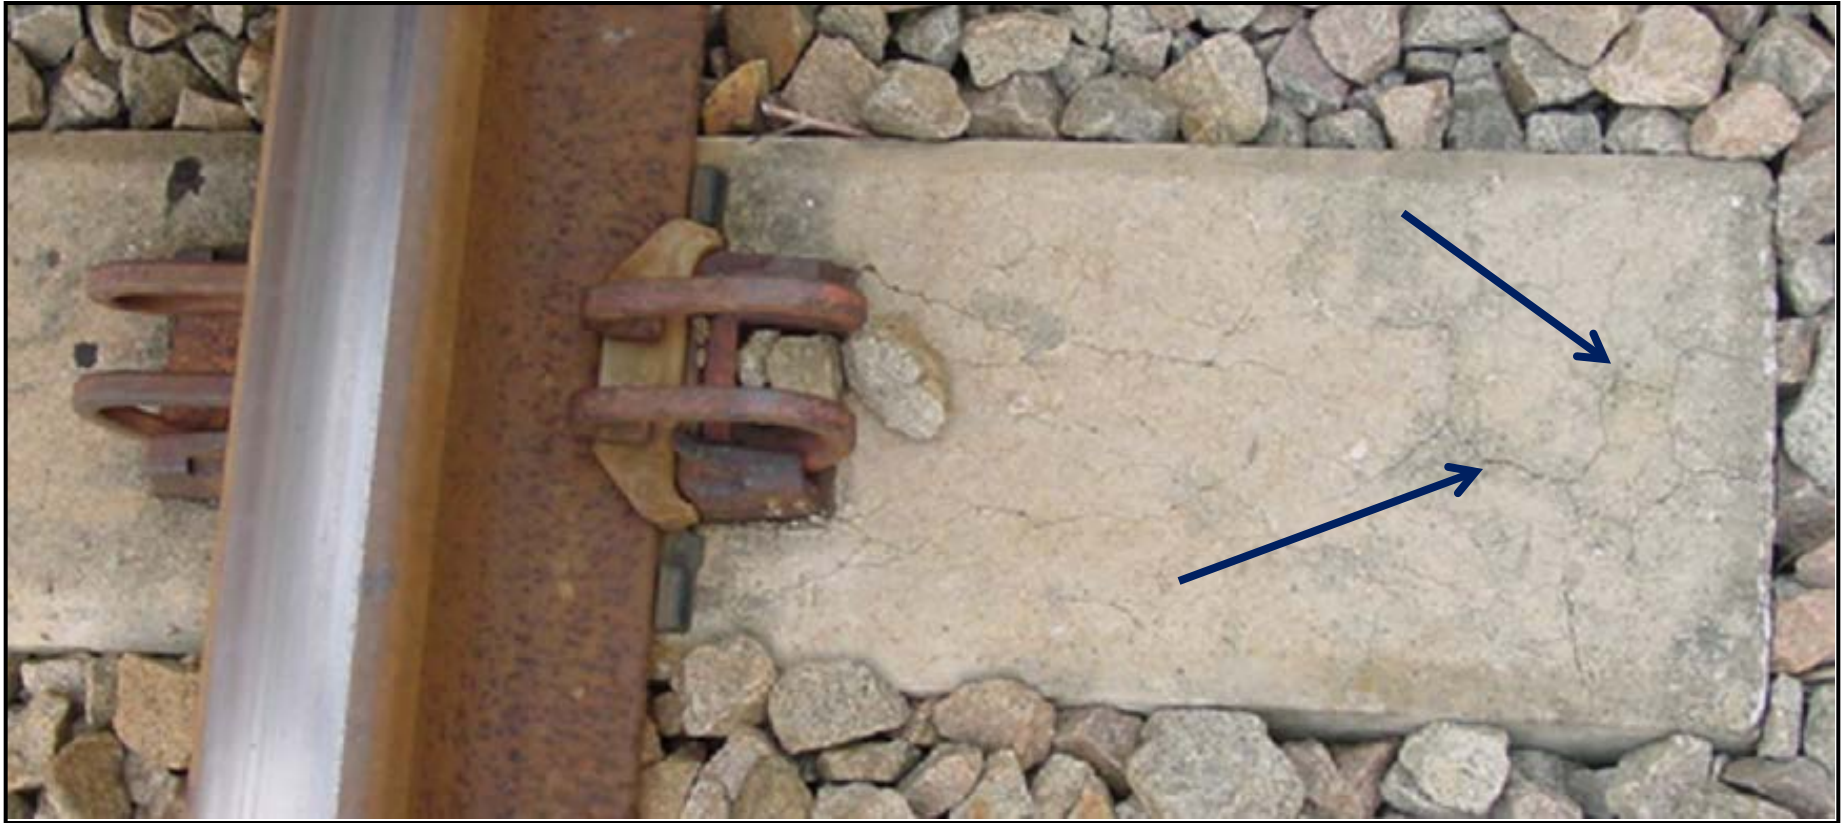
Initial Appearance of ASR/DEF

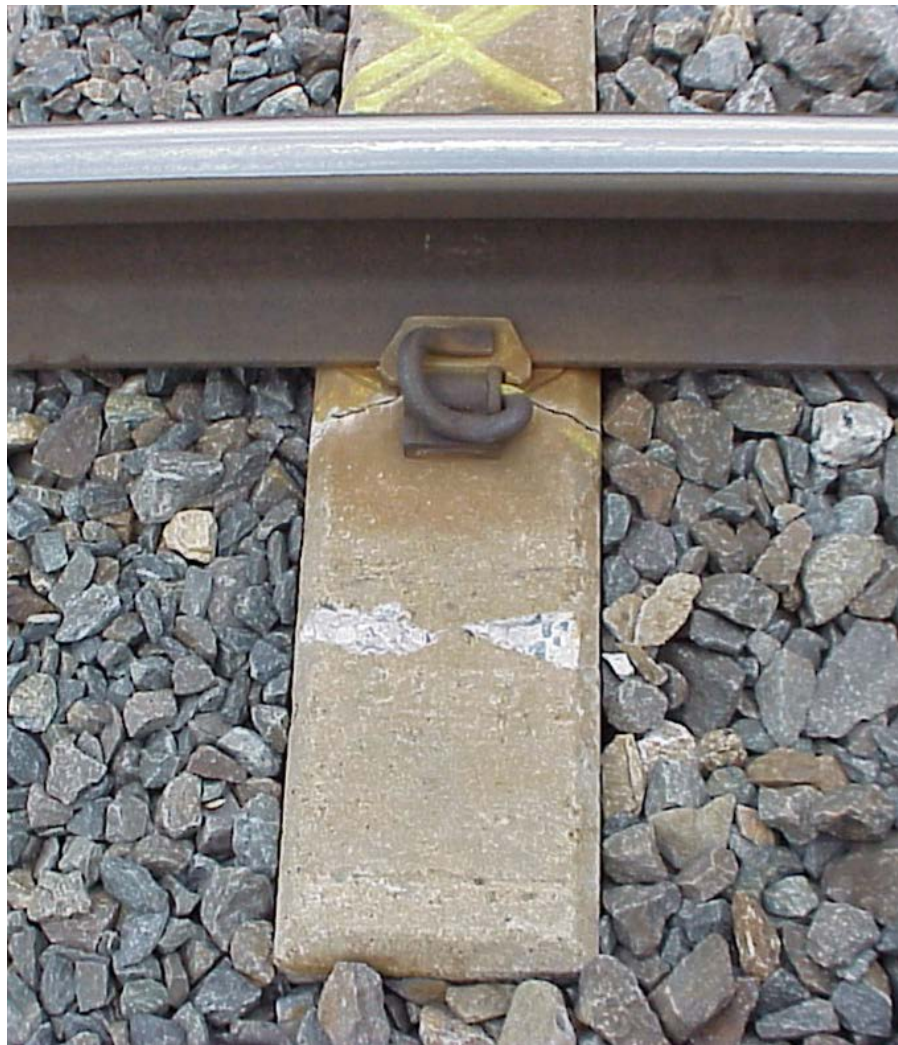
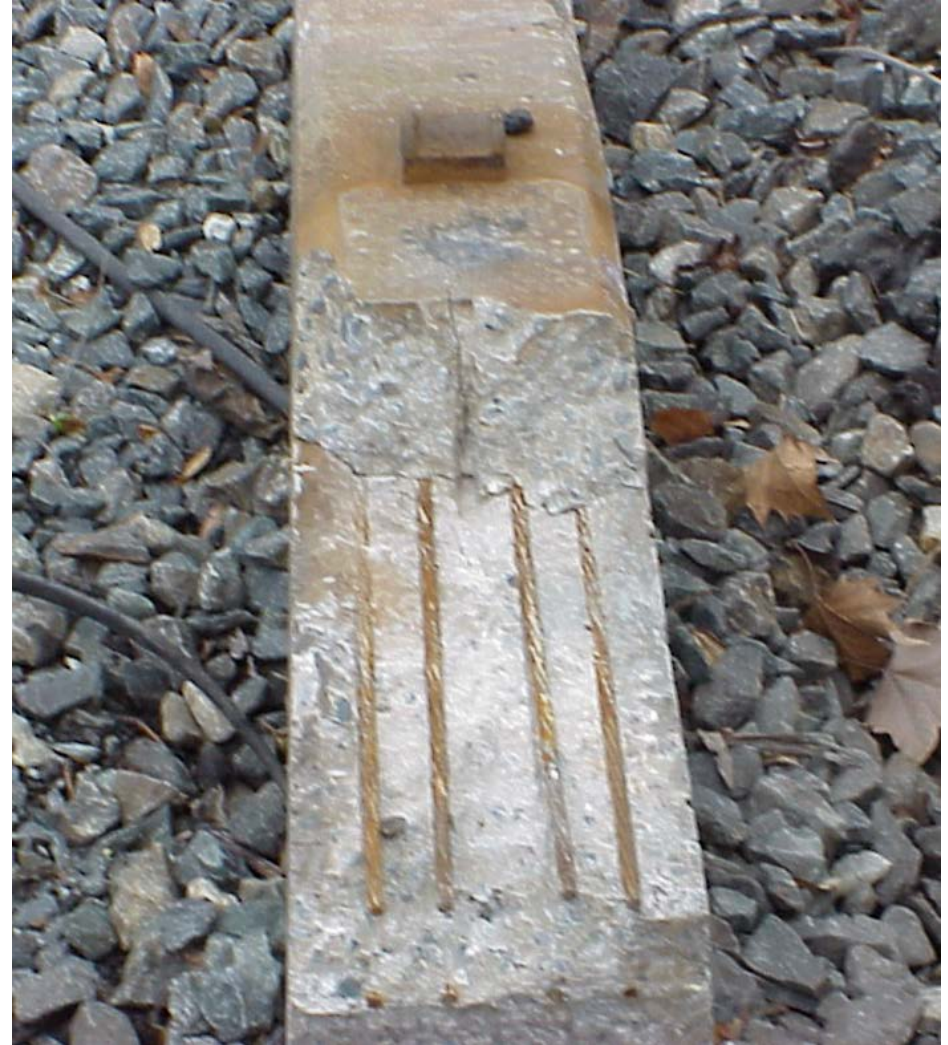
Concrete Tie Failures

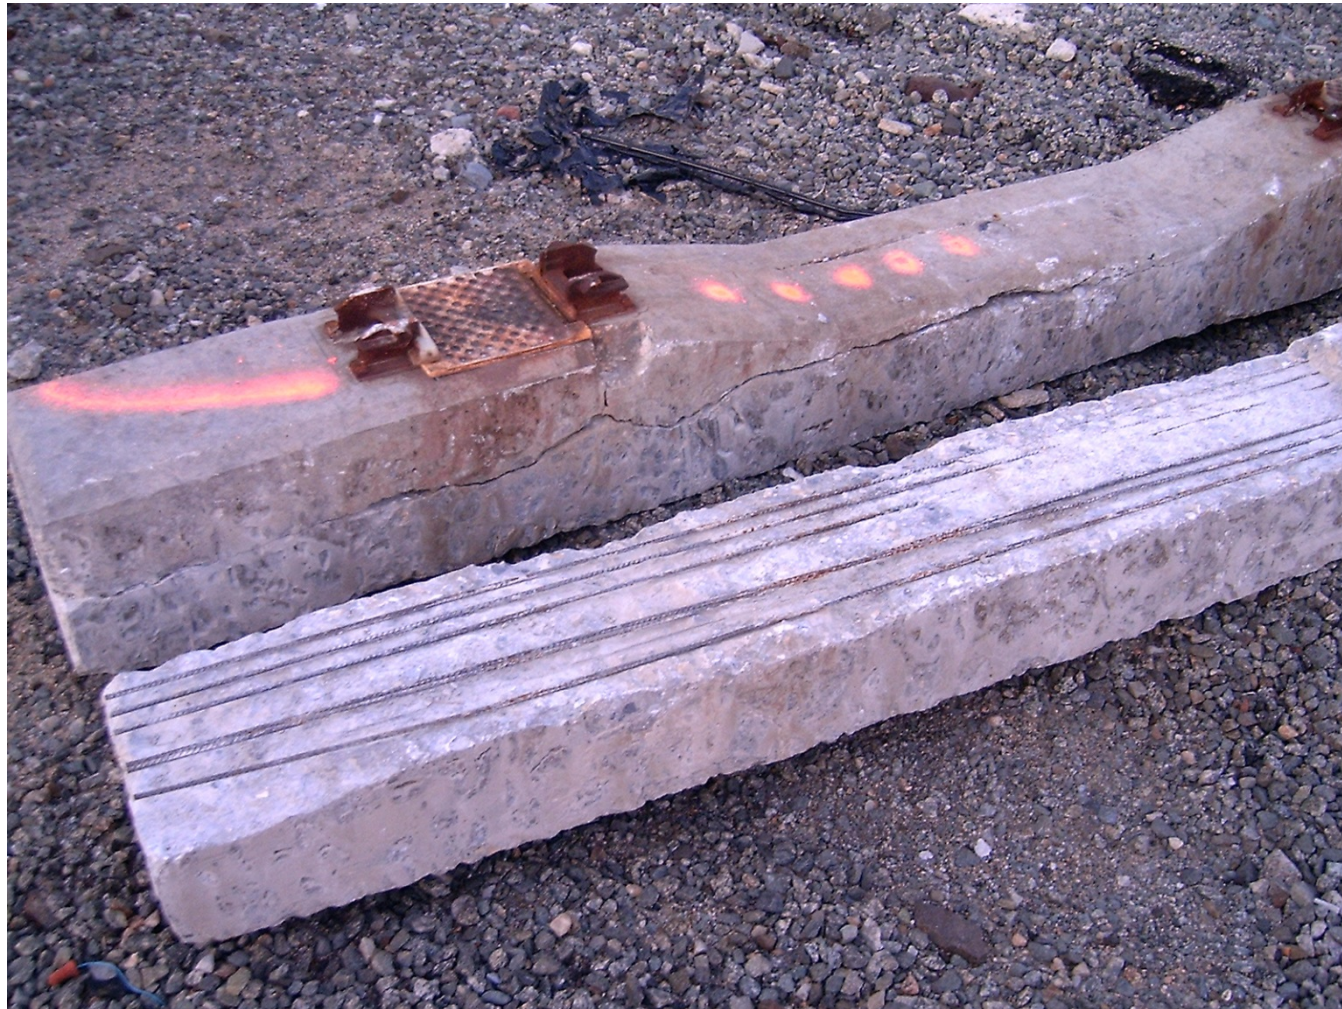
Concrete Tie Failures

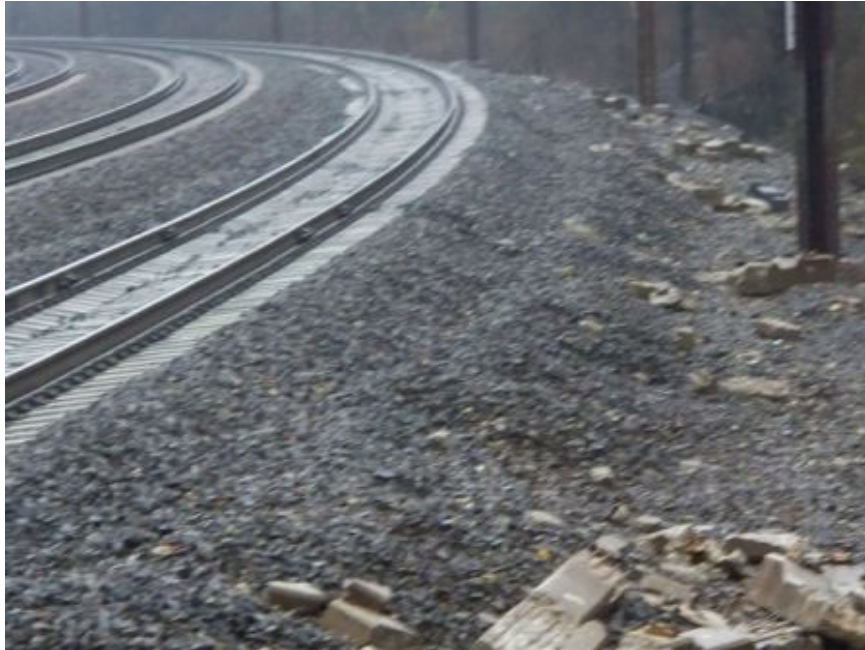
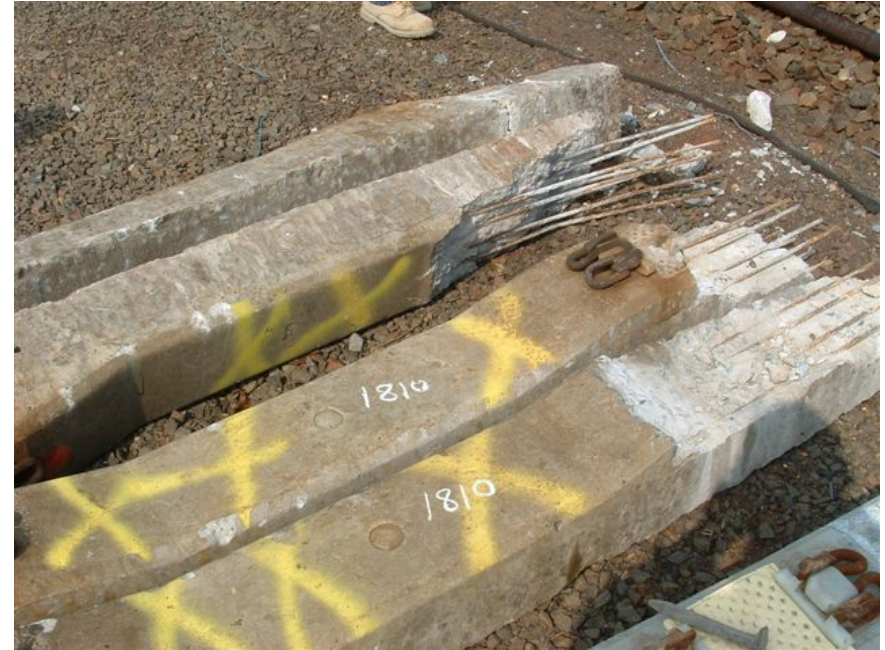
Breakage increases handling cost

- Regular production machinery cannot always handle
- Debris from breakage clutters right-of-way

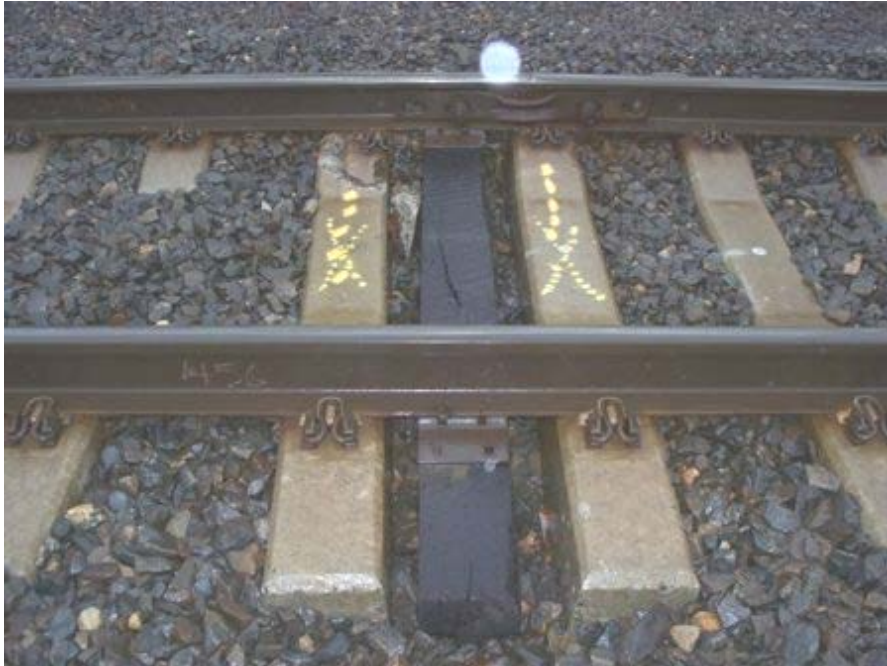
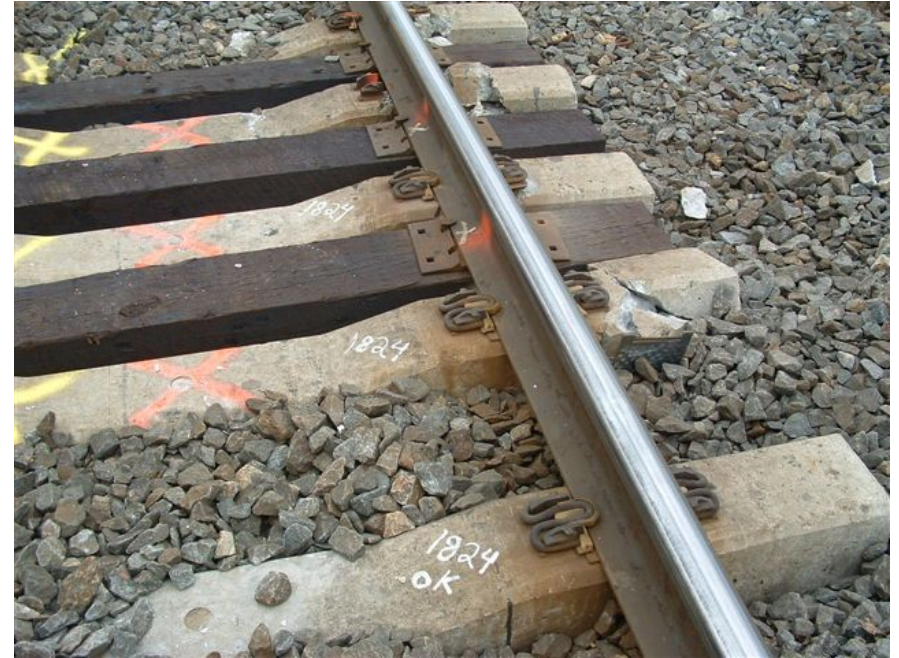
- Temporary solution to slow orders causes rework
- Laced wood ties also cannot be surfaced

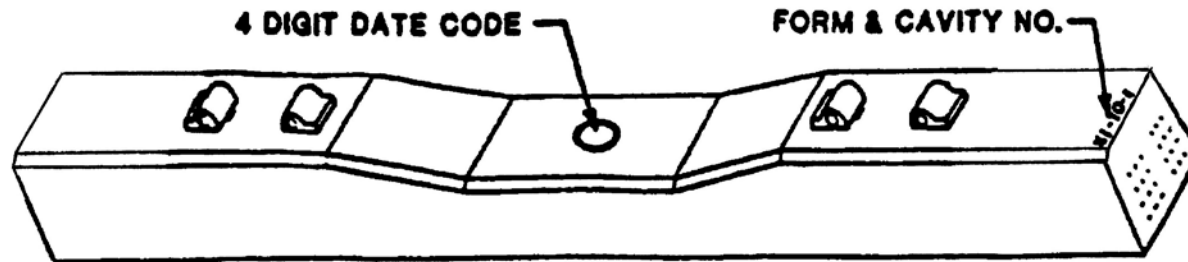
GRADE 1

Description: The tie shows no cracks, the shoulders are tight. This is an effective tie.

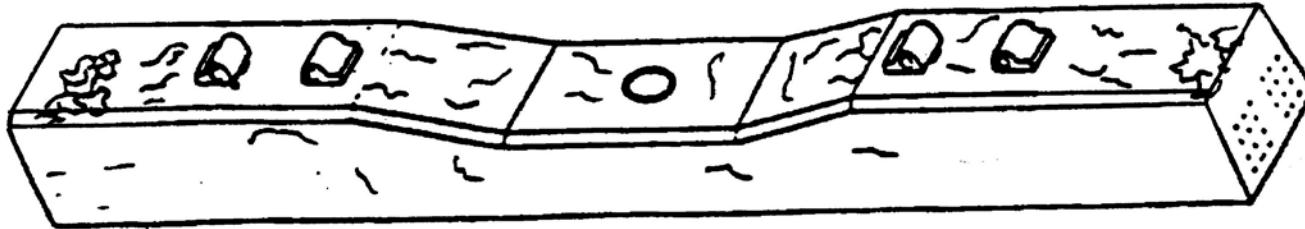
GRADE 2

Description: There is faint surface cracking on the surface of tie. The tie has the appearance similar to alligator skin. There is slight unconnected cracking near shoulders. The cracks are tight and concrete cannot be lifted out with a knife blade.

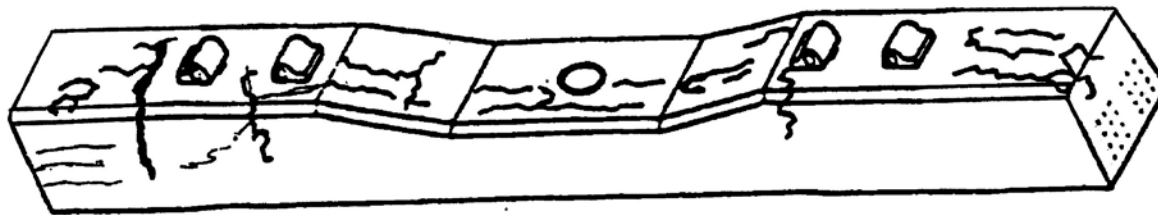
GRADE 3

Description: There are multiple cracks, either longitudinal or connected, in sections A, B or C. There is no connection of cracks observed in the rail bearing area. Cracks are tight and do not go through tie.

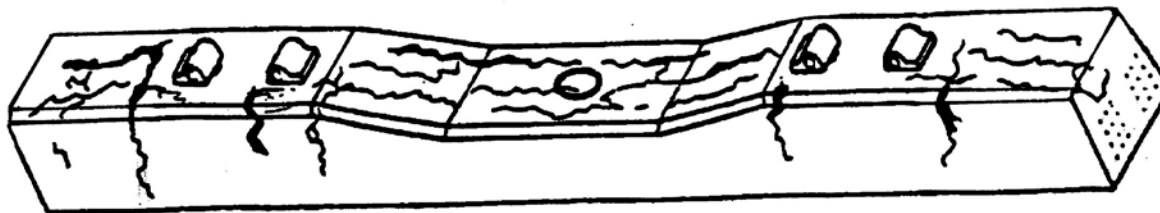
GRADE 4

Description: There is a combination of longitudinal and transverse connected cracks in both directions. Multiple cracking exists on ends and through center of tie. Transverse cracks in the shoulder area have joined together, which is a possible indication that the tie will fail in a short period of time. Clips and shoulders are tight with no change in gage. This tie could deteriorate rapidly to total failure.

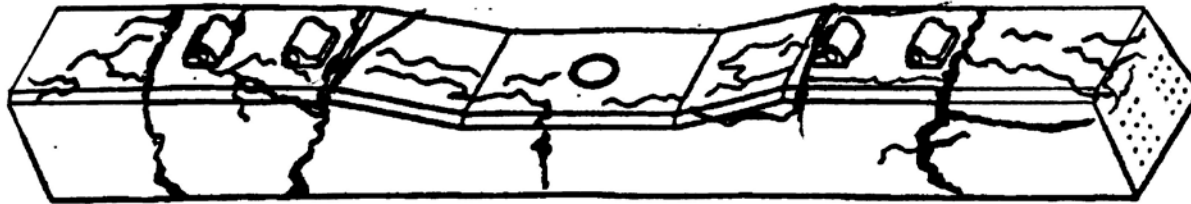
GRADE 5

Description: The concrete tie shows through transverse and/or longitudinal cracks. There is a loss of clip load. Cracks are wide. Large cracks in the shoulder area have joined together. The tie may also show crumbling or breaking apart in the shoulder/rail seat area. Expansion of gage may be evident. This tie is structurally ineffective, is considered defective and must be replaced.
