CHARACTERIZING AND INSPECTING FOR PROGRESSIVE EPOXY DEBONDING IN BONDED INSULATED RAIL JOINTS

09-1793

15 March 2009

Submitted for consideration for presentation and publication
88th Annual Meeting of the Transportation Research Board
Washington, DC – January 2009

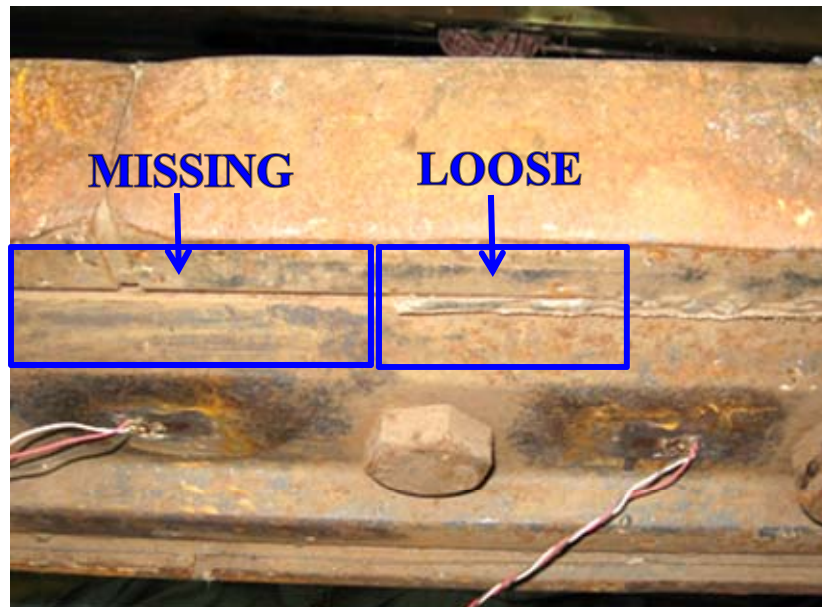
- 1.) **Loose:** some or all of the insulator and excess epoxy was still present, but it was no longer sealed to the metal surfaces. In other words, this section of the edge of the insulator layer was pulling away from the joint.
- 2.) **Missing:** no epoxy or insulator was visible at the top edge of the joint bar. This does not necessarily imply that the insulation between the rail and joint bar had worn away completely, only that the outside edge – the part that fills the space between the fillets on the top outer edge of the joint bar and the bottom outer edge of the rail head – had broken off.

Generally damage of both types extended outward from the endpost, with the region of missing insulator (if any) occurring closest to the endpost and the region of loose insulator occurring adjacent to the missing section. This suggests that the outer edge of the insulator and excess epoxy tends to loosen before eventually cracking off. In view of this, two damage metrics were adopted:

**Figure 1: Classifications of damage to the top edge of the insulator layer.
(a) Loose and Missing. (b) Loose only.**

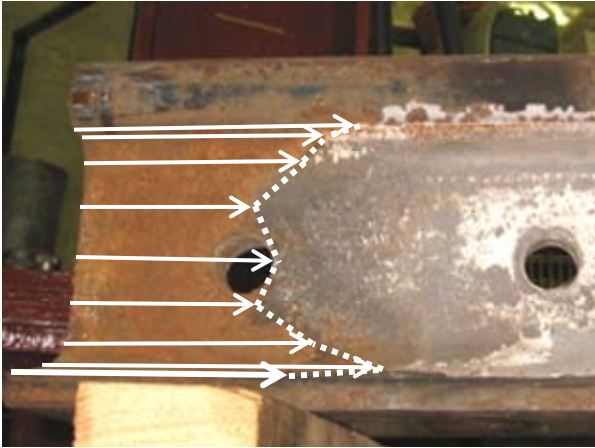
The interior surfaces of the joint were then examined. The areas that had been affected by progressive epoxy debonding can be identified visually in a disassembled joint (2). Areas where the epoxy debonded during the IJ's service life have a reddish or brown color due to oxidation on the unsealed metal surfaces. Areas where the metal is visible but shiny and unoxidized show where the epoxy pulled away from the metal only during disassembly. Such a surface appearing on the rail will usually be matched at a corresponding location on the joint bar by clean epoxy or a clean insulating fibers, and vice versa. Finally, areas with clean, exposed fibers on both sides indicate that the insulator fabric itself fractured, implying that it was still bonded to both the rail and joint bar. Thus, a dark or reddish color indicates an area that debonded before disassembly, while a light, epoxy-colored, or shiny surface indicates a part of the layer that stayed bonded until disassembly.

For each test specimen, the distance from the endpost to the first intact epoxy was measured along 9 horizontal lines – 3 on the underside of the rail head, 3 on the web, and 3 on the top side of the base (Figure 2a). These measurements were repeated for each of the four rail / joint-bar interfaces, on both the rail and the corresponding joint bar. (For two joints, TB1 and TB2, only one joint bar was successfully removed; therefore, only two rail / joint-bar interfaces were available for measurement.) When the measured distance on the rail differed from the measured distance on the joint bar, the maximum value was used. These one-dimensional measurements were then used to estimate the shape and area of the debonded regions.

Figure 2: Disassembled IJ's. (a) Measuring the debonded region. (b) Inclusive versus Strict debonding.

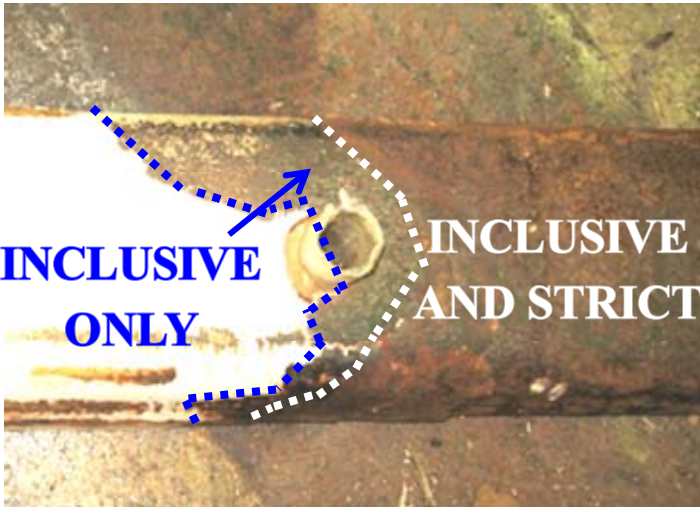
(b)

- 1.) Areas where small dark red or brown patches were speckled with other light-colored patches.
- 2.) Areas with dark brown or black, but not reddish, discoloration. All of the bonded metal surfaces should have remained clean and shiny while sealed beneath the epoxy. Given that such areas tend to occur in proximity to heavily rusted areas, they might show where the surface has debonded and been exposed to air and moisture, but not long enough for visible rust to form. On the other hand, a dark color could simply mean that some carbon or dirt was present when the joint was assembled. It could also indicate some chemical process in the curing epoxy, which might or might not affect bond strength.

It is difficult to say whether these phenomena indicate anything that would affect joint performance. Therefore, two sets of measurements were included in this study. One set, called the “Inclusive” measurement of debonding, included all areas with dark discoloration or heavy speckling. The other set of measurements, referred to as “Strict” debonding, included only those areas where reddish brown rust or dirt covered all or most of the surface. An example of the difference between the two measurement sets is shown in Figure 2b. The area of the debonded region measured using the Inclusive criteria is referred to as A_i , while the area measured using the Strict criteria is A_s .

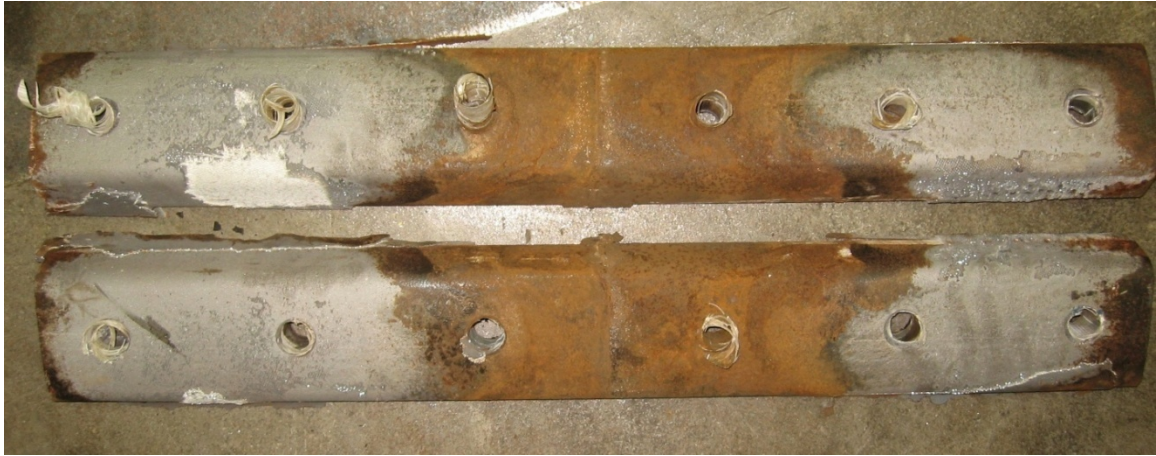
In addition to the distribution of debonding over the different rail / joint-bar interfaces, some consideration must be given to the shape of the debonded region. As noted above, debonding tends to begin near the endpost and grow outward towards the edges of the joint bar; however, the interface between bonded and debonded is usually not a straight vertical line. More common is a “V” or “U” shape (Figure 3a), where debonding extends farther along the top and bottom of the interface than along the bolt line.

The characteristic shape in Figure 3a corresponds to values of H and B that are larger than W . It appears that debonding tends to begin along the upper and lower edges of the interface (Figure 3b) – that is, H and B grow to a certain value while W remains small. It is assumed that after a certain amount of degradation all three measurements start to grow equally, so that $H-W$ and $B-W$ remain approximately constant.

Figure 3: Shape of debonded region. (a) Debonding (dark area) extends farther on head and base than on web. (b) Onset of debonding at endpost.

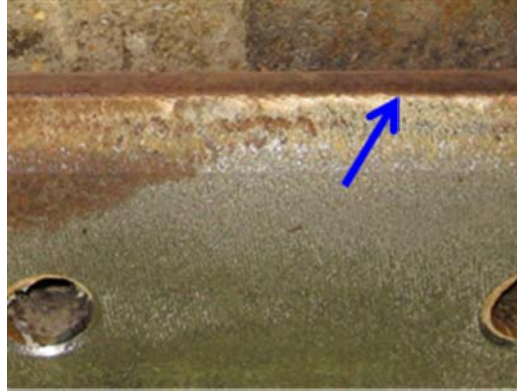
The visual inspection conducted in this study examined the top edge of the insulator layer where it is visible between the rail and joint bar. The debonding patterns observed in the disassembled IJ's suggested that inspecting only this part of the bond might be somewhat misleading. In some cases, disassembling the joint revealed that the outer edge of the insulator layer had itself come

debonded from the filleted edges on the rail or joint bar, but this debonding did not extend inwards past the fillets (Figure 4). More generally, the tendency for debonding to extend farther along the top of the interface than along the center is a potential problem for a measurement based only on the very top edge. However, comparing the results of the pre-disassembly inspection with the post-disassembly debonding measurements showed that the visual metric V_d can in fact be used to estimate the area of the debonded region with reasonable accuracy.

Figure 4: Debonding behind visible edge of insulator without corresponding debonding on hidden surface.
