Characterizing and Inspecting for Progressive Epoxy Debonding in Bonded Insulated Rail Joints

Daniel C. Peltier and Christopher P. L. Barkan

Transportation Research Record: Journal of the Transportation Research Board, No. 2117, Transportation Research Board of the National Academies, Washington, D.C., 2009, pp. 85–92.
DOI: 10.3141/2117-11

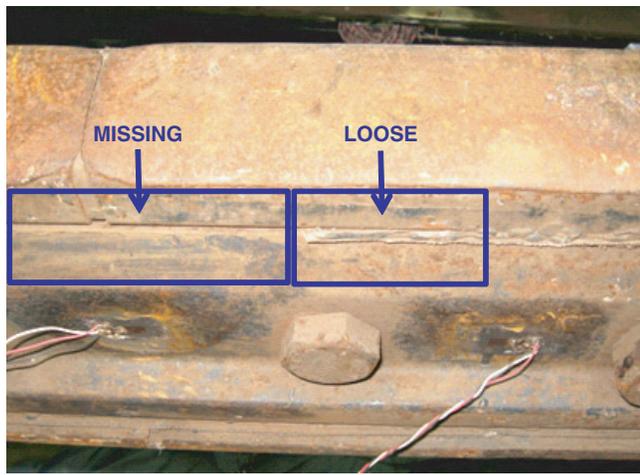
1. Loose. Some or all of the insulator and excess epoxy was still present, but it was no longer sealed to the metal surfaces. In other words, this section of the edge of the insulator layer was pulling away from the joint.
2. Missing. No epoxy or insulator was visible at the top edge of the joint bar. This does not necessarily imply that the insulation between the rail and joint bar had worn away completely, only that the outside edge—the part that fills the space between the fillets on the top outer edge of the joint bar and the bottom outer edge of the rail head—had broken off.

FIGURE 1 Classifications of damage to top edge of insulator layer: (a) loose and missing and (b) loose only.

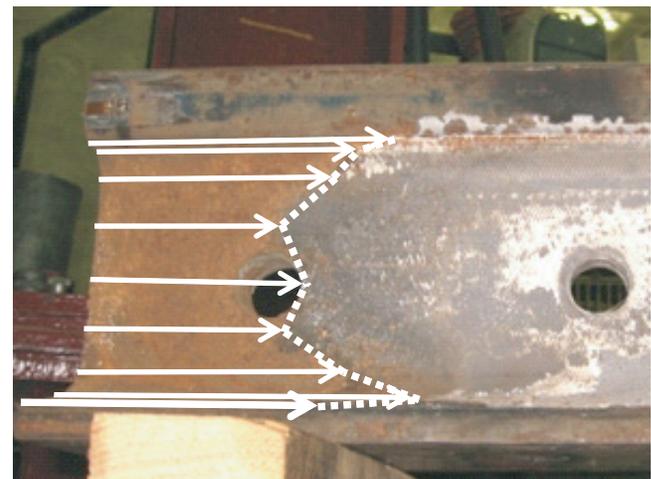
For each test specimen, the distance from the endpost to the first intact epoxy was measured along nine horizontal lines—three on the underside of the rail head, three on the web, and three on the top side of the base (Figure 2a). These measurements were repeated for each

FIGURE 2 Disassembled IJs: (a) measuring the debonded region and (b) inclusive versus strict debonding.

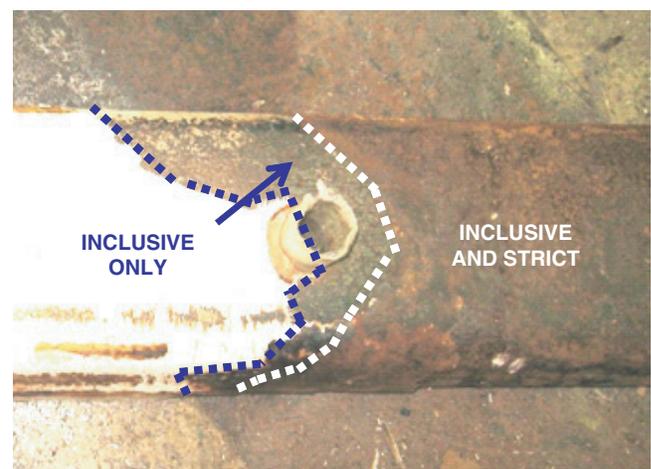
(b)

It is difficult to say whether these phenomena indicate anything that would affect joint performance. Therefore, two sets of measurements were included in this study. One set, called the inclusive measurement of debonding, included all areas with dark discoloration or heavy speckling. The other set of measurements, referred to as strict debonding, included only those areas in which reddish brown rust or dirt covered all or most of the surface. An example of the difference between the two measurement sets is shown in Figure 2*b*. The area of the debonded region measured using the inclusive criteria is referred to as A_i , whereas the area measured using the strict criteria is A_s .

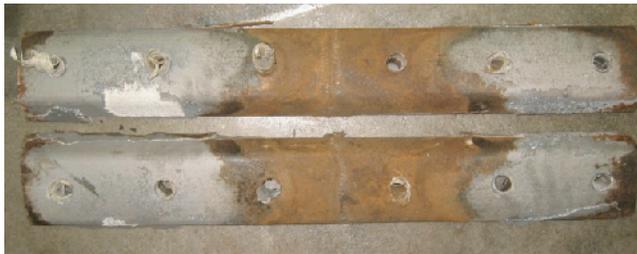
The characteristic shape in Figure 3a corresponds to values of H and B that are larger than W . It appears that debonding tends to begin along the upper and lower edges of the interface (Figure 3b); that is, H and B grow to a certain value while W remains small. It is assumed that after a certain amount of degradation all three measurements start to grow equally, so that $H-W$ and $B-W$ remain approximately constant.

FIGURE 3 Shape of debonded region: (a) debonding (dark area) extends farther on head and base than on web and (b) onset of debonding at endpost.

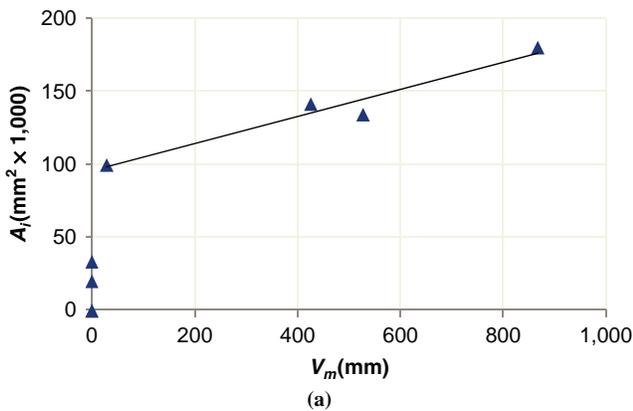
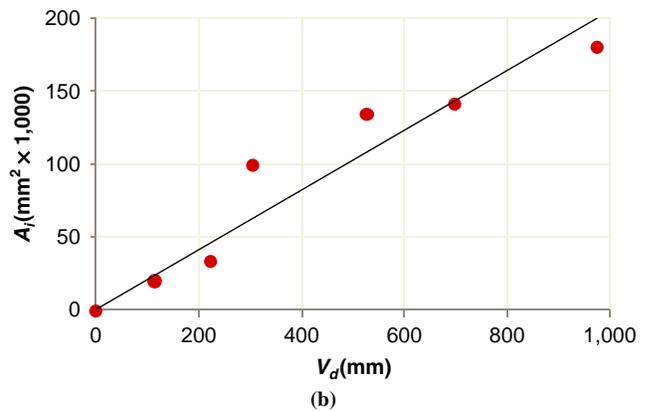
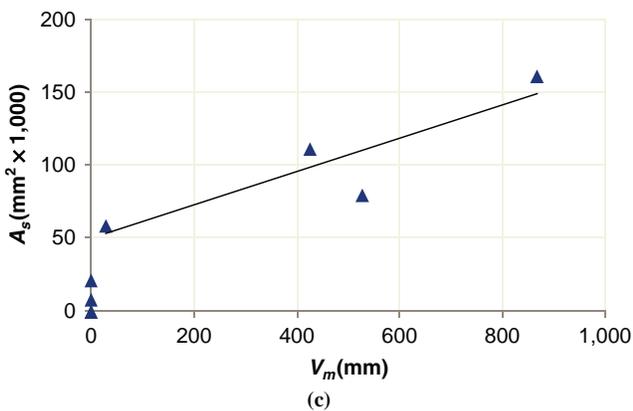
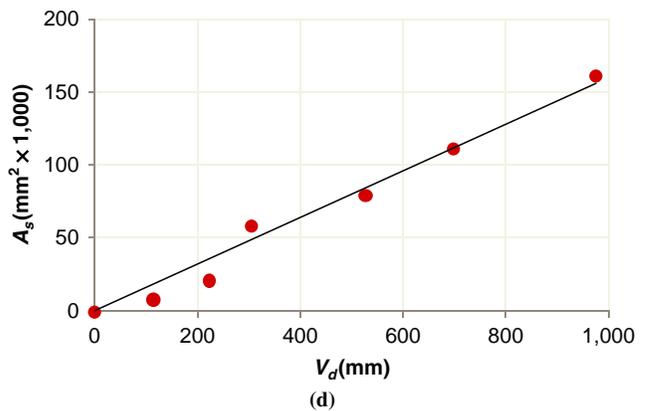
to pass through the origin, was fit to these data. V_m was complicated by several joints with measurable debonding having $V_m = 0$. It does appear that V_m has some relationship with debonding when it is nonzero, but the correlation is not as strong as for V_d . Therefore, it appears that V_d is a more useful indicator of debonded area than V_m .

FIGURE 5 Actual debonding versus visual inspection metrics for control and test specimens: (a) A_i versus V_m , (b) A_i versus V_d , (c) A_s versus V_m , and (d) A_s versus V_d .
