REPORT NO. ER-54

HOLD-DOWN FASTENINGS FOR TIE PLATES,  
INCLUDING PADS UNDER PLATES:  
THEIR EFFECT ON TIE WEAR

MARCH 1965

ENGINEERING RESEARCH DIVISION  
A.A.R. RESEARCH CENTER  
Chicago, Illinois  
60616

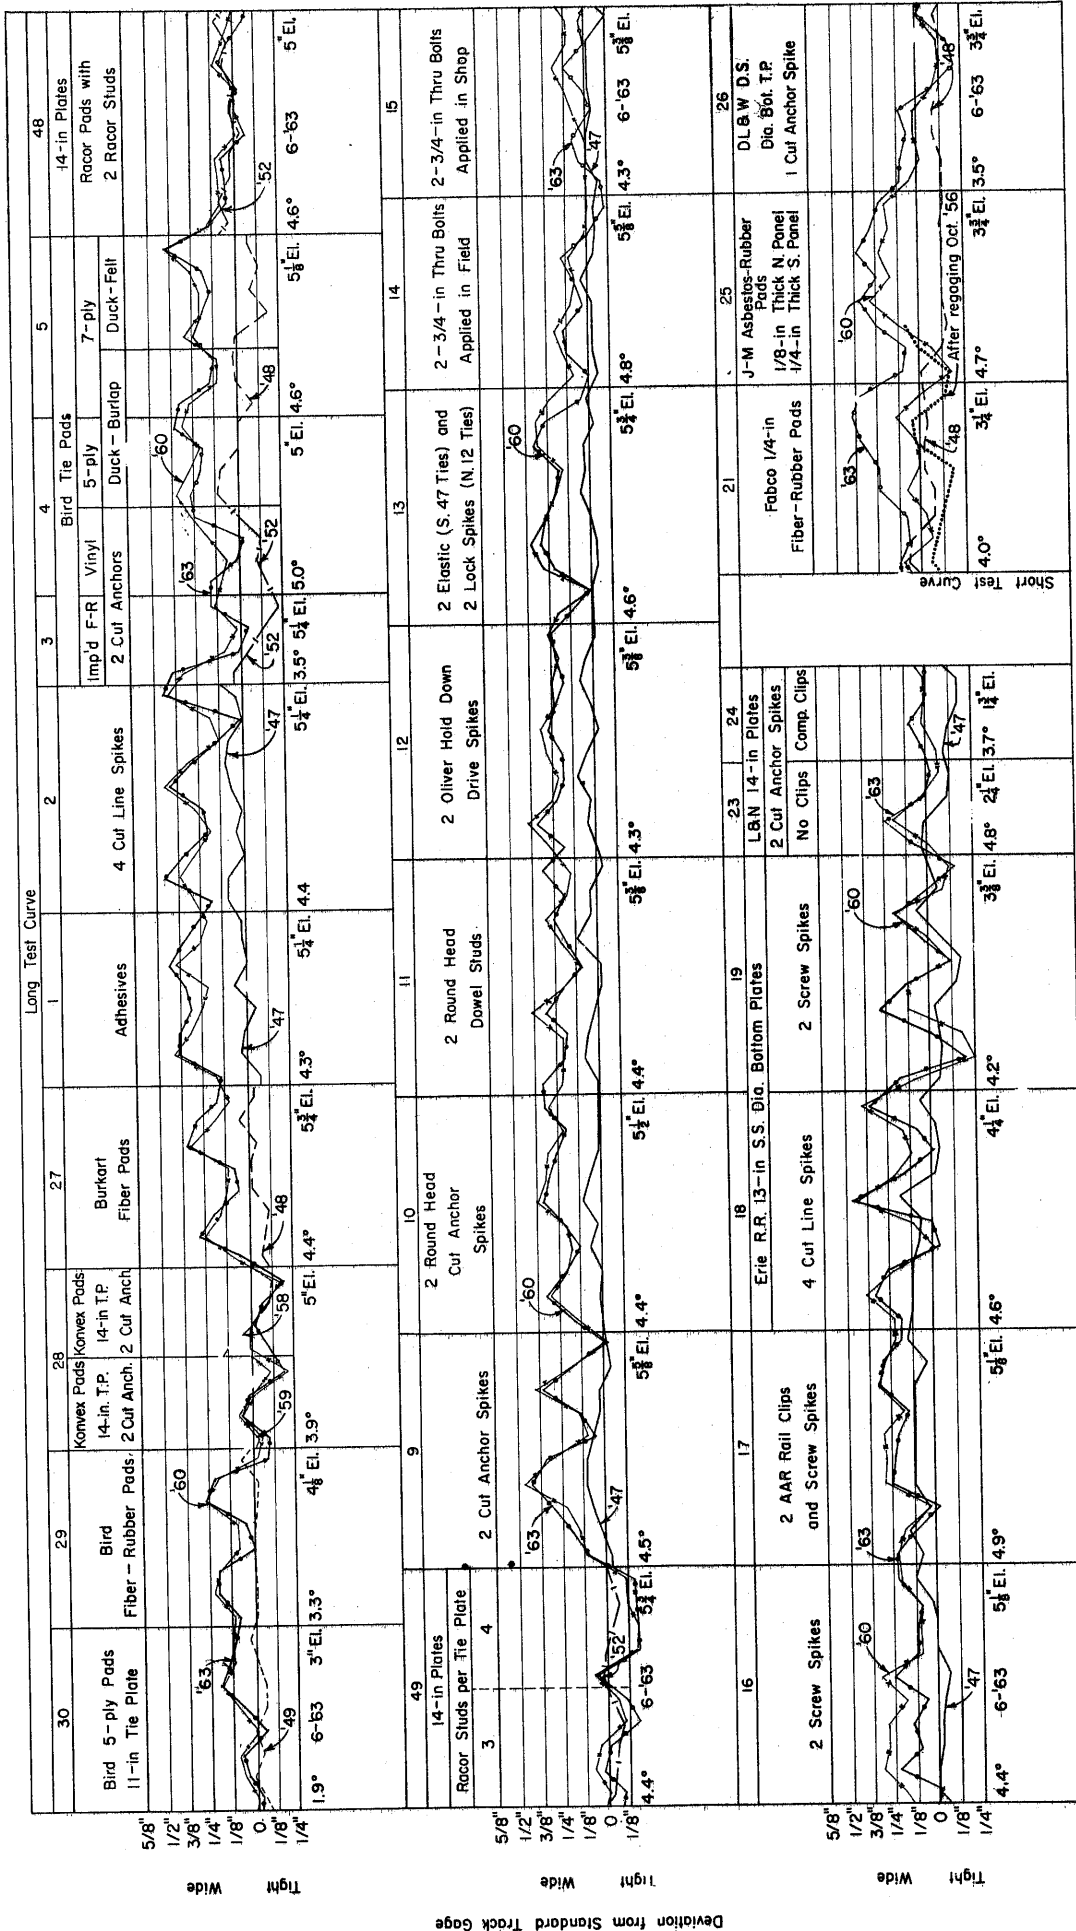
Fig. 27. Gage, Curvature and Elevation of Each Section of Test Track on the 4°-30' Curves, Mile L-154, L&NRR, near London, Ky.

Fig. 27 indicates the gage of the test sections on the two 4 1/2-deg curves. It will be noted that the special fastenings in sections 14 to 17, incl., were still holding gage well after 16 years of service. The excess widening in section 16 was caused by changing out the north outer rail of the curve September 1953. Sections 48 and 49 with Racor pads and/or studs in service 11 years had a good record of holding gage. Sections 18 and 19, Erie single shoulder plates with diamond bottoms, had a good average performance but the gage had considerable irregularity which is characteristic of single shoulder plates.

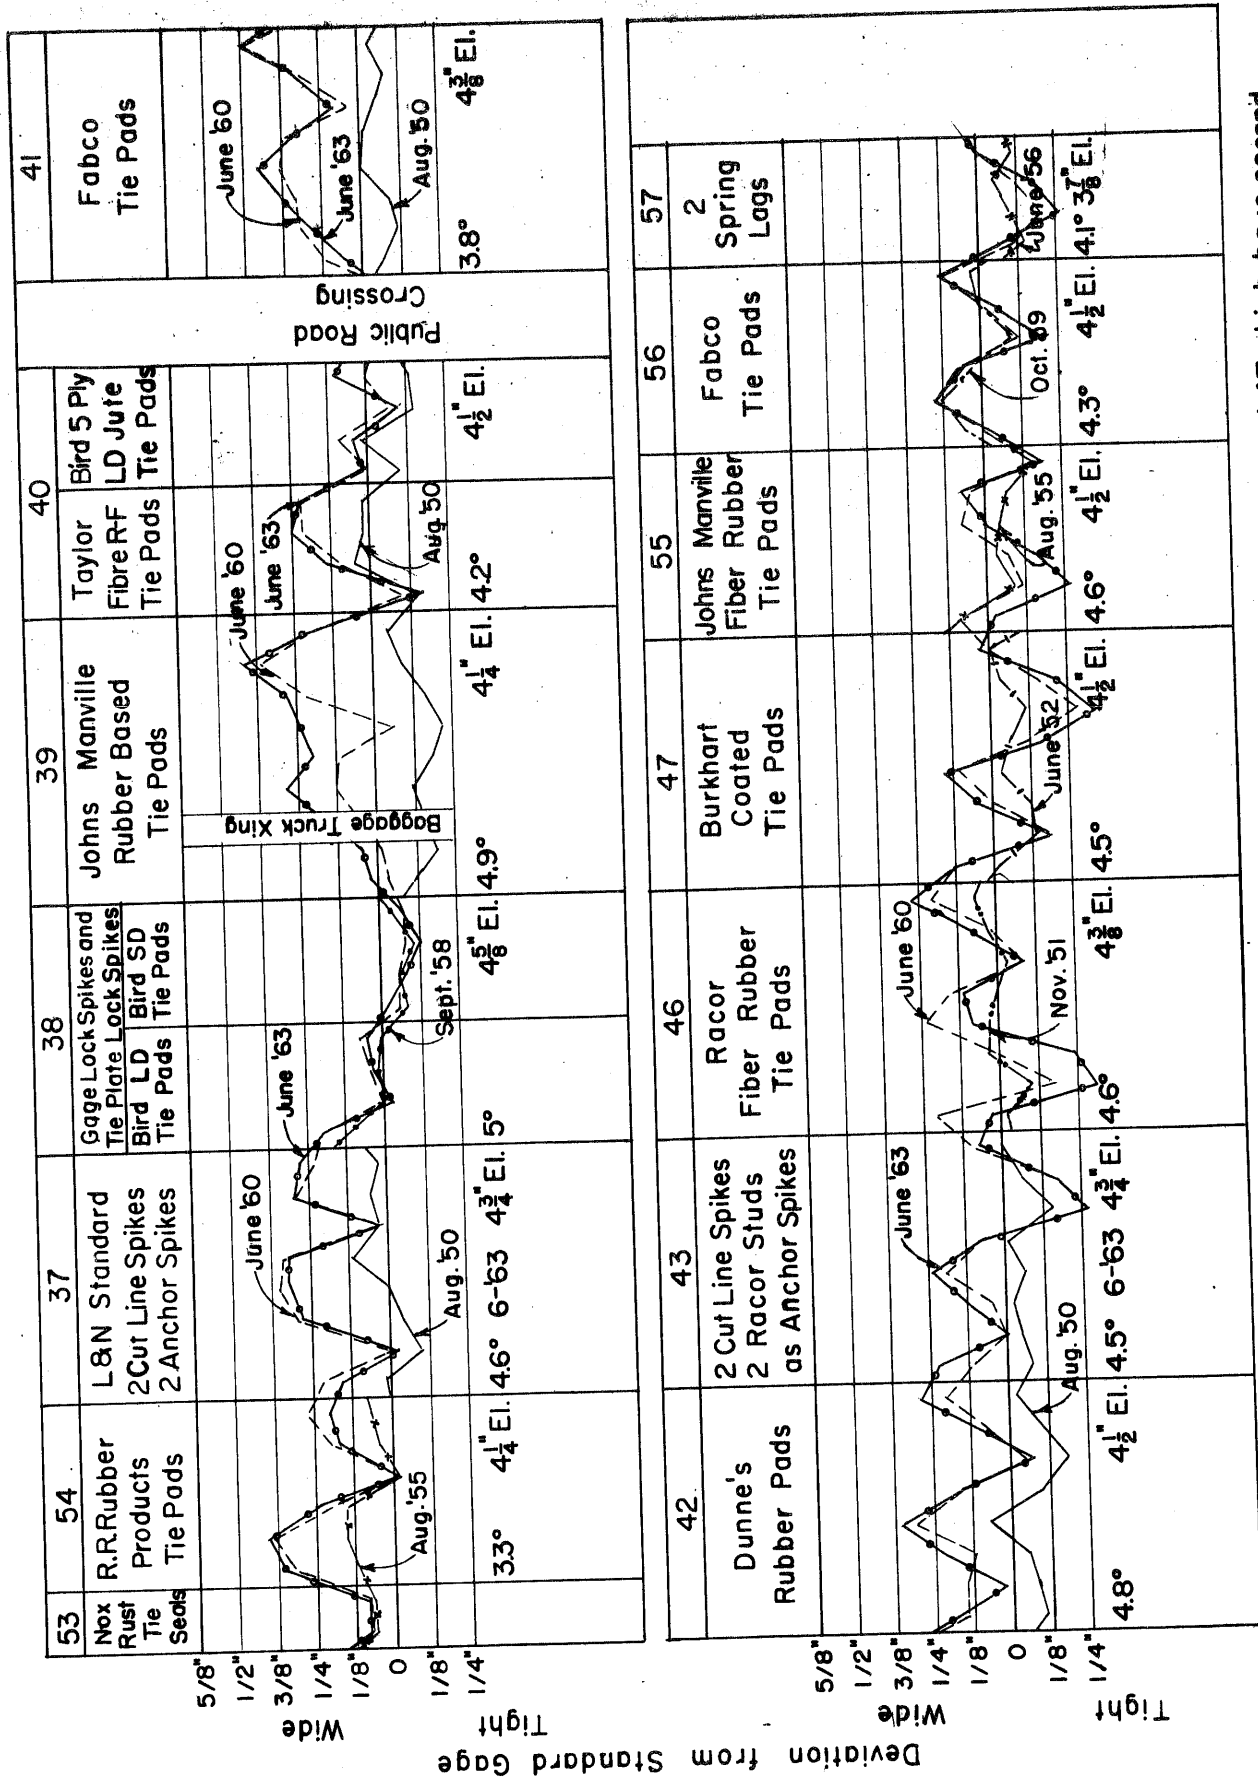
Fig. 28. Gage, Curvature and Elevation of Each Section of Test Track on the 5-deg Curve, Mile L-153, L.&N.R.R. East Bernstadt, Ky.

Fig. 28 shows gage measurements on the 5-deg curve at East Bernstadt. There continued to be irregularity at the joints except in section 38 which was only 5 years old. It is believed that this condition is partially due to heavy trains starting on the curve after stopping to pick up or set out cars for coal loading.

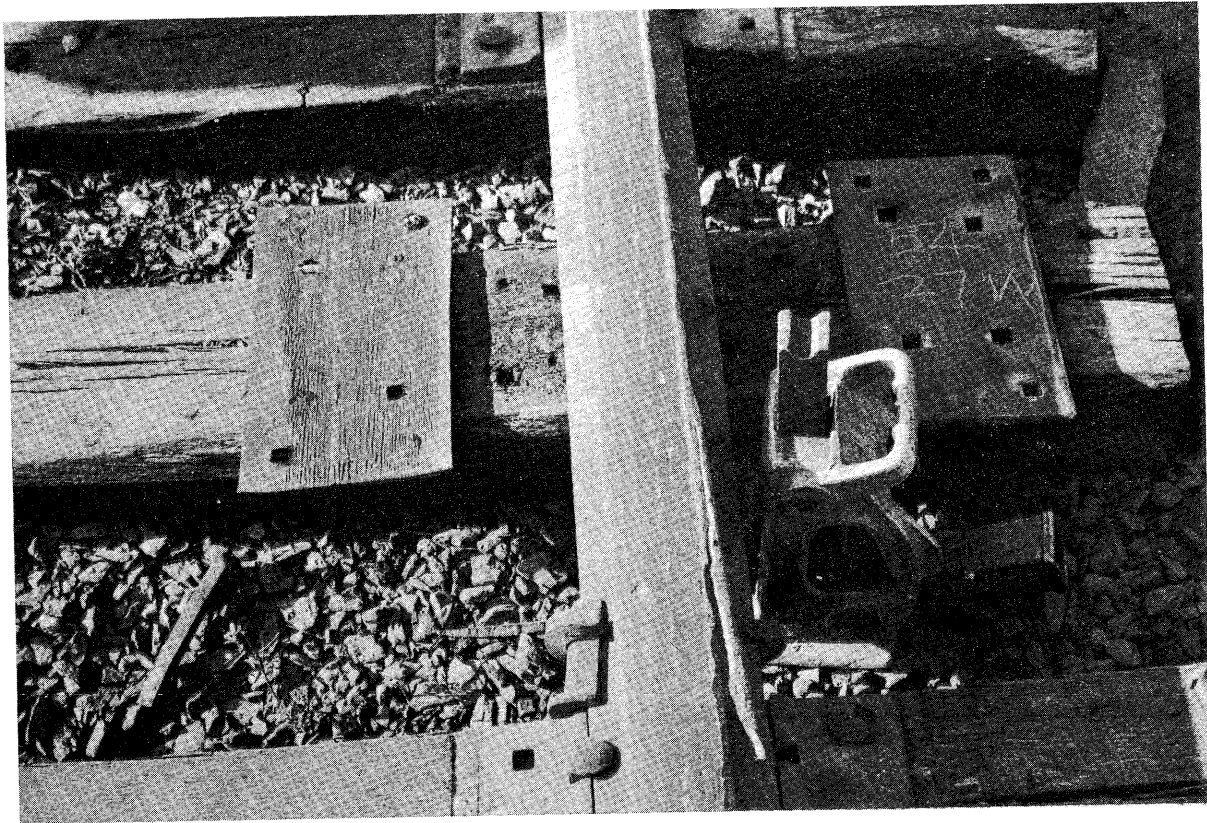
The Railroad Rubber Products pads in section 54 have given good service since installed in 1955 although slightly stretched at the anchor spike holes. Only the south 10 ties were sealed and this seal had disappeared; hence, the pad offers no protection against moisture or sand in the area under the plate.

Fig. 31 -- Section 54, 14-in Railroad Rubber Products rubber pad, 1/4-in thick, uncoated, with adzed surface coated with liquid rubber sealant, 95 months of service, inner rail of 5-deg curve. Sand and moisture under pad, some wood compression, all sealant gone in the pad area. Pad slightly stretched but otherwise in good condition, sealant of little value.

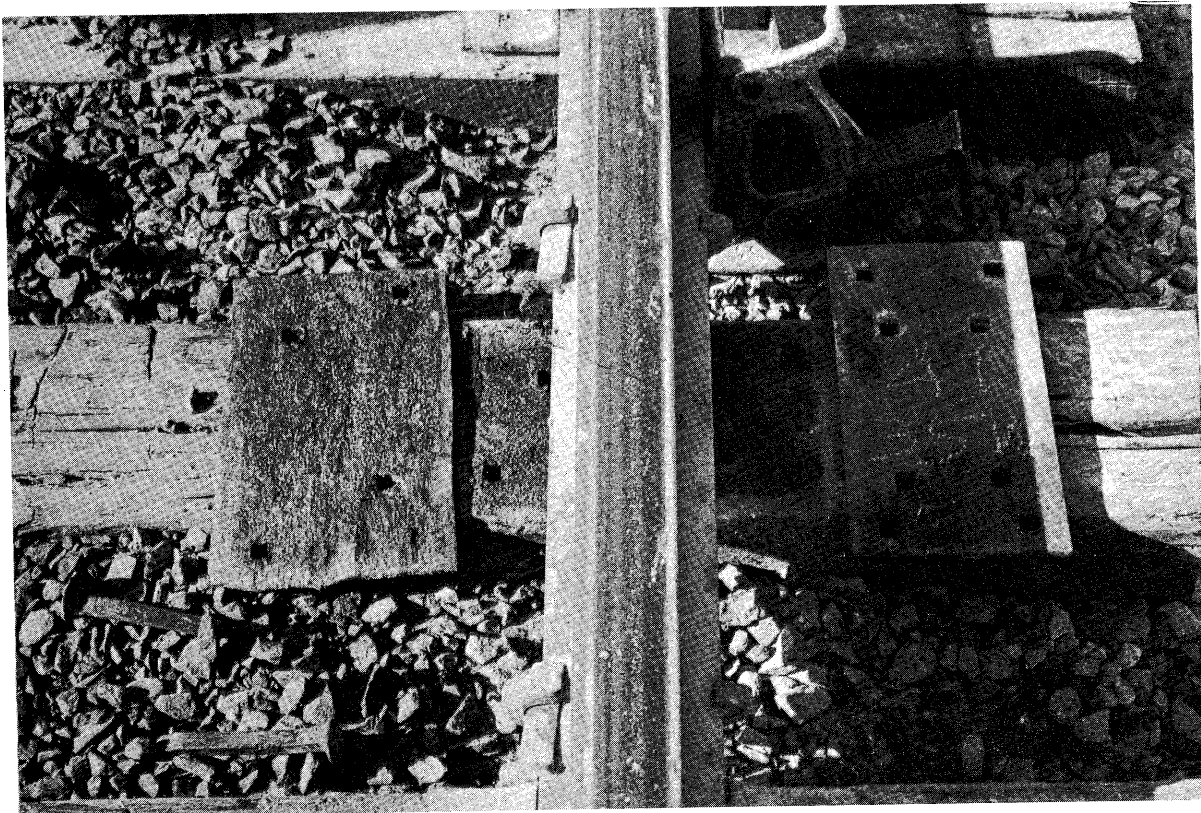
Fig. 32 -- Section 41, 14-in Fabco fiber-rubber pad with oxidized asphalt coating on the bottom side, 142 months of service, inner rail 5-deg curve. Much sand and moisture under pad together with considerable wood compression. Pad condition fair but stretched laterally on field end, sealant gone.

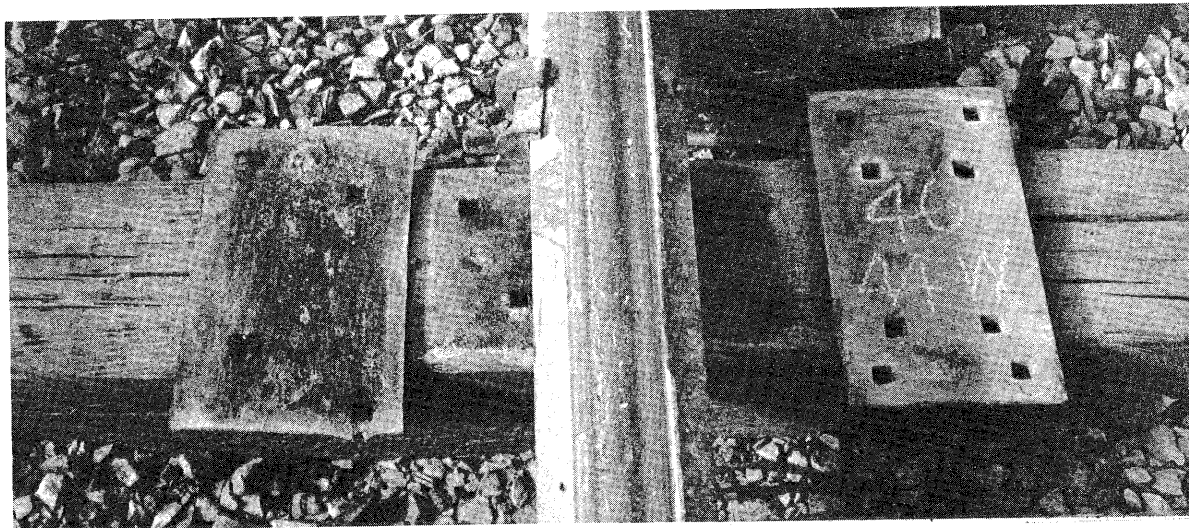
Fig. 33 -- Section 46, 14-in Racor fiber-rubber pad, coated, 138 months of service, inner rail 5-deg curve. Some sand and moisture under pad, wood compression slight. Pad condition fair. Stretched on field end split at gage anchor spike, not sealed to tie.

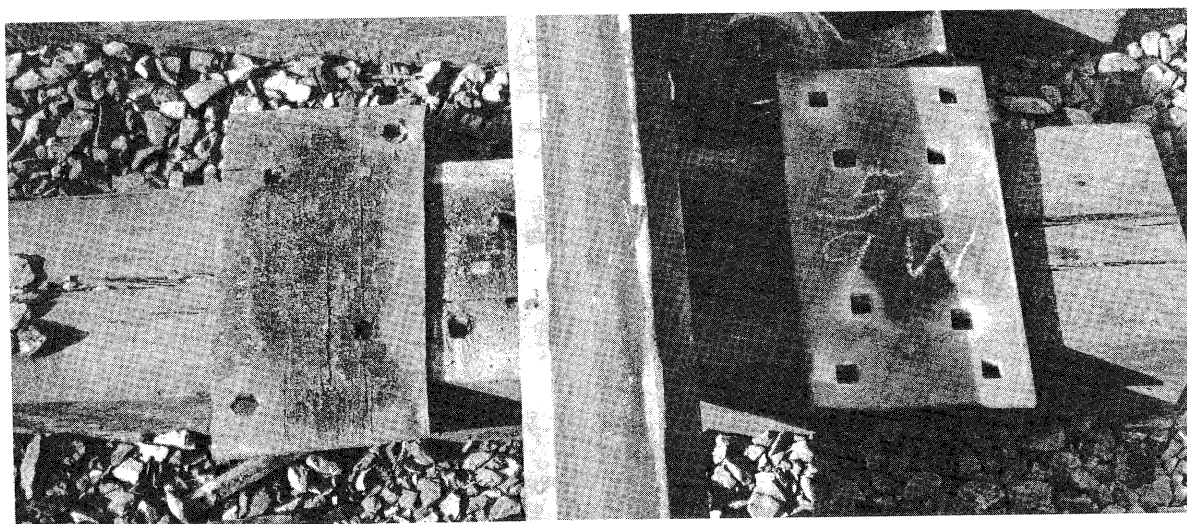
Fig. 34 -- Section 55, 14-in Johns-Manville fiber-rubber pad, 1/4-in thick, coated, 95 months of service, inner rail 5-deg curve. Pad had no seal with tie and there was some sand and moisture on the under side. There was some longitudinal stretching and pad was adhered to the plate. No wood compression.

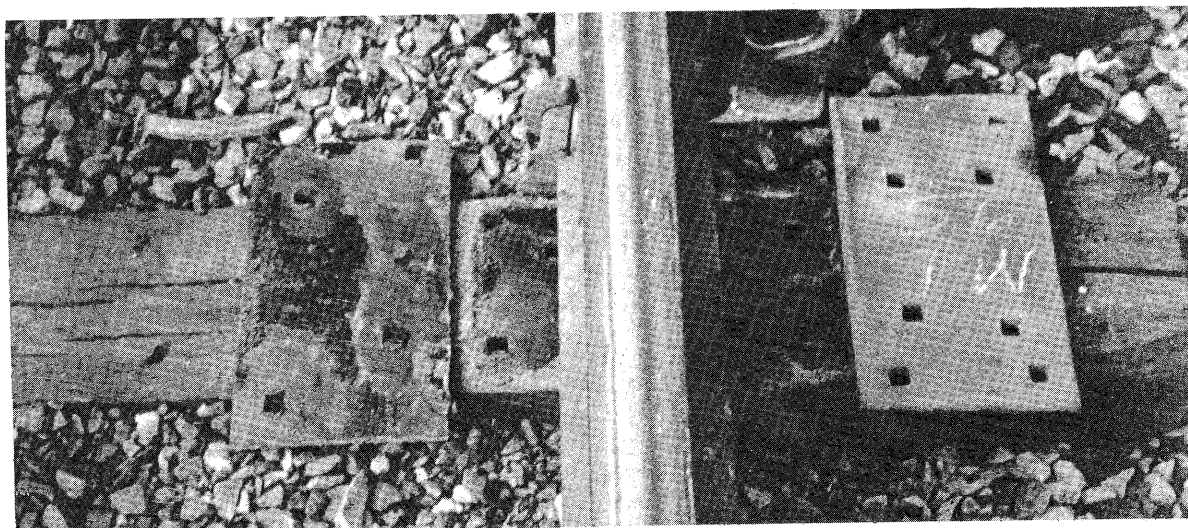
Fig. 35 -- Section 56, 14-in Fabco Super-Seal Pads, 1/4-in thick, bottom coated, 43 months of service, inner rail 5-deg curve. Pad had approximately 90 percent seal with no sand or moisture on under side.

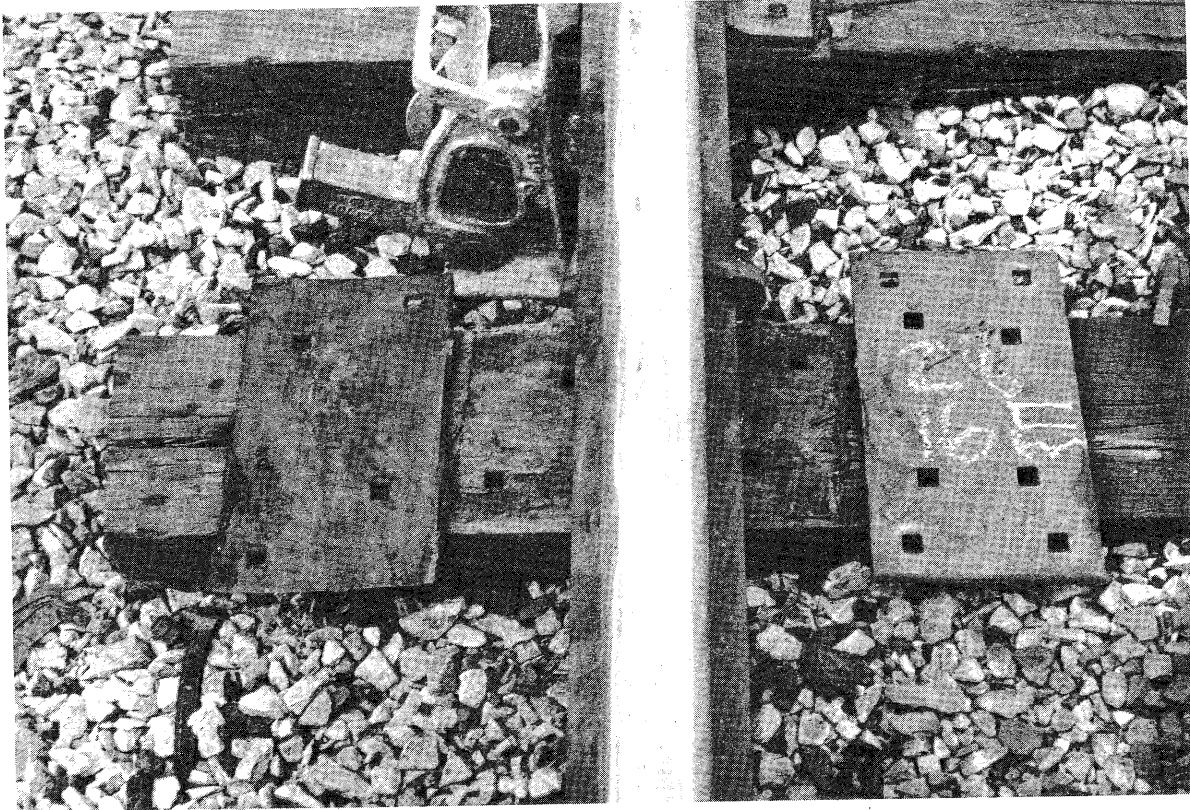
Fig. 36 -- North portion Section 28, 14-in Konvex tire carcass tie pad 3/16 in thick, coated both sides, 43 months of service, inner rail 4-1/2-deg curve. The pad had 70 percent seal with the tie and the polyethylene film on top effectively prevented a seal with the tie plate. Some coating adhered to the wood.

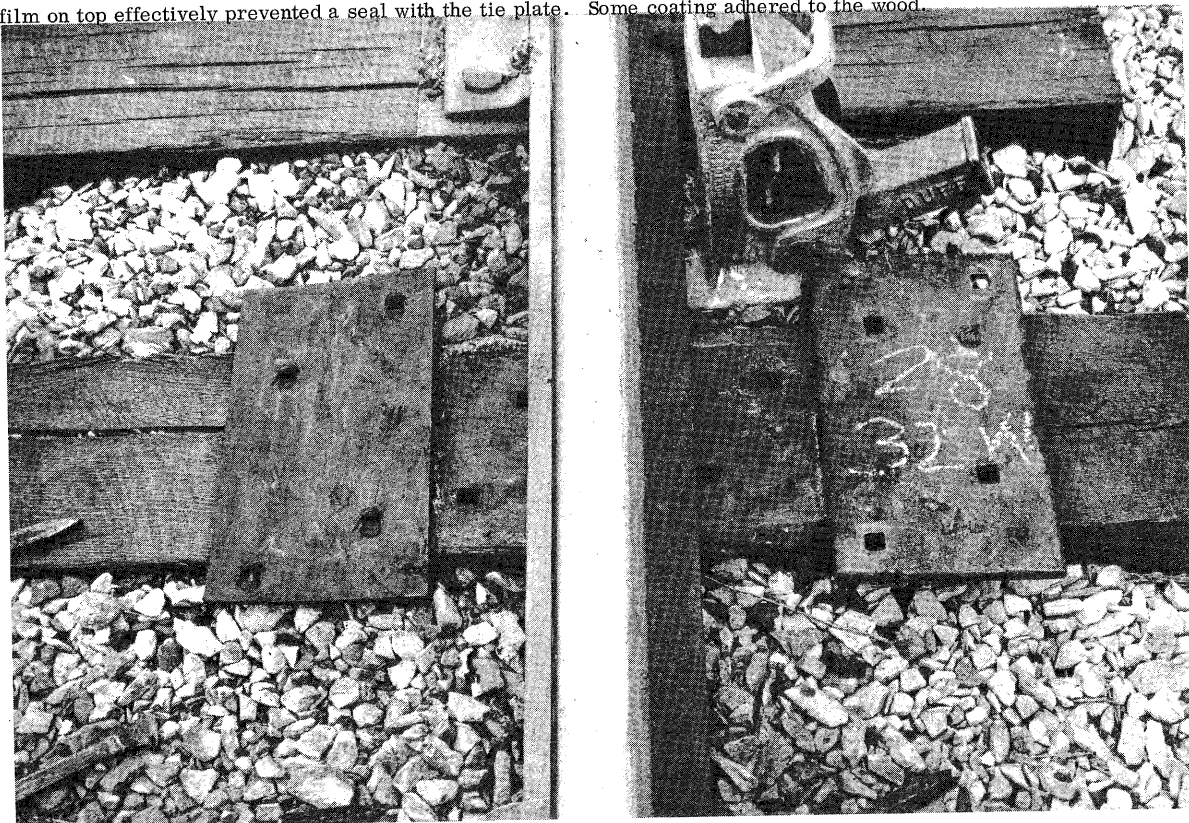
Fig. 37 -- South portion Section 28, 14-in Konvex tire carcass tie pad 3/16 in thick, coated both sides, 57 months of service, outer rail 4-1/2-deg curve. The pad had 60 percent seal with the tie. The coating on the bottom adhered to the tie and not to the pad. This pad was without polyethylene and some coating stuck to the plate. There was some sand around the anchor spike holes.

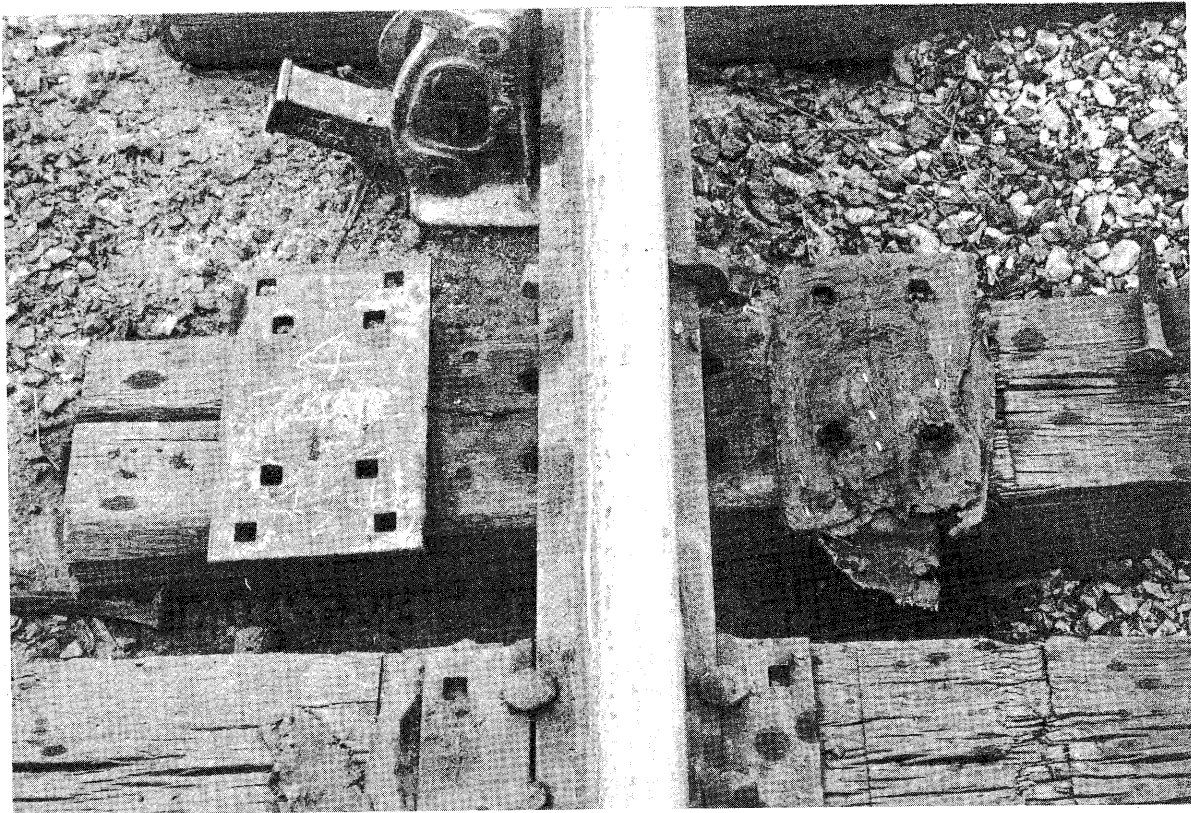
The Bird duck burlap pads in Figs. 38, 39, 40 and 41 have given generally good results over nearly 15 years in service. The ratchet action on the low rail of the 4 1/2-deg curve has tended to cause delamination of this type of pad and in the case of the 5 ply pad, Fig. 38, the seal was entirely gone. In spite of the poor pad condition, the wood was still protected from wear. The 7 ply pad, Fig. 40, gave somewhat better performance on the low rail.

Bird duck-burlap pads replaced the duck-felt pads in part of sections 4 and 5 of the 4 1/2-deg curve in 1948. The 5 ply pads are shown in Figs. 38 and 39 and the 7 ply pads in Figs. 40 and 41. While about 15 percent of the pads had become badly delaminated, many still held a seal and were protecting the tie. In 1949, section 30 was established with duck-burlap pads and 11 in. tie plates to determine if pads might permit shorter tie plates. The performance of these short pads was reasonably good, but they showed greater damage than those under the 13 in. plates. Duck-burlap pads were in the south 1/2 of section 38 with tie plate lock spikes and gage lock spikes but this installation was only 5 years old and there was no progress to report except that it was in excellent condition.

Fig. 38 -- South portion Section 4, 13-in Bird 5-ply duck burlap pad coated, 177 months of service, inner rail of 4-1/2-deg curve. Pad had lost its seal and there was small amount of sand and moisture on the tie surface. There was considerable delamination and stretching on the field end together with some wood compression.

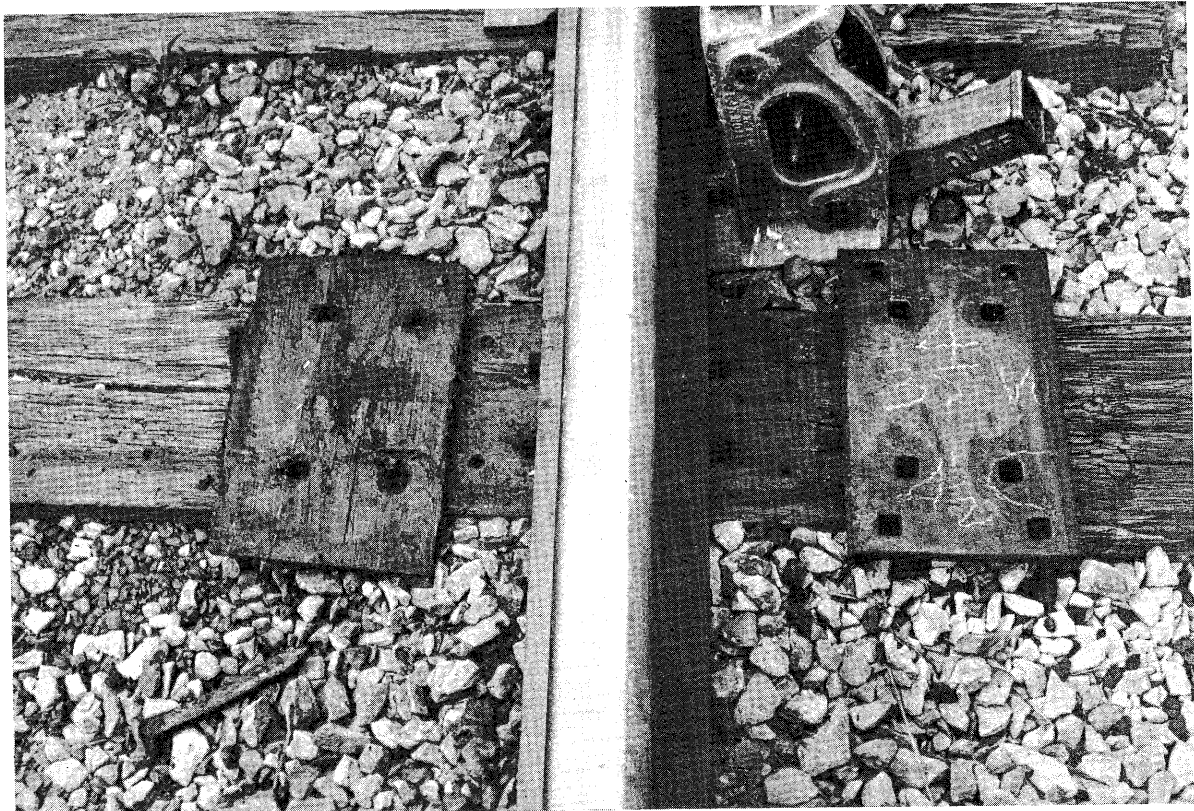
Fig. 39 -- South portion Section 4, 13-in Bird 5-ply duck burlap pad coated, 177 months of service, outer rail of 4-1/2-deg curve. Pad had 90 percent of its seal and tie surface was free from sand and moisture. The pad condition was good, and there was no wood compression.

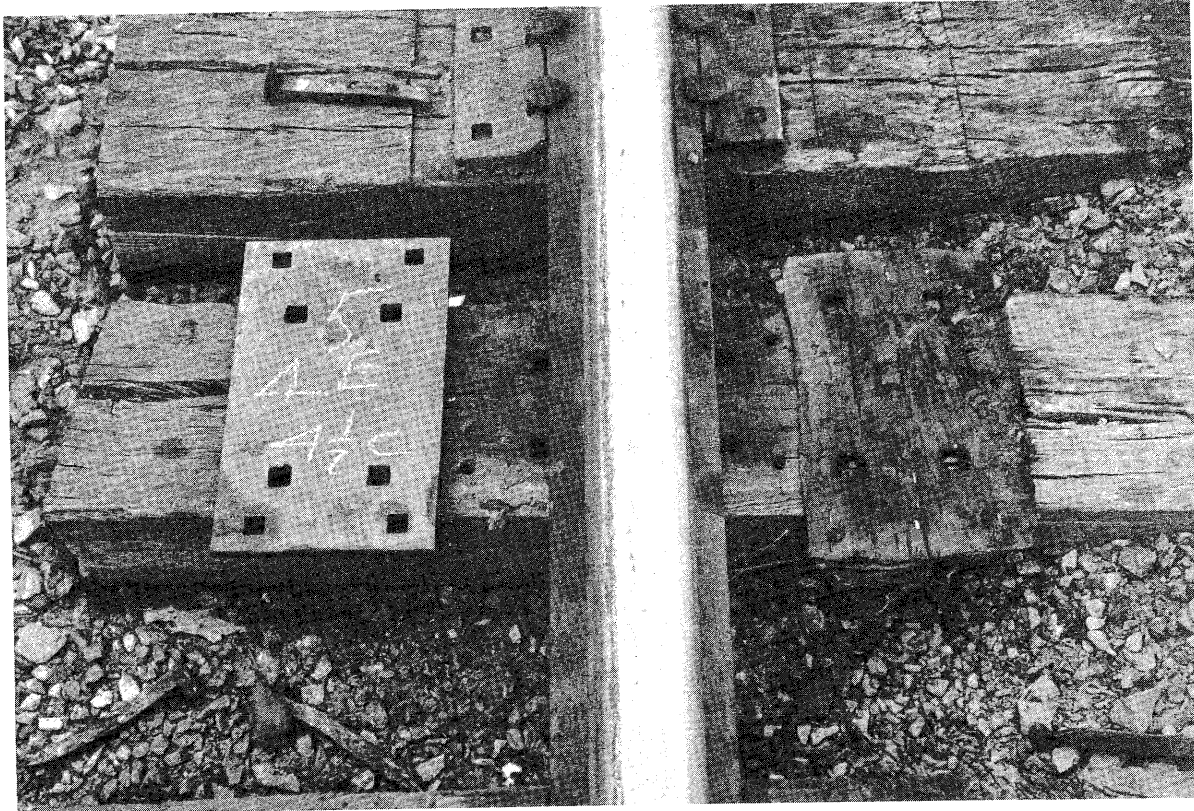
Fig. 40 -- North portion Section 5, 13-in Bird 7-ply duck burlap pad coated, 177 months of service, inner rail of 4-1/2-deg curve. The pad area was 60 percent sealed and free from moisture although there was some around the spikes. The pad condition was fair with some stretching and there was a little wood compression on the field end.

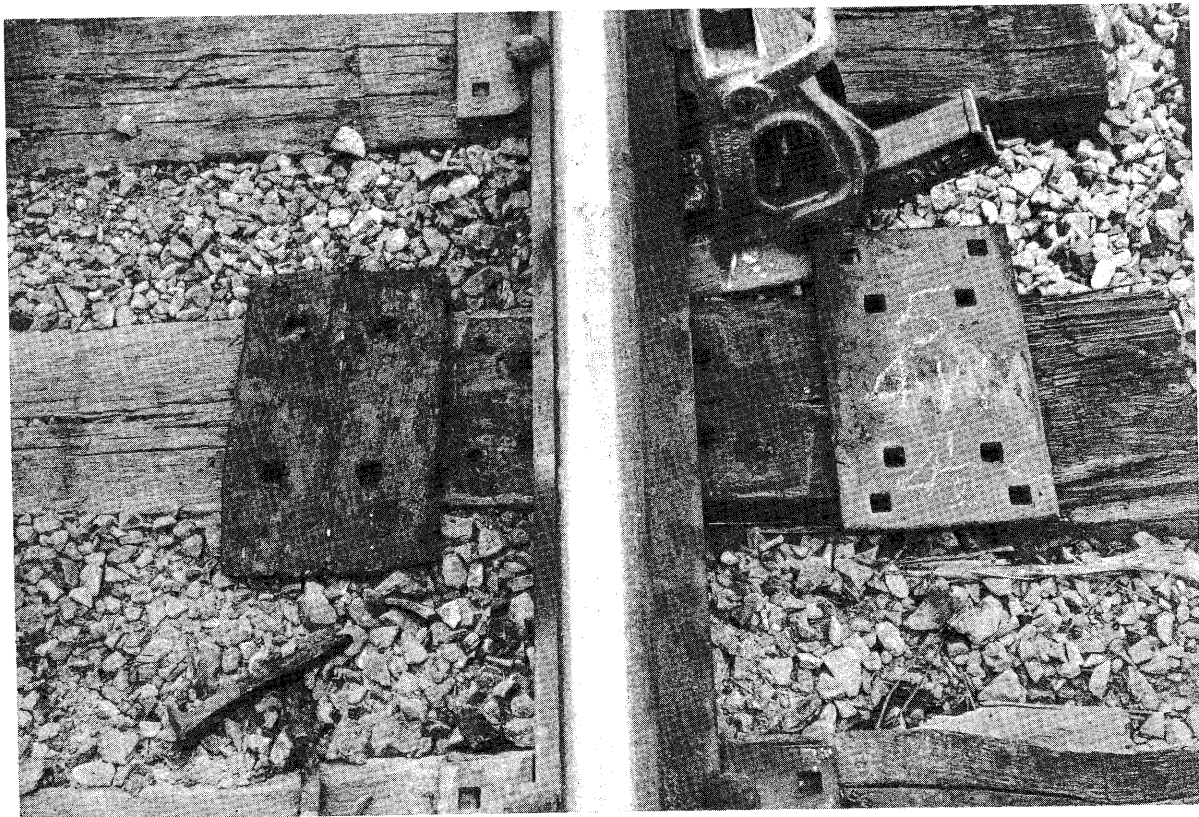
Fig. 41 -- North portion Section 5, 13-in Bird 7-ply duck burlap pad coated, 177 months of service, outer rail 4-1/2-deg curve. The pad was 80 percent sealed and the tie surface was without sand or moisture. The pad condition was good and there was only slight wood compression on the field end.

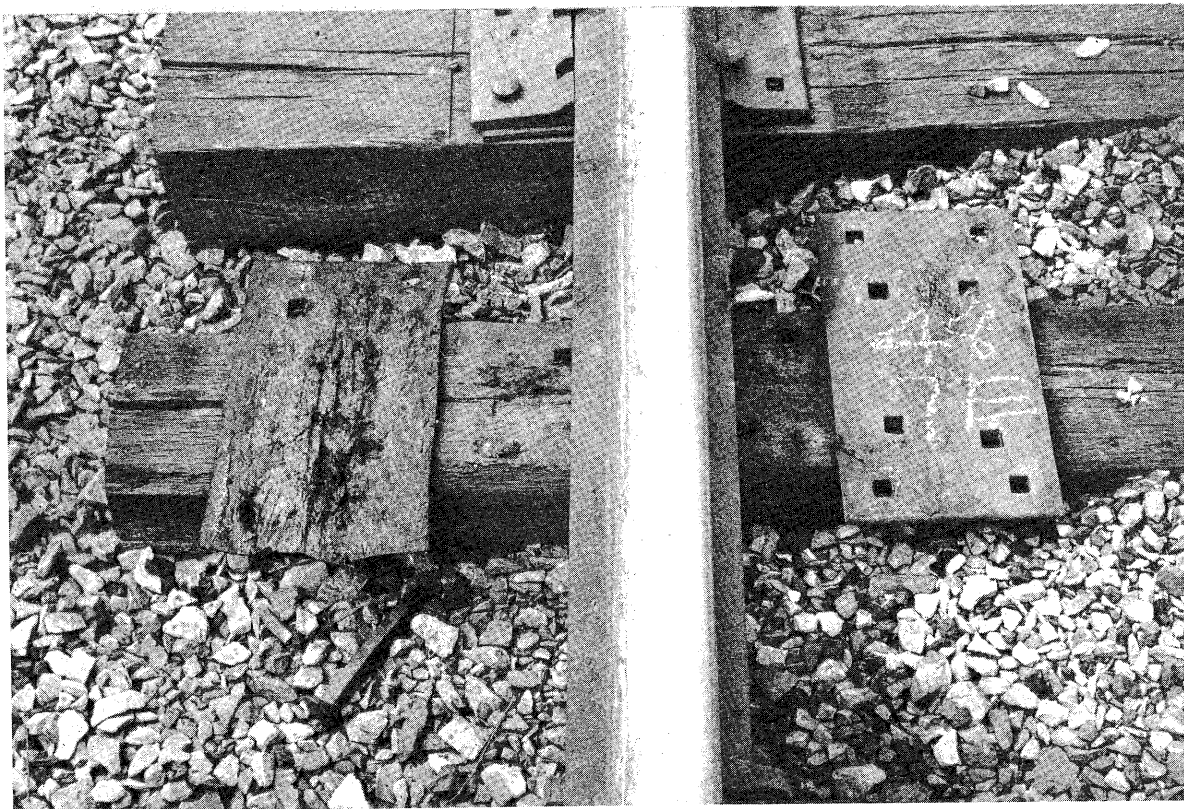
Fig. 42 -- Section 48, 14-in Racor fiber rubber tie pad, coated, 2 Racor studs, 129 months of service, inner rail of 4-1/2-deg curve. The under pad area was 60 percent sealed, had some sand around anchor but was free from moisture. Pad condition good except some stretching on field end, torn when prying from tie surface, no wood compression.

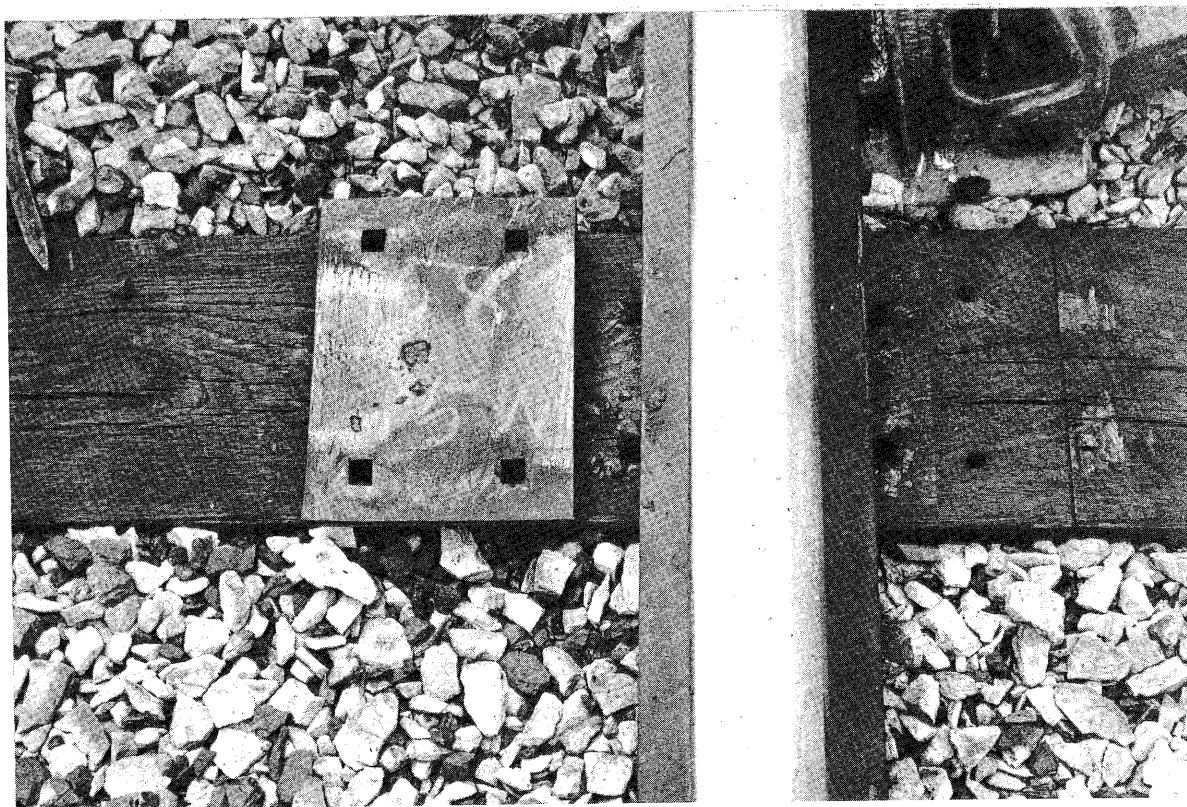
The Railroad Rubber Products Company rubber tie plate in section 58, Fig. 43, had less than 5 years of service. The splits at the spike holes were caused by the spikes at the time of installation and had little if any growth during service. There has been 0.07 in tightening of the gage since installation, but otherwise the section is essentially as it was when built in 1958.

Fig. 43 -- Section 58, Railroad Rubber Products rubber tie plate, 57 months of service on oak tie tangent. Pad condition good except slight splits at spike holes. Some sand, moisture and wood compression on tie surface.

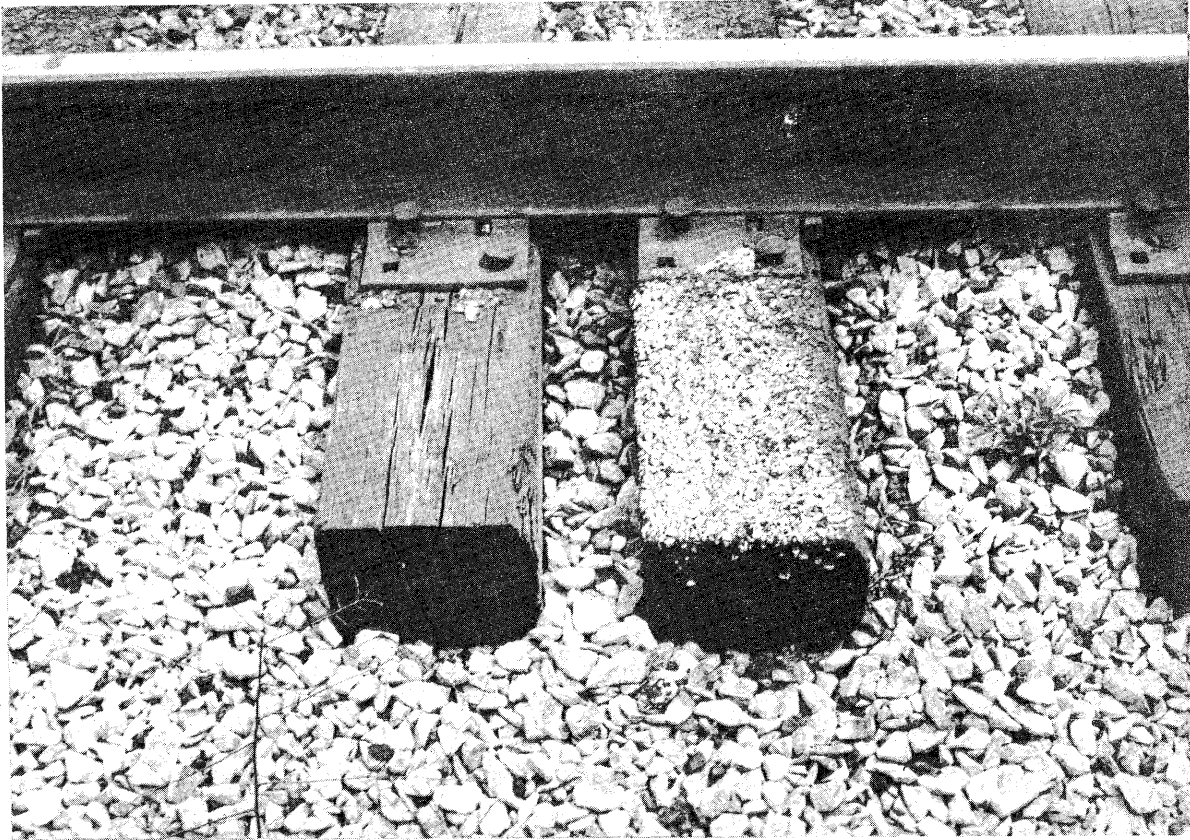
From the standpoint of moisture content and number of splits, the coated ties appeared to be doing a superior job, but as of 1963 the tie renewals in section 35 favored the uncoated ties. Only 3 uncoated ties or 5 percent had been renewed compared with 7 ties or 12 percent of those with coating. A check of renewals of oak ties in the 4 1/2-deg curve since 1947 shows 5 percent the same as the uncoated ties in section 35. Possibly a longer service period would show an improvement in the performance of the coated ties, but at this time a favorable report cannot be made. Figs. 44 and 45 show coated and uncoated ties in the north half and south half of the section respectively. From these pictures there is no basis on which to favor the coated ties. In section 36 where existing ties were coated, 29 ties or 25 percent have been renewed. This is a normal rate of renewal for the period involved and affords no basis for any conclusion.

Fig. 44 -- North 1/2 Section 35, alternate new creosoted oak ties coated with Koppers No. 16 Sealing Compound, total service life 154 months with ties recoated after 97 months.

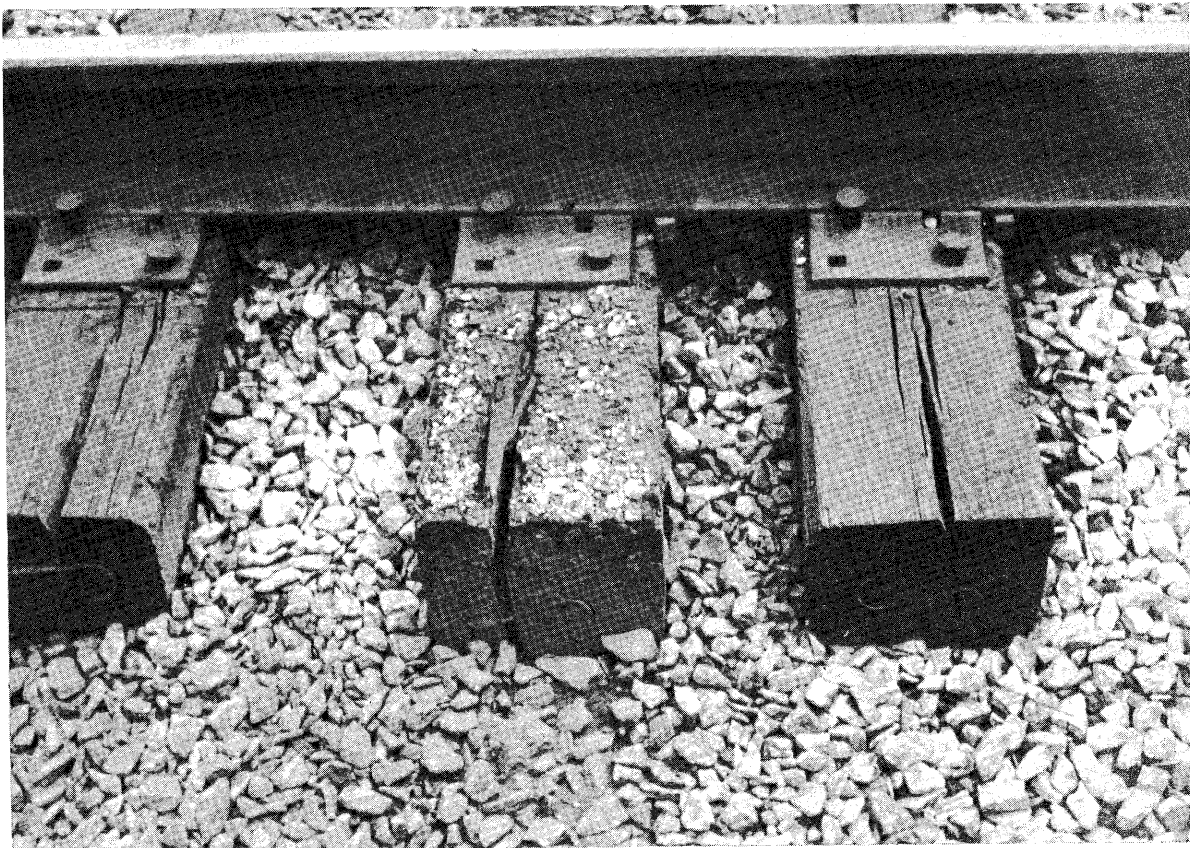
Fig. 45 -- South 1/2 Section 35, alternate new creosoted oak ties coated with Koppers No. 16 Sealing Compound, service life 154 months, ties not recoated. Coating does not appear to have retarded the splitting.
