REPORT NO. FRA/TTC-80/02

CONCRETE AND WOOD TIE TRACK PERFORMANCE THROUGH 150 MILLION GROSS TONS

MARCH 1980

INTERIM REPORT

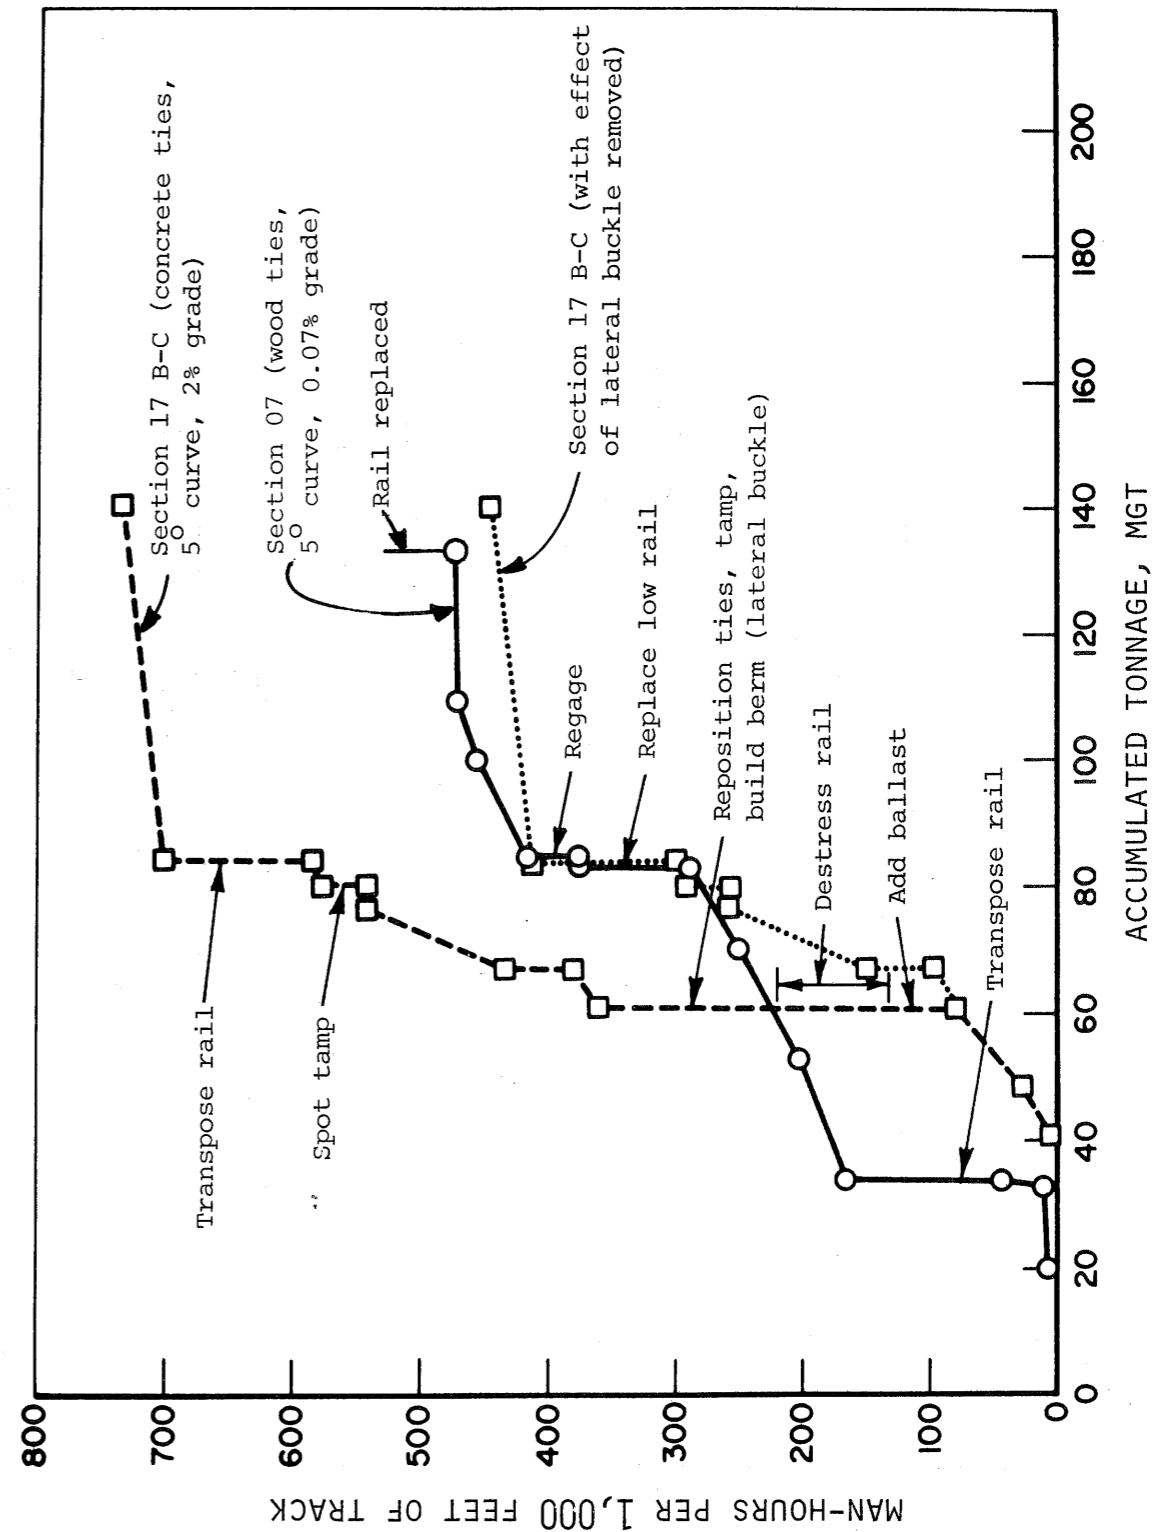
FIGURE 4-1. MAINTENANCE MAN-HOURS PER 1,000 FEET OF TRACK ON 5° CURVES OF CONCRETE AND WOOD TIE TRACK.

This comparison is significant because instability in the concrete tie curve is believed to have been caused by the poor ballast performance, derived in part from lack of ballast in both the crib and shoulder.

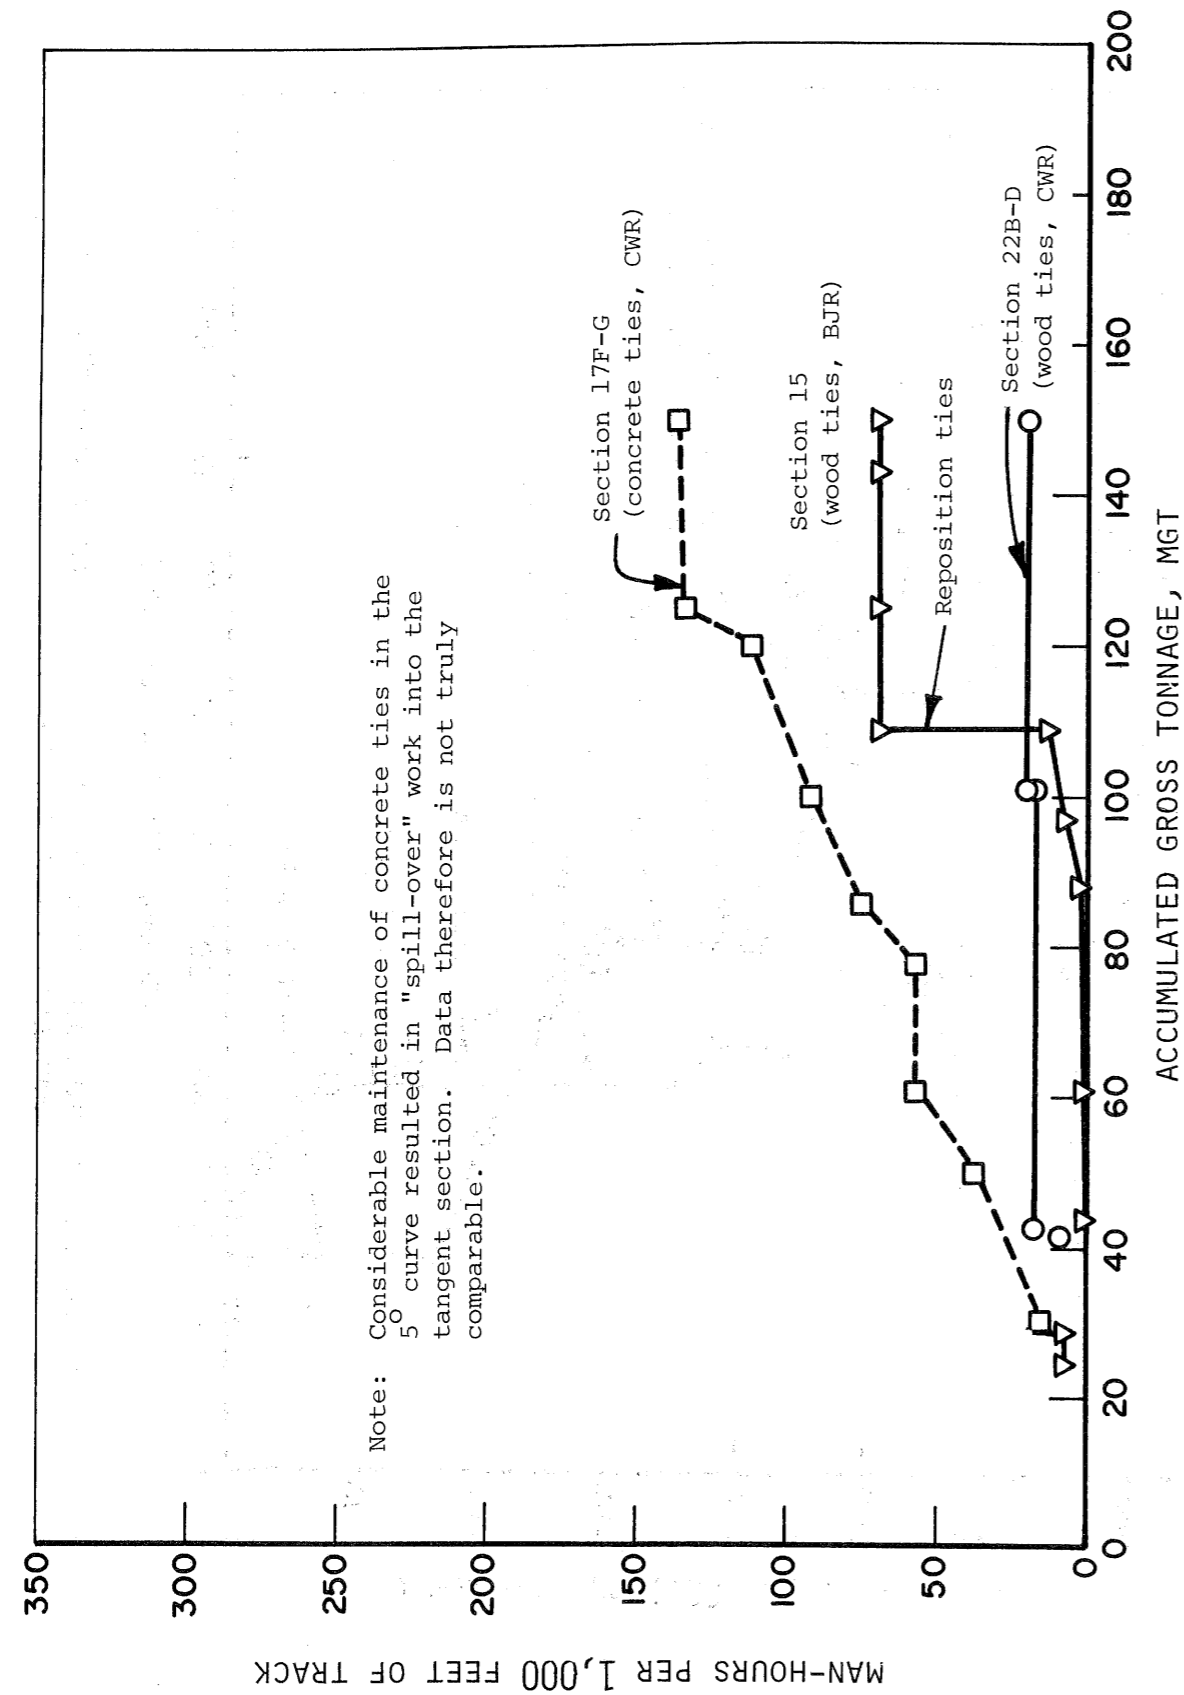
FIGURE 4-2. MAINTENANCE MAN-HOURS PER 1,000 FEET OF TRACK ON TANGENT SECTIONS OF CONCRETE AND WOOD TIE TRACK.

Figure 4-2 compares man-hours per 1,000 ft of track for the tangent segment of concrete tie track with two wood tie tangent segments, one with bolted joint rail (BJR) and the other with continuous welded rail (CWR). When the requirement for switch maintenance in the BJR wood tie Section 15 is removed, the results showed that the tangent concrete tie track segment required about five times the maintenance of CWR wood tie track and about twice the maintenance of the BJR wood tie section. It should be noted, however, that the CWR wood tie Section 22 was part of an existing track before its incorporation into FAST. Thus, the initial consolidation and a number of the early problems caused by new ballast and subgrade may have been avoided.

The concrete tie tangent segment received considerable ballast maintenance (shoulder reshaping, surface/line/tamping, and tamping only), which was mainly spillover of maintenance from work begun in the 5° curve. Other major items included the retightening of bolted fasteners and one rail plug was required at a defective weld.

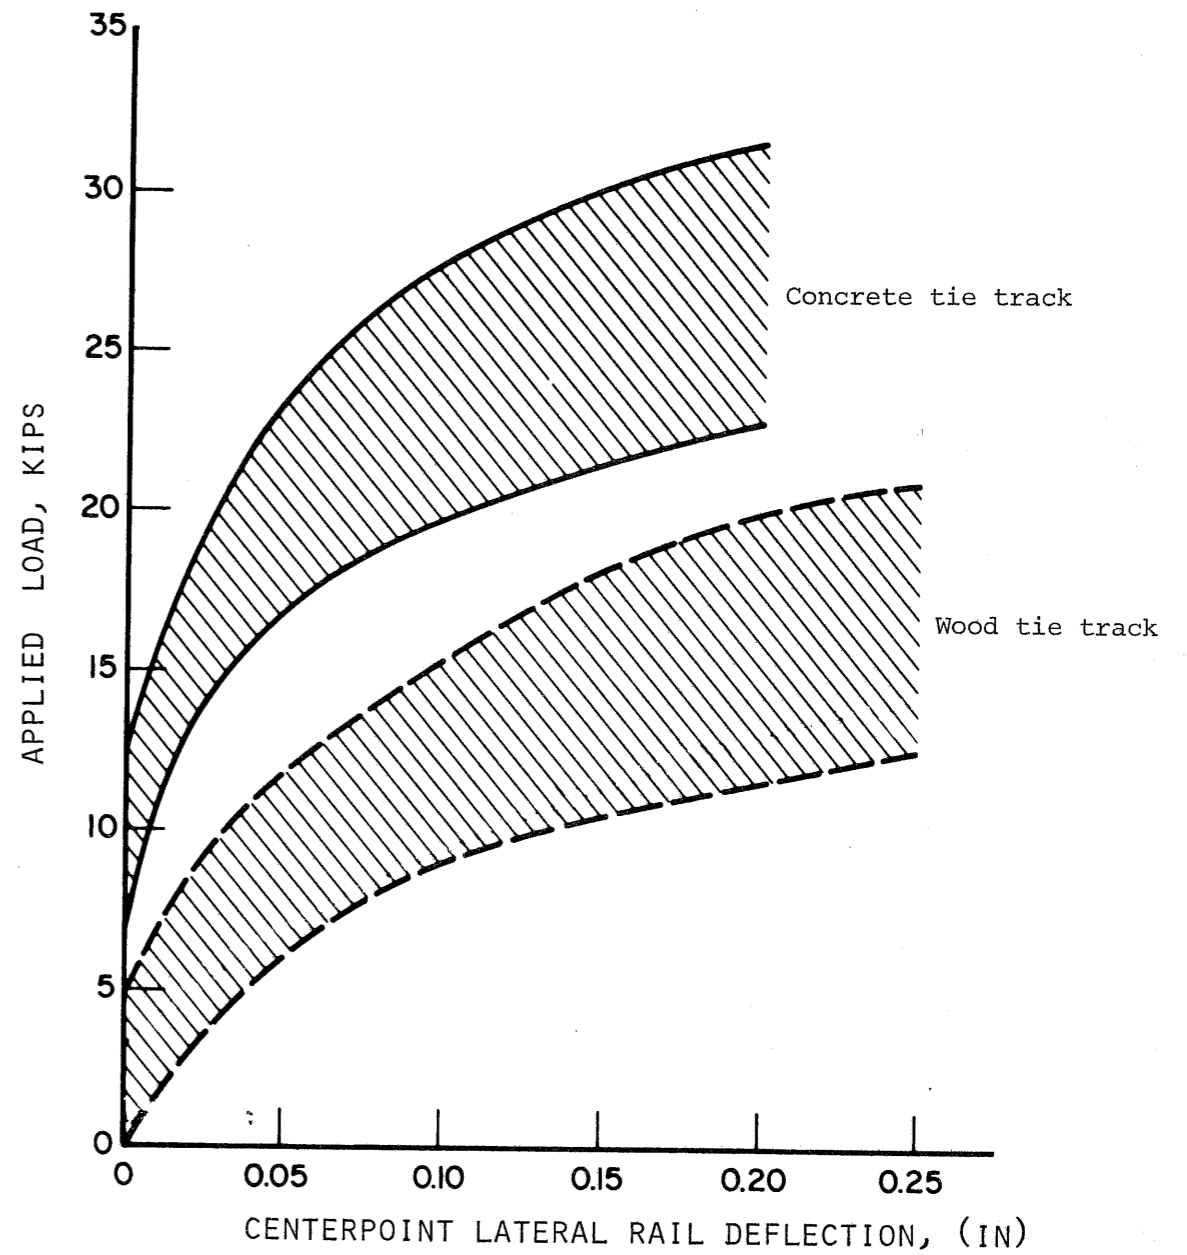
FIGURE 4-7. ENVELOPES AND CURVES OF CENTERPOINT LATERAL RAIL DEFLECTION vs. APPLIED LATERAL LOAD FOR SECTIONS OF CONCRETE AND WOOD TIE TRACK, 0-150 MGT.

The two envelopes shown in figure 4-7 differ in these important respects:

- Concrete tie track shows higher initial stiffness than wood tie track as evidenced by higher initial breakout loads (loads at zero displacement) and higher slips in the small deflection range, and
- Concrete tie track shows consistently higher maximum lateral resistance loads than wood tie track.

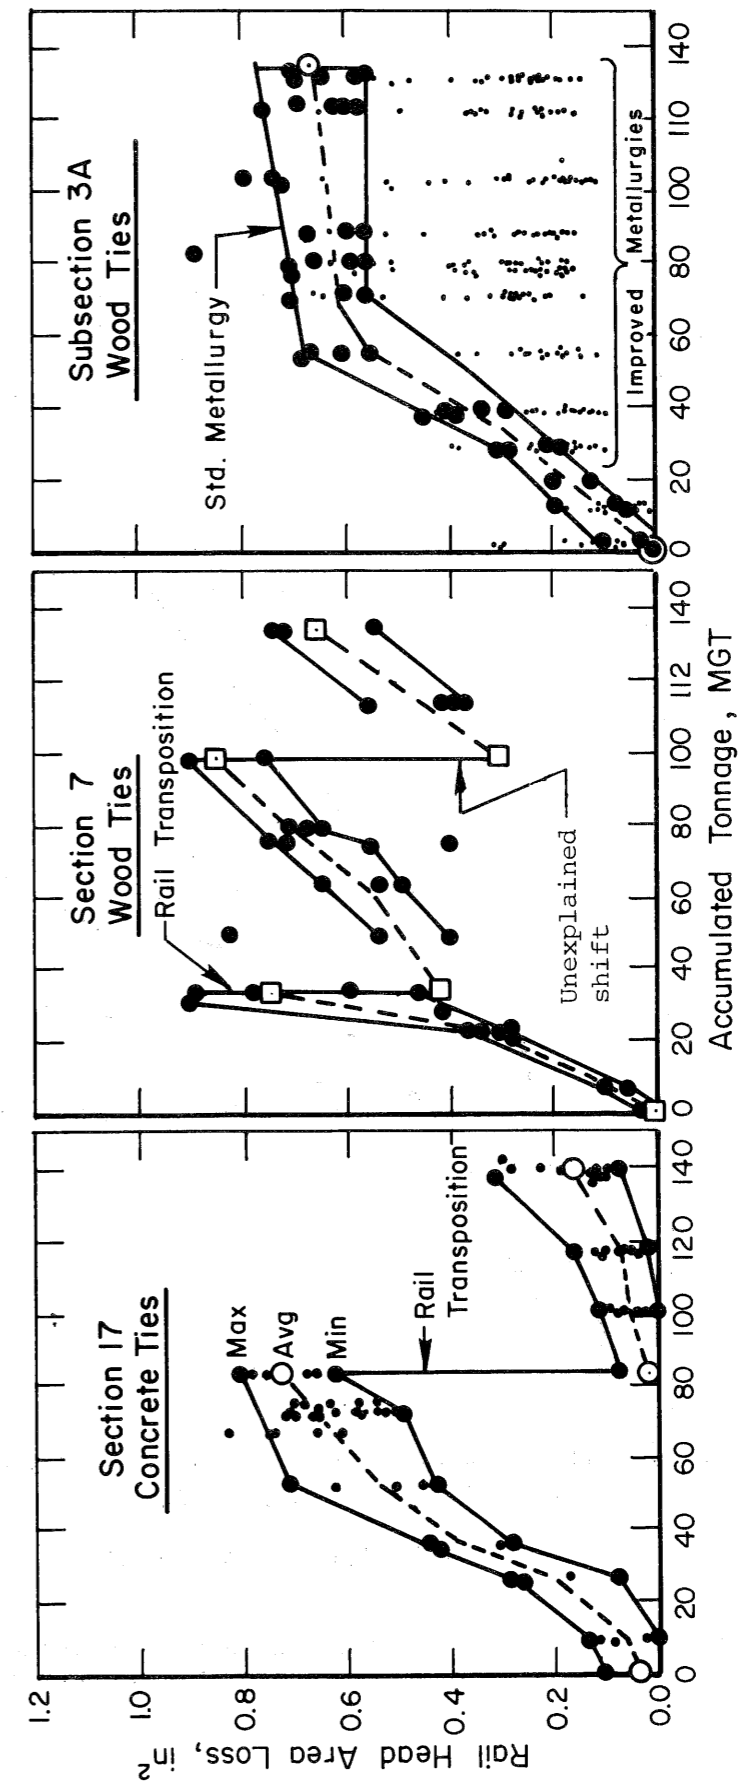
FIGURE 4-8. COMPARISON OF RAIL WEAR ON HIGH RAIL OF 5° CURVES IN SEVERAL SECTIONS OF CONCRETE AND WOOD TIE TRACK.

Figure 4-8 summarizes the results of measurements taken with a rail head profilometer in the 5° curves of concrete tie Section 17 and wood tie Sections 07 and 03A. Curves show the maximum, minimum, and average values found at a given MGT in each test section. Between 0 and 135 MGT, each subsection of Section 03 contained rails with five different metallurgies, each in a 78-ft segment. In figure 4-8, the standard metallurgy segment is plotted separately from improved metallurgies--these included chrome molybdenum, fully heat-treated, high silicon, and head hardened rails.

Sharp breaks in the area loss plots occur for each test section. Two are caused by rail transposition, but one break at 100 MGT in Section 07 cannot be explained by maintenance activity. There is a sharp knee in the envelope for standard metallurgy in subsection 03A. This was probably caused by the addition of effective rail lubrication between 40 and 50 MGT. Lubrication substantially reduced the wear rate.

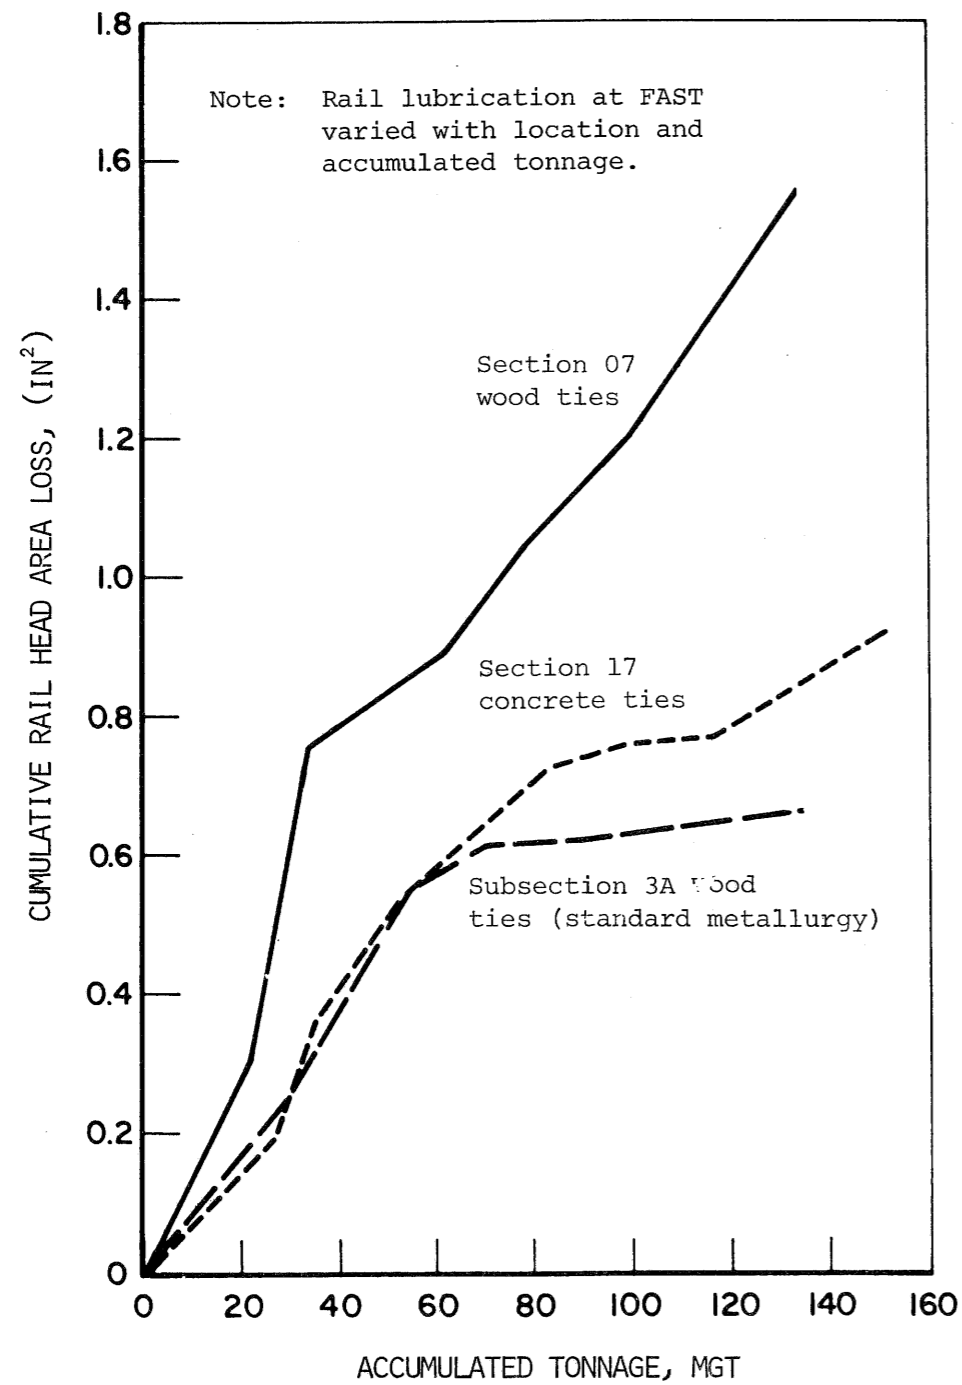
FIGURE 4-9. CUMULATIVE AVERAGE RAIL WEAR ON THE HIGH RAIL IN 5° CURVES OF CONCRETE AND WOOD TIE TRACK.

Cumulative average rail head area loss is plotted vs. MGT in figure 4-9. The curves were constructed by eliminating maintenance-related discontinuities in figure 4-8. Through 135 MGT, the rail in the wood tie Section 07 experienced approximately 80% greater wear than the rail in the concrete tie Section 17. Wear of standard rail in the wood tie subsection 03A was equivalent to that in Section 17 up to 50-60 MGT, when rail lubrication produced a significant reduction in wear rate.

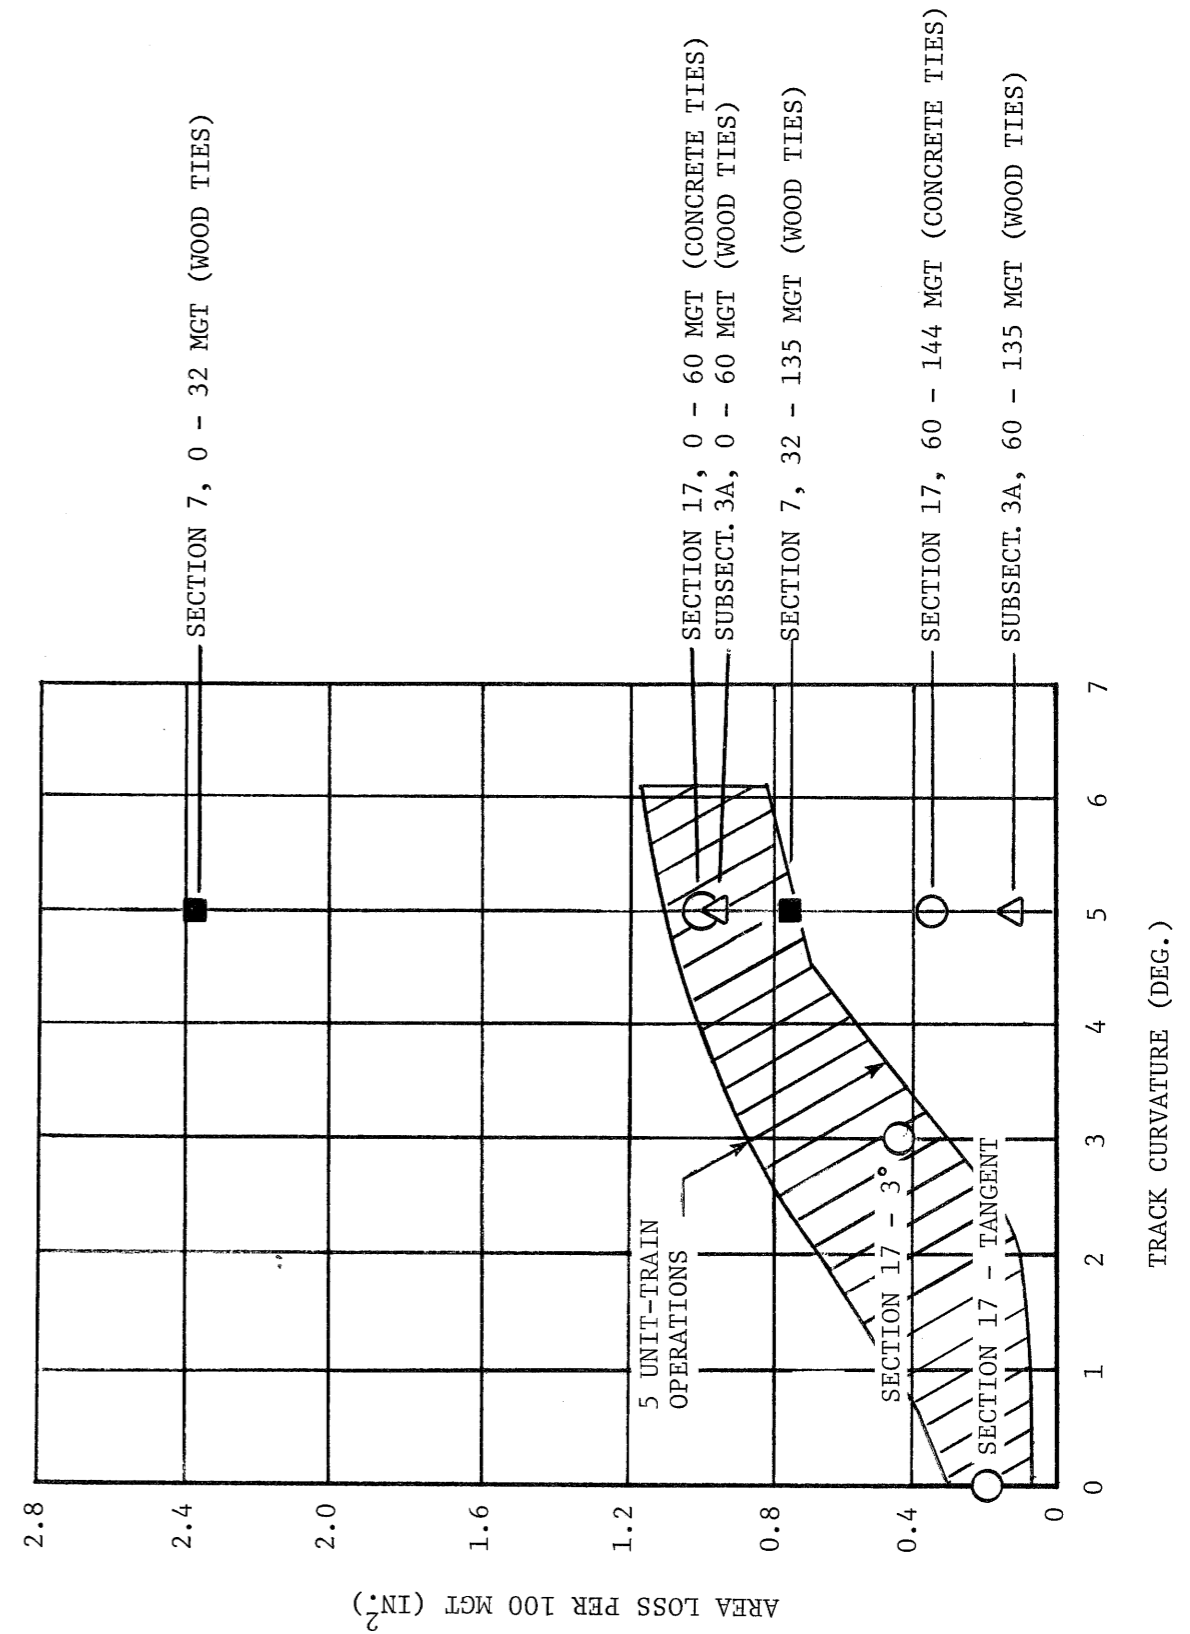
FIGURE 4-10. RAIL HEAD AREA LOSS PER 100 MGT VS. CURVATURE FOR SEVERAL SEGMENTS OF CONCRETE AND WOOD TIE TRACK.

In figure 4-10, average rates of wear from the FAST test segments are compared with those of five-unit train operations in Australia, Canada, Brazil, and the U.S.⁴⁻³ Wear rate is expressed as area loss per 100 MGT. By far the greatest wear rate occurred in Section 07 to 32 MGT, at which time the rail was transposed. All sections experienced much more wear during the early phase of operations than in later periods. Initial FAST operations with all new rail and new wheel profiles probably produced atypical wheel/rail contact geometry that caused unusually high wear rates when combined with little or no rail lubrication.

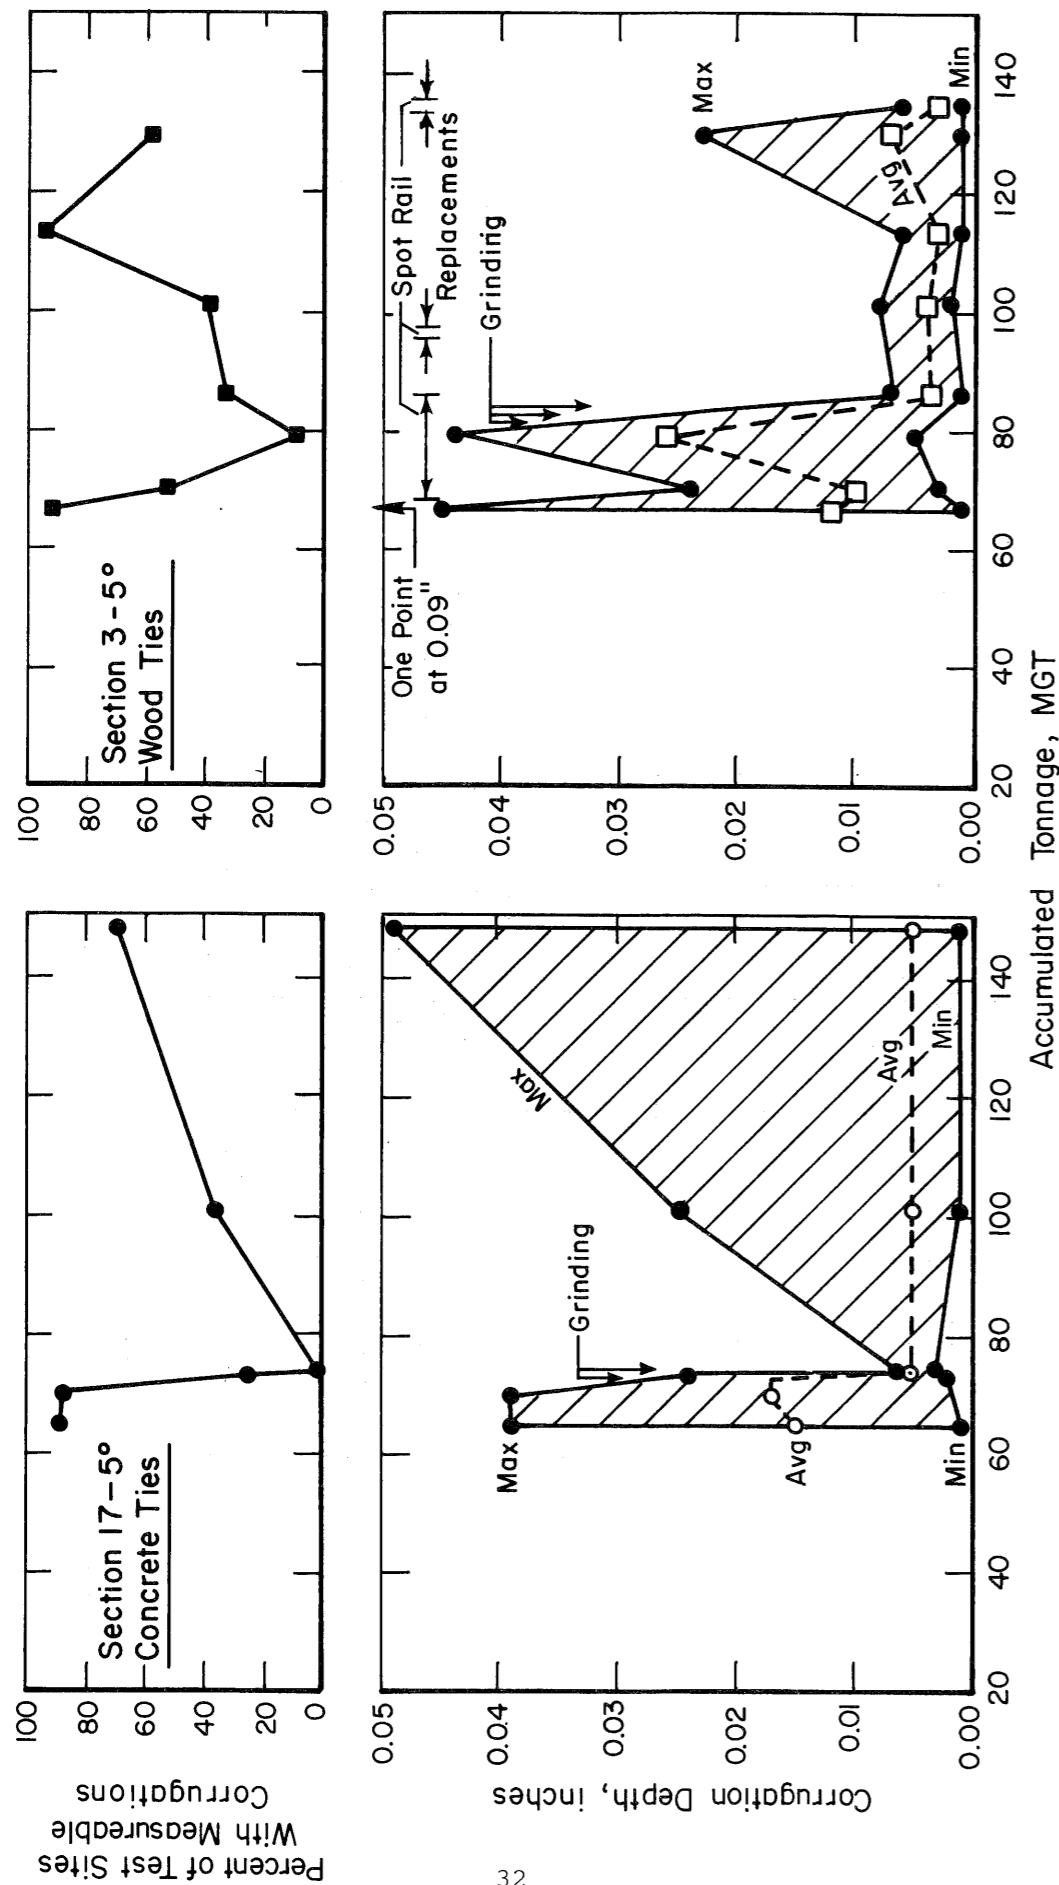
FIGURE 4-11. GROWTH OF RAIL CORRUGATIONS IN 5° CURVES OF CONCRETE AND WOOD TIE TRACK.

Figure 4-11 summarizes rail corrugation measurements taken in the 5° curves of the concrete tie Section 17 and the wood tie Section 03.

The top plot for each section in figure 4-11 contains the percentage of total measurement sites where measurable corrugations were found each time measurements were made. The data show that grinding effectively removed corrugations although they quickly redeveloped.

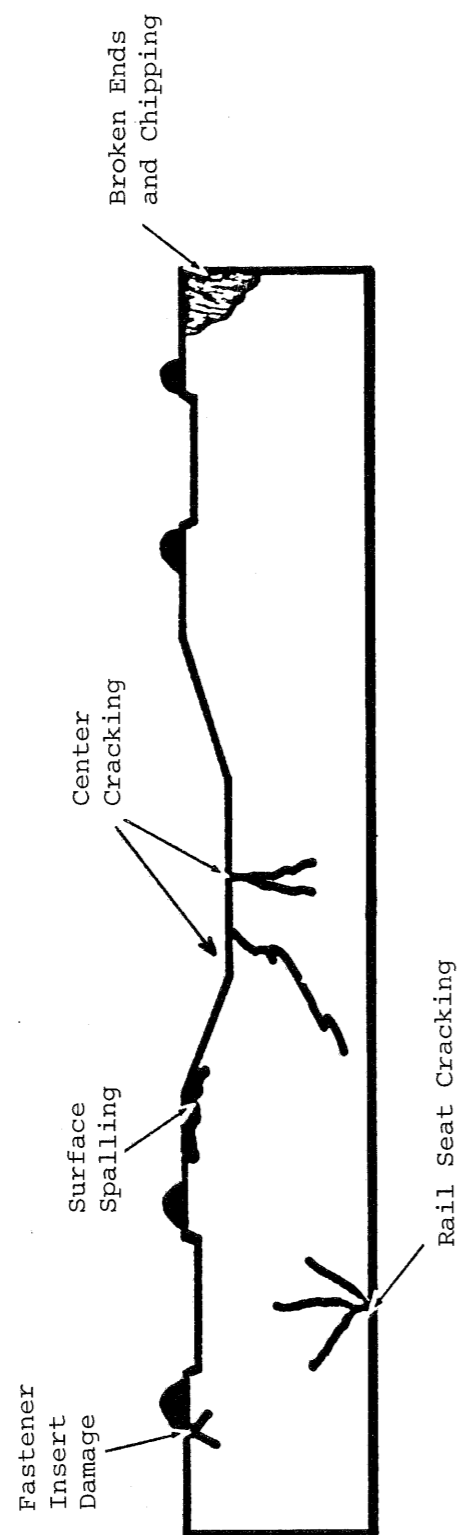
FIGURE 5-1. TIE DEGRADATION AND FAILURE MODES.

Figure 5-1 illustrates the types of tie flaws which were included in regular inspections of limited numbers of ties in 12 concrete tie subsections. Several problems which were encountered in the inspections include:

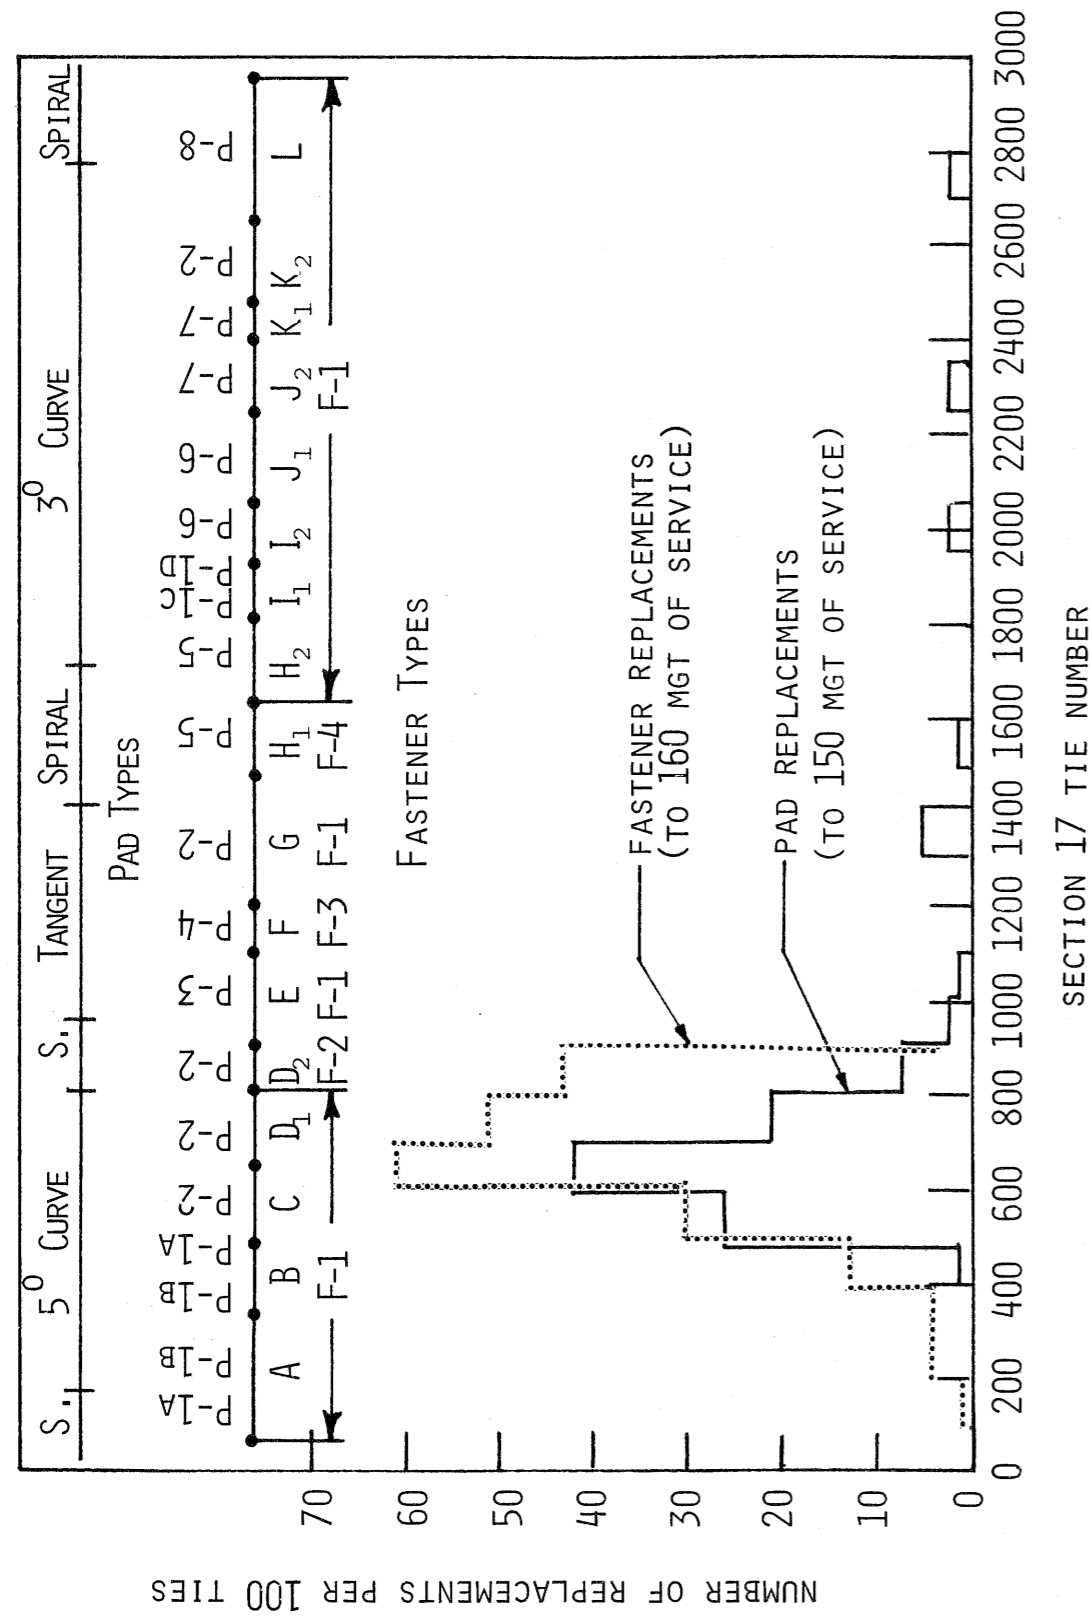
FIGURE 5-4. SUMMARY OF RAIL PAD AND FASTENER CLIP FAILURES IN SECTION 17.

Extensive fatigue fractures of type F-1 elastic rail clips began to develop in one region of the 5° curve of Section 17 at about 100 MGT. These fasteners were all new, installed after the track buckled at 61 MGT. The fractures were concentrated over the region of the 5° curve where the type P-2 pads, one of the softest tie pads, were installed. Other fasteners, which were installed at 61 MGT in the 5° curve with different pads, had much lower failures rates.

Replacement of worn pads was concentrated in the type P-2 pad region on the 5° curve. The dominant failure mode was concentrated wear (abrasion, fraying) over a 1"- 2" diameter area in the center of the pad.

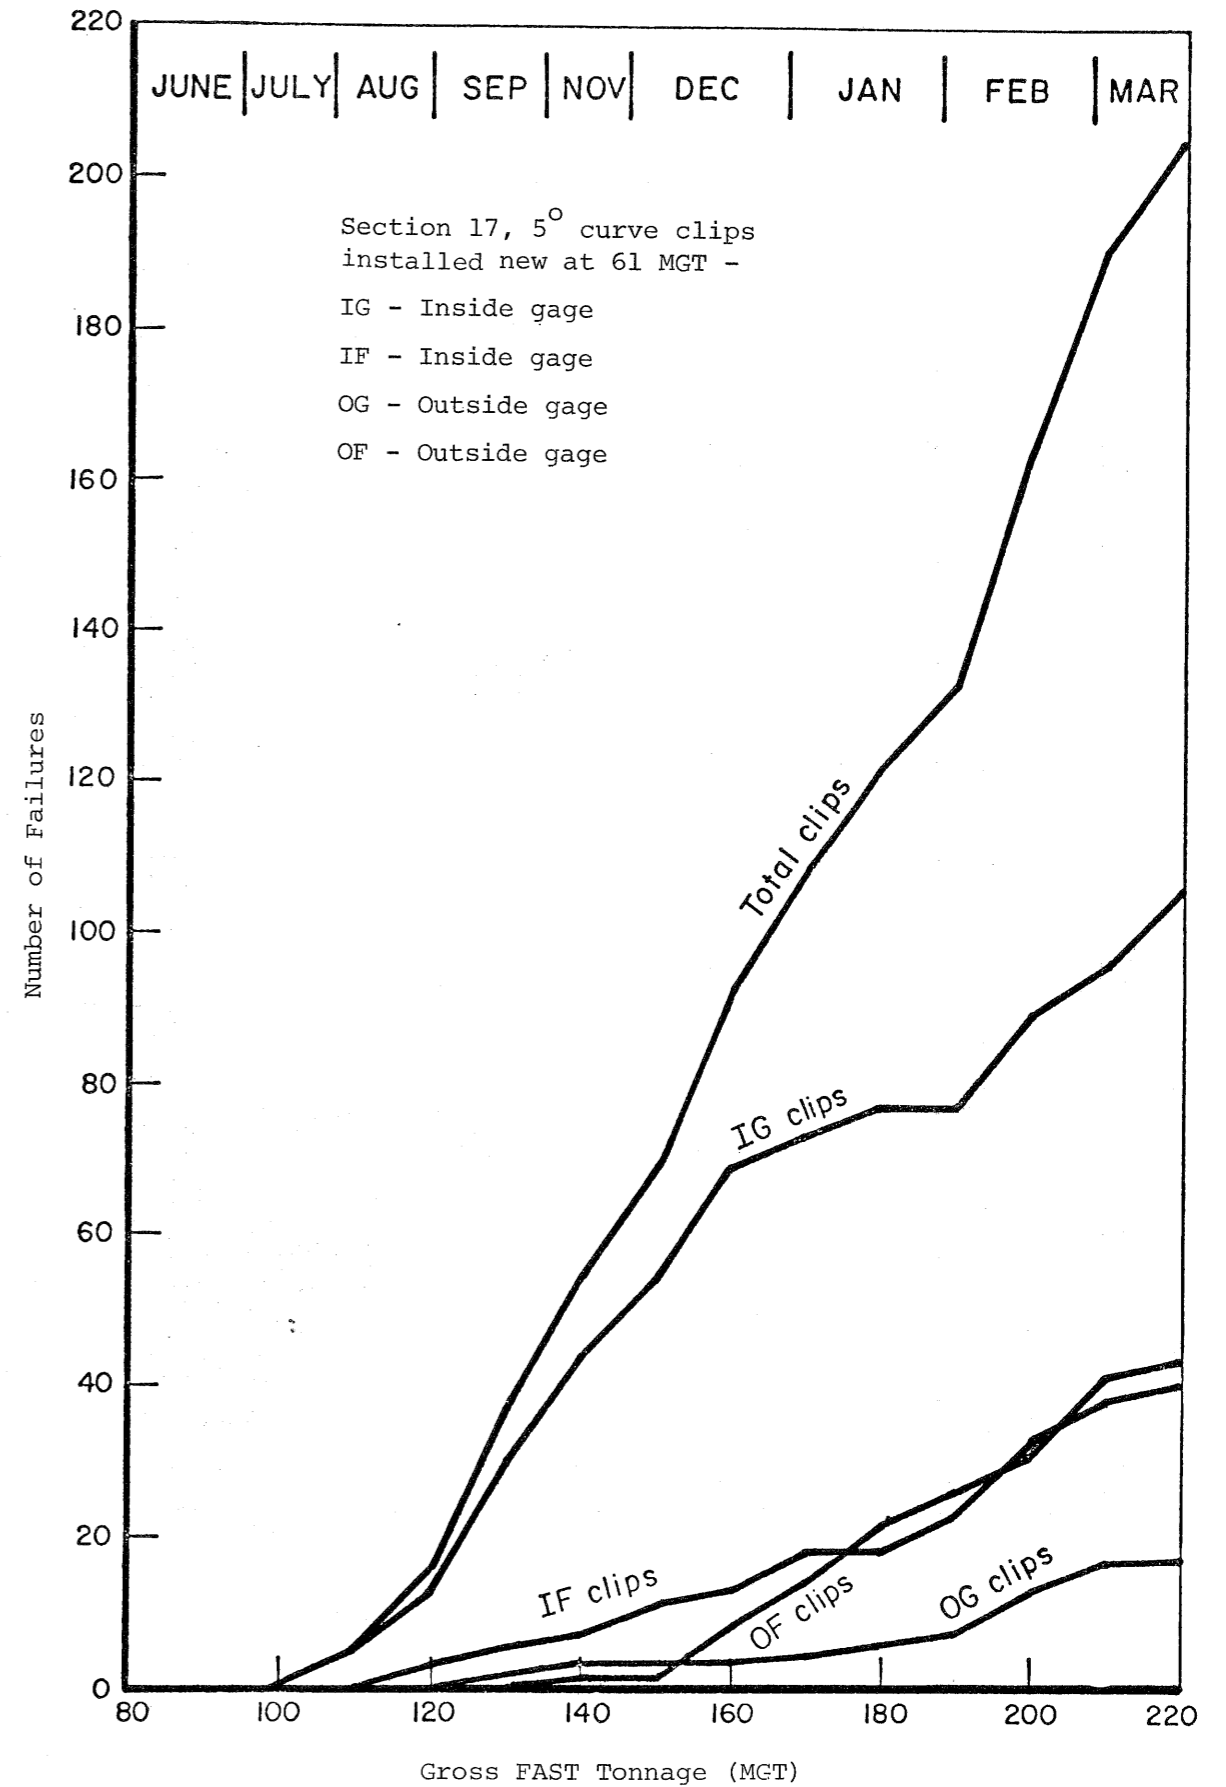
FIGURE 5-5. ELASTIC CLIP FAILURES AT EACH CLIP LOCATION VS. MGT.

Extensive fatigue failures of type F-1 elastic clips began to develop in one region of the 5° curve of Section 17 at about 100 MGT. These clips were

all from a batch installed at 61 MGT after the lateral track buckle. No clip failures had been reported prior to 100 MGT.

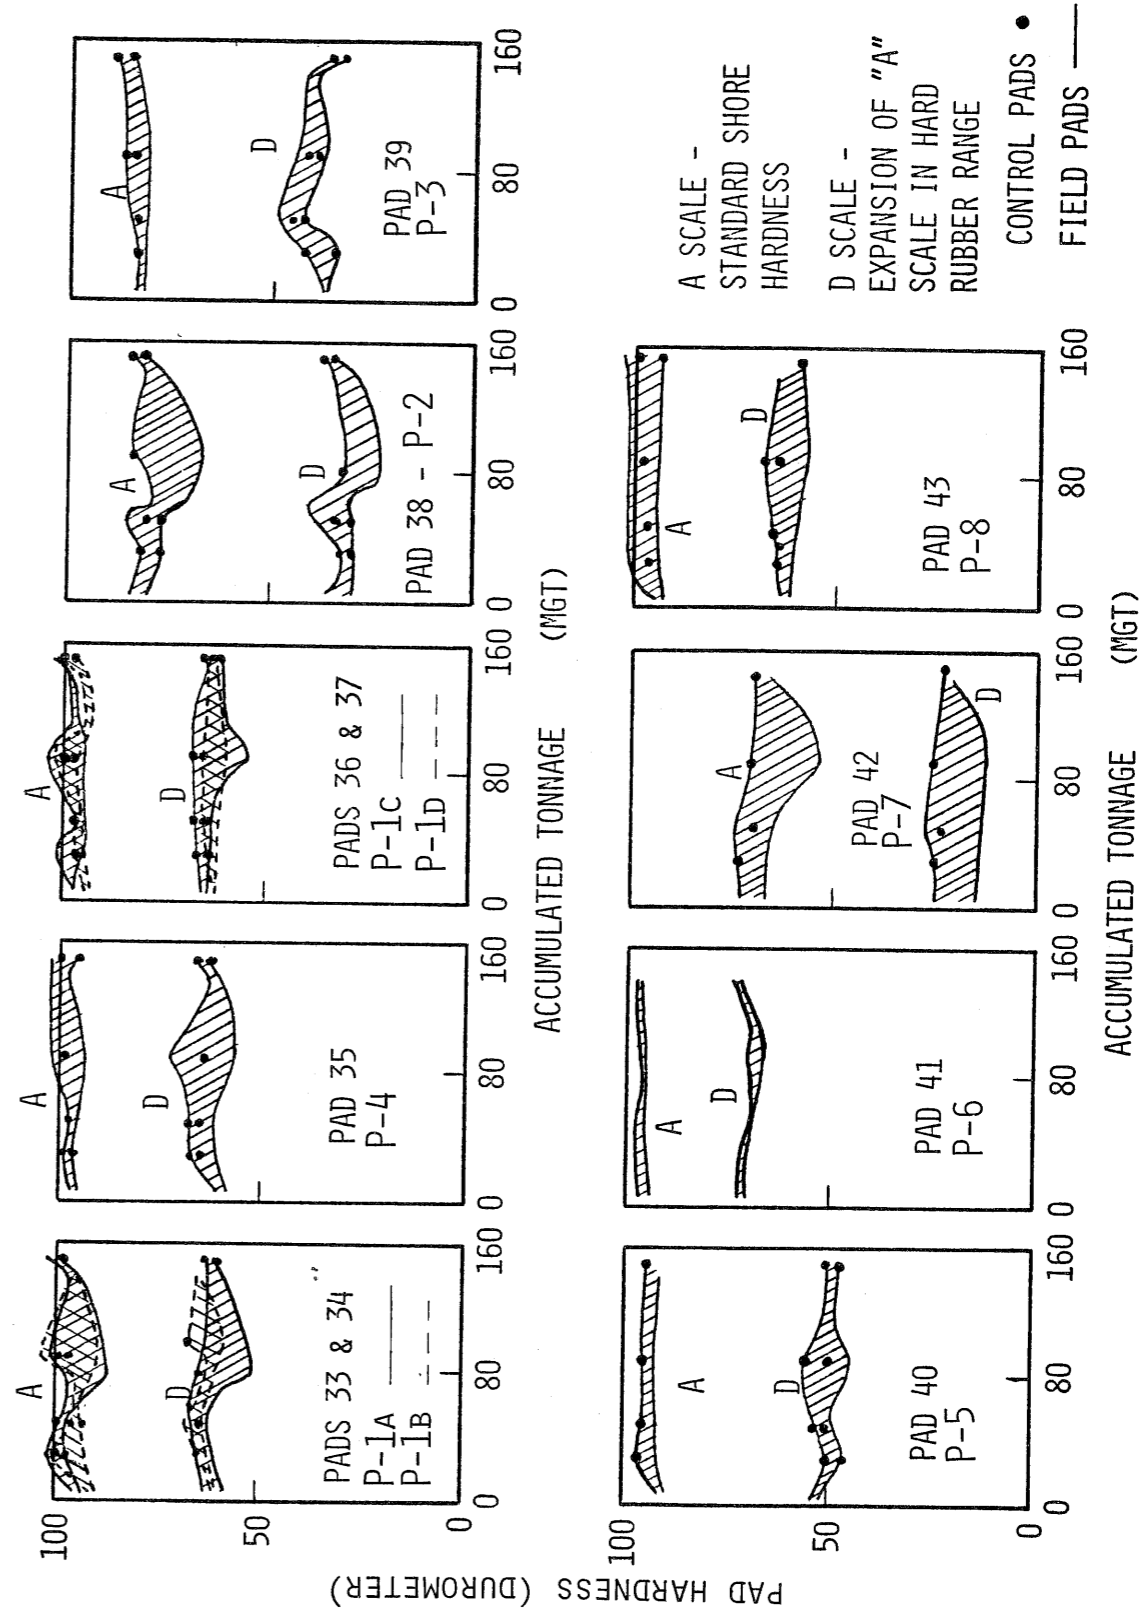
FIGURE 5-7. SUMMARY OF PAD HARDNESS MEASUREMENTS.

Figure 5-7 summarizes the hardness data. Black dots show measurements of control pads kept in the laboratory, and shaded regions show the measurement ranges for the service pads. In general, there was little variation with tonnage, but the pads can be classified into three ranges of hardness:

- Hard pads--P-1 a through d, P-4, P-6, and P-8,
- Medium pads--P-3 and P-5, and
- Soft pads--P-2 and P-7.

The softness of the P-2 pad probably contributed to the concentration of rail fastener clip failures in the 5° curve.
