CONCRETE AND WOOD TIE PERFORMANCE THROUGH 425 MGT

TRANSPORTATION TEST CENTER
PUEBLO, COLORADO 81001

1. Report No. FRA/TTC-81/06		2. Government Accession No.		3. Recipient's Catalog No.	
4. Title and Subtitle Concrete and Wood Tie Performance, 425 MGT				5. Report Date October, 1981

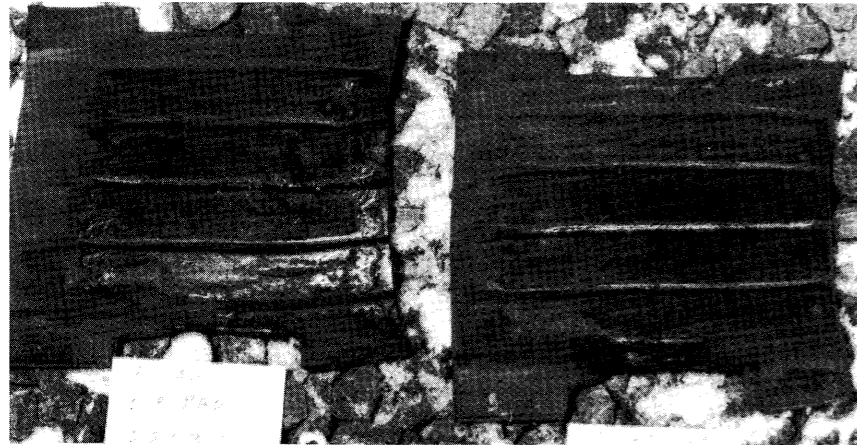
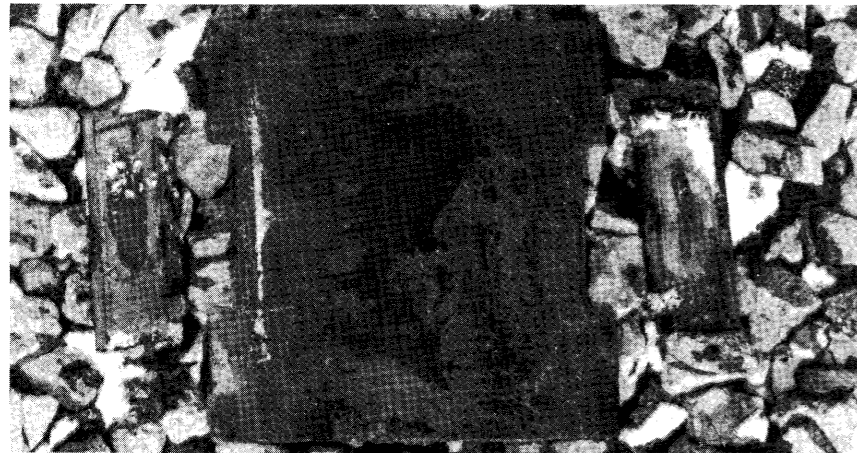
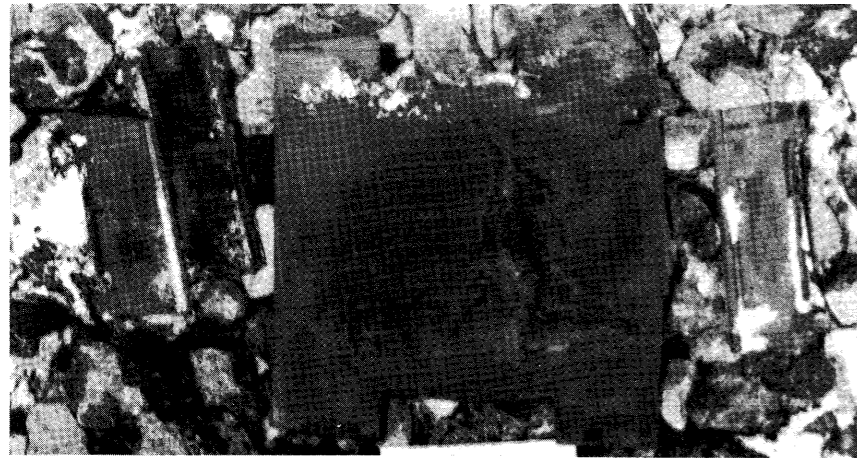
FIGURE 5-8. TYPICAL CONDITION OF PADS FROM 3° CURVE OF SECTION 17, 235 MGT.

An inspection of pads and insulators was conducted in most subsections after rail removal in preparation for the rebuild at 235 MGT.⁸ Results of the inspection and subsequent action are summarized in Table 5-1. Among pad types inspected, the largest percentages judged defective (cracked, frayed, torn) were found in the "soft" Type P-2 corded rubber pads and Type P-3 fiber-reinforced pads in the 5° curve. The failure rate of P-2 pads on the tangent section was much lower.

Type P-7
Soft, grooved
rubber pads

Type P-8
hard poly-
ethylene pad

Type P-2
Soft corded
rubber pad

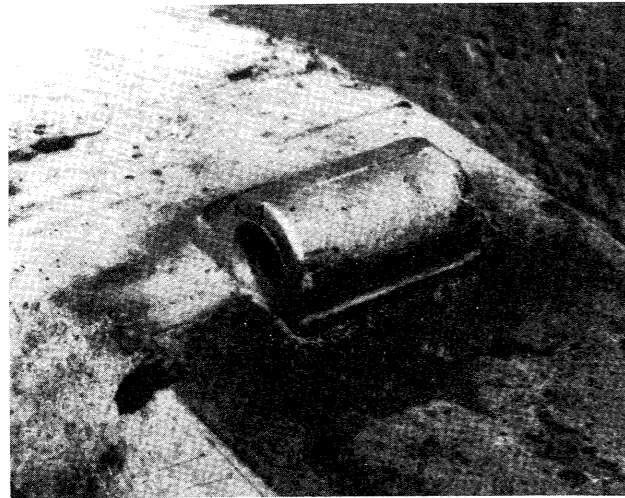
FIGURE 5-10 FASTENER SHOULDER WEAR.

Fastener shoulder wear was found in subsections D₂ and H₁ where internal insulation was used, and was also found where external insulators were broken or missing. The wear occurred on the field side inserts where the rail base contacted the insert shoulder, as shown in Figure 5-10. Measurements made during the inspection at 235 MGT⁸ showed that the wear in subsection D₂

frequently exceeded 1/8" and ranged up to 3/16". Wear up to 1/8" also was found in subsection H₁. This type of wear will result in gage widening and could eventually result in loss of ties, unless weld repair of the shoulders is undertaken.

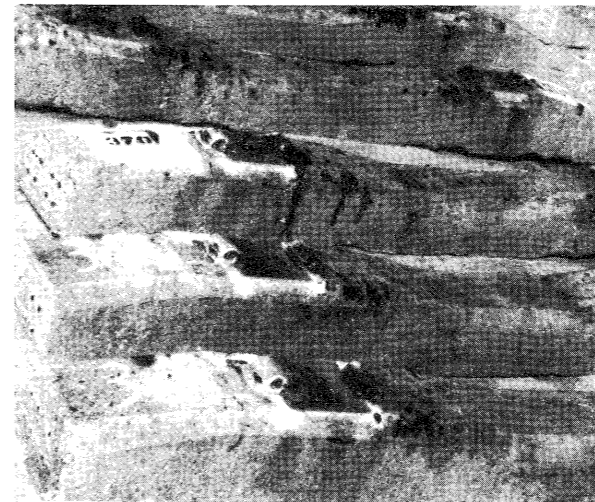
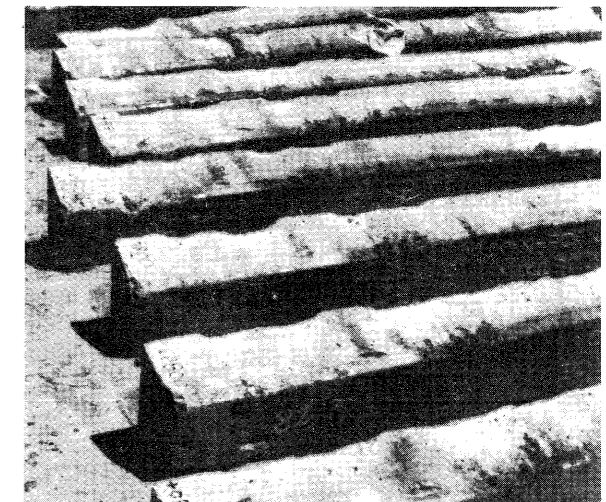
FIGURE 5-11 GENERAL CONDITION OF TIES REMOVED FROM SECTION 17.

Type T-2 Ties

Type T-1 Ties

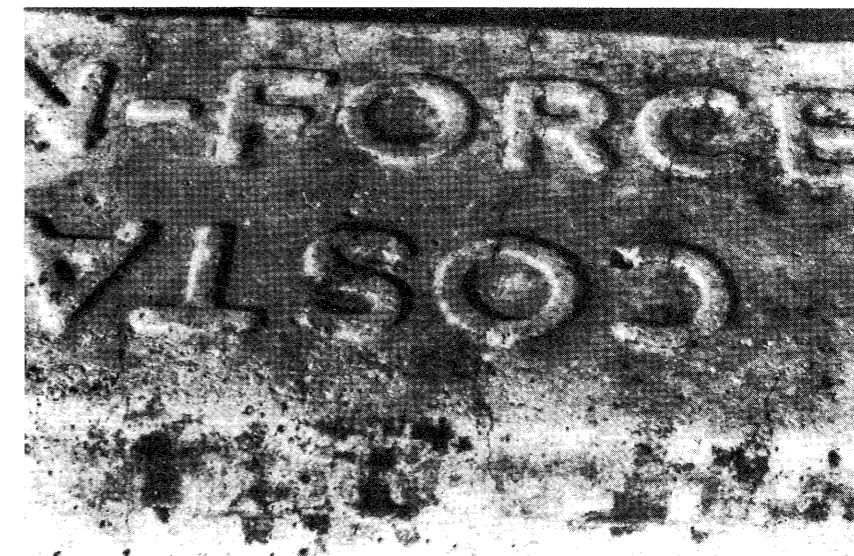
FIGURE 5-12 TOP SURFACE CRACK PATTERN ON TYPE T-1 TIES.

- Top surface cracks as shown in Figure 5-12 could be seen on many of the Type T-1 ties from a small region of the curve. These cracks were discovered very early in the operations program and were originally inspected at 100 MGT. It was noted that they had grown very little in the following 325 MGT. The original inspection identified 35 ties with cracks of this type, 32 of which were located in a zone of 141 ties in subsection 17A, which contained hard polyethylene pads. The top center cracks were

noticed very early in the FAST operations program, and observers have reported that they grew very little after first appearing. Therefore, the cracks could have been caused by an initially poor ballast support condition.

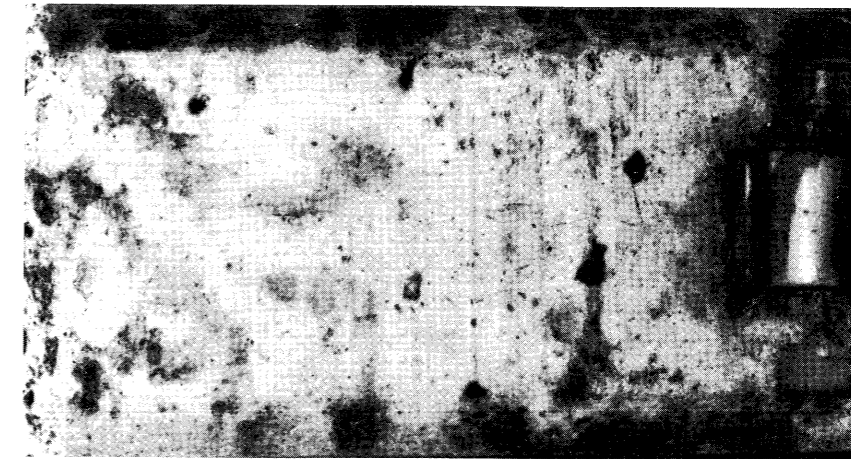
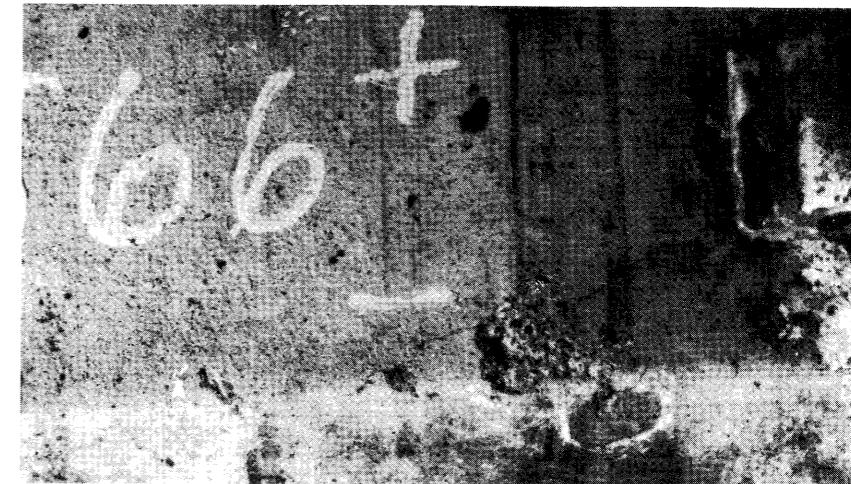
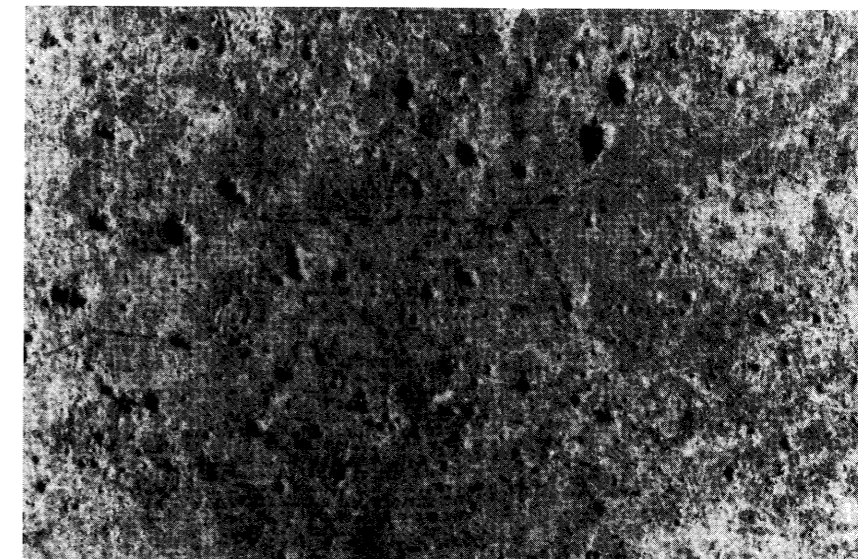
FIGURE 5-14. TYPICAL LONGITUDINAL SURFACE CRACKS ON TIE FACE.

*Top surface cracks on Type T-2 ties extended from fastener shoulder outward to end of tie.

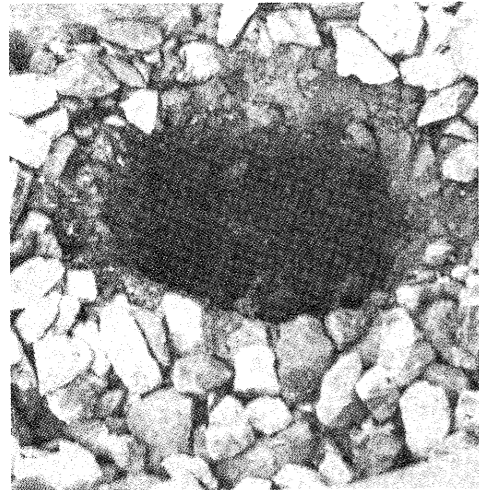
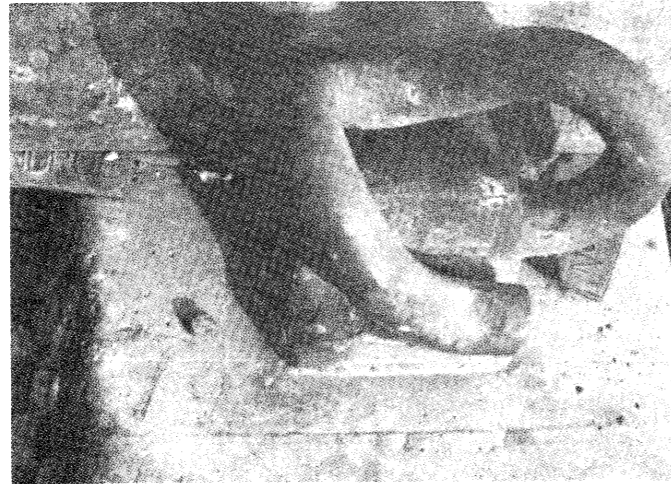
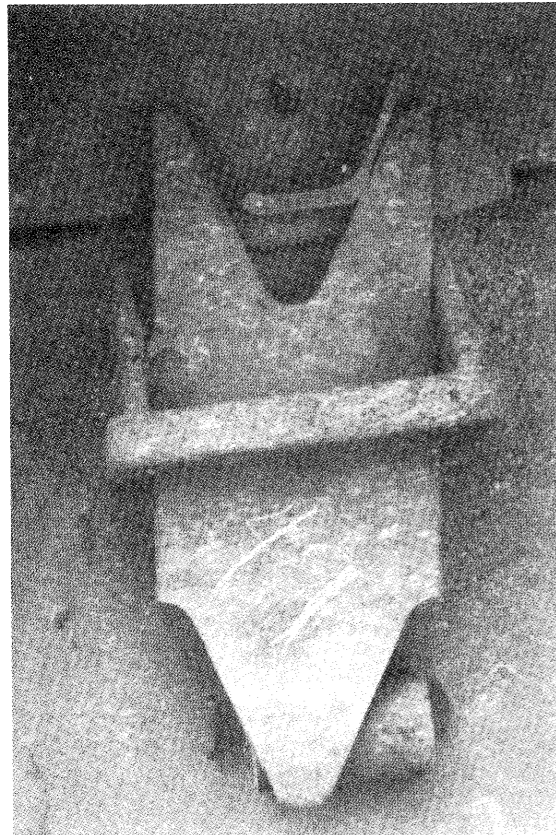
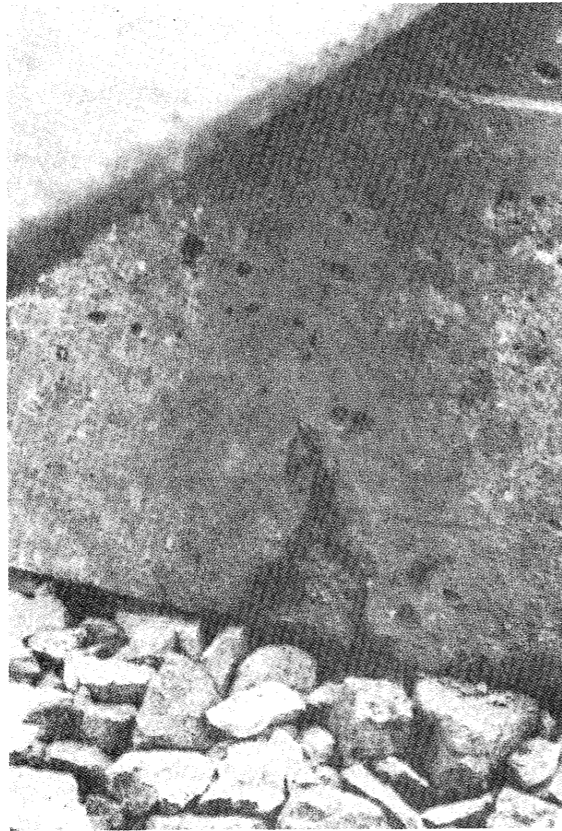
(c) Insulator Broken,
Clip Displaced

(Ties installed in 1974, photos taken in 1980.)

(d) Rail Seat
Bending Crack
