Update: New Crosstie and Fastening System Test at FAST

Rafael Jimenez and David Davis

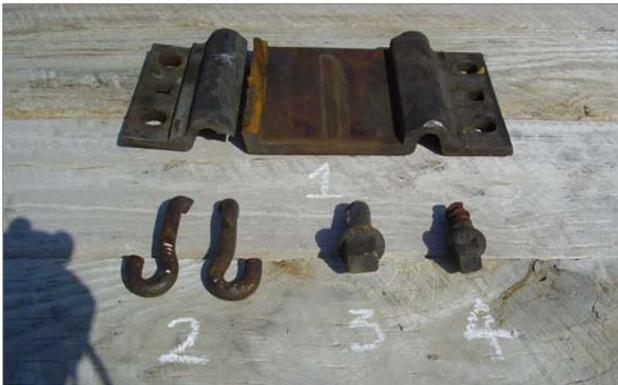
Broken screw spikes and broken tie plates, as shown in Figure 1, were a significant problem in Control Zone 1, where 44 percent of the tie plates had two or more broken LB&N high strength screw spikes and 14 percent of the Pandrol rolled steel tie plates fractured. It appears a failure cycle may have been at work in this zone, where broken screw spikes contributed to the broken tie plates, which in turn led to more broken screw spikes. This type of tie plate, with its diagonally opposed e-clips, has a tendency to skew relative to the tie. The skewing causes point loadings, which continue to result in increased plate fracture rates under heavy axle load (HAL) traffic at FAST. Given that, when two of the four screw spikes break, the screw spike holes in the plate and in the tie become oblong, the plate is freer to skew, it is subjected to point loading, and it ultimately breaks. The remaining screw spikes are then left to react against higher, per screw spike loads that are introduced by lateral translation of the plates.

LB&N submitted the result of a test conducted by an independent laboratory to TTCI on a single broken screw spike sample. The lab's report suggested problems related to rolling laps from the threading process and decarburization. LB&N indicated these issues are continually addressed and improved in their manufacturing process.

Figure 1. Component Failure under HAL Traffic
(1) Pandrol 16-in. rolled steel tie plate (2) NorFast rail clip (3) LB&N High Strength Screw Spike (4) No. 5760 Screw Spike

TTCI's current maintenance procedure is to cut spike those tie plates where two or more screw spikes have fractured inside the tie. This is done as a preliminary remedial action. After a number of plates have been cut spiked due to broken screw spikes, those plates are replaced with ones of a different screw spike pattern. To avoid the track component failure cycle, the tie plate cutting, and the track gage degradation that was seen under HAL traffic in Control Zone 1, it is likely best to eliminate the preliminary remedial action step (cut spiking the plates) and to proceed directly to replacing the plates using four new screw spikes.

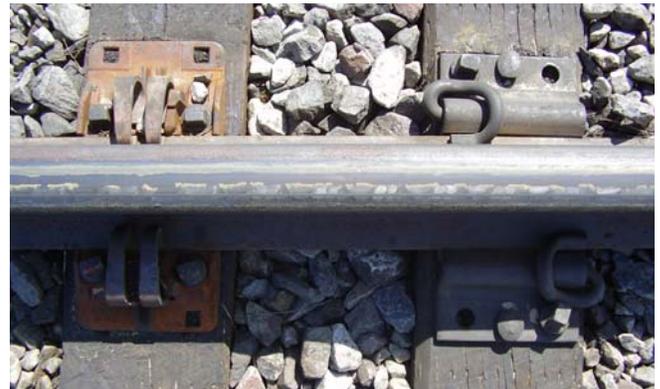
The right tie in Figure 2 shows a tie plate that was cut spiked after two screw spikes broke off inside the tie. The left tie is providing higher track strength. The tie was refitted with

a plate of different screw spike pattern where all four screw spikes can be used again.

Figure 2. Right Tie: Cut Spiked after Two Screw Spikes Broke Off Inside the Tie. Left Tie: Providing Higher Track Strength with All Four Screw Spikes in New Holes

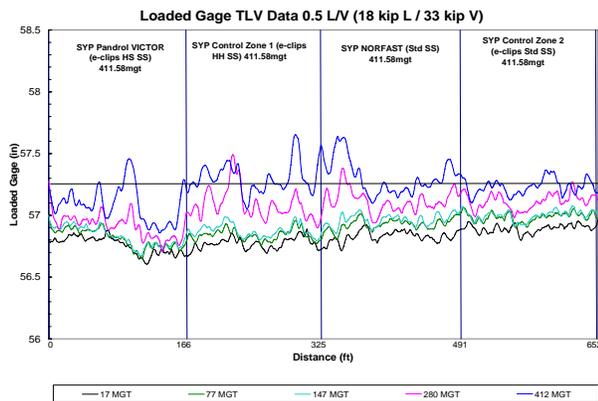
Figure 3. Loaded Gage Measured in the Fastening System Test Zones under the 0.55 L/V TLV Gage Spreading Load at 12 mph

The initial average loaded gage measured in Control Zone 1 and in the NorFast test zone, after 17 MGT, was 56.77 inches and 56.83 inches, respectively. After 412 MGT of HAL traffic, however, the track gage exceeded 57 1/4 inches in more than 50 percent of each of these test zones under the dynamic gage spreading load of the TLV. This gage widening was likely a result of the high number of broken screw spikes in Control Zone 1 and the high number of screw spike uplift in the NorFast test zone.

Less than 10 percent of the Pandrol Victor test zone widened more than 57 1/4 inches compared to almost 20 percent of Control Zone 2. The portion of the Pandrol Victor test zone that exceeded 57 1/4 inches, however, widened more (about 57 1/2 inches) than the widest portion of the control zone. This may have been due to the higher number of tie plates with more than two broken screw spikes in the Victor Zone (11%) as compared to Control Zone 2 (1%).

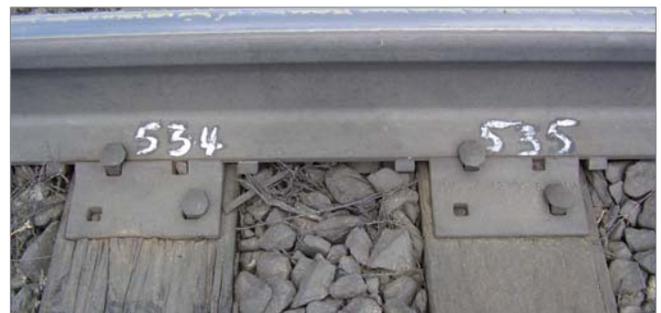
Two types of solvents were used in the copper naphthenate treatment of the parallel strand lumber species ties and the solid southern yellow pine ties. The two solvents are designated CPT-2 (No. 2 oil) and BWR-5 (No. 5 oil). Although some tie plate cutting is evident in all of these alternative treatment test zones, the ties treated with the BWR-5 solvent appear to have a thicker and perhaps more durable protective surface layer than the ties treated with the CPT-2 solvent. The BWR-5 ties also appear to be experiencing less tie plate cutting, as Figure 4 shows.

Figure 4. Two Southern Yellow Pine Parallel Strand Lumber Ties Treated with Copper Naphthenate. Tie No. 534 Treated with CPT-2 Solvent. Tie No. 535 Treated with BWR-5 Solvent Appears to have a Thicker Protective Layer and Experiencing Less Tie Plate Cutting
