**JRC2018-6166**

## **ENVIRONMENTAL AND TRACK FACTORS THAT CONTRIBUTE TO ABRASION DAMAGE**

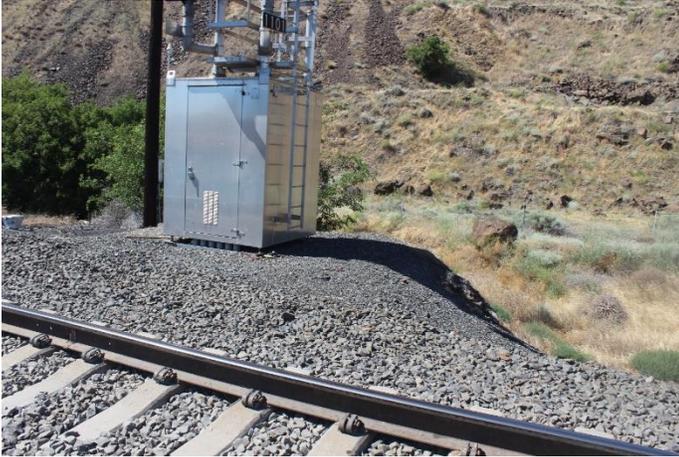
The presence of water or poor drainage was an issue at all sites with significant abrasion damage. Poor drainage was seen in 95 percent of the sites with measured abrasion damage greater than 0.5 in. The cause of the poor drainage was in many cases inadequate grading, such as that shown in Figure 1. In other cases it could have been caused by ballast breakdown. Sites visited with center-binding cracking but without significant abrasion were in locations with excellent drainage and often in arid climates. In a tunnel location, water was seen in the ditches on both sides of the road, as shown in Figure 2. After the water in the south-side ditch traveled a few dozen yards from the tunnel entrance, it turned and went through the track structure to empty out into the north-side ditch. Concrete ties near the location where the water went under the track were recently replaced in part because of abrasion damage.

Figure 1: Location with concrete tie abrasion damage had grading issues at signal controls

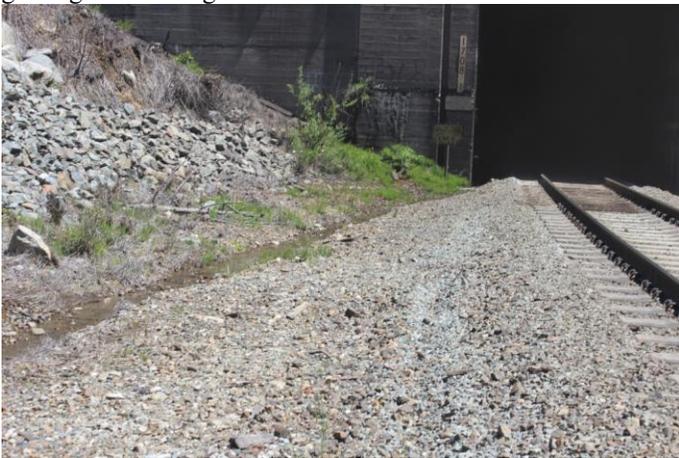
Figure 2: Water emanating from tunnel portal

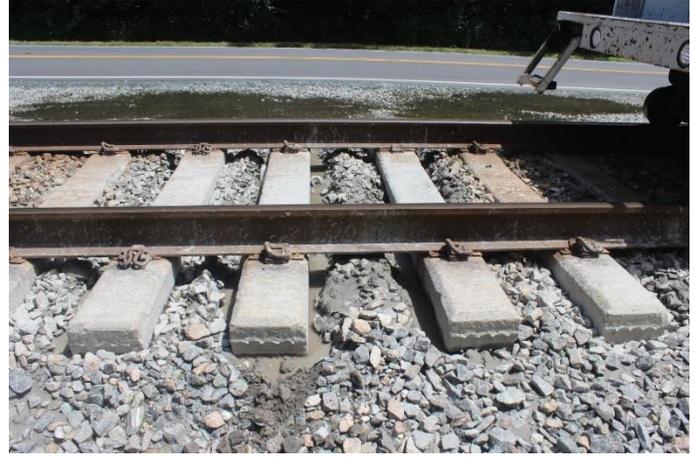
Mud pumping was seen in sites both with and without severe abrasion damage but was seen in 89 percent of the sites with measured abrasion damage greater than 0.5 in. The sites that did not have evidence of pumping had maintenance performed recently, making it inconclusive on those sites whether pumping was a factor or not. Ponding was also seen in track locations with pumping and abrasion damage, as shown in Figure 3. Pumping occurs when ties are loaded and apply pressure on the ballast below. When this occurs, water in the pores is pressurized. High pressure causes the water to move to areas of lower pressure, forcing water around the tie. When the loading is removed from the tie, the water pressure in the ballast pores decreases, sucking the water back in to the ballast [11]. Hydro-abrasion damage from the mud pumping could contribute to the tie bottom rounding observed.

Figure 3: Water ponding in track, contributing to mud pumping

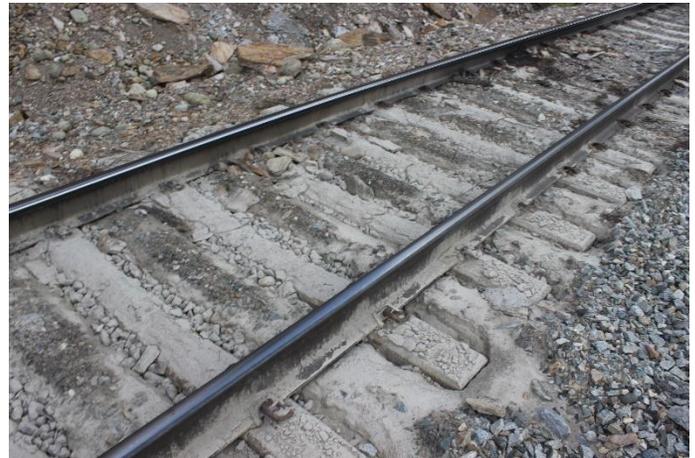
Pumping evidence was seen in four locations in two different states with low amounts of abrasion damage. These sites included an asphalt intersection, a curve, and two tangent track locations. These sites did not contain gray mud and had low amounts of ballast underneath, giving much different support conditions. This indicates that pumping by itself is not sufficient to cause bottom tie abrasion.

Figure 4: Pumping with very little ballast under ties and only minor abrasion damage

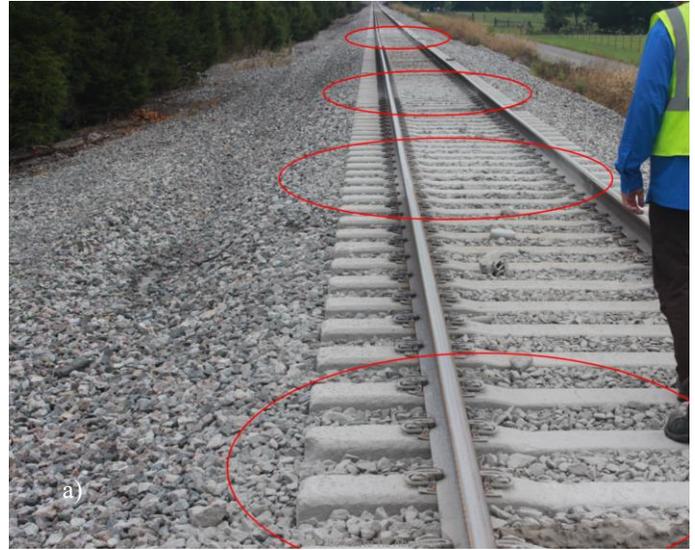
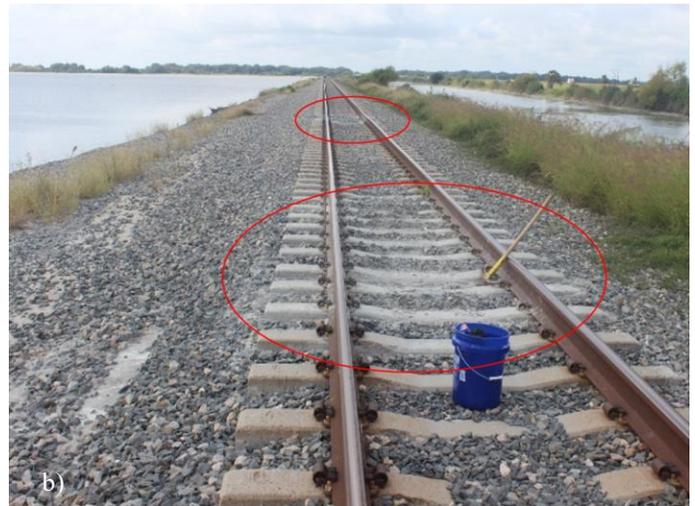
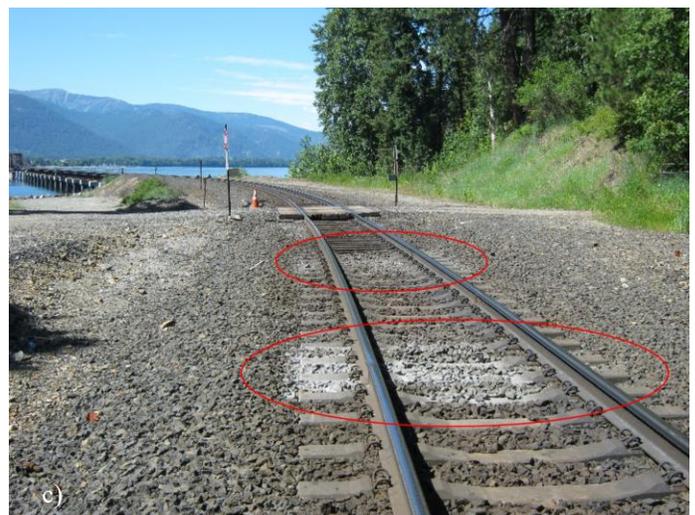
Figure 5: Locations of concrete tie abrasion found that show train vertical harmonics in the a) U.S. Southeast, b) U.S. South-Central, and c) U.S. Mountain West region

Bumps or track stiffness changes were not a requirement for abrasion to occur but were found on 9 out of 19 sites with more than 0.5 in. of measured abrasion loss. Abrasion damage was found at some locations in curves and tangent track without these features. Track bumps could be a trigger for ballast breakdown and changes in track conditions that could cause abrasion damage.

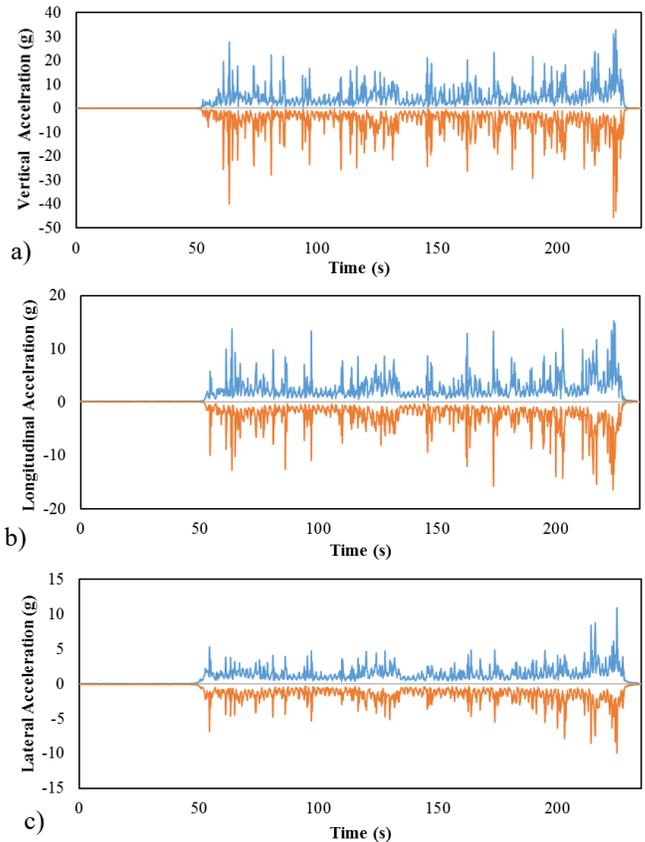
There was a gap between the tie and ballast underneath many ties that showed abrasion damage. This was felt after removing the ballast from the side, or in other cases when mud pumping removed the ballast surrounding the sides of the tie, and the research team was able to feel the gap underneath. Accelerations in the rail or tie direction could create frictional rubbing given sufficiently high tie normal forces to cause significant abrasion. Gaps between the ties and ballast were also seen in video footage to allow ballast to move or vibrate. Vibrational motion of abrasive material on a surface is known to cause wear. Besides translational motion, ties are known to have a slight rocking as the train load is applied to the tie. This rolling could also create frictional forces. The role of acceleration in the rail or tie directions in causing abrasion damage warrants further examination.

Figure 6: Concrete tie acceleration in the a) vertical direction, b) longitudinal (rail) direction, and c) lateral (tie) direction

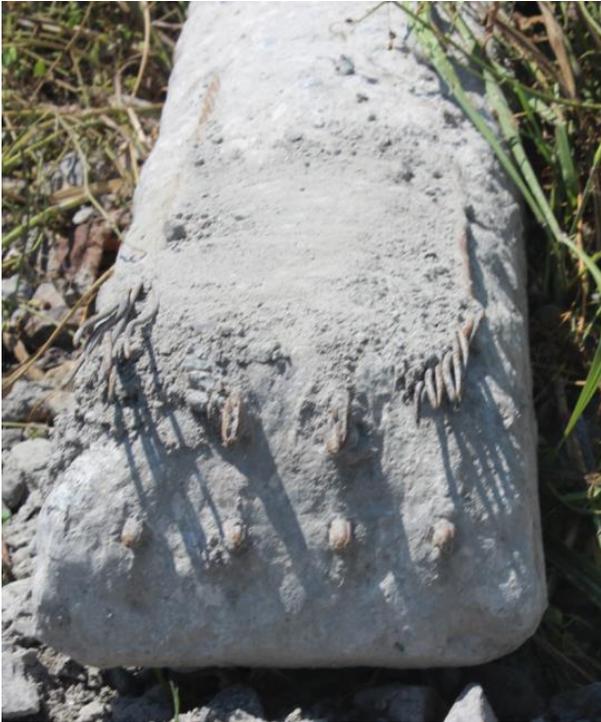
across the tie bottom and sides, with tie bottom corner rounding being more pronounced as shown in Figure 7. Compared to siliceous gravel, the hardness of limestone aggregates is more similar to that of cement paste, giving a more even wear. Abrasion on concrete ties with siliceous aggregates was much more varied, as shown in Figure 8, with the cement paste wearing at a much faster rate than the aggregates. This gave the ties with siliceous aggregates more topology on the bottom. The more even wear seen on ties with limestone aggregates is indicative of faster abrasion rate; however, a more in-depth, controlled study is needed.

Figure 7: Abrasion damage found on concrete made with limestone aggregate

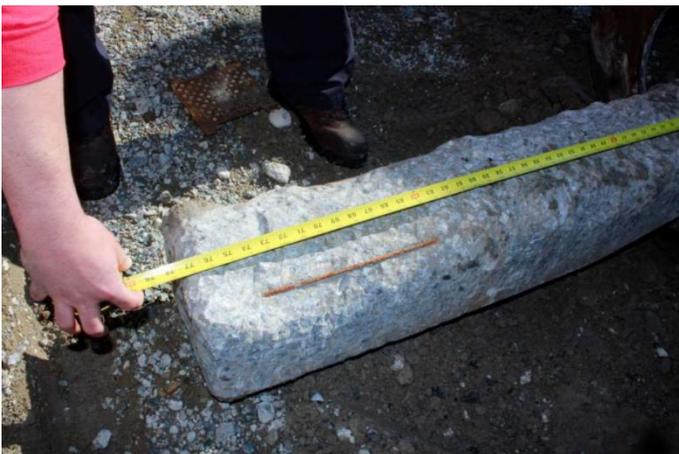
Figure 8: Abrasion damage found on concrete made with siliceous coarse aggregates

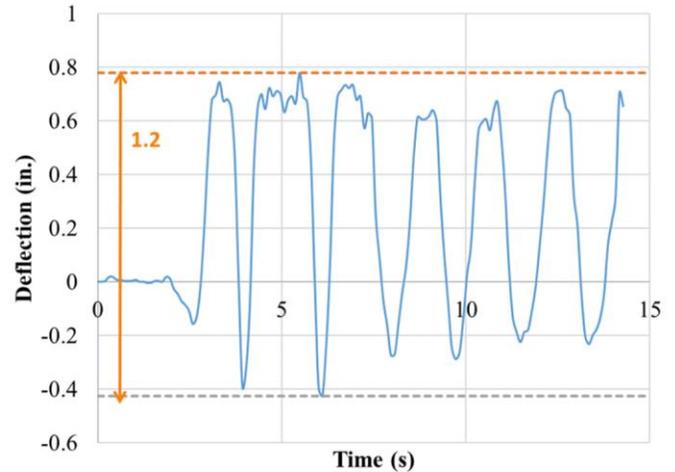
Large amounts of tie deflection was measured on a site near an insulated joint during a train pass as shown in Figure 9. Deviations in the alignment occurred just from one train pass because of poor horizontal ballast restraint from mud pumping around the ties, ballast fouling, and tie wear, as shown in the before and after pictures in Figure 10 and Figure 11, respectively. After the train passed, maintenance crews removed a tie from service, allowing the team to measure the bottom wear. Figure 12 shows the concrete wear measured in the tie removed from track.

Figure 9: Rail vertical deflection on site near insulated joint

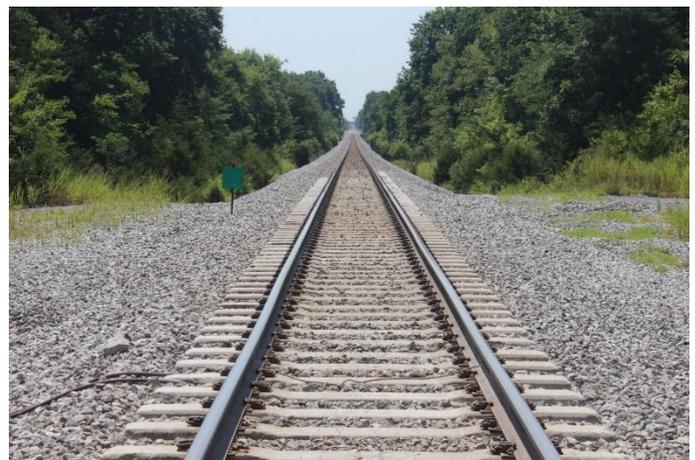
Figure 10: Track near insulated joint before train pass

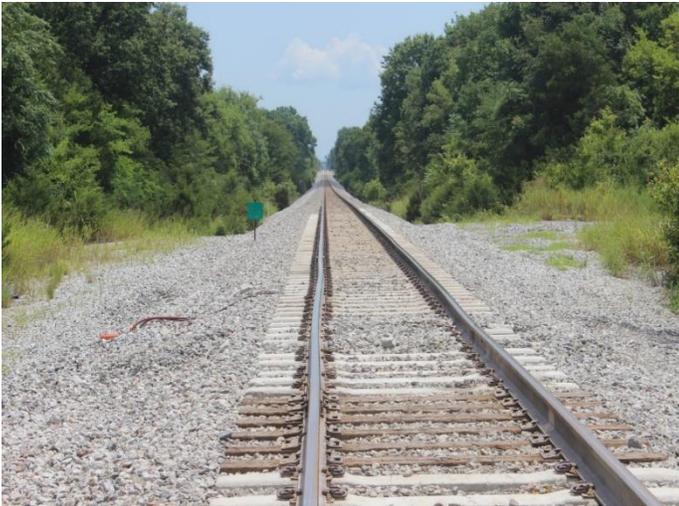
Figure 11: Track near joint after train pass, showing alignment issues

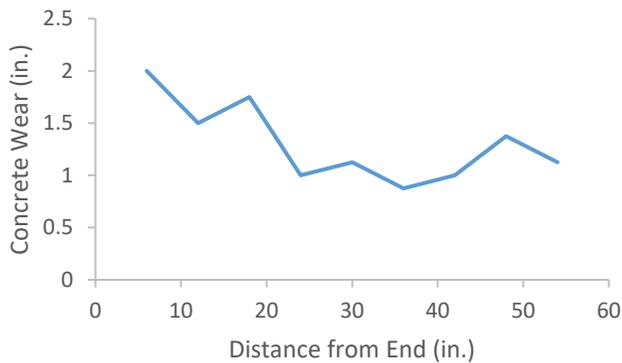
Figure 12: Bottom wear on tie removed from track shown in Figures 10 and 11

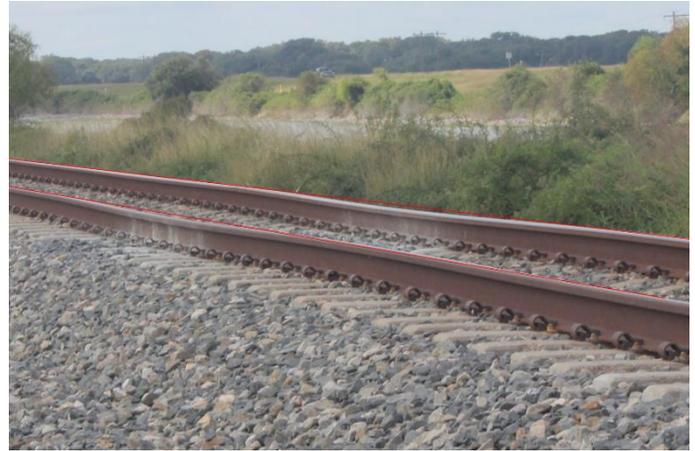
A track site in the U.S. South-Central region was visited that was built on top of an old concrete highway. At one location, a large rail surface profile variation was seen at the location of a mudspot and concrete tie bottom wear, as shown in Figure 13. This level of rail and tie deflections during loading could fatigue the rail or contribute to rail breaks. Rail welds were commonly found at locations with abrasion damage. Worn out rail sections were also occasionally found discarded on the side of the track, indicating a lower rail life than the rest of the track – a potential side effect of concrete tie wear.

Figure 13: Rail surface profile variations seen in a track site constructed over an old concrete highway. Red lines drawn to highlight the more than 1.3 in. of surface profile variation measured by Automated Track Inspection Program (ATIP) geometry car about 2 years before the research team visited the site

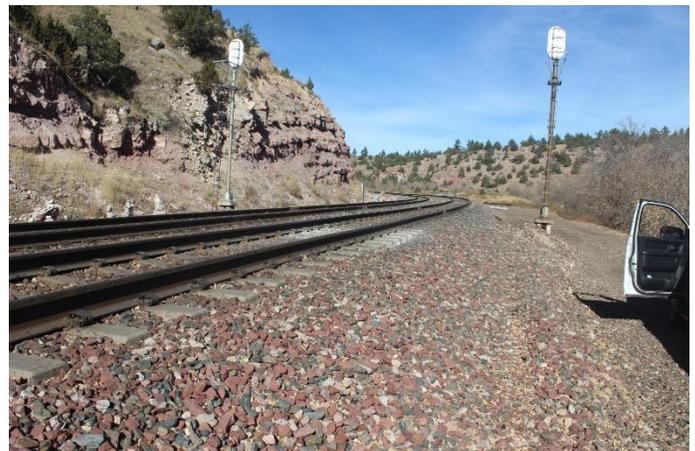
It did not take much abrasion wear to cause alignment issues in ties made without scallops, as seen in a curve in a canyon in the U.S. West region in Figure 14. Ties in the curve had only minor abrasion damage but had problems with track wander, causing the ties to be replaced. Scallops would prevent minor wear from causing track wander.

Figure 14: Canyon site with ties that after only minor abrasion started to cause alignment wander

Some locations had low amounts of gray mud and abrasion damage. Track maintenance was emphasized at these locations, such as the canyon site shown in Figure 14, with significant resources being continually used to ensure good track conditions. The locations were well graded, ballast was undercut periodically, and ballast tamping was regularly performed. All of these factors ensure good drainage. The concrete ties at these locations showed far less abrasion wear than other locations with the ties made at approximately the same time but without the same level of maintenance.

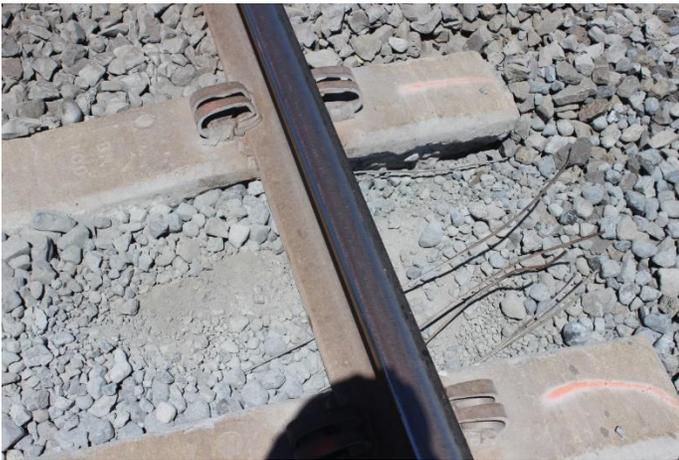
Another location that was especially illustrative of the effects of increased track stiffness was a curve visited in the U.S. Pacific Northwest region. Two ties were found with severe abrasion on the sides facing towards each other. Part of an old tie was left between the two ties with severe side abrasion damage, as shown in Figure 15. The low amount of ballast between the old tie and damaged in-use ties created stiff track conditions between the ties as well as fouled ballast to retain moisture. Other locations with fines and insufficient ballast underneath ties showed mud pumping, but only minor amounts of abrasion damage. Track with fouled ballast is known to have varying stiffness depending on the track moisture content. During dry conditions, the fines greatly increase the track stiffness, while during wet conditions they greatly decrease the track stiffness.

Figure 15: Ties with old tie in between and side abrasion

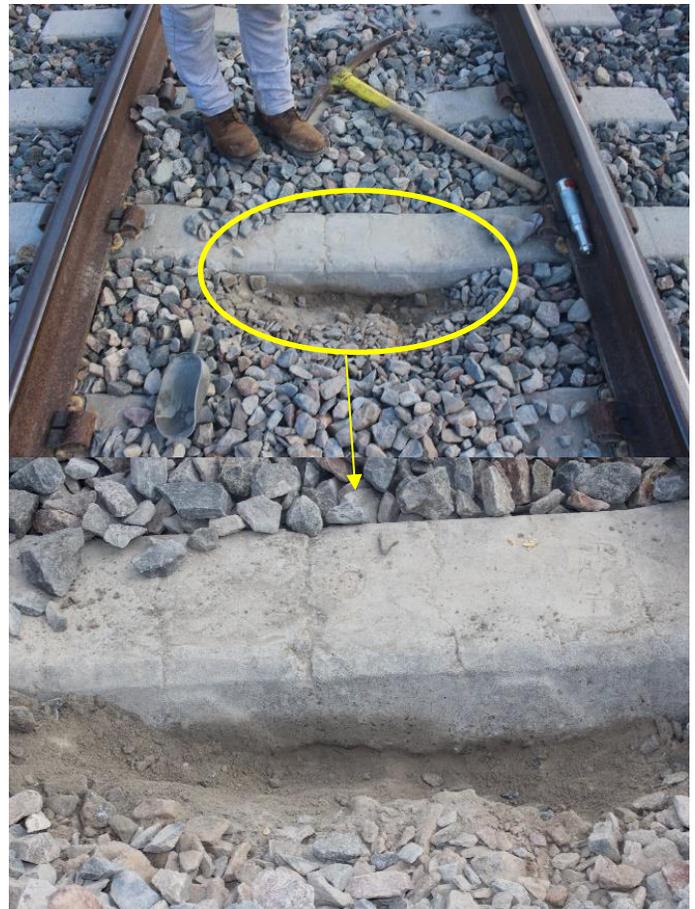
Figure 16: Track at concrete bridge eight months after ballast was replaced

nothing to address the underlying conditions that contribute to tie abrasion. Tamping does not remove fouling, significantly improve drainage, or change track stiffness. Mud pumping and variable track support conditions returned after tamping. Local cribbing out of ballast was tried on a concrete bridge visited by the research team. After only eight months after the ballast cribbing, fouling was present, as shown in Figure 16. Ballast replacement does not change track stiffness and only removes part of the fouled ballast. Mud spots have a tendency to spread and grow in size. It is also difficult to remove all of the fouled ballast since it is often present in a larger area under the surface. Track undercutting is more helpful but does not change underlying stiffness issues in track. Although pumping could eventually return, performance after undercutting was much better than that achieved with tamping alone and also provided improvement over a longer period of time.
