FRA/TTC-80/06

EVALUATION OF STEEL TIE PERFORMANCE AT THE FACILITY FOR ACCELERATED SERVICE TESTING

SEPTEMBER 1980

FINAL REPORT

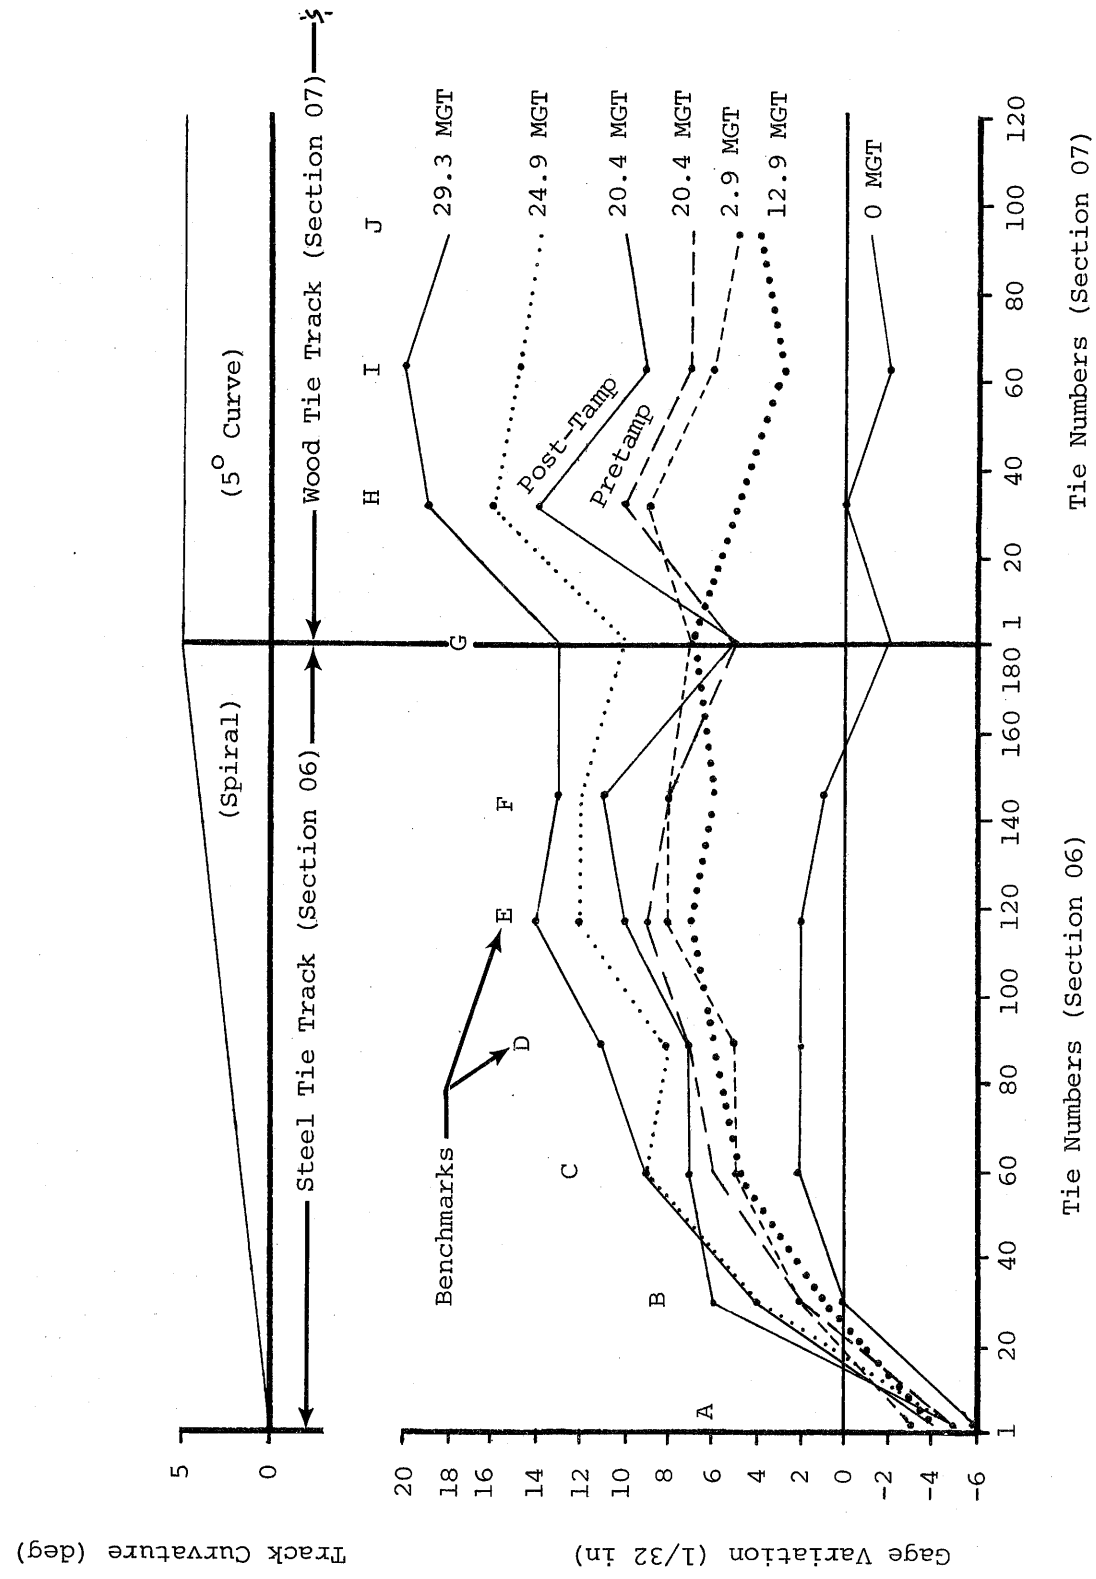
FIGURE 2-2. GAGE VARIATION VS. DISTANCE ALONG TRACK.

The gage widening data shown in figure 2-2 are biased by the fact that after the fastener tabs began to bend and crack, gage bars were installed to prevent track failure. The dates of installation and the distribution of gage bars are not known. However, a possible effect of the gage bars can be seen in the figure 2-2 plots of gage widening vs. track distance for each of the seven measurement cycles conducted over the steel tie service period. The plots "dip" over about the latter third of Section 06, in contrast to a general trend of increase in gage with increasing track curvature. Maximum gage widening was actually reached in the wood tie Section 07, but it was not accompanied by failure of the wood tie fasteners. (There were four cut spikes per rail in the measurement zone of Section 07). It should also be noted that much of the gage widening in Section 07 and in the higher-curvature portion of Section 06 was caused by rail wear.

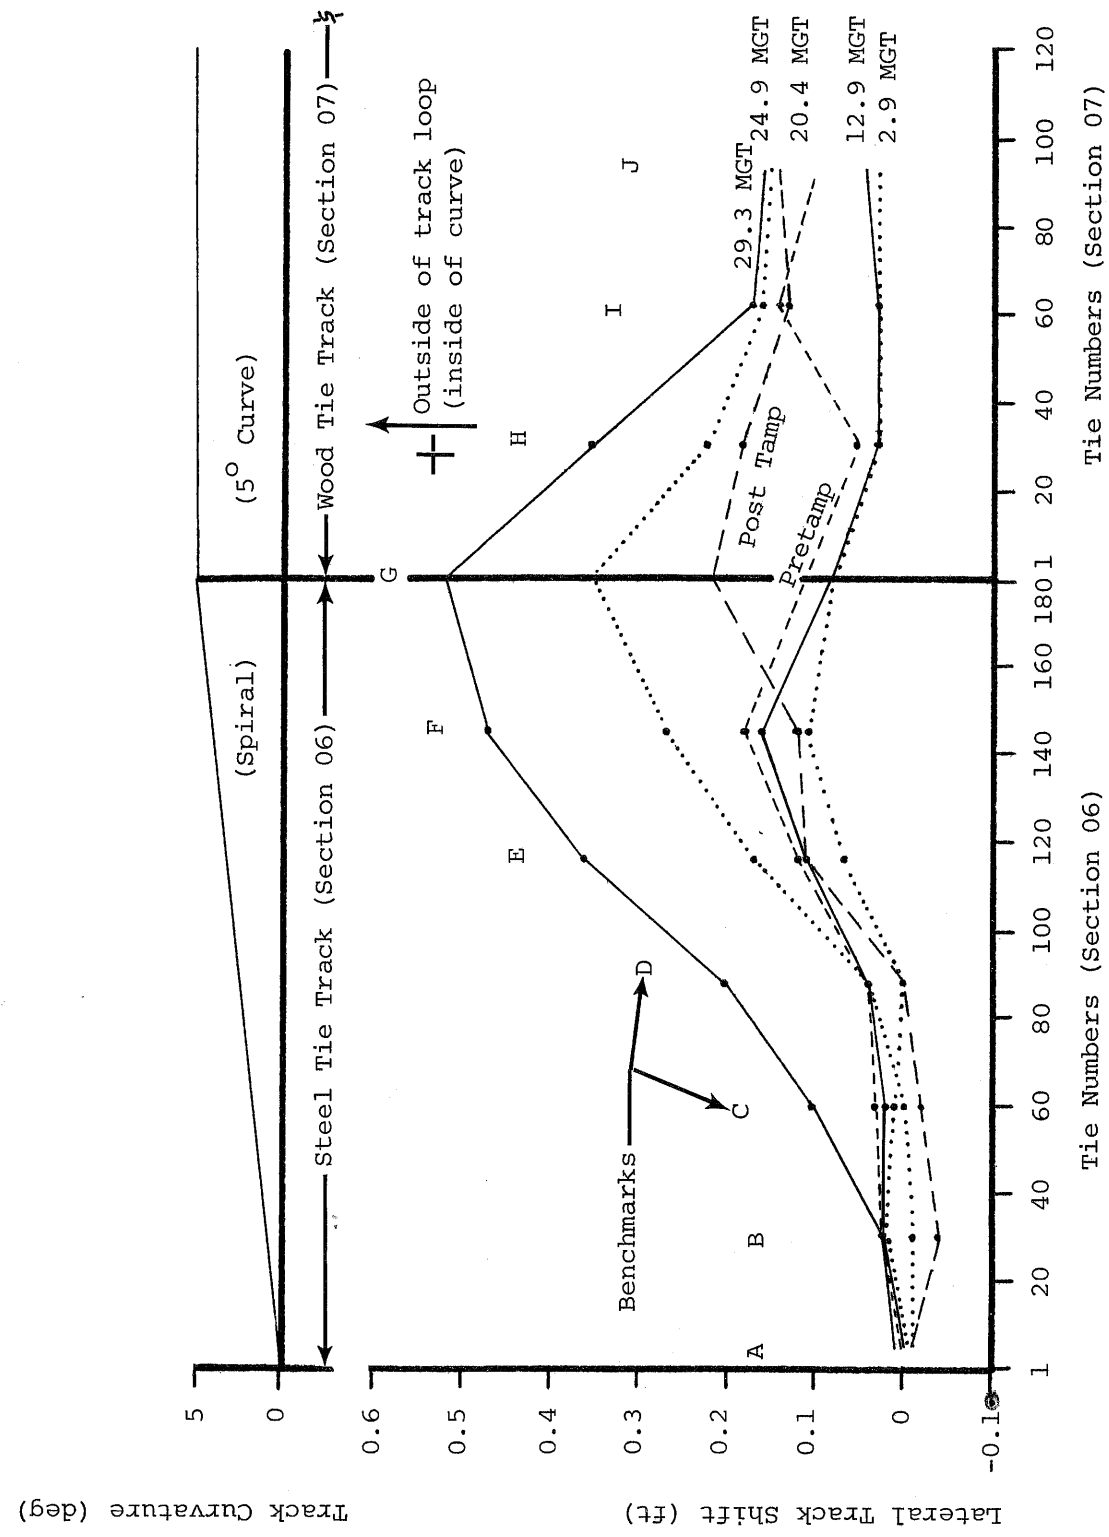
FIGURE 2-3. LATERAL TRACK SHIFT VS. DISTANCE ALONG TRACK.

Figure 2-3 shows the lateral shift of the track plotted vs. track distance for each of the seven measurement cycles. It can be seen that a slight bulge

had begun to develop in Section 06 near tie 06-0145 before the tamping at 20.4 MGT. The shift generally increased with curvature, reaching a maximum of 0.5 ft at the boundary of Sections 06 and 07 just before the ties were removed at 29 MGT. The lateral shift in the wood tie section dropped rapidly from this peak. It can also be seen that the rate of shift increased dramatically during the final 9 MGT of service after the tamping.

The direction of the lateral shift was to the outside of the loop, or to the inside of the 5° concave curve of Section 07. This occurrence was opposite from the direction which would normally be expected in a region of significant curvature where the train runs in an overbalanced condition. With 4" of nominal superelevation in the curve, the top speed of 45 mi/h represents 3" of overbalance.

In any case, the data convincingly demonstrate that the steel tie track experienced a major track shift problem. The design of the steel tie with open ends may have less resistance to lateral shift of track than a wood tie. However, it should be pointed out that in subsequent FAST operations, both the wood and concrete tie track have experienced track buckles (in the transitions of Sections 03/04 and 05/06 for wood ties and in the 5° curve of Section 17 for concrete ties). All of these shifts may be attributed as much to inadequate ballast resistance as to any feature of the tie and fastener construction. In none of these cases was the actual cause of the shift proved.

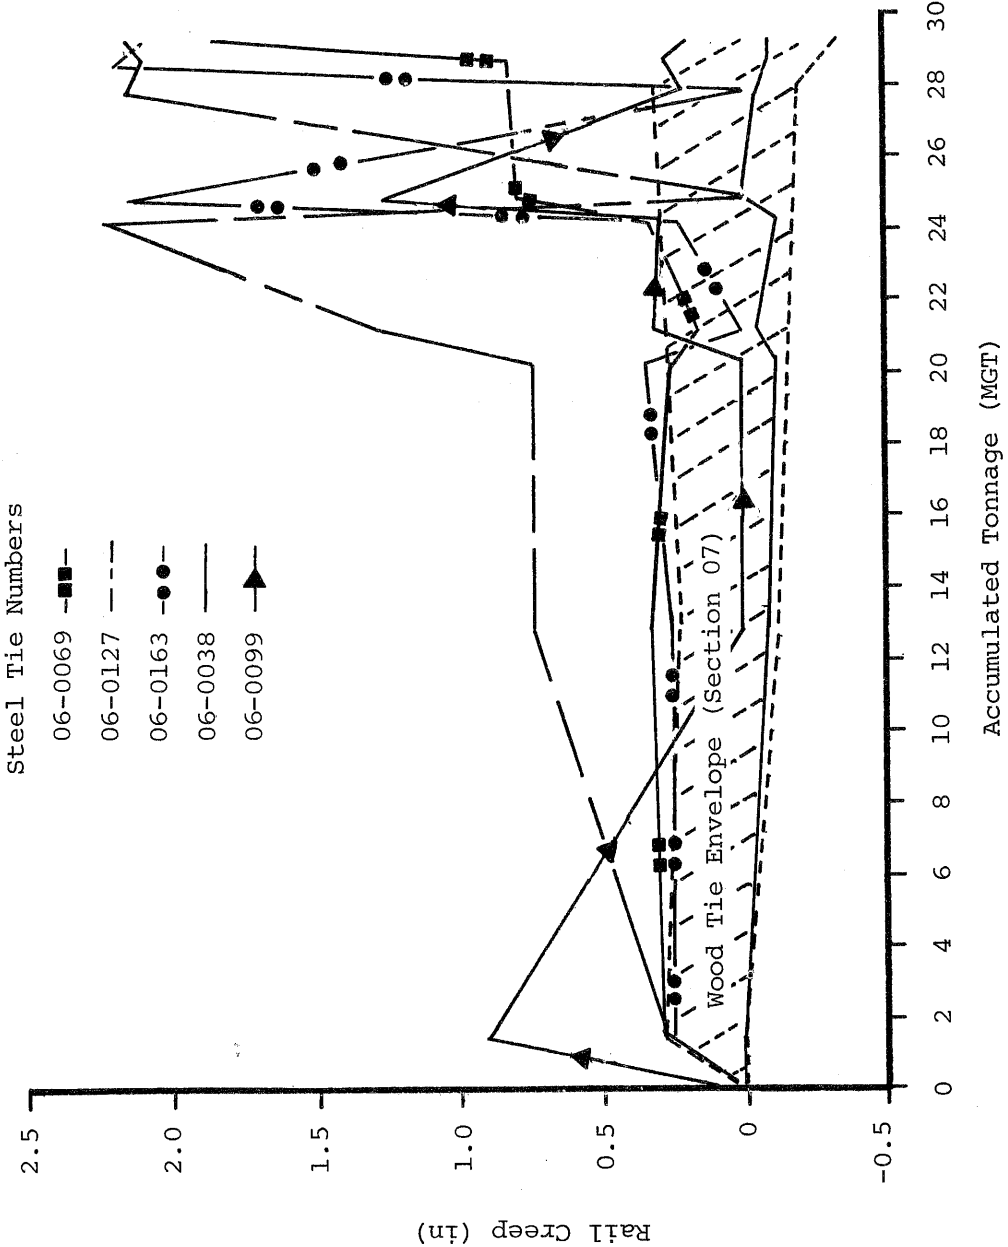
FIGURE 2-5. RAIL CREEP VS. MGT FOR INSIDE RAIL OF SECTIONS 06 (STEEL TIES) AND 07 (WOOD TIES).

Rail creep data are plotted vs. MGT for the inside and outside rails in figures 2-5 and 2-6, respectively. The loss of fastener strength in the higher-curvature end of the steel tie section is definitely indicated by figure 2-5.

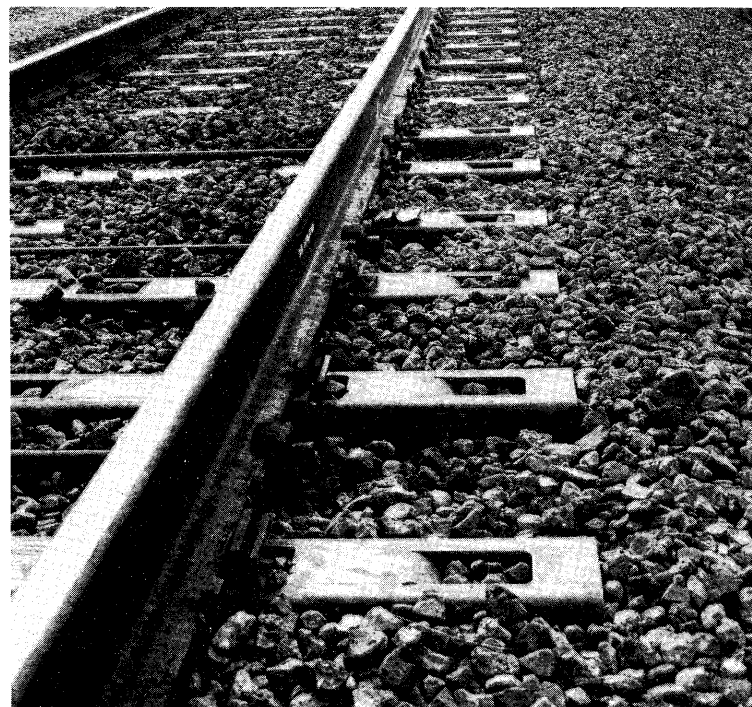
Figures A-2 through A-5 illustrate the tie installation, which took place in June 1976. High-density polyethylene pads were placed over the rail seat and the partially bent fastener tabs (figure A-2). After placement of the rail, the fastener tabs were bent by hand tools (figure A-3) while the gage was controlled with jacks and gage bars. Figure A-4 shows the ties in place before track raising. Figure A-5 shows the completed section just before the beginning of operations in September 1976. Figure A-6 shows the section on November 22, with gage rods and broken tabs evident. Figure A-7 shows an example of a tab with a lateral crack.

FIGURE A-6. STEEL TIE TEST SECTION (NOVEMBER 22, 1976) SHOWING GAGE RODS INSTALLED AND FAILURE OF FASTENING TABS, HIGH RAIL, FIELD SIDE.

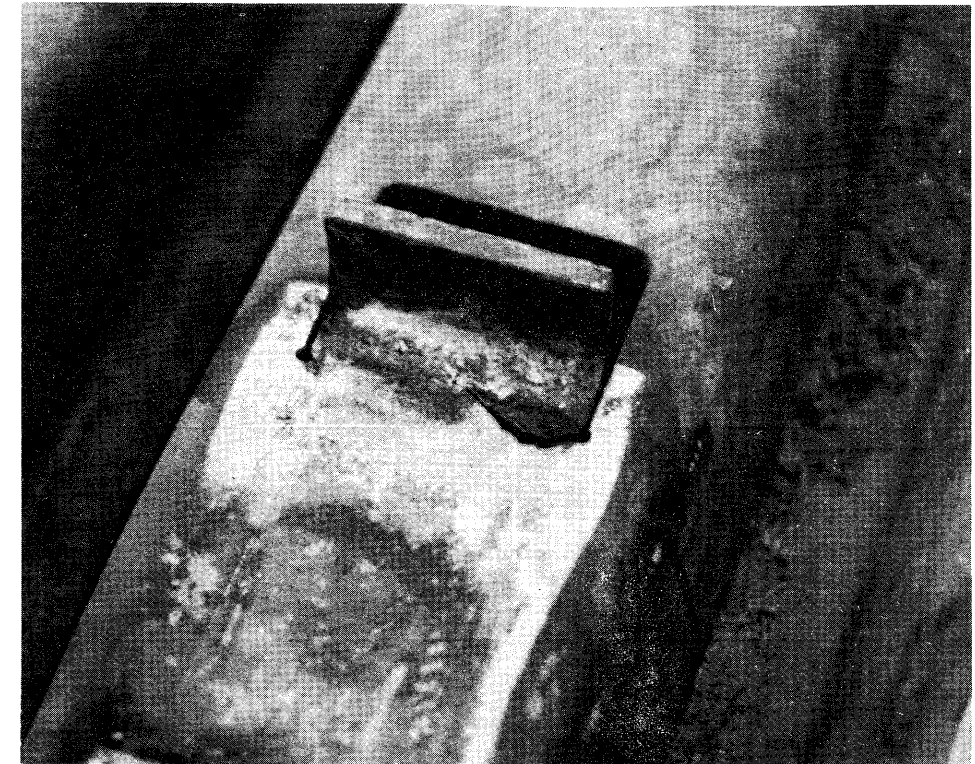
The exact cause of the cracks in the fasteners can only be determined by metallurgical examination. However, since they occurred in the rail seat region of the tie, it is possible that all of the following effects could have contributed to the failures:

- Residual stresses resulting from the original bending of the tabs to fasten the rail,
- Plastic deformation of the tabs in service, and
- Cyclic stresses at the base of the tab produced by lateral loads on the tab and by vertical loads, which can produce bending stresses in the top surface of the tie. Such bending stresses are normally maximum in the rail seat region.

FIGURE A-7. EXAMPLE OF TAB WITH A LATERAL CRACK.

It is recommended that the redesign of the fastener system take into account the existence of this combination of effects. The redesign should also consider the necessity of fastener reopenings or removal to transpose or replace rail.

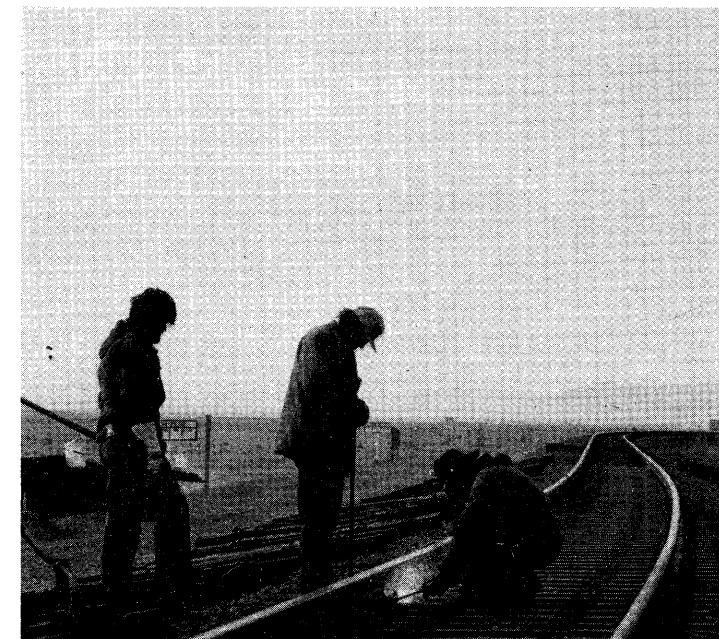
Figure A-8 illustrates the cutting of the fastener tabs required for removal in late December 1976. After the rail was jacked, the ties were removed in conventional fashion, as shown in figure A-9.

FIGURE A-8. CUTTING THE FASTENER TABS BEFORE REMOVING TIES.
