Research Results

RR08-21
December 2008

Evaluation of Tie Plate Cracking on Composite Ties

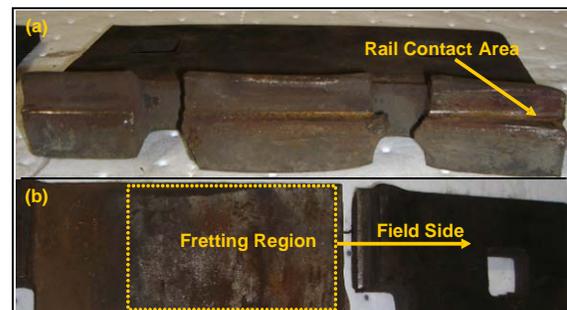
Figure 2. Rail Contact and Tie Plate Fretting Regions

In addition to the fatigue cracks in the shoulder of the plates, several other locations on the tie plate exhibited damage. Fretting occurred in the bearing seat and on the ridge between the bearing seat and the shoulder of the plate (Figure 2).

The fretting damage was observed on all three plates on the field side only. Little or no fretting damage was found on the gage side of the plate. The location of fretting helps to determine its effect on the fatigue damage in the plate. It is unlikely that the fretting caused the fatigue initiation because of the crack initiation points. If fretting was the primary cause of the failures, the initiation points would be near the ridge of the plate (Figure 2a). The crack initiation and propagation, in this case, would be due to lateral loads imparted on the plate causing contact between the toe of the

rail and the ridge of the plate. Since there is no evidence of crack initiation points in this area, the evaluation concluded that lateral forces alone, were not the cause of the failures. Although the fretting is not the primary cause of the fatigue failures, it can be used to understand the loading profile on the plates and its effect on the failures.

The prominent fretting toward the field side of the tie plate indicates that the field side of the plate supports the majority of the load. The study operations occur at overbalance speed, which may contribute to the field side fretting and cracking. Train operations above curve balance speed put more vertical load on the high rail of the curve. At FAST, the average high rail vertical load is about 45,000 lb [Ref. 1]. The spike holes near the shoulder of the tie plate are inherent stress risers and in overbalance situations, high levels of stress are expected on the field side of the plate.

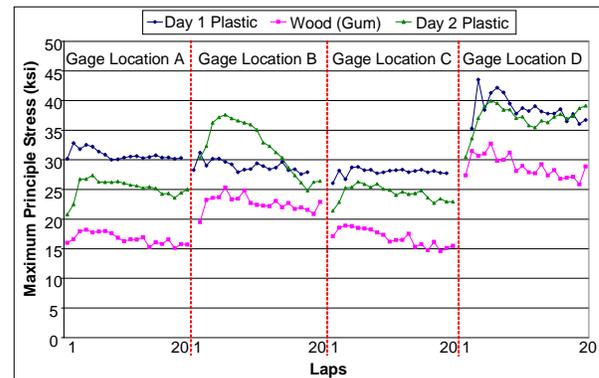
Figure 3. Maximum Principal Stress for Plate 1.

Figure 3 is typical of all three of the plates tested showing that both of the plastic tie zones show higher values of maximum principal stress at all four gage locations. Plate 2 had one exception at gage C, where the stress was similar for the first plastic tie zone and the wood tie zone.

The maximum stress for all laps and gage locations is 43.6 ksi, occurring at gage D. Compared to the yield strength of steel, approximately 60 ksi for medium carbon steel, the stress values were well below the yield strength of the tie plate. Although none of the principal stress values reached critical yield, the plates were affected by material fatigue. Figure 4 shows the average stress (all gages combined) values for all laps over each zone. In all cases, the stress in the plastic tie sections was higher than those in the wood tie zone. Again, none of the values exceed the yield strength of the material, but were still contributing to fatigue. Test results indicated that the plates mounted on plastic ties experienced higher stress than plates mounted on wood ties.

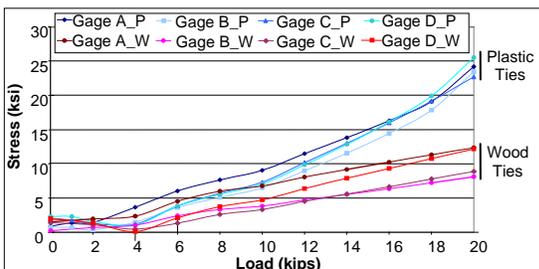
Figure 6. Maximum Principal Stress for Half-Tie Test.

The stress for plastic ties is greater than for wood ties. The maximum value of stress, 25.5 ksi, was recorded at gage D for the plastic tie test, at the same location

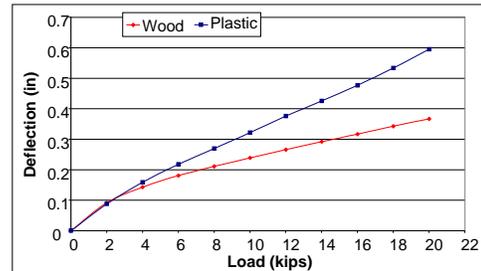
Figure 7. Total Deflection Recorded.

with the highest stress during field-testing. Figure 7 correlates higher stress in the tie plate to the tie itself and represents the total deflection in the ties for 2,000- to 20,000-lb loads. Figure 7 shows that the plastic tie total deflection is much greater than the wood-tie deflection during the half-tie test.
