#### Use of Ground Penetrating Radar (GPR) to Locate Contaminant Beneath Railroad Track

Jim Hyslip – HyGround Engineering Christopher Oakes – Norfolk Southern Russell McDaniel – Norfolk Southern Kenneth Battyanyi - WSP

> Railroad Environmental Conference University of Illinois, Urbana-Champaign 28 - 29 October, 2014

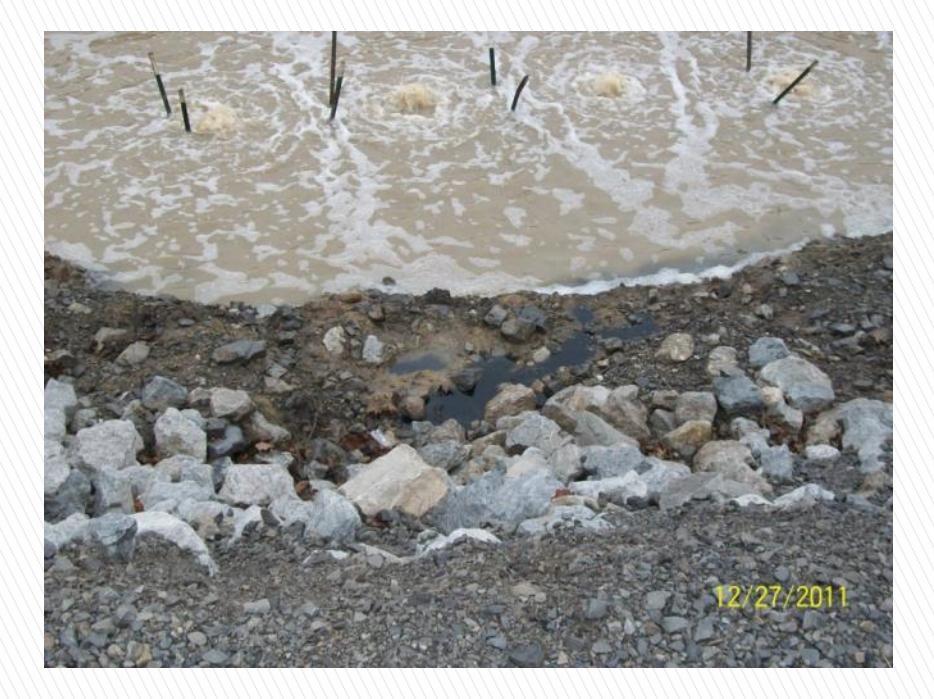
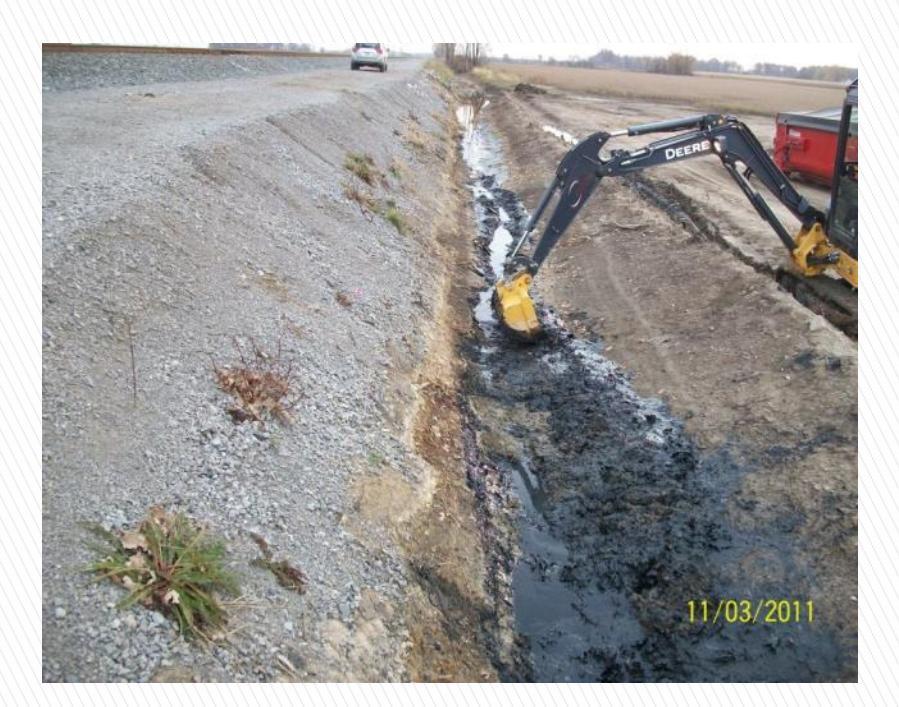
- Seeps Continued from Beneath Track Bed
  - Affected D.O. in Surface Water
  - Impacted Sediment in Drainage Ditches
