# Use of Screening Tools to Quickly and Efficiently Update the CSM at a CN Site

*Presented by Robert Noel de Tilly*

19<sup>th</sup> RAILROAD ENVIRONMENTAL CONFERENCE

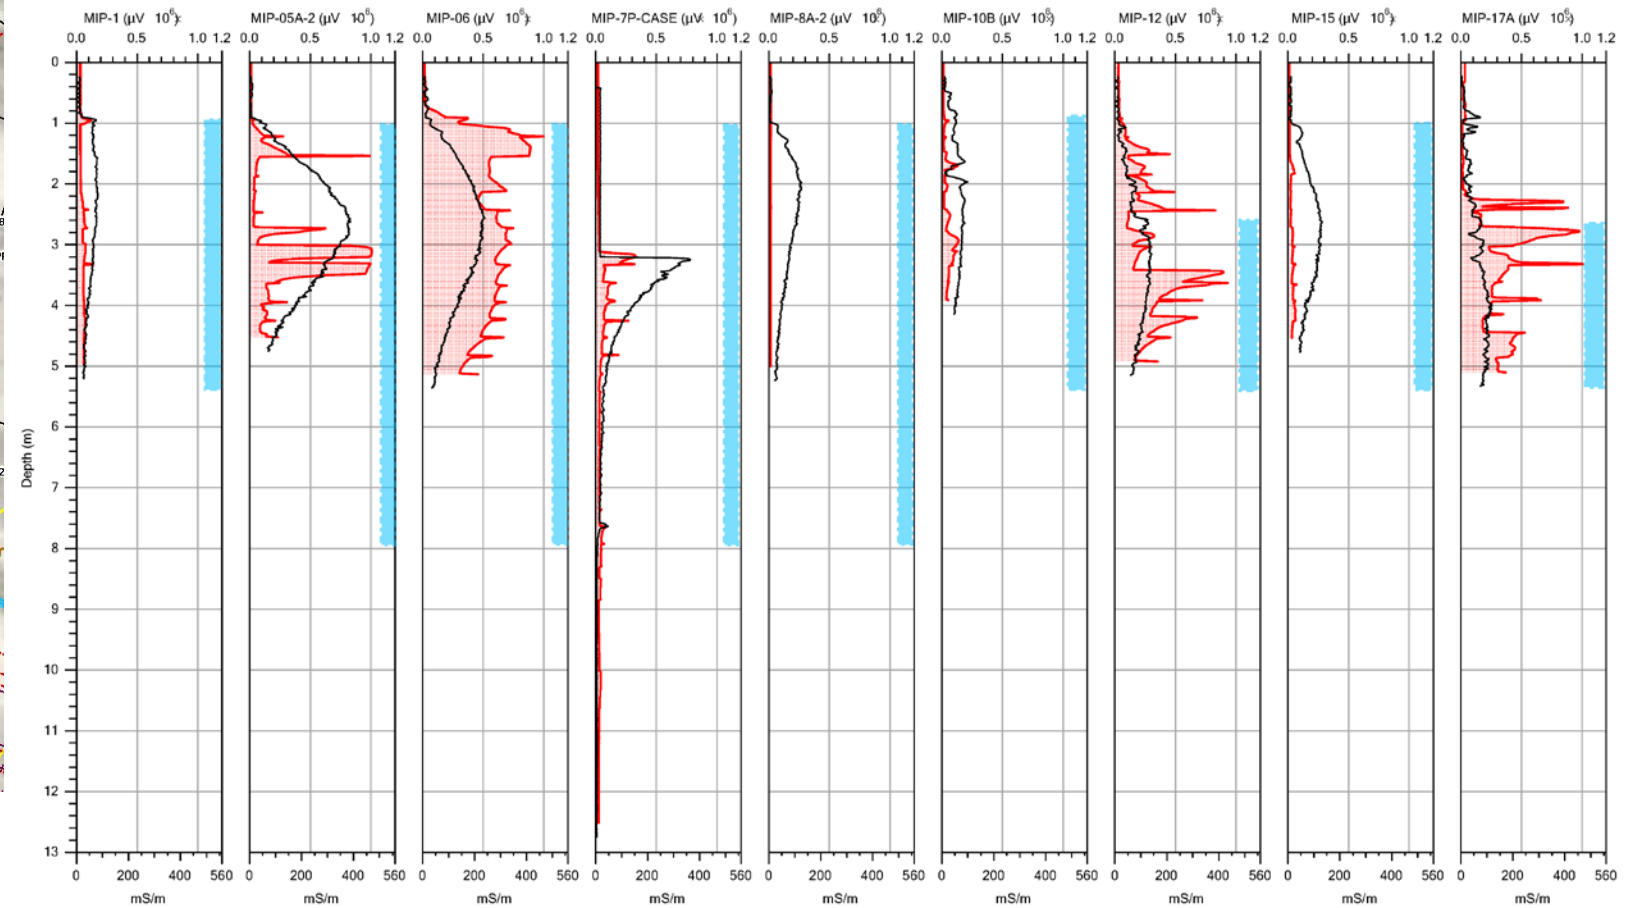
# MIP Results – Building sector

MIP-1	MIP-5	MIP-6	MIP-7P	MIP-8	MIP-10	MIP-12	MIP-15	MIP-17
<b>Depth reached (m)</b>	4,983	4,526	5,135	12,527	5,013	3,916	4,922	4,541	5,105
<b>Max (µV)</b>	143 208	1 007 950	1 006 043	329 371	18 616	138 401	937 758	73 397	1 008 637
<b>Depth max val. (m)</b>	3,322	3,109	1,219	3,185	0,792	2,926	3,627	3,658	3,322
<b>Min (µV)</b>	27 696	13 886	13 047	16 633	13 810	11 597	28 459	11 444	8 087
<b>GeoMean (µV)</b>	47 182	75 128	322 929	31 697	15 754	31 722	158 964	24 001	92 649
<b>Median (µV)</b>	51 577	69 811	554 560	28 993	15 336	31 015	195 319	24 949	174 986
<b>N</b>	328	298	338	823	330	258	324	299	336

Company:		Operator:		MIP-1.MIP		MIP-7P-CASE.MIP		MIP-12.MIP	
Vertex	VE630	Eric	WSP	2016-10-26	2016-11-01	2016-11-01	2016-11-01	2016-10-27	2016-10-27
Project ID:		Client:		MIP-05A-2.MIP		MIP-8A-2.MIP		MIP-15.MIP	
				2016-11-02		2016-11-02		2016-10-28	
				MIP-06.MIP		MIP-10B.MIP		MIP-17A.MIP	
				2016-10-29		2016-10-28		2016-10-25

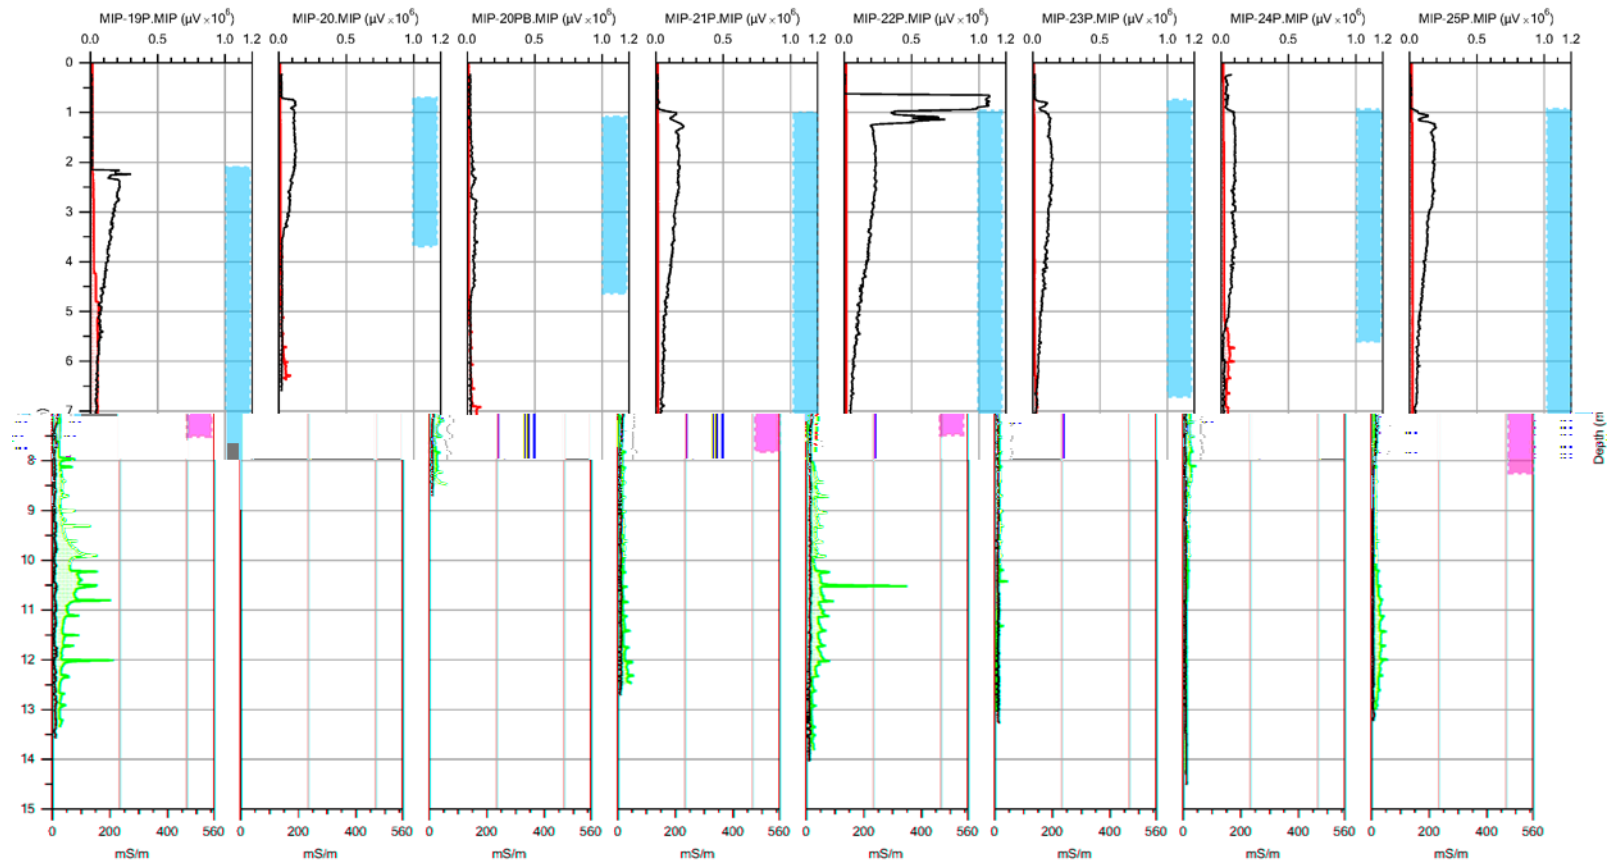
# MIP Results – South of the Building (Transect 1)

MIP-19	MIP-20	MIP-20P	MIP-21	MIP-22	MIP-23	MIP-24	MIP-25
<b>Depth reached (m)</b>	13,349	6,37	8,473	12,481	13,807	13,045	14,279	12,999
<b>Max (µV)</b>	450 682	91 479	129 246	118 030	745 796	96 362	102 161	115 284
<b>Depth max val. (m)</b>	12,009	6,294	8,473	12,314	10,516	10,424	5,73	11,994
<b>Min (µV)</b>	15 946	9 308	9 384	12 360	11 673	8 927	15 793	13 810
<b>GeoMean (µV)</b>	47 872	14 921	16 991	22 721	28 764	17 211	26 799	25 293
<b>Median (µV)</b>	53 713	11 750	10 681	16 556	15 412	15 259	21 973	21 783
<b>N</b>	877	419	557	820	907	857	938	854

XSD Max / EC			
Company:	Vertex	Operator:	P O'Neill
Project ID:	VE630	Client:	WSP
MIP-19P.MIP	2015-11-02	MIP-22P.MIP	2016-10-31
MIP-20.MIP	2016-10-28	MIP-23P.MIP	2016-10-31
MIP-20PB.MIP	2015-10-28	MIP-24P.MIP	2016-11-02
MIP-21P.MIP	2016-10-29	MIP-25P.MIP	2016-11-02

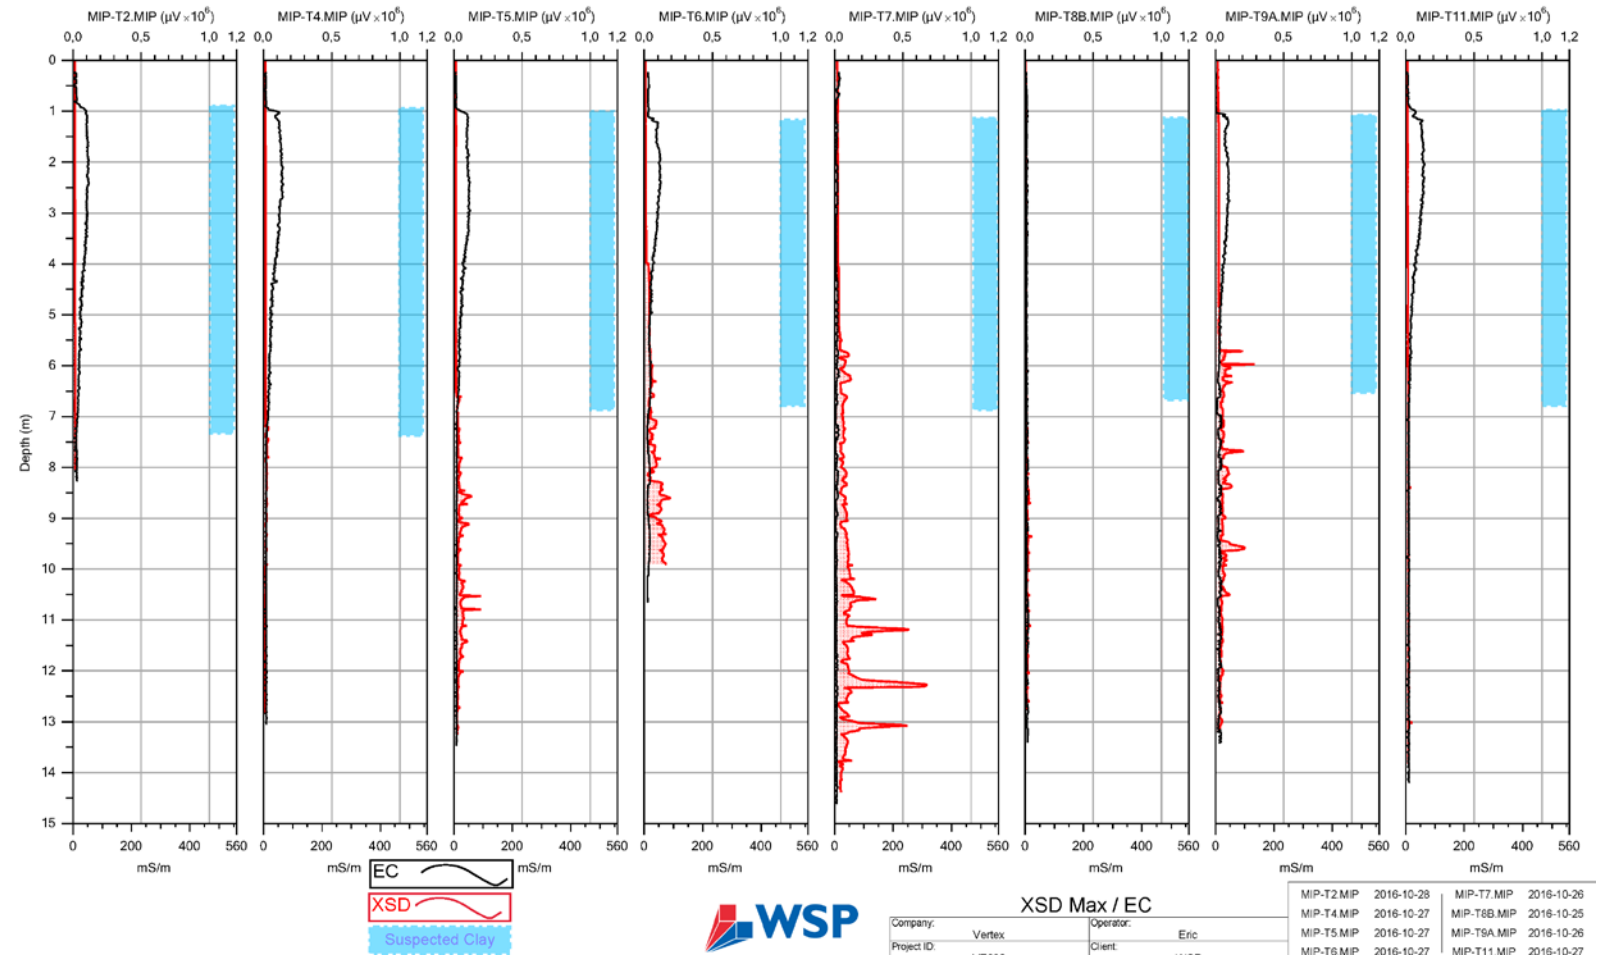
# MIP Results – Downstream of the Building (Transect 2)

MIP-T2	MIP-T4	MIP-T5	MIP-T6	MIP-T7	MIP-T8	MIP-T9	MIP-T11
<b>Depth reached (m)</b>	8,046	12,831	13,243	13,243	14,387	13,41	13,197	13,822
<b>Max (µV)</b>	21 592	38 911	196 081	190 283	674 154	49 059	286 569	45 854
<b>Depth max val. (m)</b>	7,422	7,803	10,79	8,595	12,283	9,357	5,974	13,015
<b>Min (µV)</b>	10 987	12 284	12 131	8 469	18 006	5 036	18 235	11 597
<b>GeoMean (µV)</b>	14 057	16 369	23 934	29 639	51 409	9 980	37 429	15 904
<b>Median (µV)</b>	13 962	15 717	21 668	36 927	50 508	9 003	36 546	16 709
<b>N</b>	529	843	870	653	945	839	867	908

XSD Max / EC			
Company:	Vertex	Operator:	Eric
Project ID:	VE630	Client:	WSP

MIP-T2.MIP	2016-10-28	MIP-T7.MIP	2016-10-26
MIP-T4.MIP	2016-10-27	MIP-T8.MIP	2016-10-25
MIP-T5.MIP	2016-10-27	MIP-T9A.MIP	2016-10-26
MIP-T6.MIP	2016-10-27	MIP-T11.MIP	2016-10-27

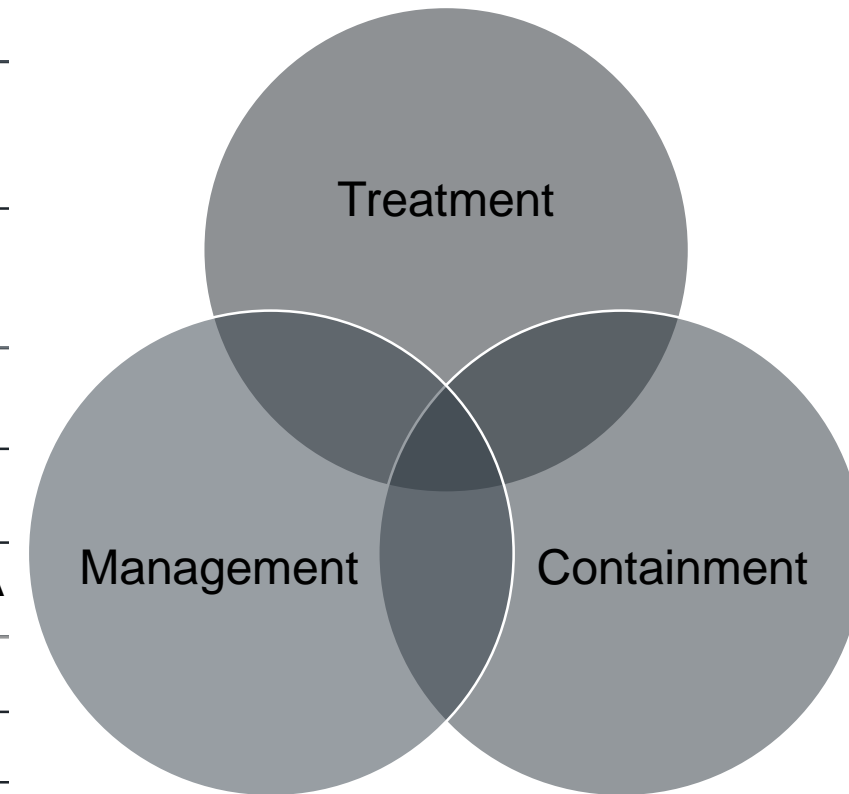
Passive treatment barrier by stimulation of abiotic, biotic and adsorption processes
