GLXS 2014, Urbana, August 3 - 8

Light Barrier at Level
Crossings in the Czech
Republic

This presentation contains mainly the results of the research project SVEZA - Research on the applicability and effectiveness of the so-called light barrier at level crossings in the CR (2011 – 2014), carried out in cooperation with TRAKCE, under the financial support of the Technology Agency of the CR. Main goals: Define conditions (legal and technical) of application of the light barrier in the Czech Republic, set up 3 – 4 pilot applications at crossings with varied characteristics and using products of different producers, investigate impact of the light barrier on users' behavior, and carry out public acceptance

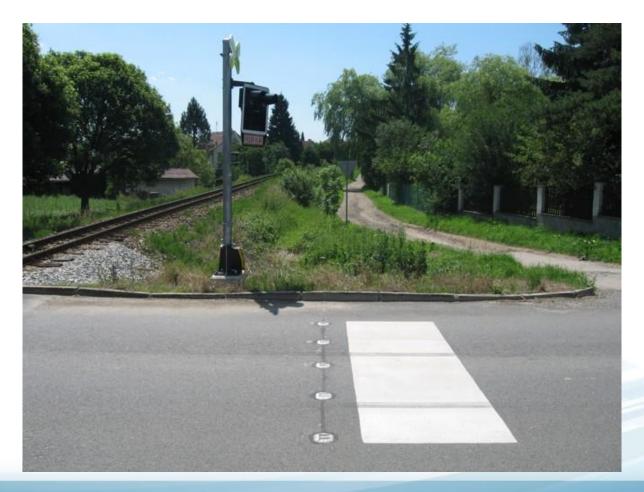
- Additional warning enhancing the status of basic warning on a level crossing
- Main purpose double information given by basic warning system, and thus increase attention of driver
- Due to its position, the device is well perceived even by drivers that are stressed or not fully concentrated on driving performance; compared to basic warning lights, it is also better visible by strong daylight

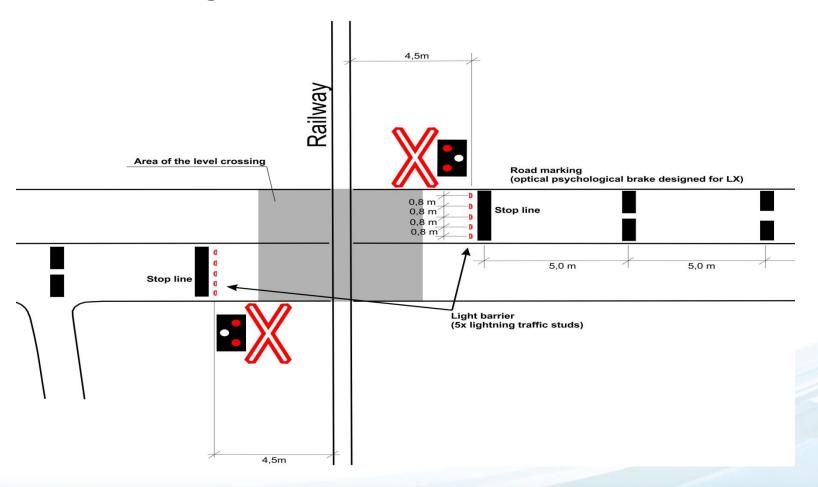
- The device consists of the set of red traffic light studs
- Studs light up flashing red lights simultaneously with the basic warning lights, creating optical barrier
- Activated by a non-potential contact of the crossing signaling device relay; any failure must not effect basic warning light device

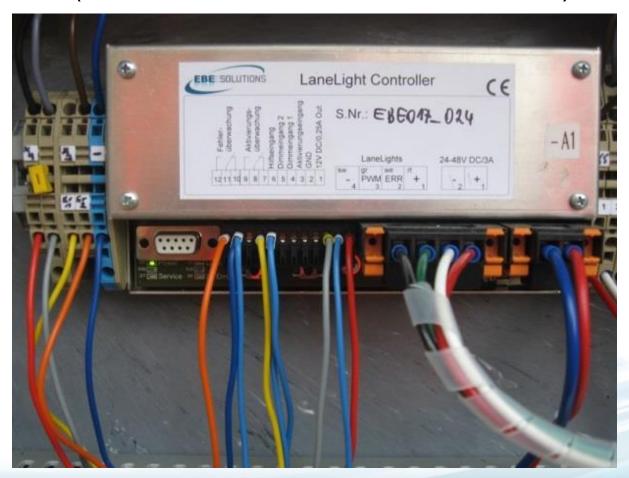
Pilot implementation in Nová Včelnice

(control unit EBE Solutions, GmbH)

- Installation June 2011, in operation since July 2011
- No accidents during the testing period
- Technical checks: no functionality errors identified until now, minor damages on cover glasses of the studs and deficiency of one LED diode
- Survey of public opinion, observation of road users' behavior, and measurement of luminance carried out

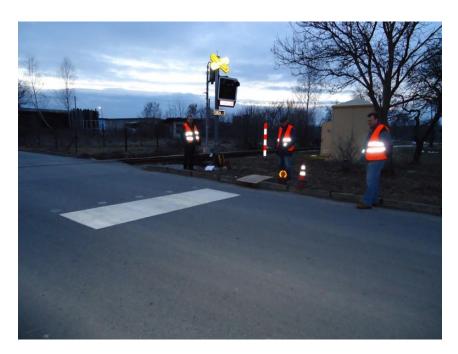
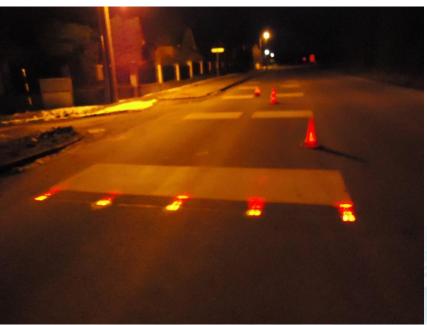
Measurement of luminance

horizontal angle vertical angle	20°	15°	10°	5°	0 °	5°	10°	15°	20°
15°		1.9	2.4	3.9	4.5	3.4	2.0	1.4	
10°	1.7	3.4	7.3	15.4	16.7	11.8	4.7	2.7	1.0
5°	2.7	8.2	23.2	66.0	79.1	51.8	16.7	5.1	1.3
2° 20′	3.1	10.6	33.5	84.0	113	69.5	25.3	5.9	1.5

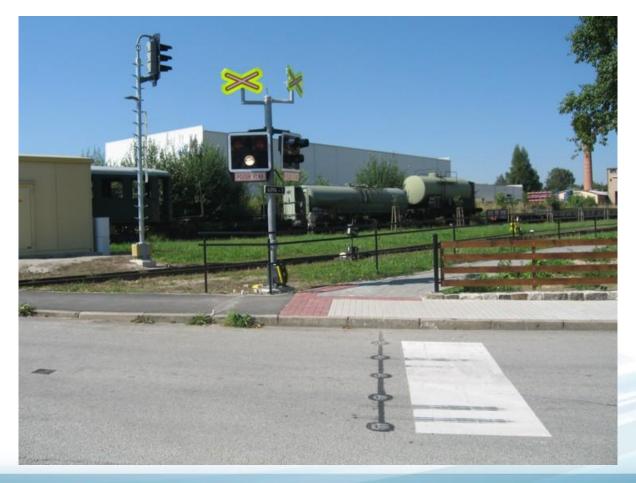
Pilot implementation in Kamenice nad Lipou

- Installation and start of operation in June 2013
- No accidents during the testing period
- Technical checks: neither functionality errors identified until now, nor technical defects
- Survey of public opinion was carried out at this site

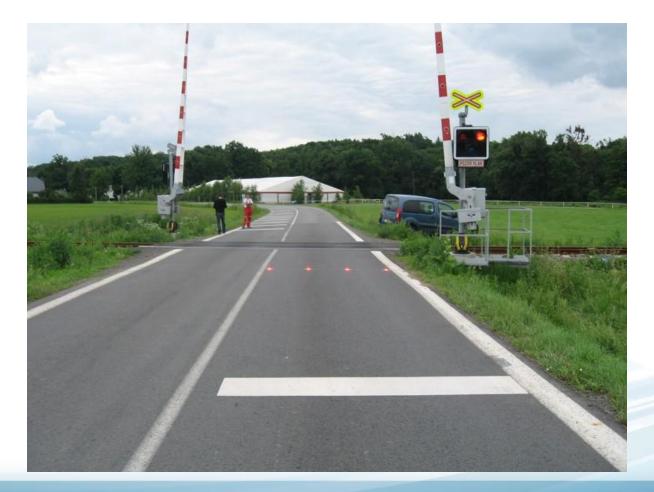
Pilot implementation in Otice

- Installation September 2012, start of operation June 2013; this installation required development of special convertor for plugging
- The level crossing is equipped with warning lights and complementary barriers; basic idea was to enhance the significance of the warning signal
- No malfunctions or defects until now
- Before/after observations of road users' behavior carried out

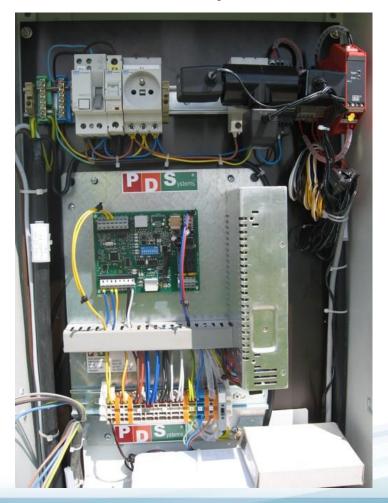
Pilot implementation in Otice

(control unit PDSystems s.r.o.)
