# COUNTERMEASURES FOR DERAILMENT AT LEVEL CROSSINGS IN WINTER

Takaki Kubo  
East Japan Railway Company

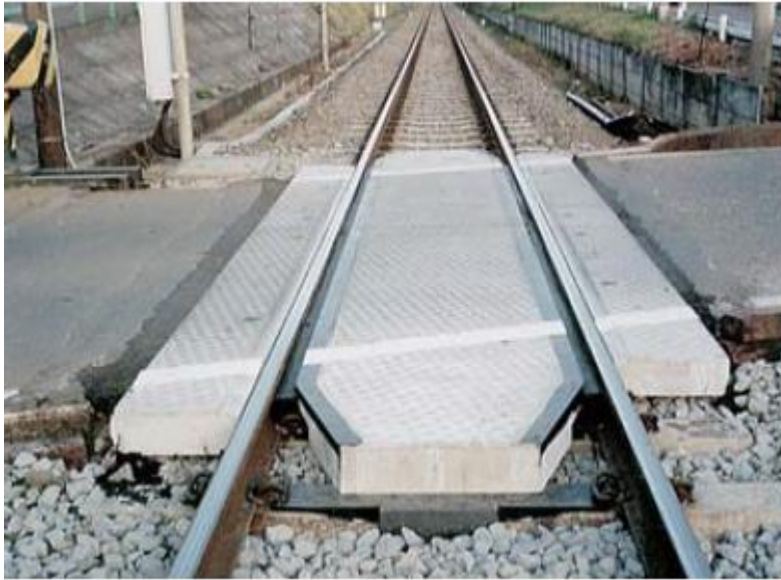
RTRI type crossing

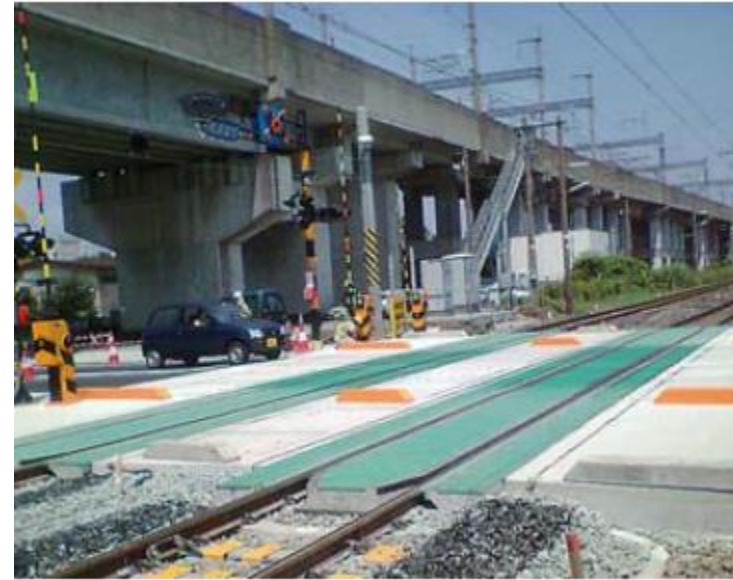
Precast prestressed crossing

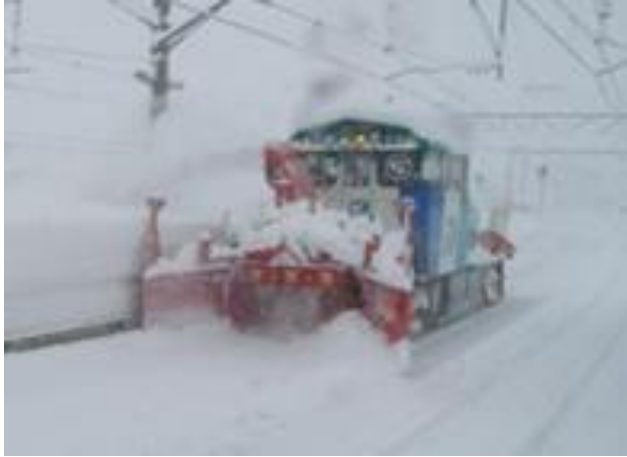
Snow cleaning car

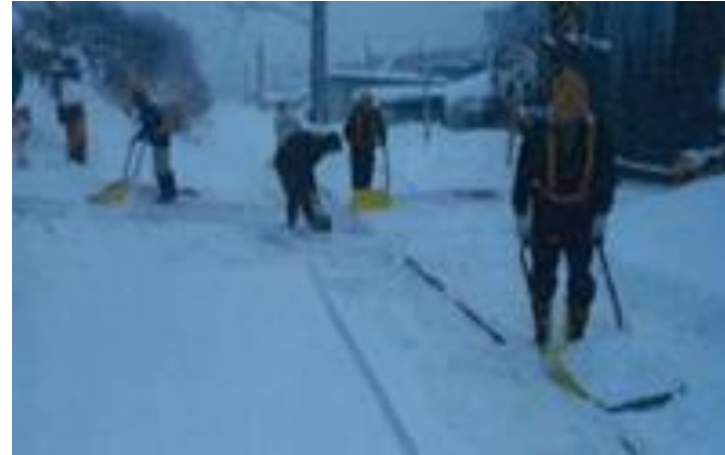
Manned removal

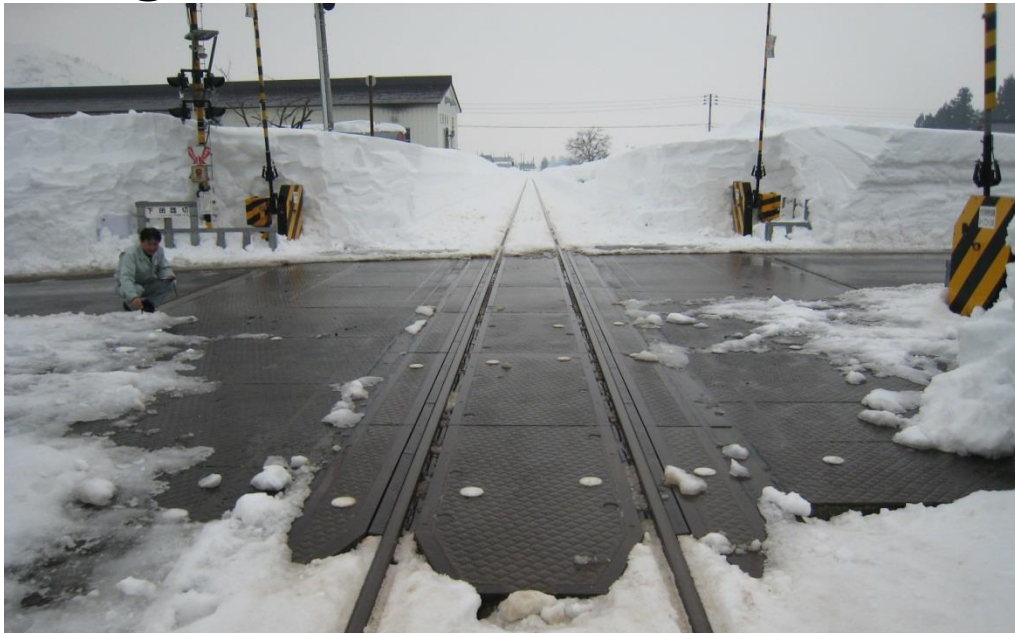
## Level crossing with snow removal device

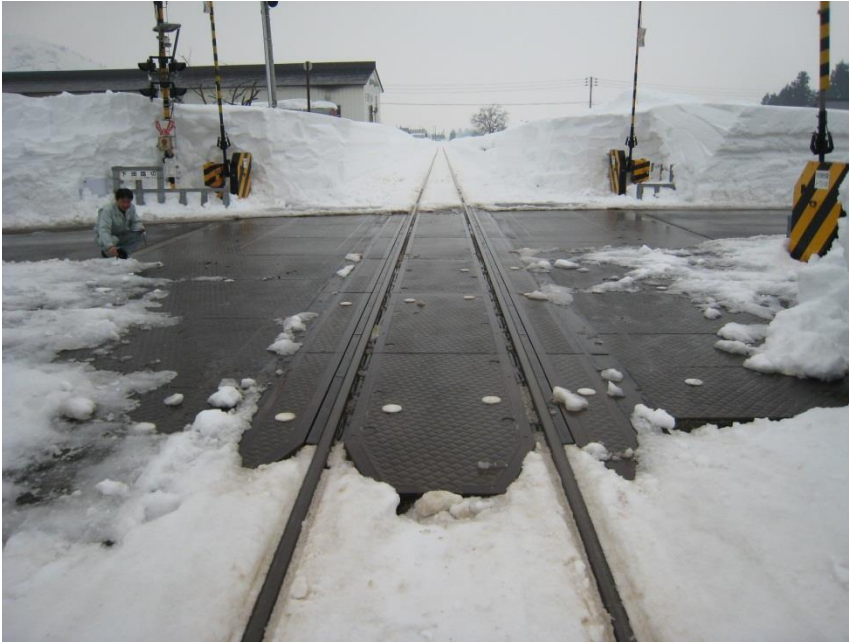
# Conventional level crossing heater

Calorie is over  $300\text{W}/\text{m}^2$

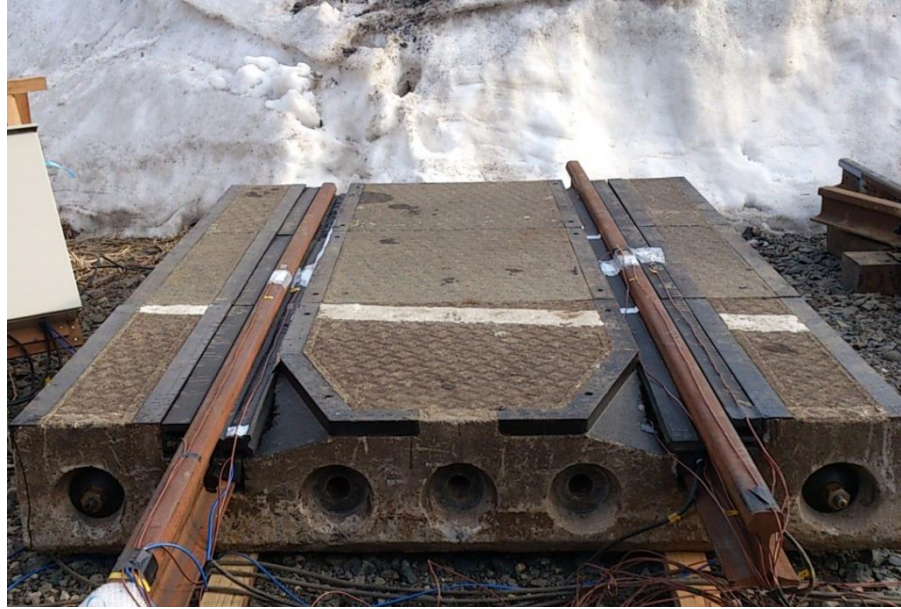
Test pieces

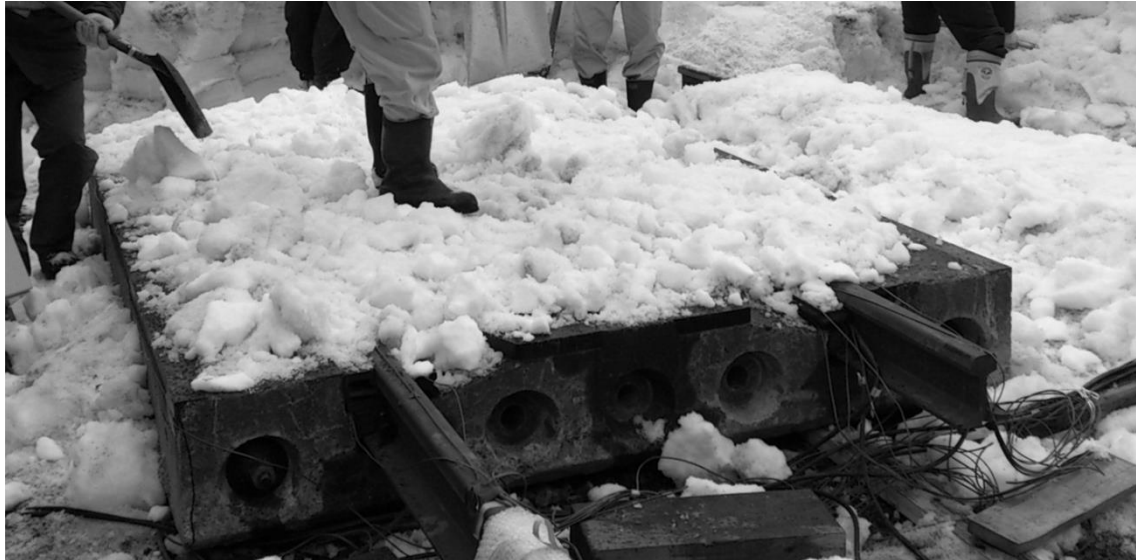
Test condition

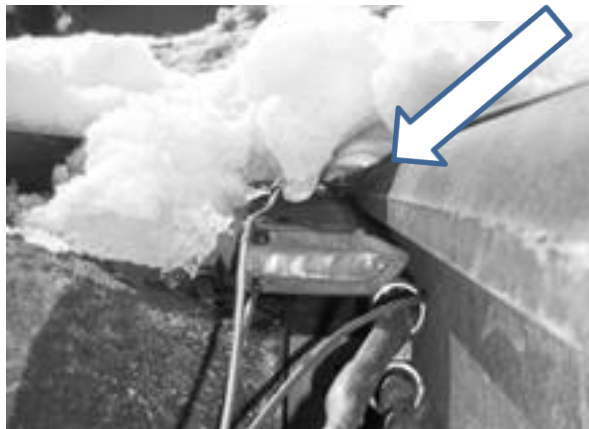
Snow condition after 17 hours

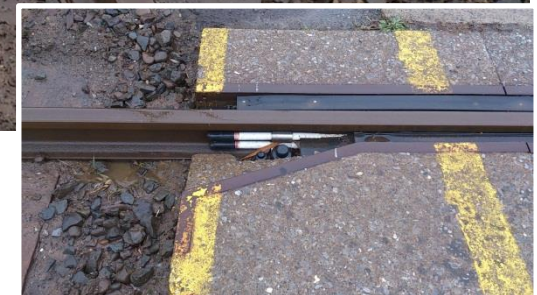
Heater

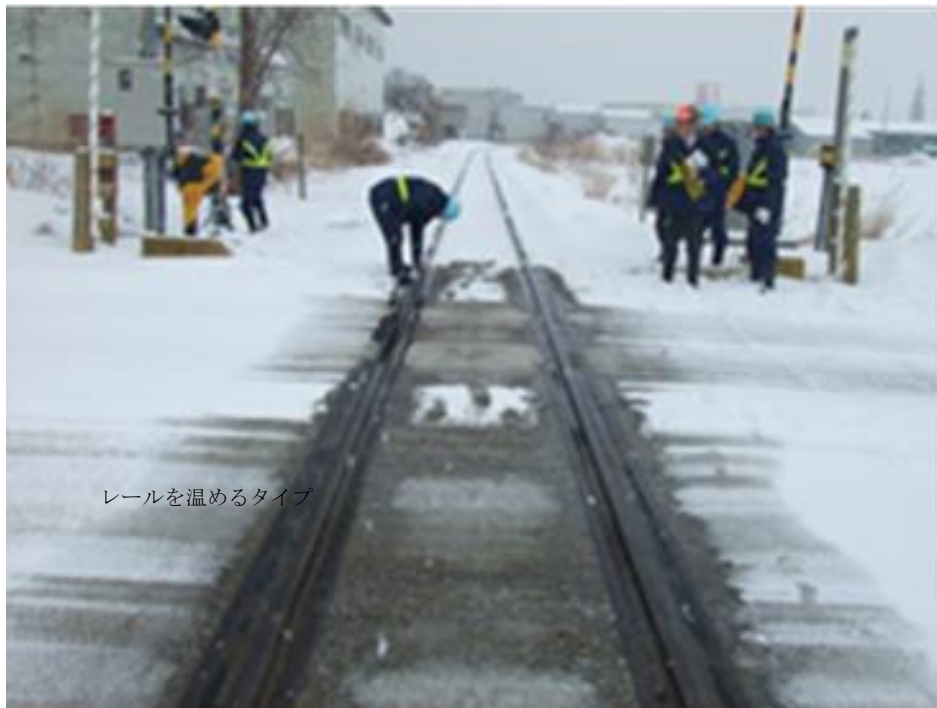
Temperature of rail at level crossing: 12.0 C°  
Temperature of rail outside level crossing: -7.5 C°  
Temperature of cover: 2.0 C°  
Outside air temperature: -4.0 C°

(a) Visible image

(b) Thermometer

Level crossing with new heater
