Investigation of Deteriorated Crossties and Support Conditions

2016 International Crosstie and Fastening System Symposium

14 June 2016

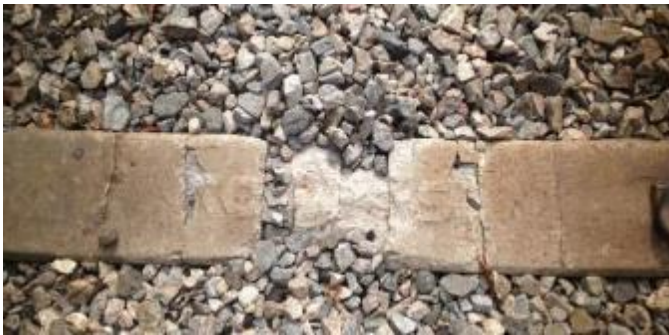
Broken crosstie

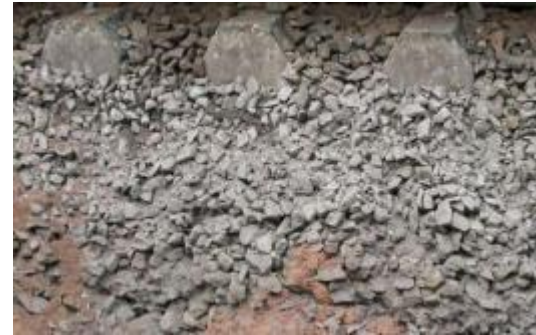
Fouled ballast

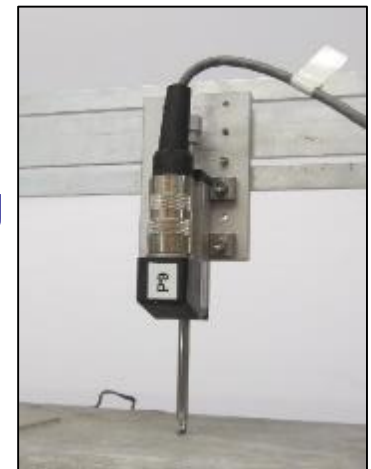
- **Linear Potentiometers**
 - Measurement of vertical displacements
 - Estimation of crosstie shape and gauge widening

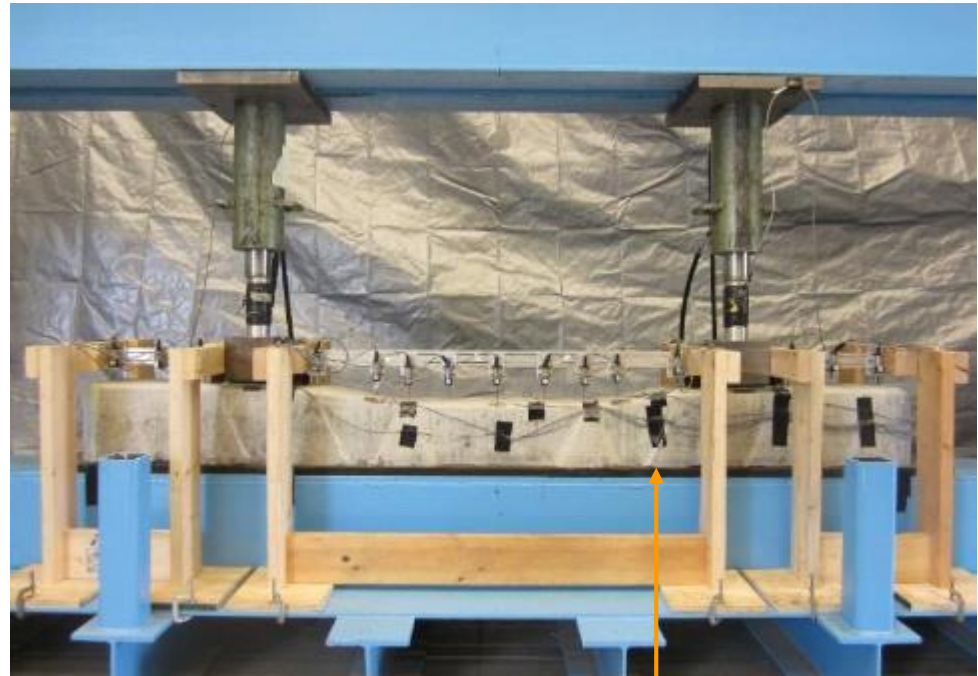
Static Loading Testing Machine (SLTM)

- Loading frame

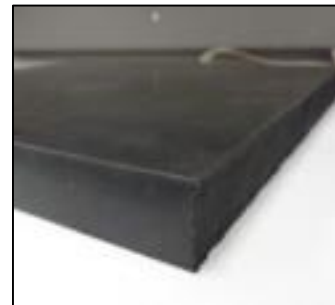
- Supporting rubber pads

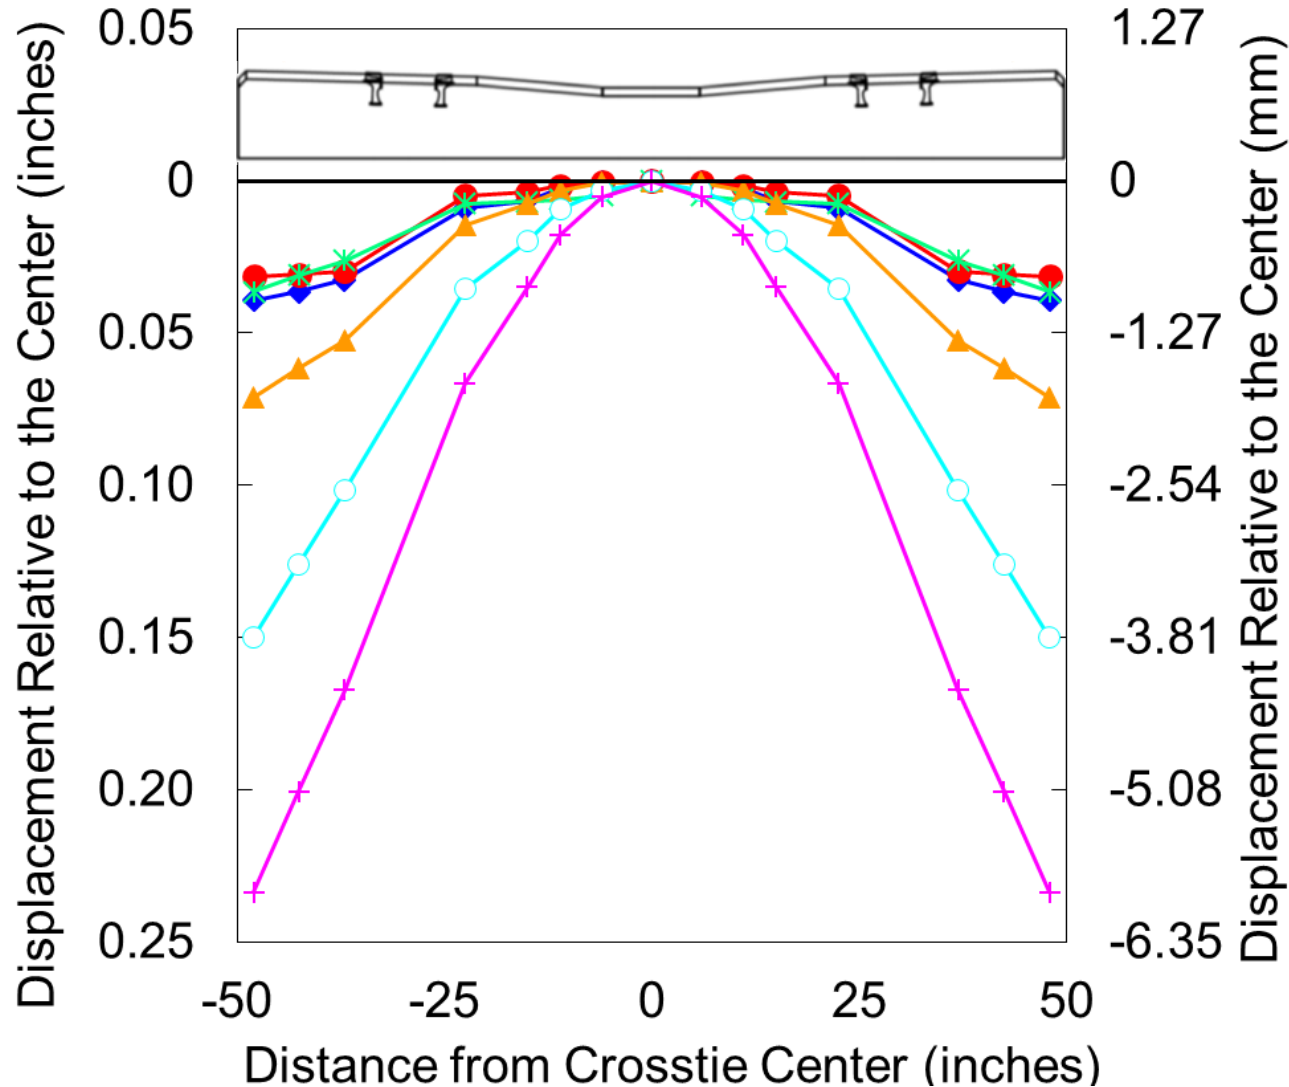
Crosstie Shape under Different Support Conditions

Rail Seat Load: 20 kips (89 kN), Healthy Crosstie

Distance from Crosstie Center (mm)

◆ Lack of Rail Seat Sup.

● Full Support

* Lack of Center Sup.

▲ Light Center Binding

○ High Center Binding

+ Severe Center Bind.

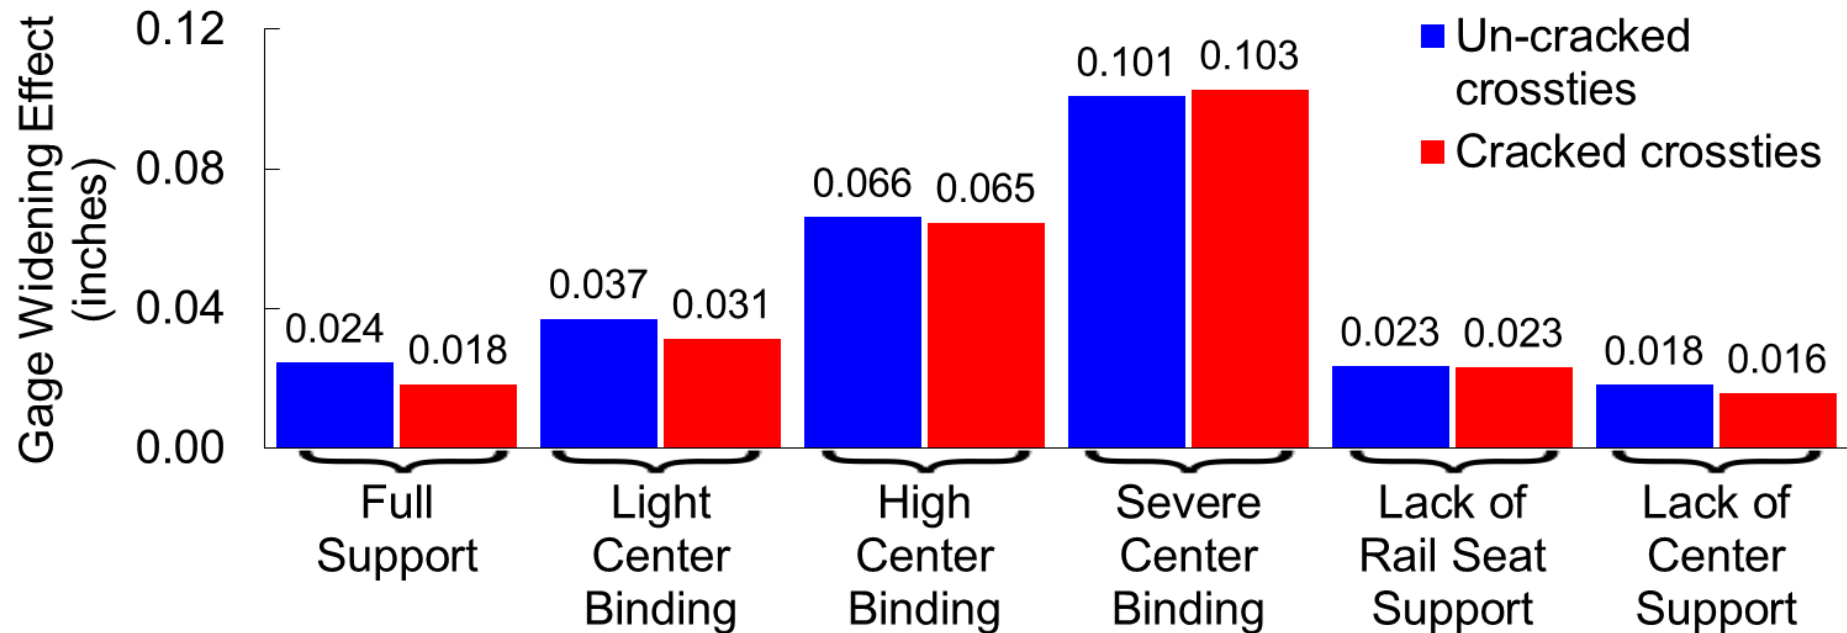
Gauge Widening Effect due to Crosstie Bending

ANOVA* for gauge widening has the same conclusions as for bending moments

- Support conditions have a significant impact on gauge widening (p-value <0.0001)
- Cracking does not have a significant impact on gauge widening for particular cracking pattern and crosstie model used in this study (p-value of 0.25)

- Track gauge increase up to 0.103 inches due to concrete crosstie bending
- The change in gauge due to crosstie bending is small but not negligible

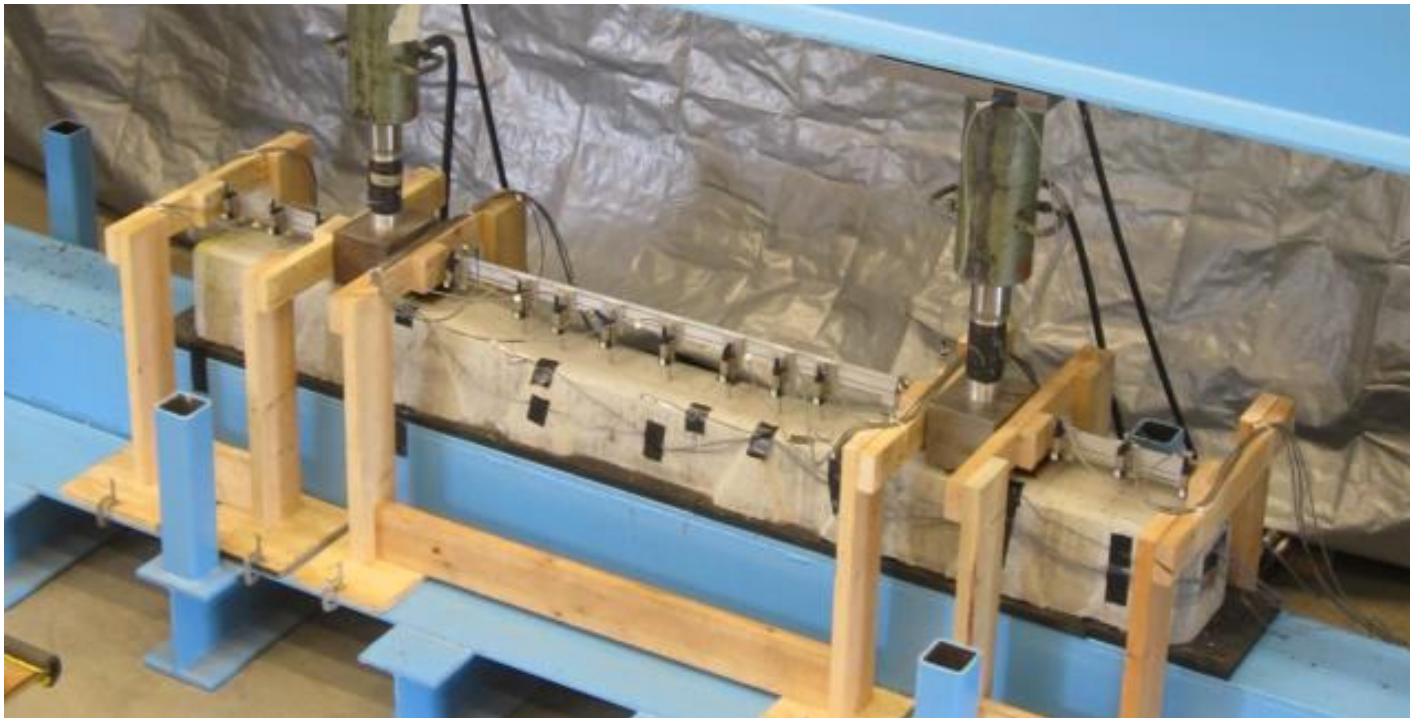
Comparison of Two Crosstie Designs

Rail Seat Load: 20 kips, Severe Center Binding

- Additional experiments with different crosstie models shows the influence of design on the crosstie performance

Design A		Design B		% Change
End Displacement in (mm)	-0.234	(-5.94)	-0.314	(-7.97)	34%
Expected Gauge Widening in (mm)	0.101	(2.56)	0.119	(3.02)	18%
Center Moment kip-in (kNm)	-413	(-46.6)	-309	(-34.8)	-25%

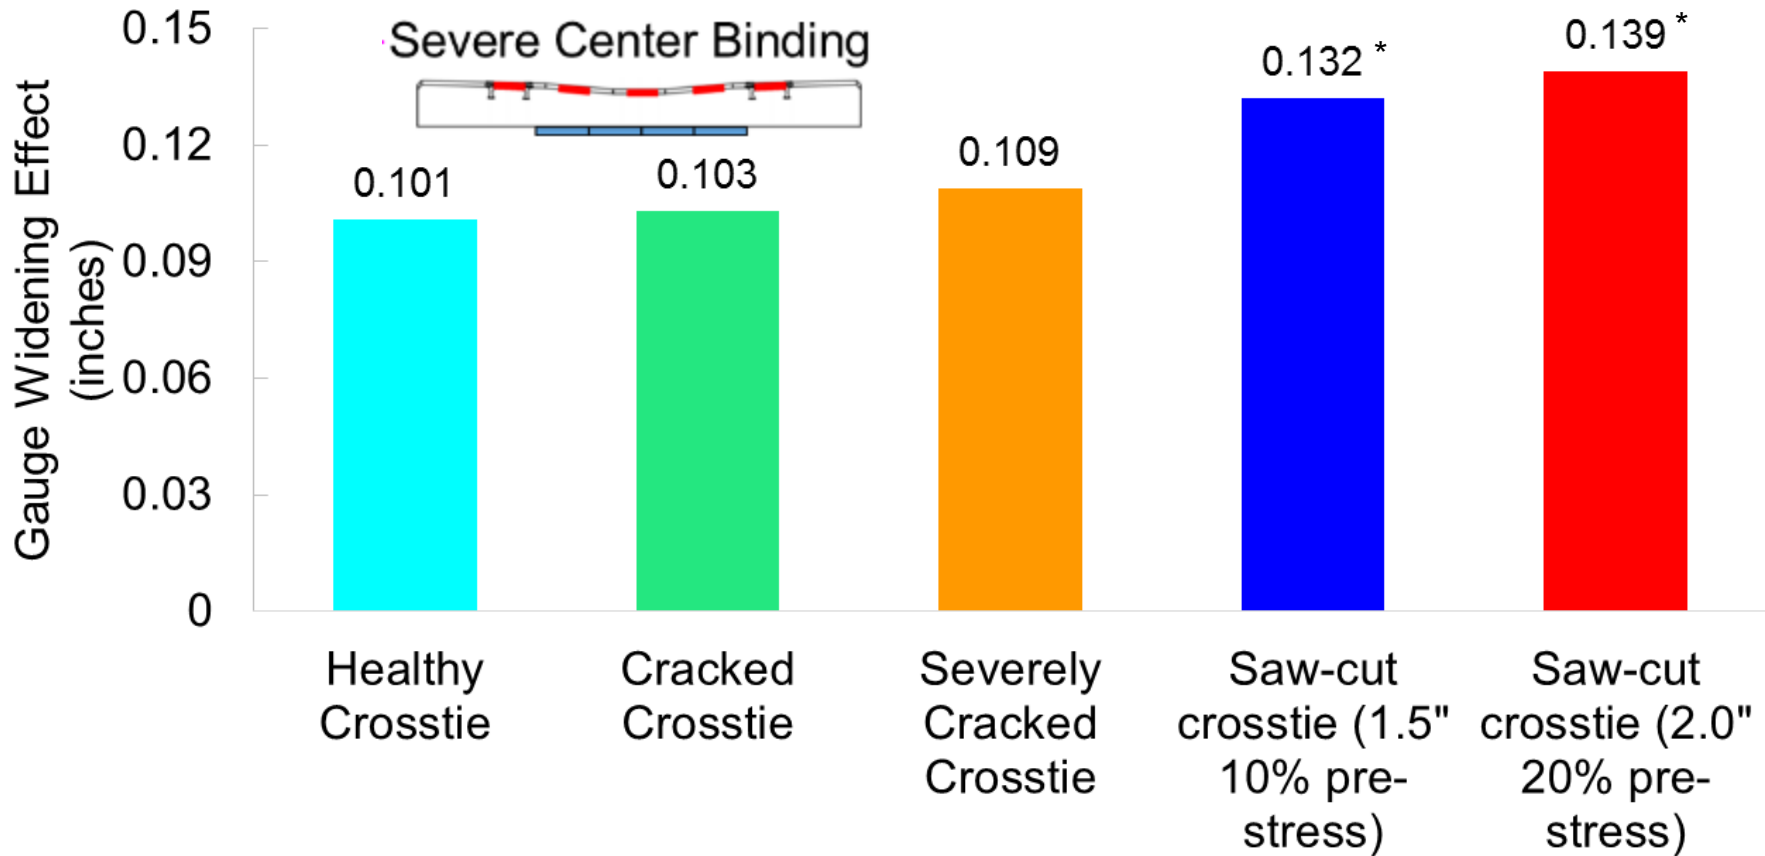
Gauge Widening in Different Crosstie Conditions

Rail Seat Load: 20 kips (89 kN) Severe Center Binding Support

- Gauge widening effect differences with full support are smaller
- These results suggest that center cracks and even some loss of pre-stress do not play a significant role in gauge widening

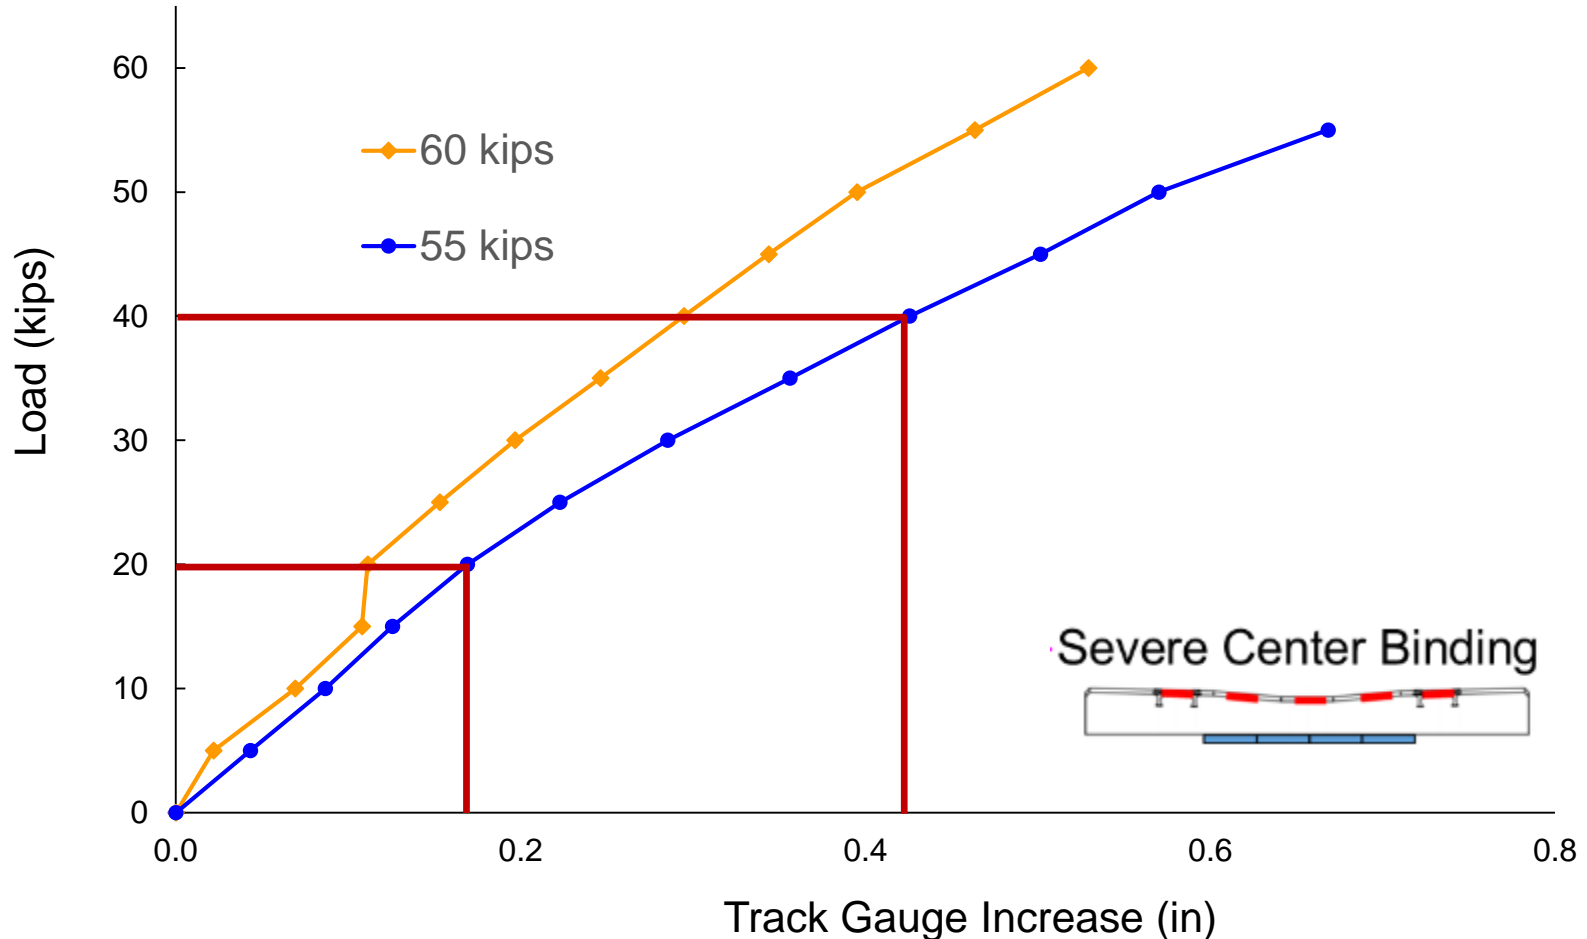
Load vs. Gauge Widening at Higher Loads

- Gauge widening was between 0.1 – 0.2” when subjected to 20 kip rail seat load
- Gauge widening becomes potentially significant at higher rail seat loads

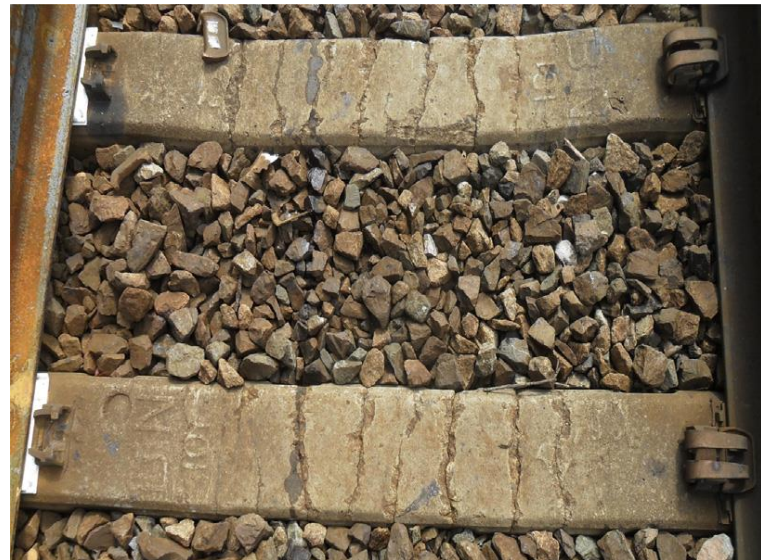
Center Negative Repeated Load Test

- Center cracks still constitute a risk that are not fully understood
 - Testing to-date has consisted of applying a single static load
- Dynamic, center negative repeated load tests will be performed to investigate center crack propagation direction and rate
 - Could impact AREMA Chapter 30 design tests
 - Could also improve inspection/maintenance guidelines

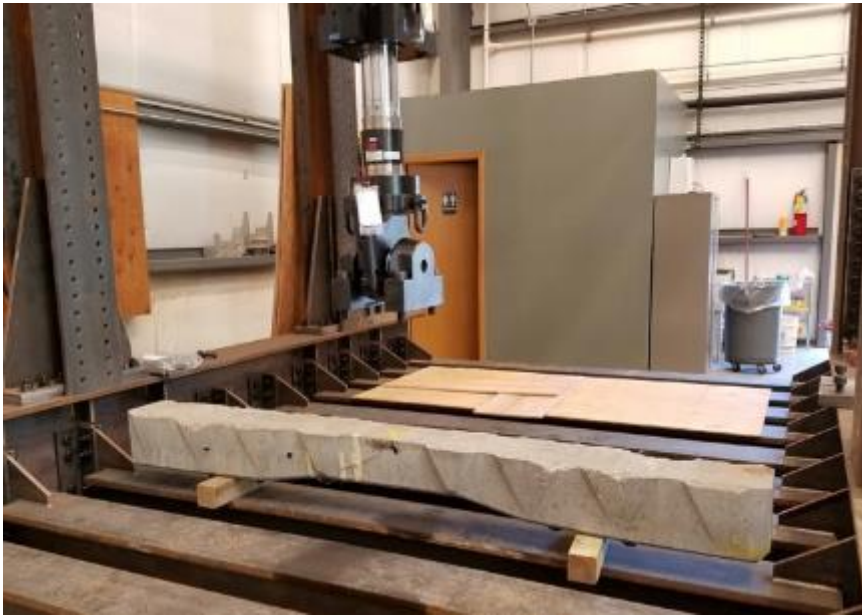
Large Scale Test Frame (LSTF)

- New frame currently installed at RAIL
- Linear potentiometers to capture deflections
