Field Measurements and Analysis of Concrete Crosstie Bending Moments

2016 International Crosstie & Fastening System Symposium

14 June, 2016

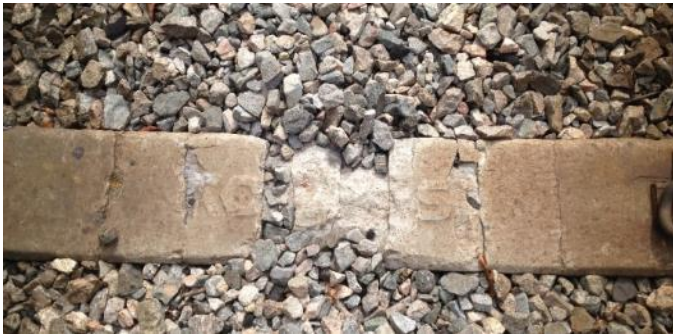
Broken crosstie

- Previous analysis of FRA accident database indicated that deteriorated concrete crossties and support conditions are among the major track related accident causes in the US

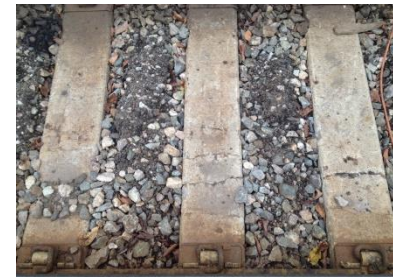
Crosstie Instrumentation

- 5 surface strain gauges installed on each crosstie:
 - Rail seat gauges (to measure rail seat positive bending)
 - Center gauge (to measure center negative bending)
 - Intermediate gauge (to measure asymmetric loading or support)

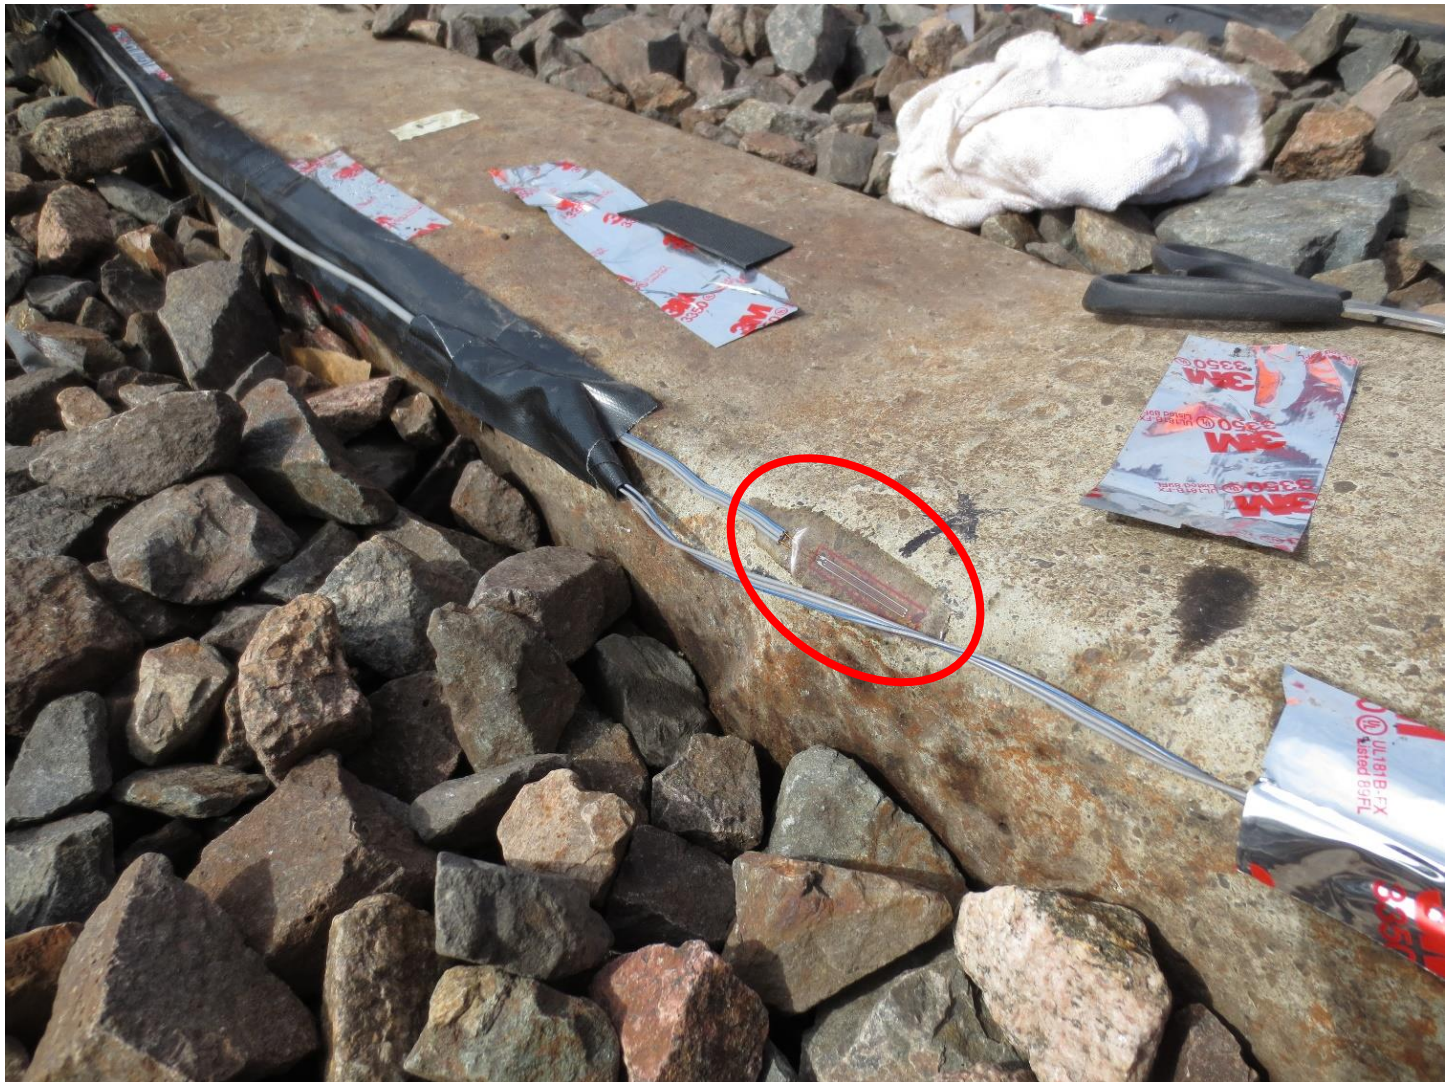
Close-up of Intermediate Strain Gauge

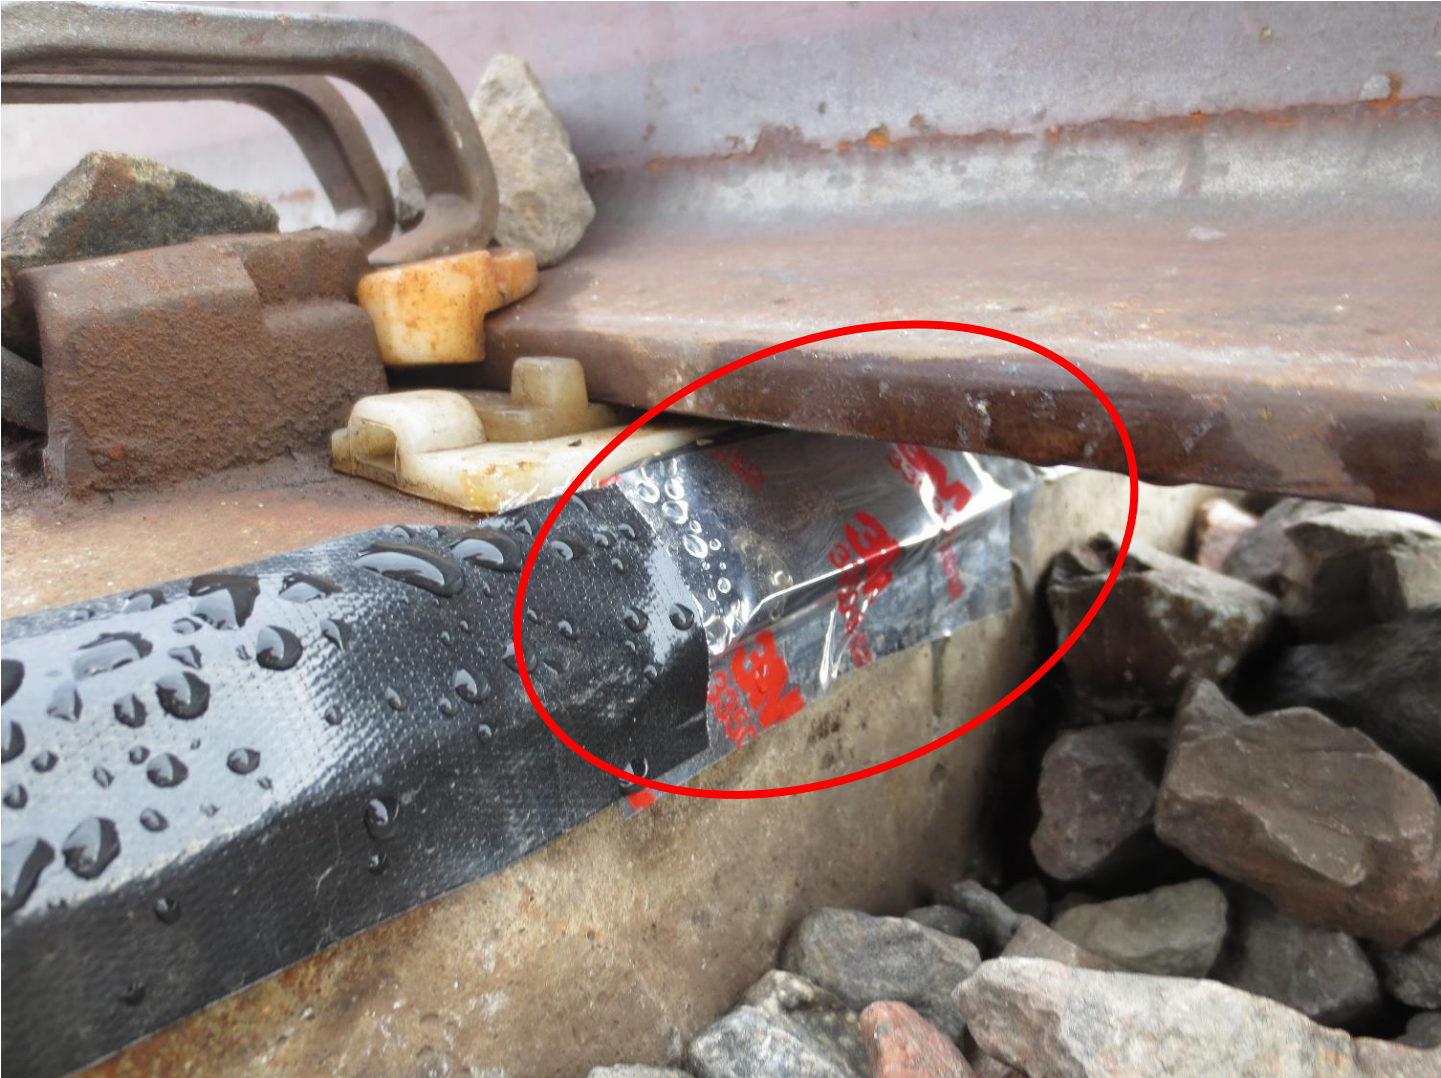
Installed and Protected Rail Seat Gauge

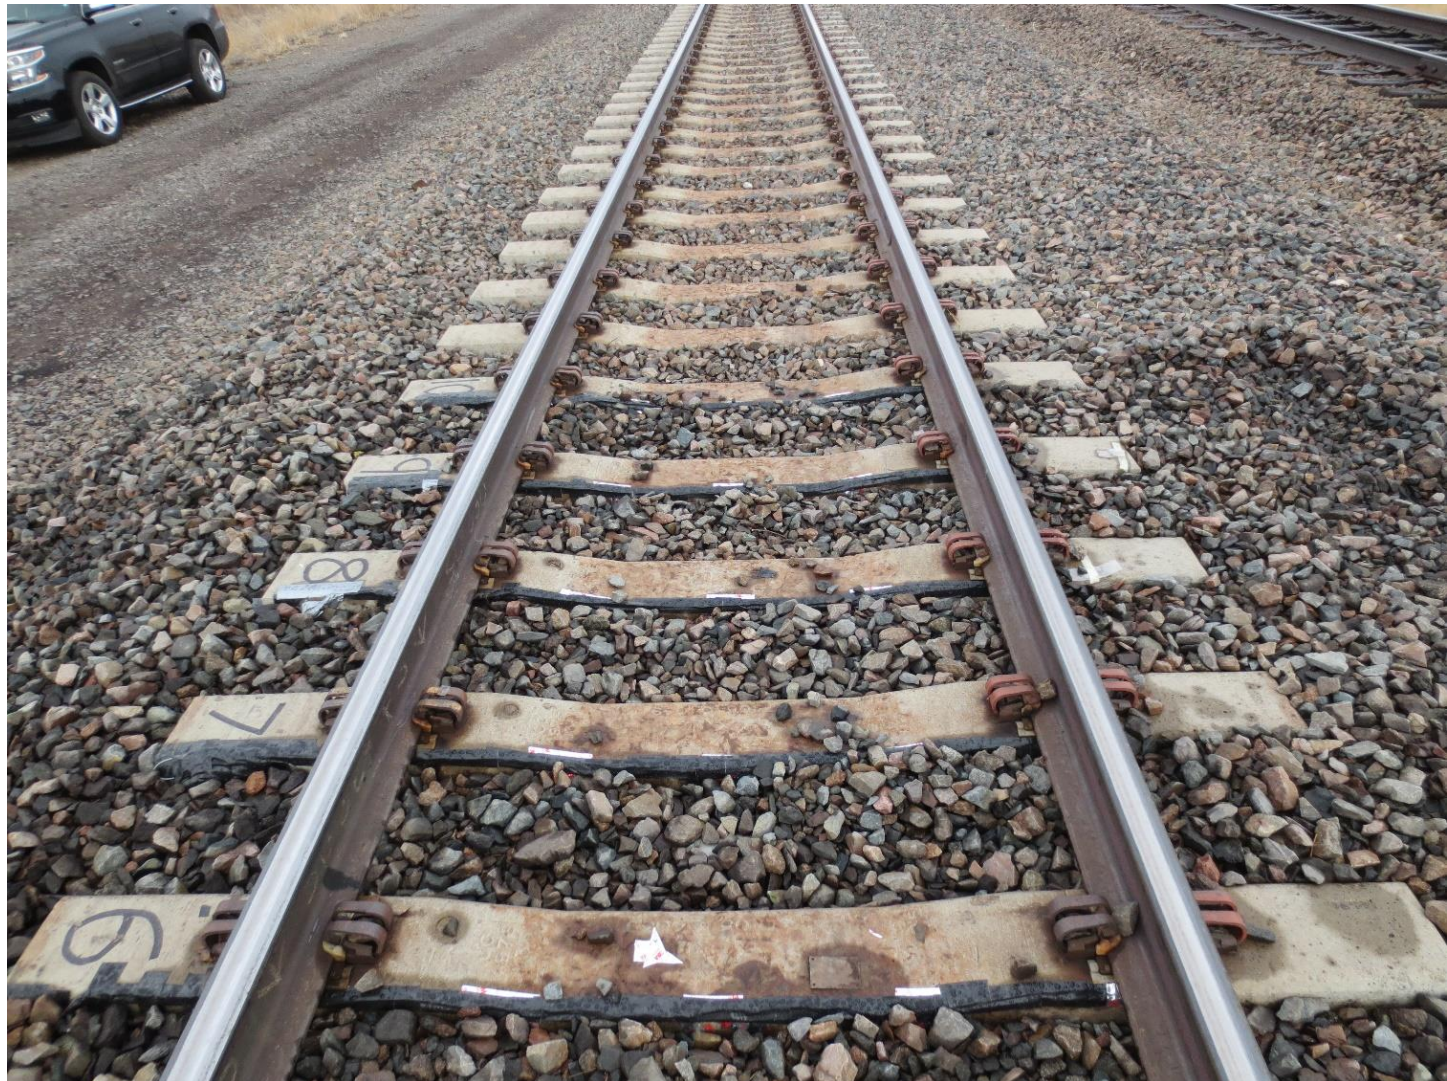
Completed Instrumentation Zone

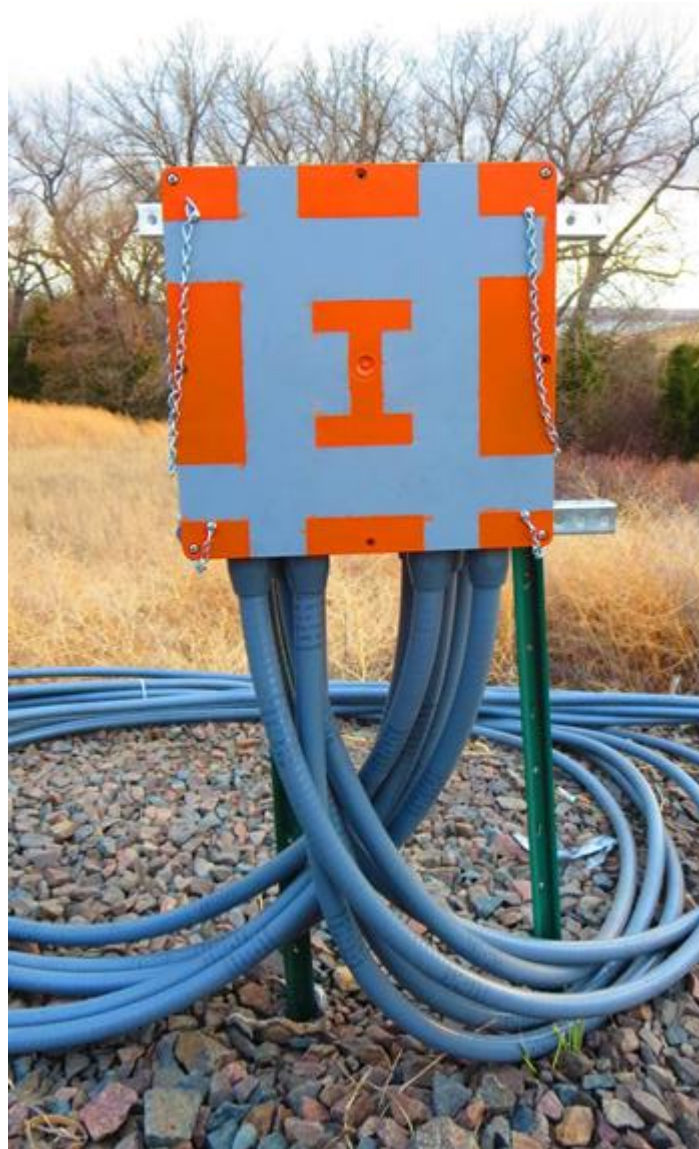
Completed Junction Box

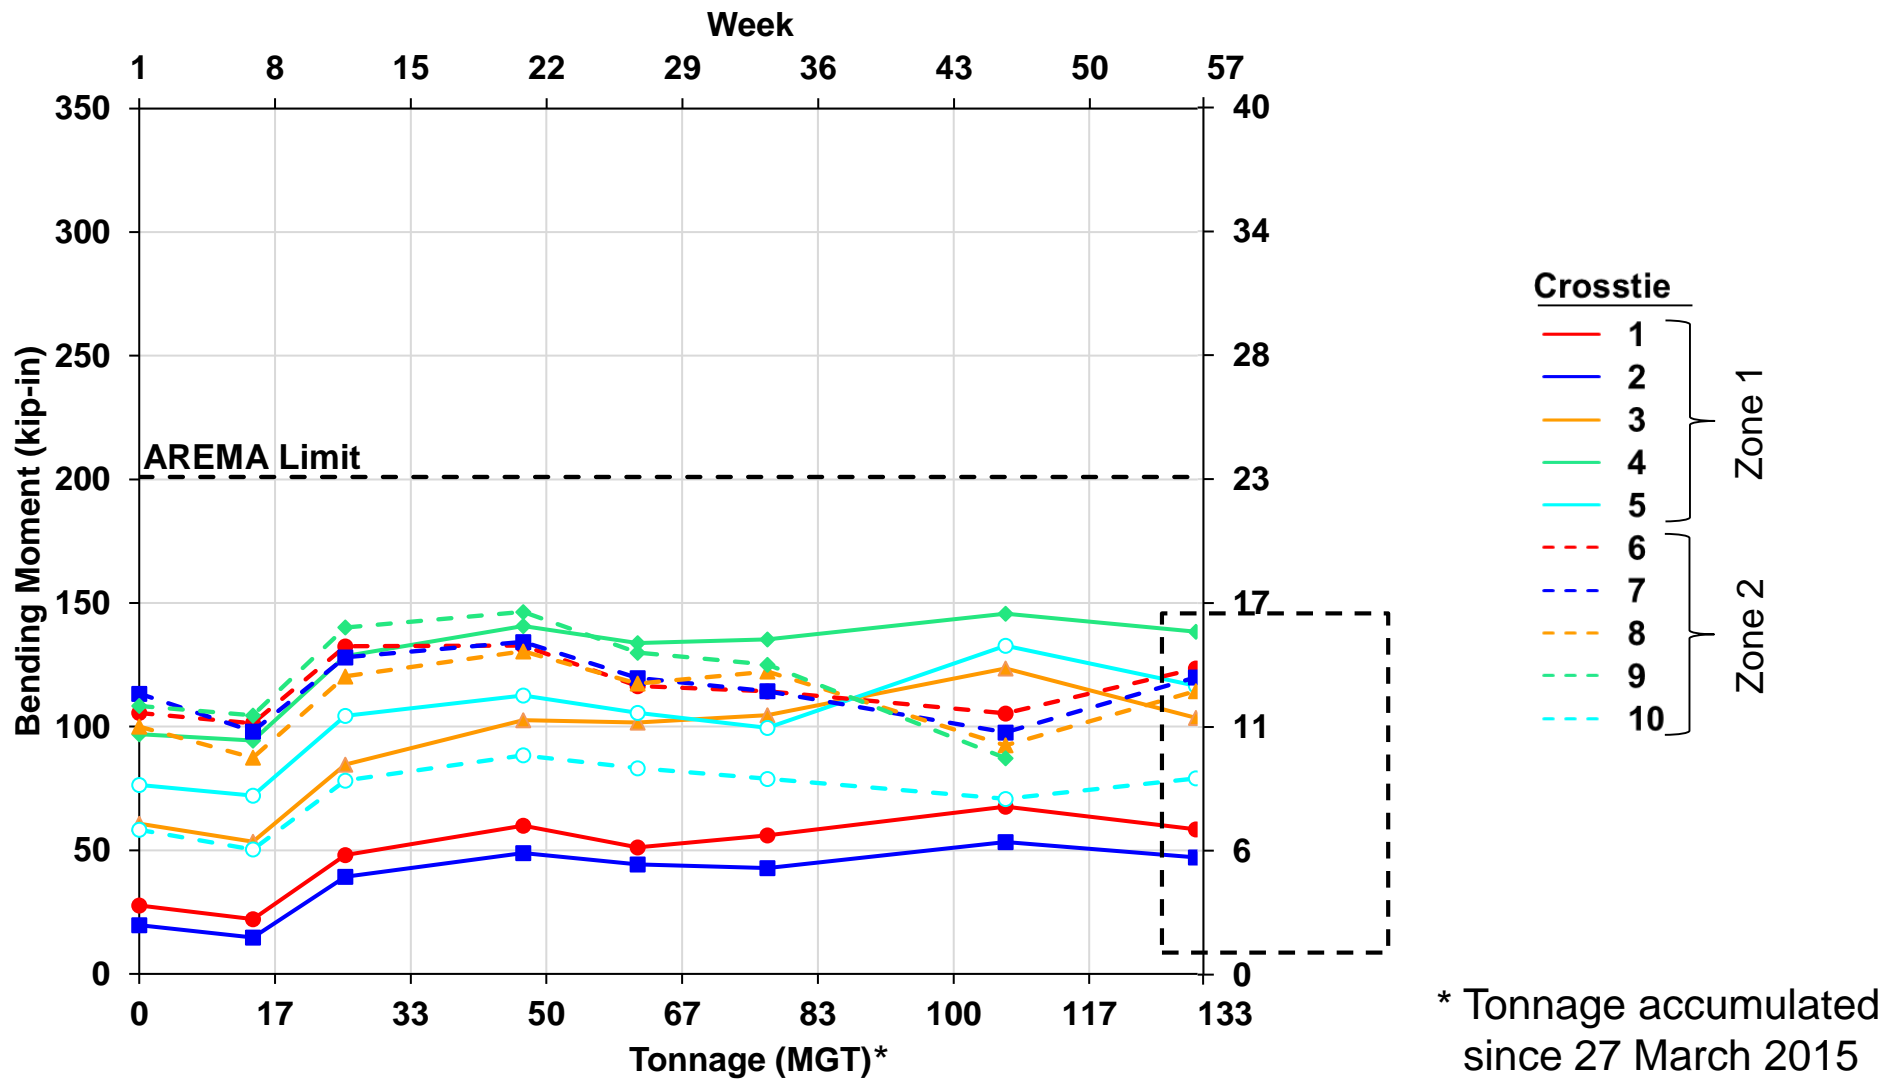
Average Center Negative Bending Moment vs. Time/Tonnage (Gauge C)

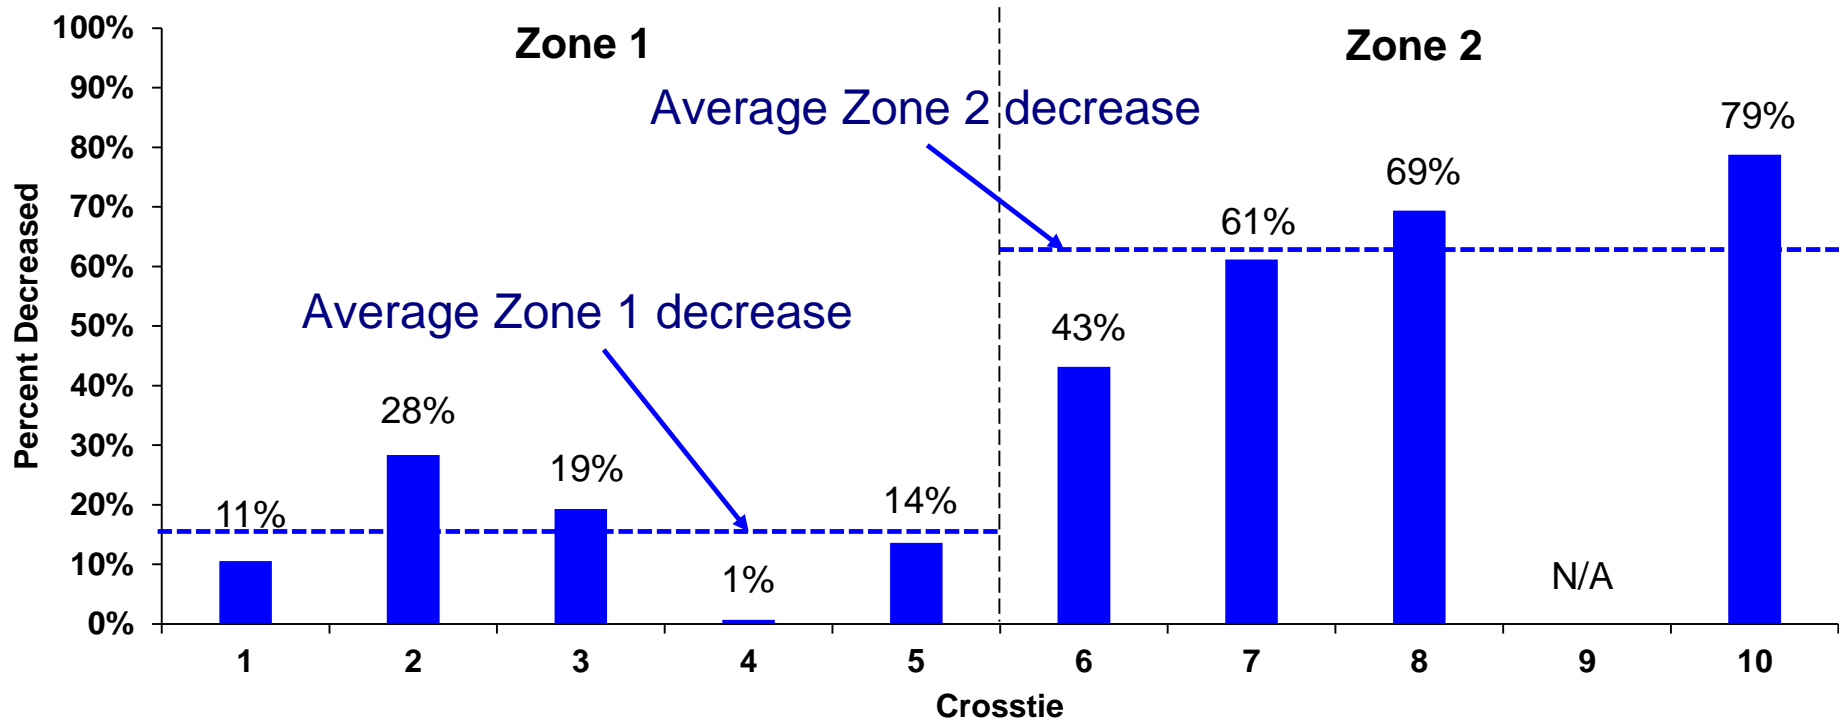
Change in Average Center Negative Bending Moments after Tamping (Gauge C)

- Average center moment of all crossties decreased, but those in Zone 2 (tamped zone) decreased more significantly

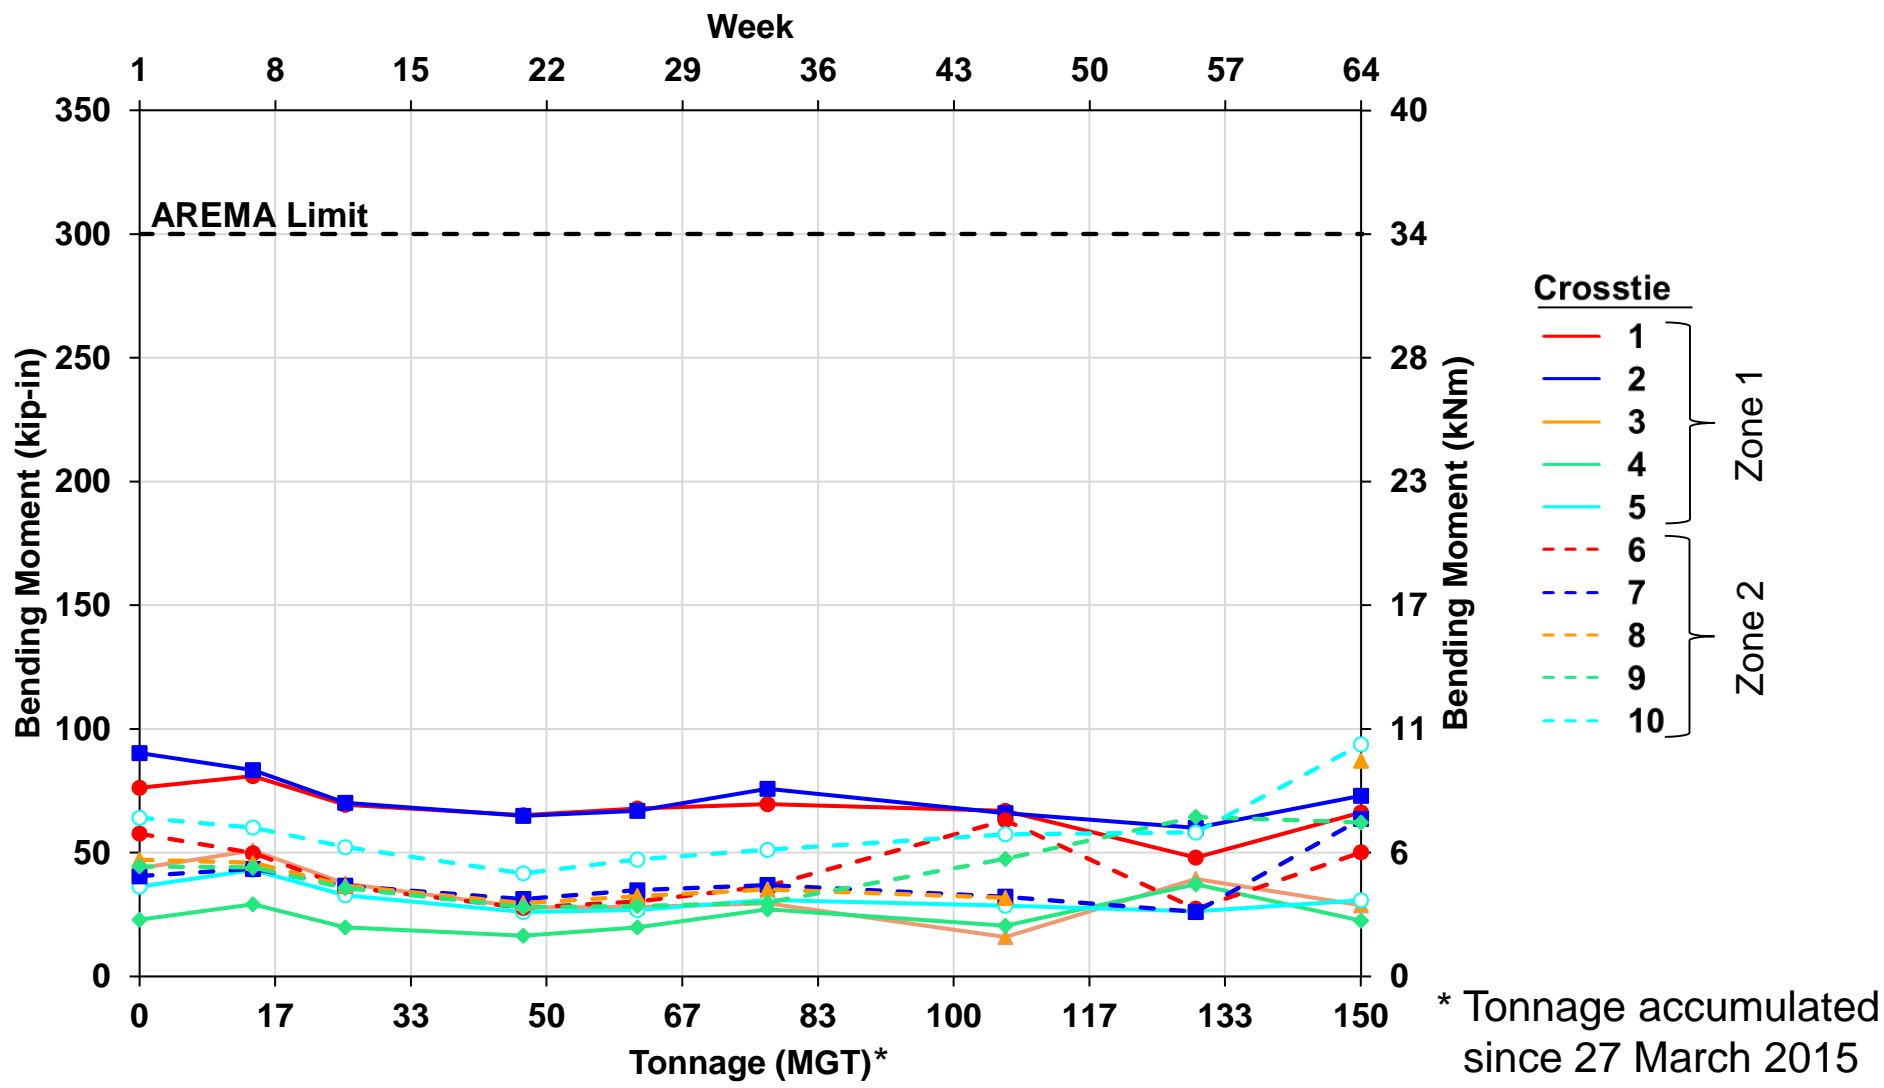
Average Center Negative Bending Moment vs. Time/Tonnage (Gauge A & E)

* Tonnage accumulated since 27 March 2015

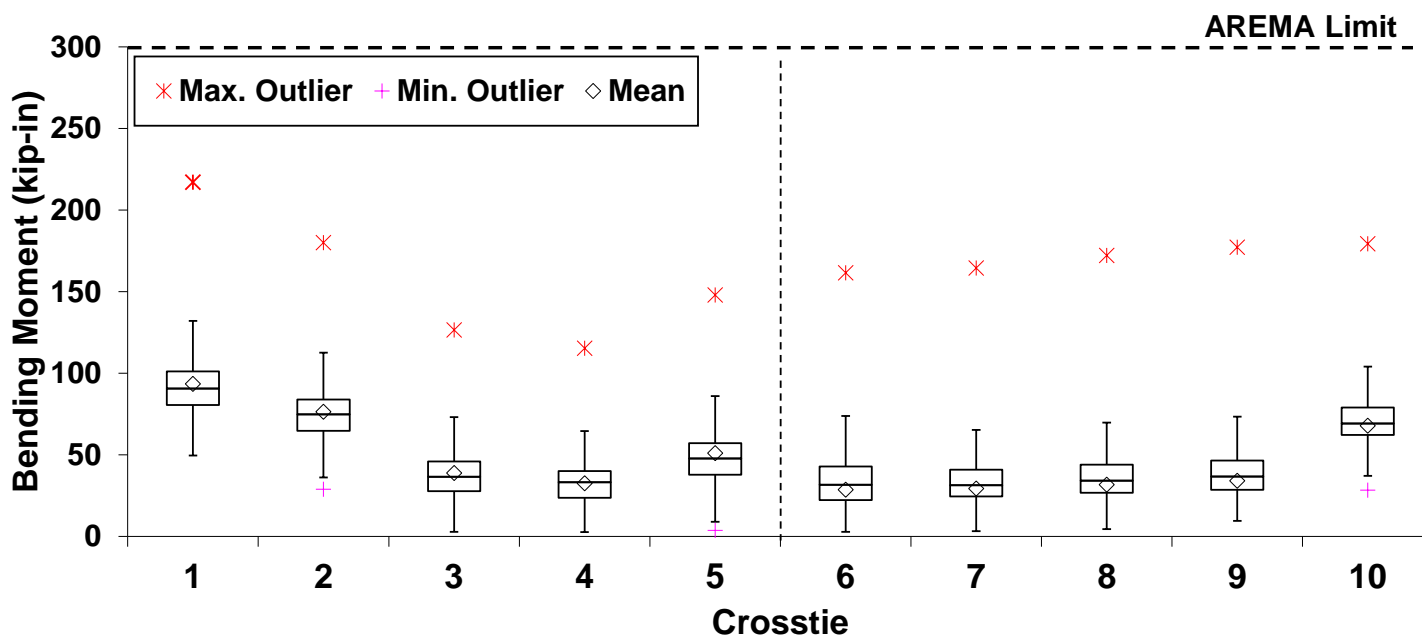
Gauge E

Box Plot for Rail Seat Positive Bending Moment (Gauge A & E)

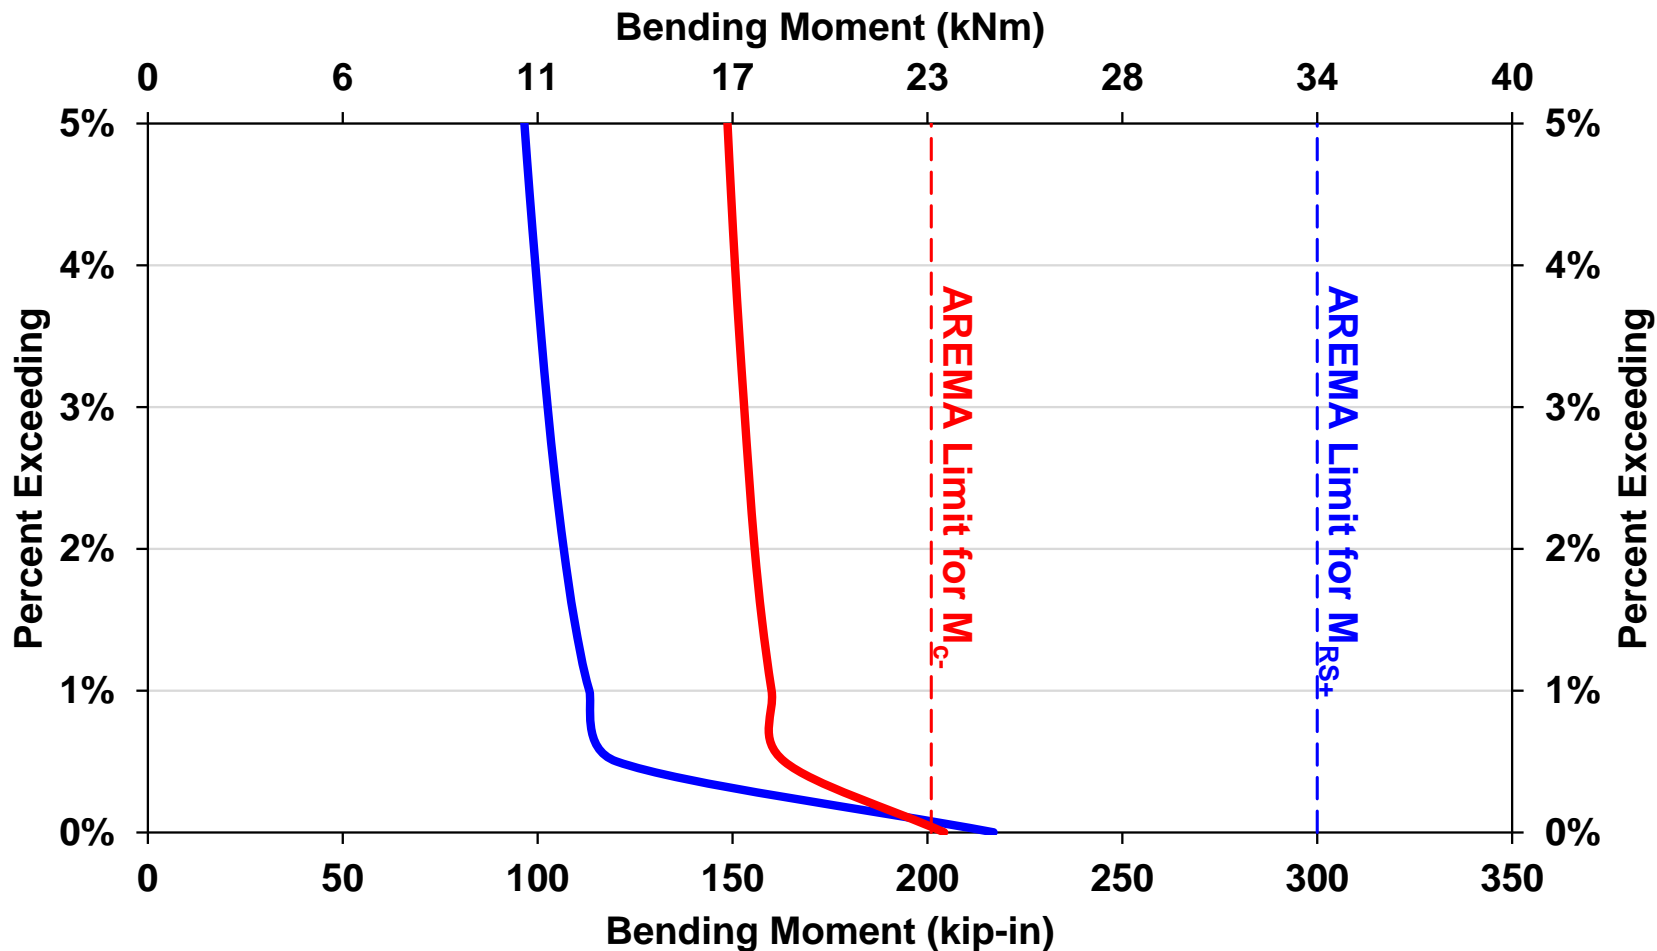
Percent Exceedance Plot for Center and Rail Seat Bending Moments (Gauge C, Gauge A & E)
