UPRR Tie Treating Plant, The Dalles, OR

DNAPL Recovery Progress

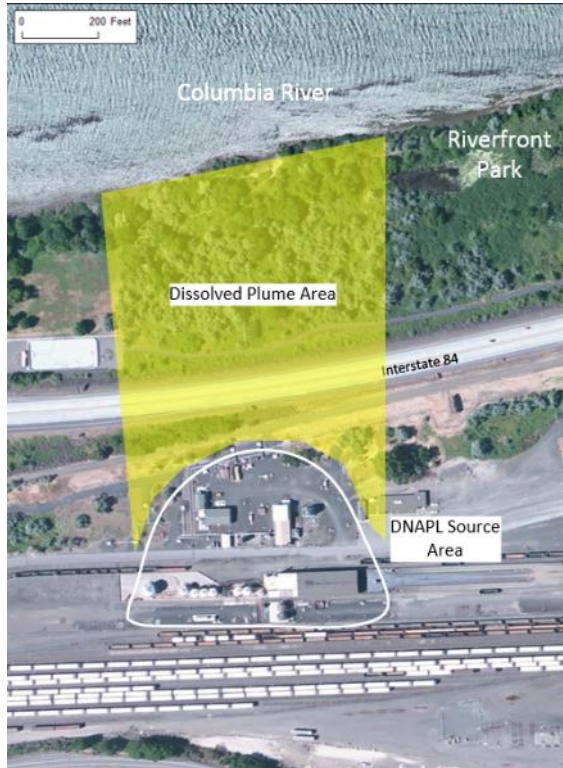
Impact Areas and Remedial Objectives

- The groundwater remedy is characterized by two separate areas
 - DNAPL source area
 - Dissolved plume area
- Before remedy, wells in Riverfront Park were all above water quality standards for surface water
- 1996 remedy required
 - Containment of DNAPL source area and groundwater restoration if technically feasible
 - Technical Impracticability waiver obtained for source area
 - Monitoring of dissolved area plume
 - Achieve DNAPL RAO

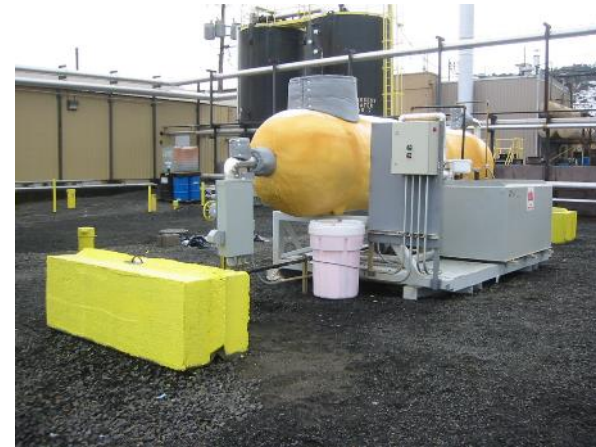
Pressurized Oil/Water Separators

- Closed loop system with DNAPL recovery, storage, and reinjection

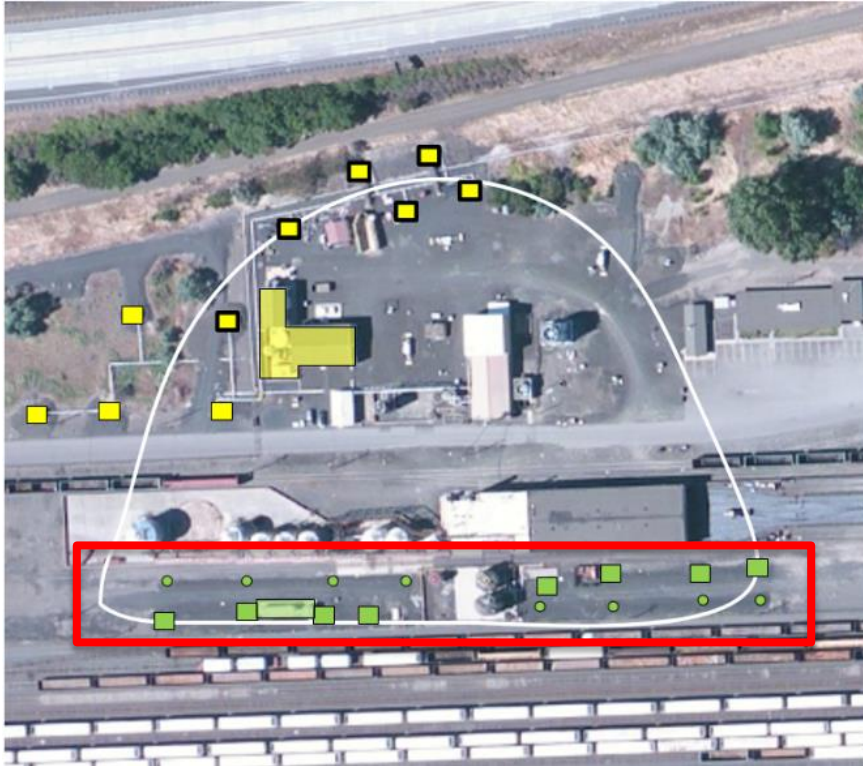
Module 1 DNAPL Recovery System

- Module 1 constructed on the upgradient edge of DNAPL source area
- Started in 1999
- Equipment:
 - 8 extraction wells
 - 1 pressurized oil water separator
 - 8 injection wells
- Operated ~10 years
- Over 12,000 gallons of DNAPL recovered

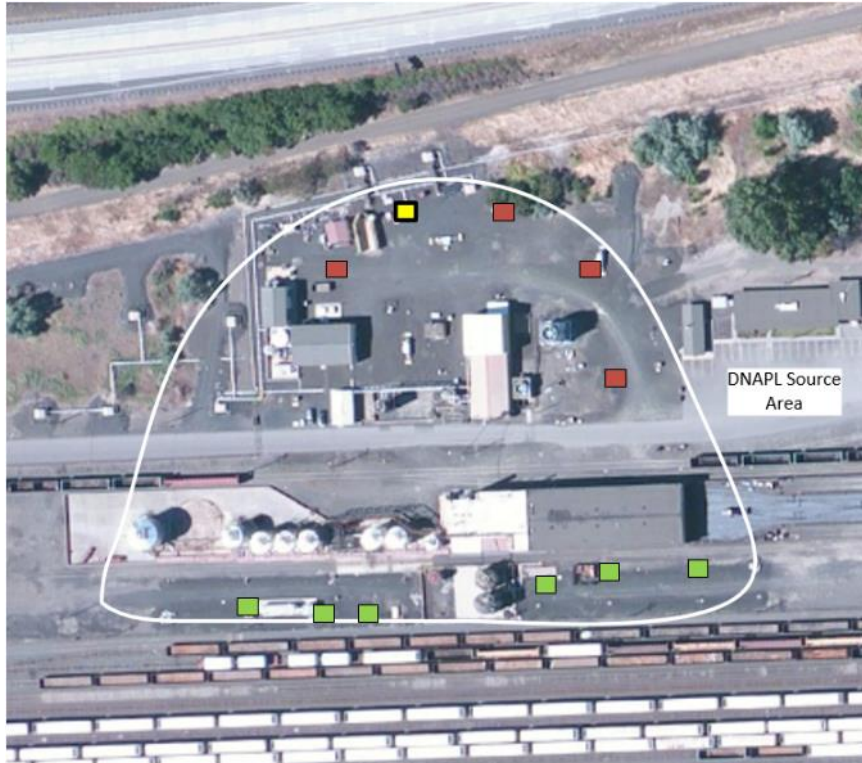
Transmissivity Analysis Program

- DNAPL transmissivity testing program
 - Historic data
 - Planned tests
- Measurements at different times for different wells
 - 1 hydraulic containment well
 - 6 Module 1 wells
 - 4 Module 2/3 wells

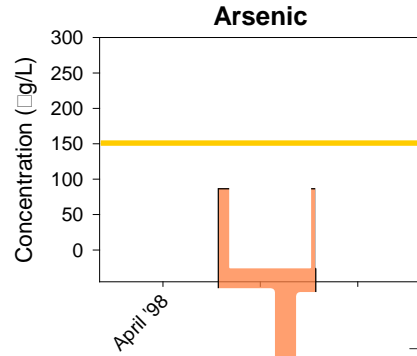
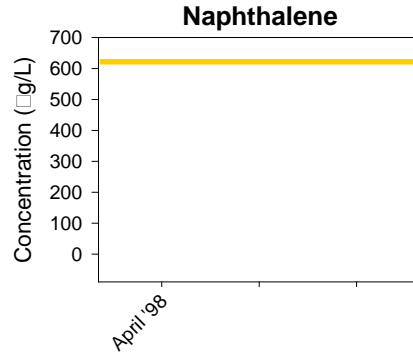
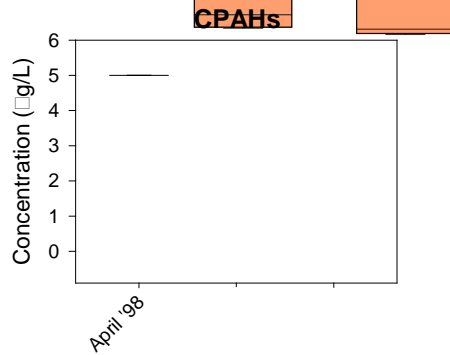
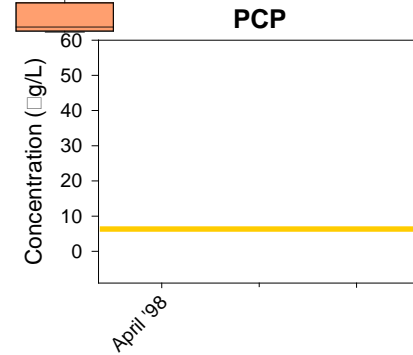
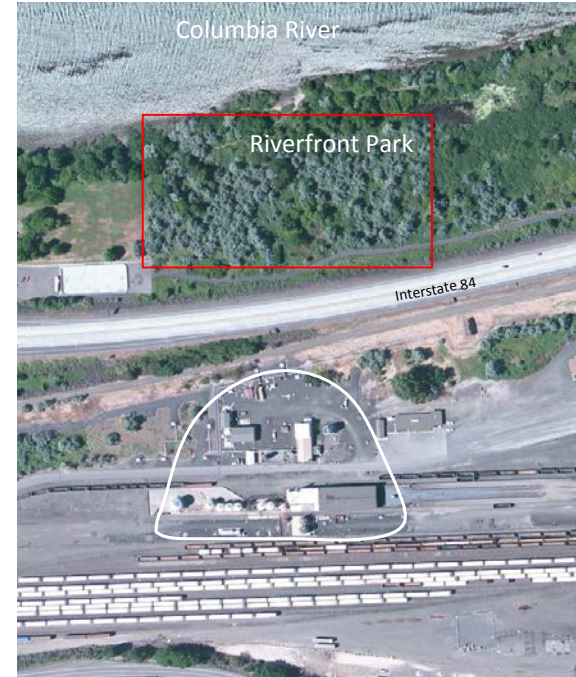
Downgradient Results Below Ambient Groundwater Criteria

— Freshwater Screening Criteria

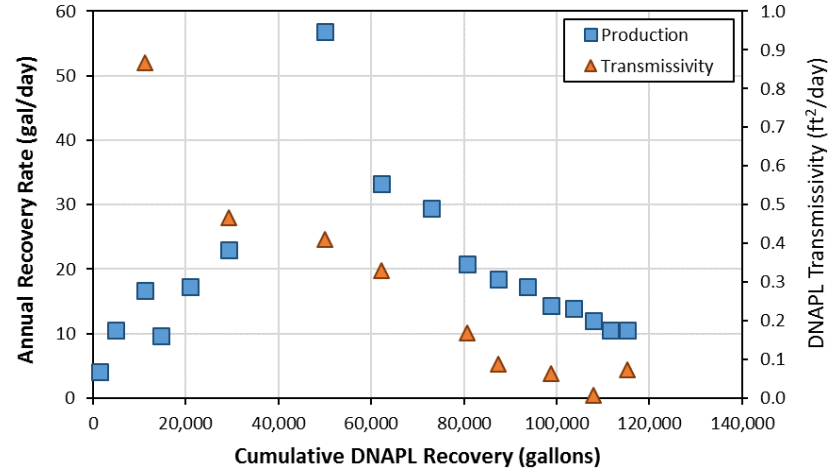
Production and Transmissivity

Data analysis method: Reyenga, Lisa. 2016. "Estimating Expected Ultimate Recovery." Applied NAPL Science Review. Vol. 6, Issue 2, July.

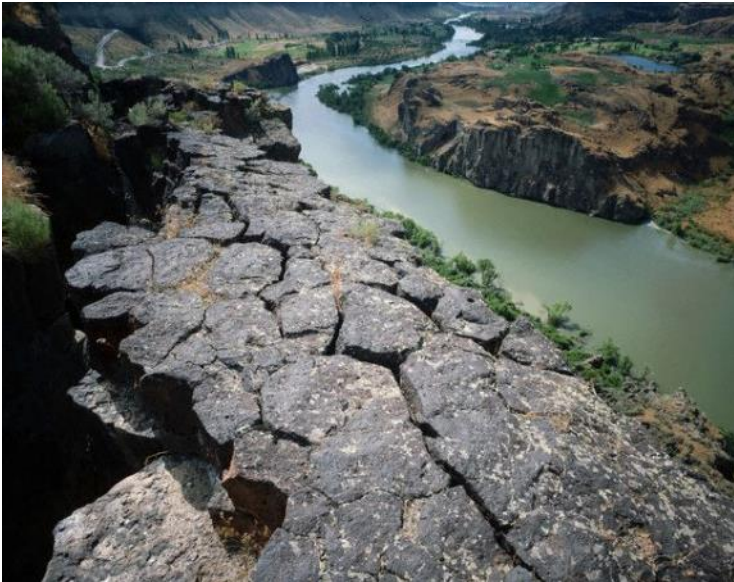
Example Top of Columns

- Prevent downward migration of DNAPL
- Analytical calculations show it takes five feet of head on the columns for downward migration
- Prior to remediation, up to 18 feet of head was observed in some locations

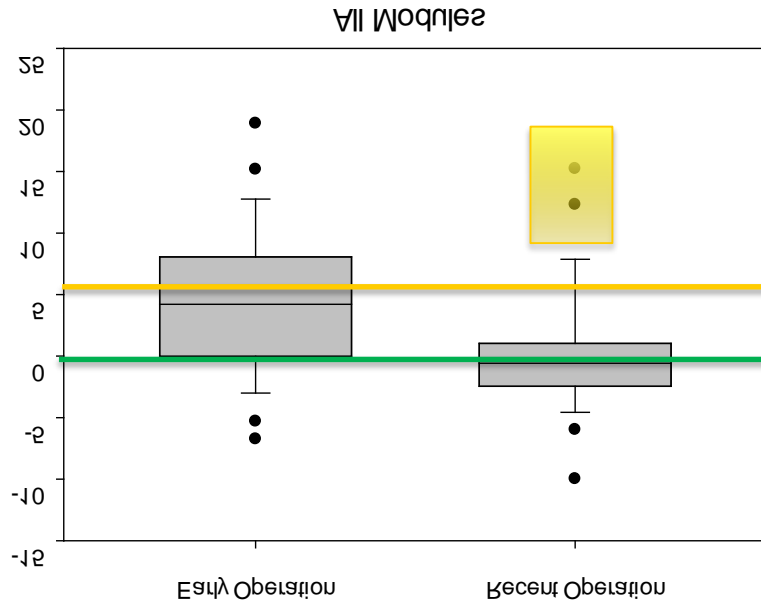
Current DNAPL Head Levels

- Median of all wells near 5 feet DNAPL head in early operation
- Current median of all wells near zero
- Current focus on two wells with higher heads
