UIUC FRA Crosstie and Fastening System BAA 2014-2: Investigation of Deteriorated Crossties and Support Conditions *Experimental Matrix Development*

FRA and FTA Crosstie and Fastening System Research Program
Industry Partners (IP) Meeting

4 November 2015

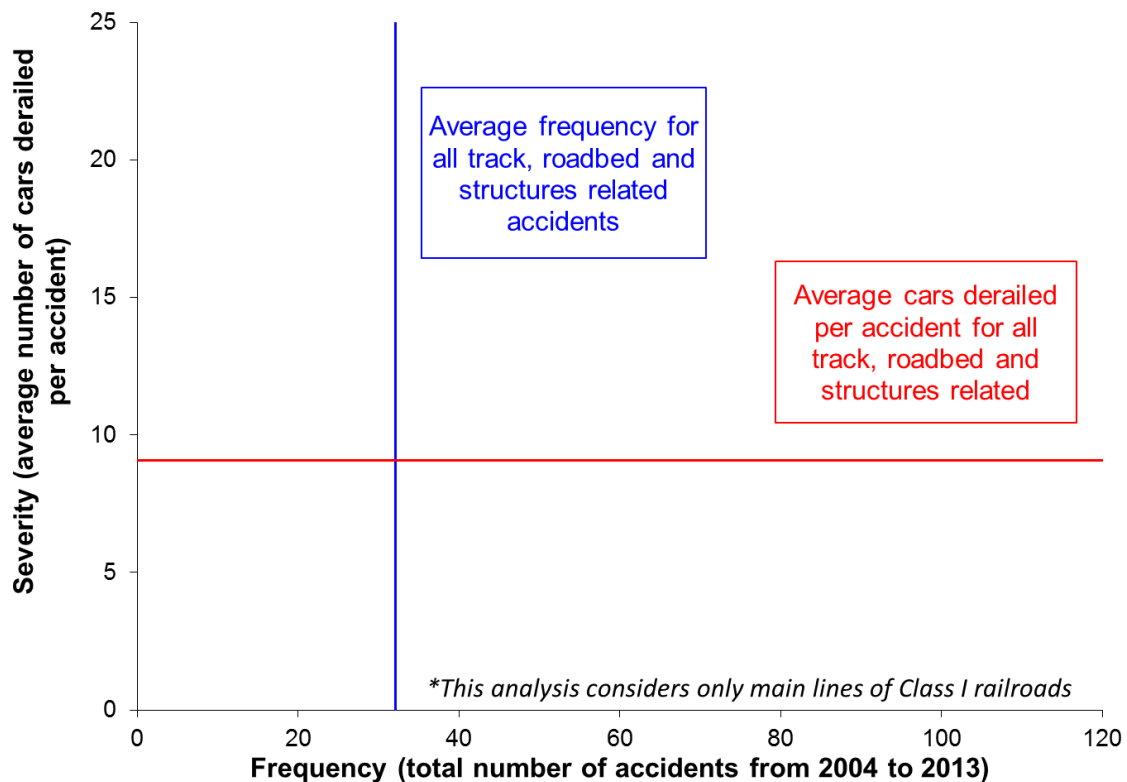
Overview of Track-caused Derailments

- Performed analysis of 10 years of accident data from the FRA accident database, from 2004 to 2013, filtering for the following accident causes:
 - **T001** Roadbed settled or soft
 - **T105** Insufficient ballast section
 - **T110** Wide gage (due to defective or missing crossties)
 - **T111** Wide gage (due to defective or missing spikes or other rail fasteners)
 - **T205** Defective or missing crossties
 - **T206** Defective spikes or missing spikes or other rail fasteners (use code T111 if results in wide gage)

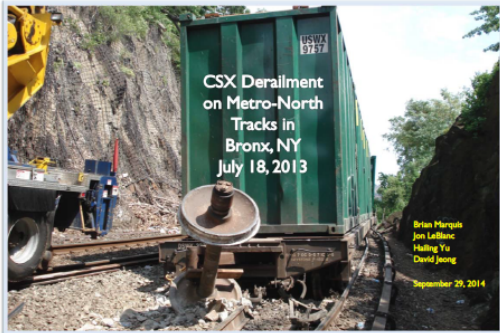
- Volpe report on 2013 derailment of CSX freight train on Metro-North tracks in Bronx, NY

- Caused by combination of degraded track conditions caused derailment as presented within report:
 - Poor drainage
 - High temperature induced rail to push under insulator
 - Center bound and worn crossties

- Accident cause reported to FRA as *T110 Wide Gage (due to defective or missing crossties)*

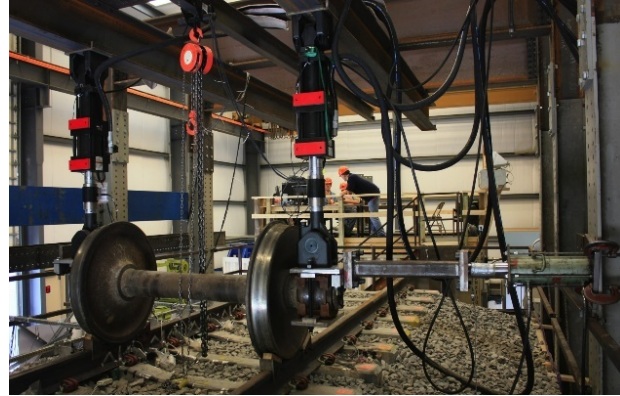
TLS at RailTEC's RAIL

- Results from this project will guide future experimentation using the **Track Loading System (TLS)** at UIUC
