Survey About **D**eterioration of **C**oncrete **T**ies Due to **A**brasion against **R**ail-way **B**allast

2016 International Crosstie and Fastening Symposium

Design of Concrete Crossties (Session 3)

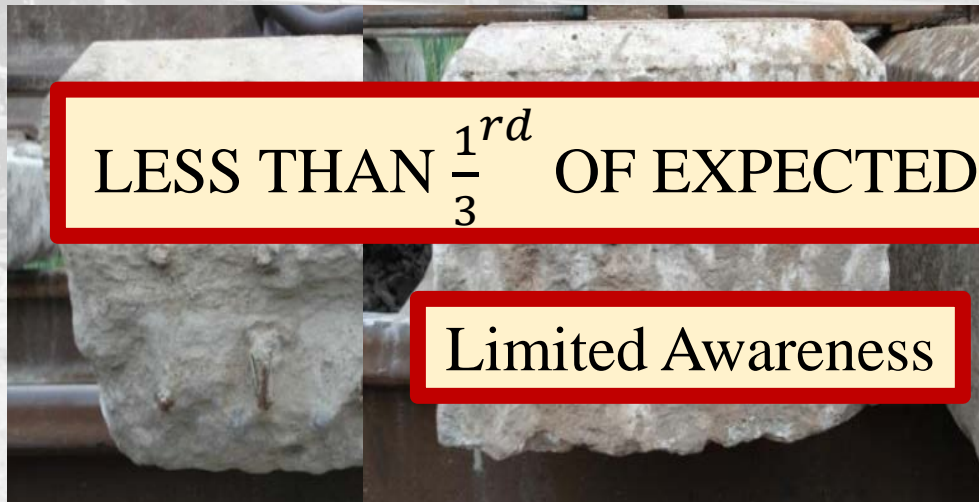
Northbound CSX Transportation (CSX) train **derailed** on the Metro-North Railroad
July 18, 2013
Bronx, New York

NTSB investigation identified partially abraded prestressed concrete ties

LESS THAN $\frac{1}{3}^{rd}$ OF EXPECTED LIFETIME

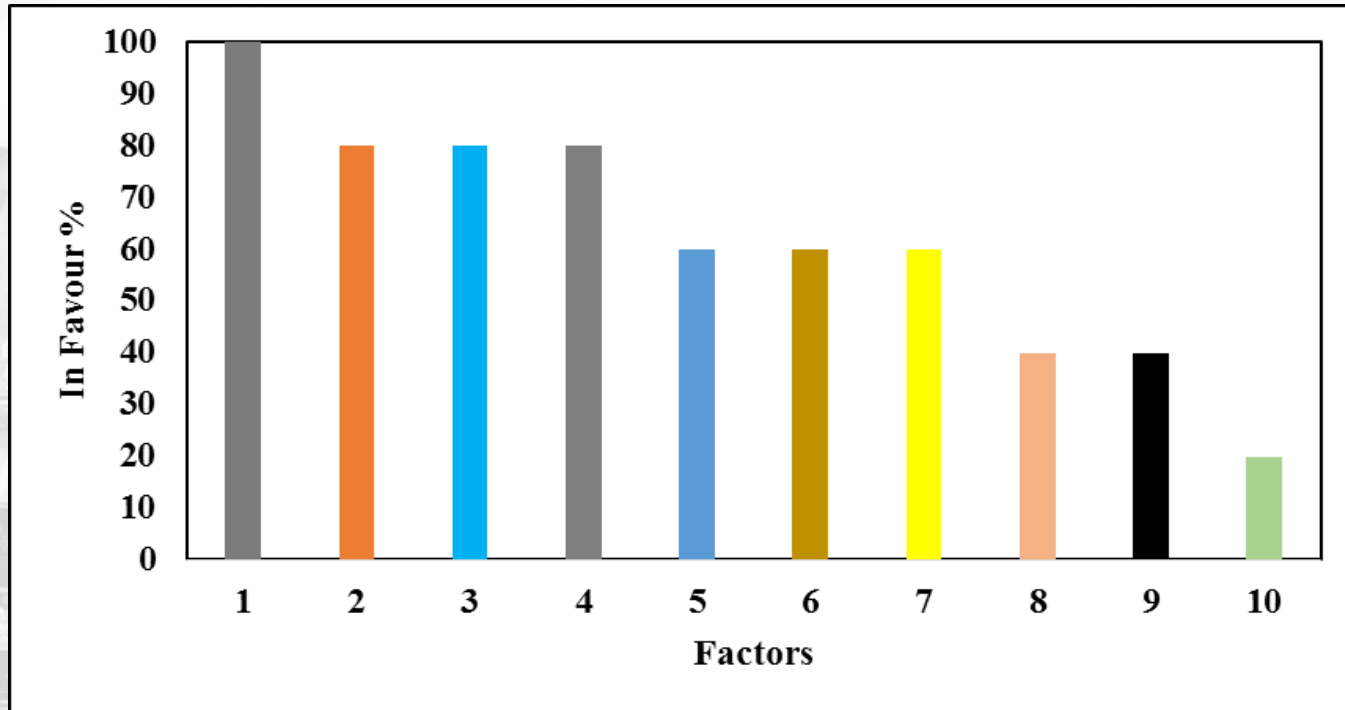
Factors Contributing to Abrasion

| ■ 1 Material of the Ballast | ■ 6 Relative Displacement b/w Tie and Ballast |
| ■ 2 Material of the Ties | ■ 7 Track Discontinuities |
| ■ 3 Drainage | ■ 8 Weather/Temperature and Humidity |
| ■ 4 Geometry of the Ties | ■ 9 Subgrade |
| ■ 5 Contact Forces | ■ 10 Fabrication |

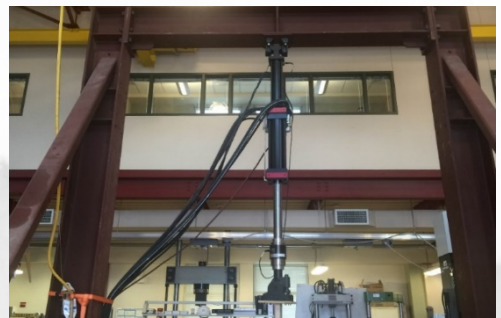
3. Laboratory testing
