CONESTOGA-ROVERS & ASSOCIATES

***IN SITU* CHEMICAL AND BIOLOGICAL TREATMENT OF TCE IN GROUNDWATER AT A LEGACY RAILROAD SITE**

2014 Railroad Environmental Conference

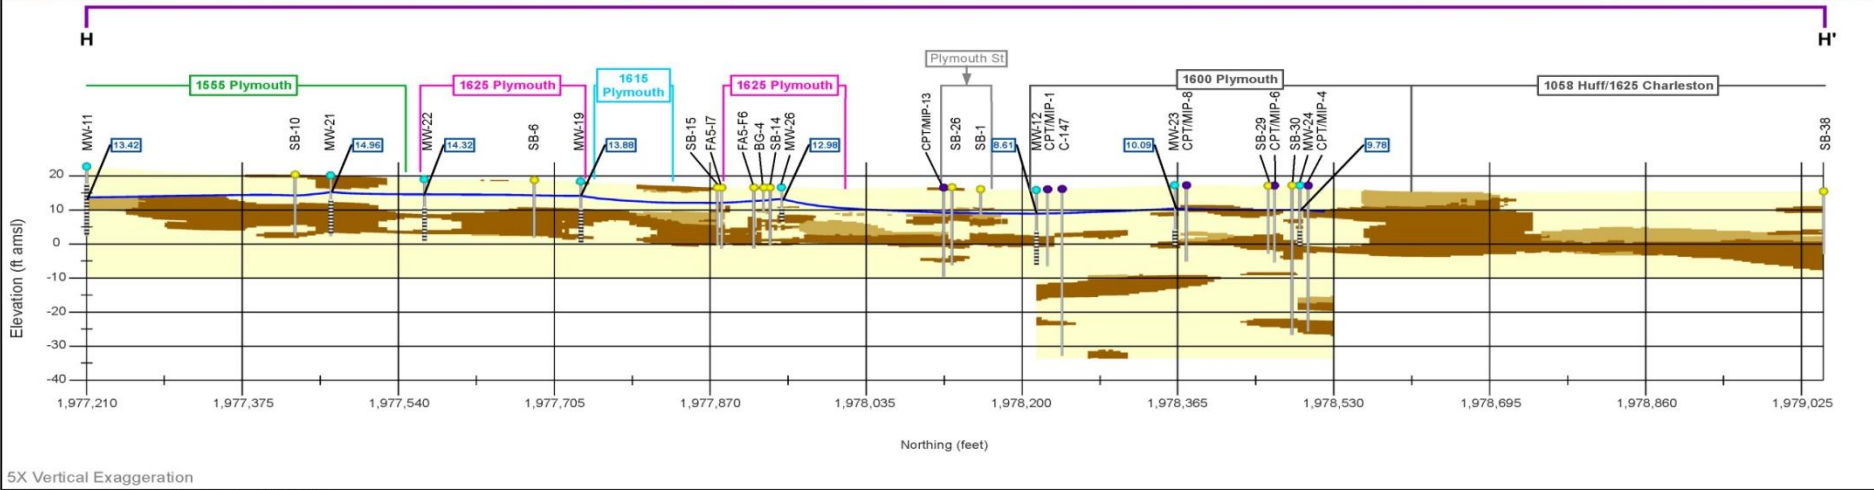
Figure 6H

GEOLOGIC CROSS-SECTION H-H'
 UNION PACIFIC RAILROAD COMPANY
 PLYMOUTH STREET SITE
 Mountain View, California

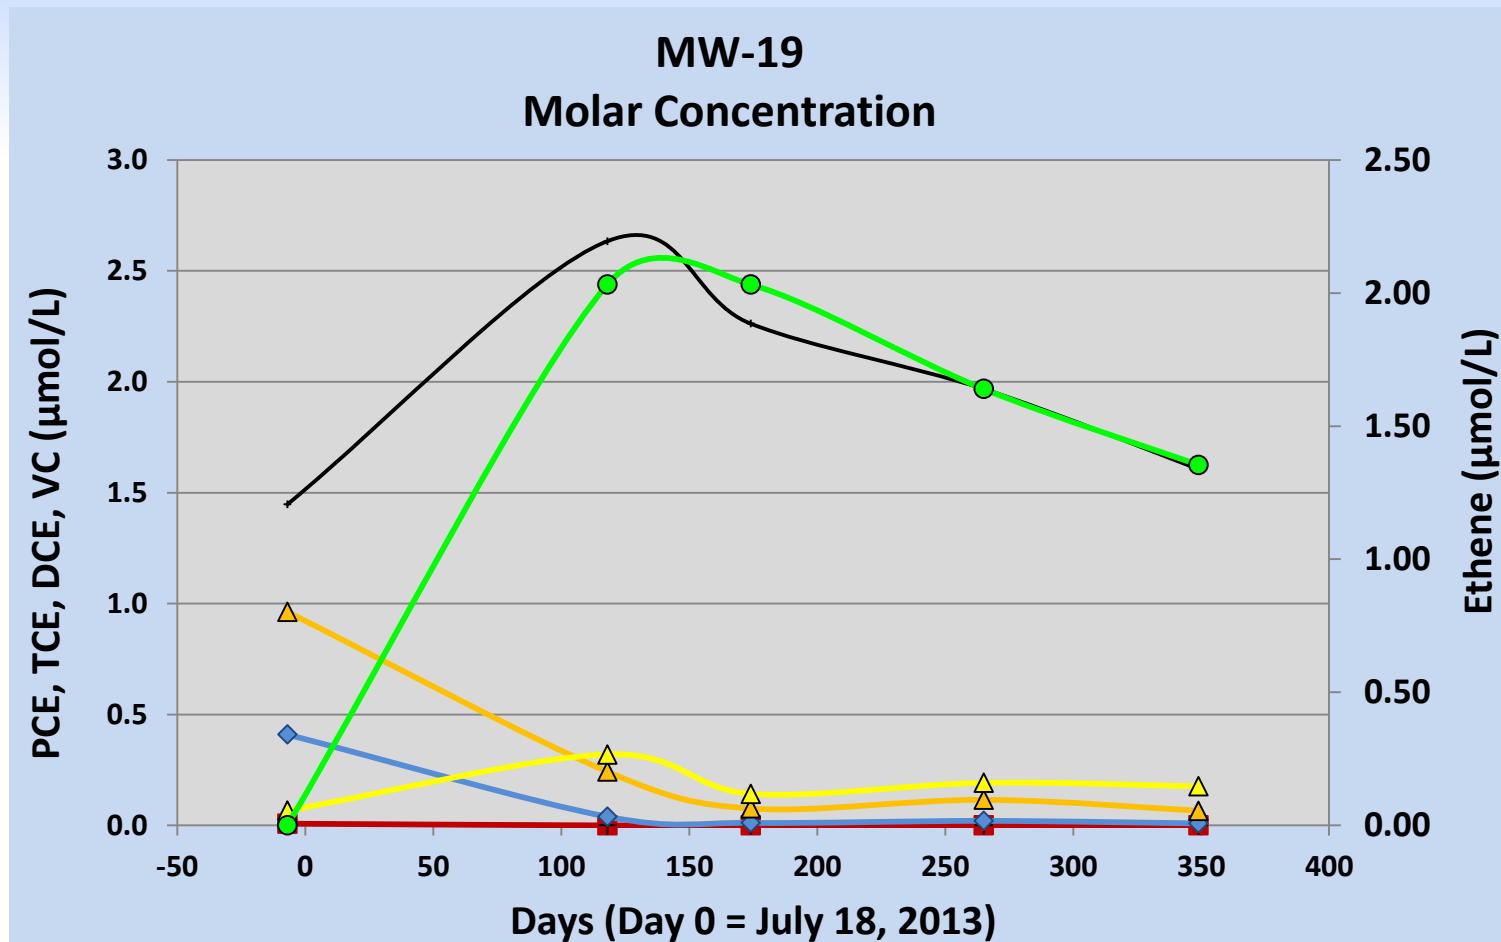
■ PCE ◆ TCE ▲ Total DCE ▲ VC — Total ● ethene

- A 75 to 99 % reduction in TCE concentrations
- Transient increases in cis-1,2-DCE and vinyl chloride
- Presence of ethene in all five treatment areas indicates complete reductive dechlorination
- Strong reducing conditions with sulfate reduction and methane production
- EHC and bioaugmentation were found to be effective for site-specific treatment of TCE

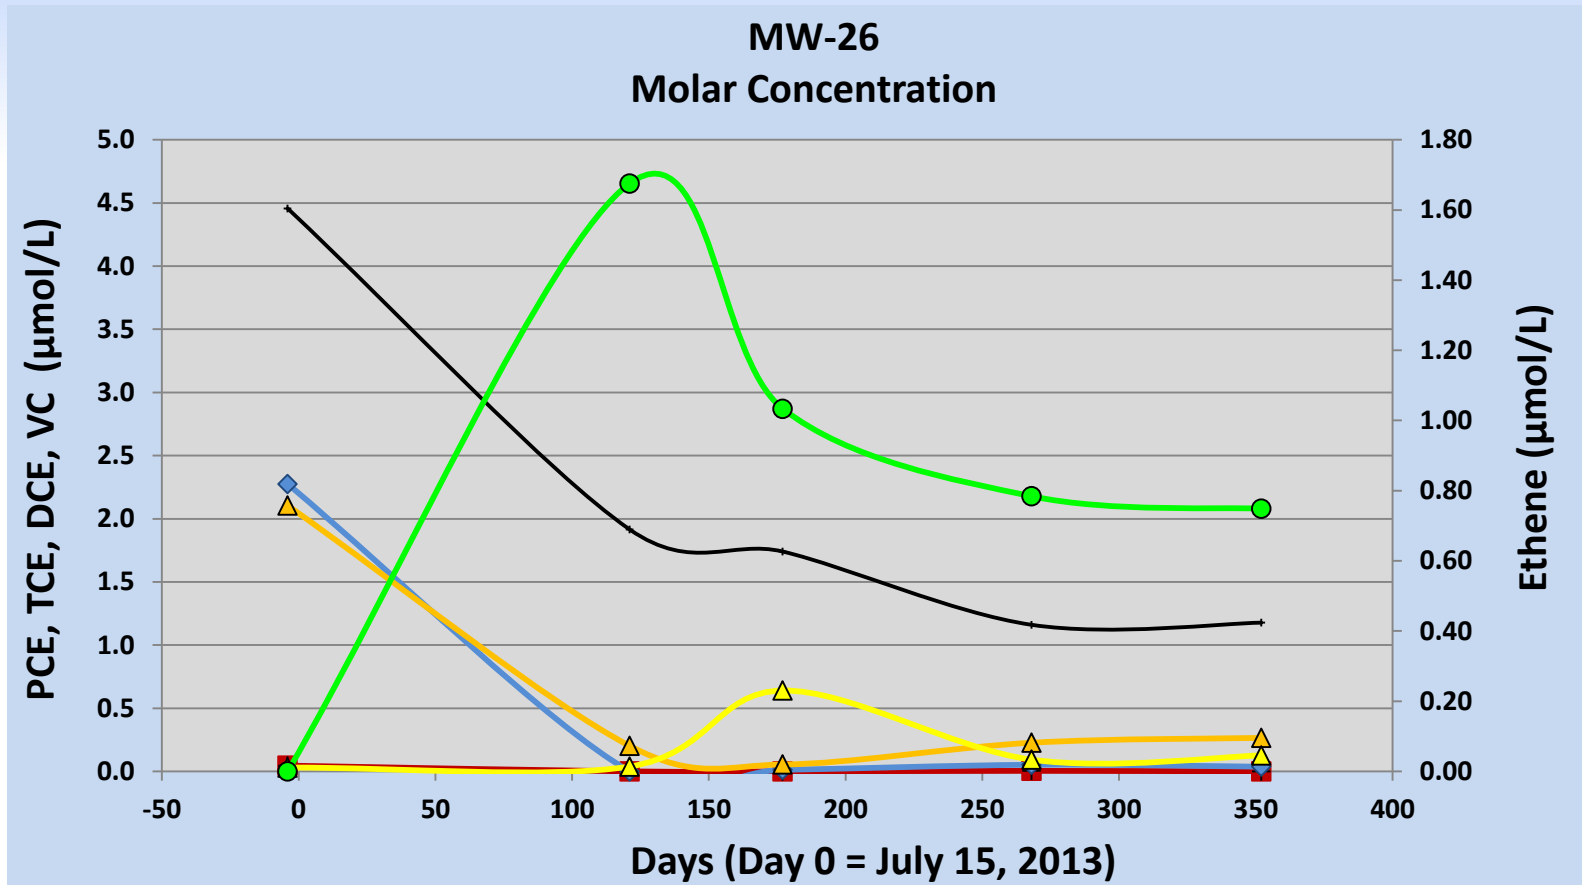
■ PCE ◆ TCE ▲ Total DCE ▲ VC — Total ● ethene

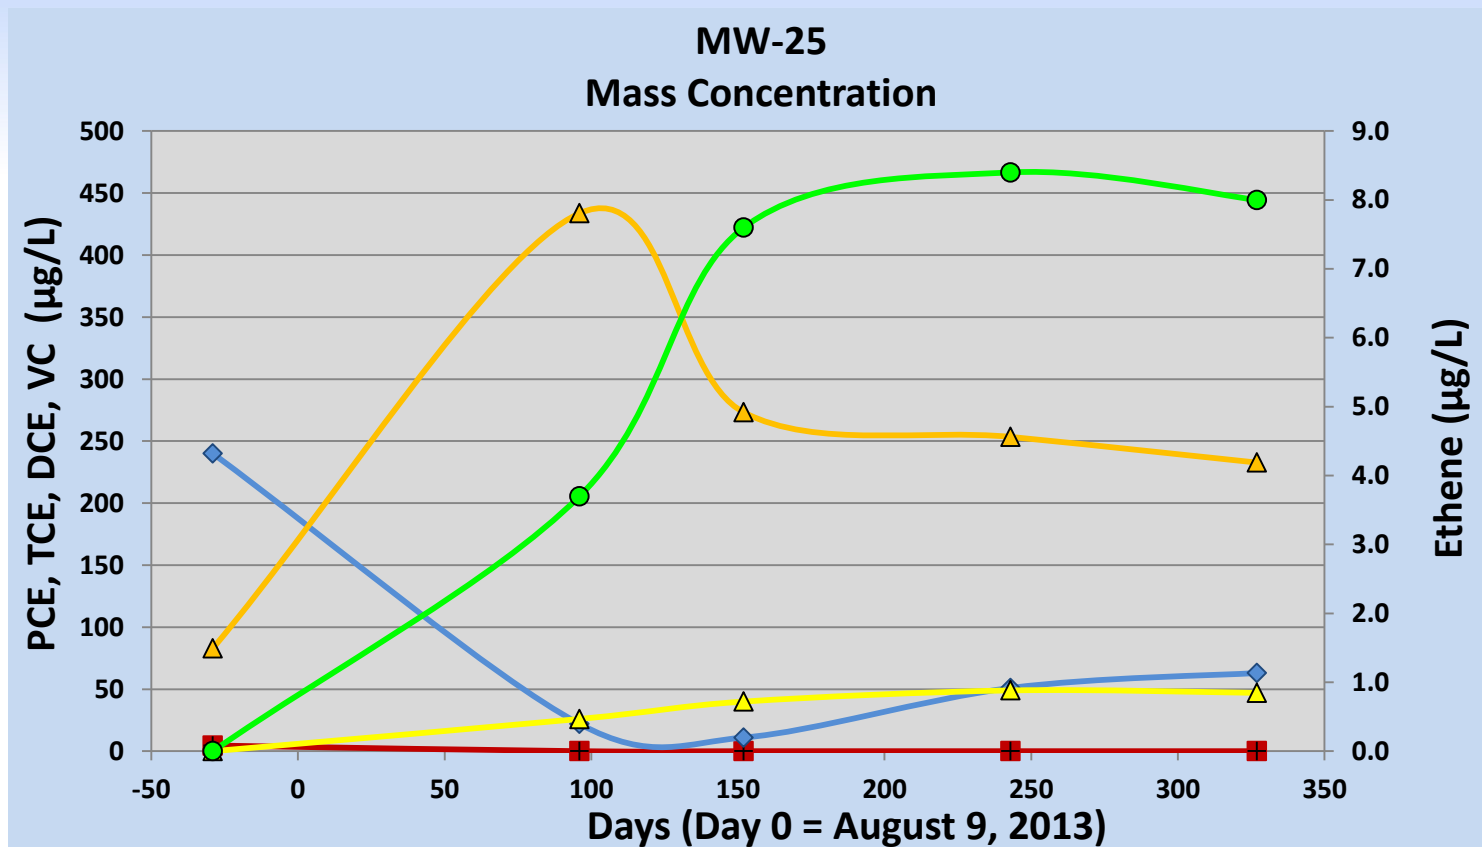
■ PCE ◆ TCE ▲ Total DCE ▲ VC — Total ● ethene
