Crosstie & Fastener Experience

BNSF Railway

June 14, 2016 Univ. of Illinois, Crosstie and Fastening System Symposium

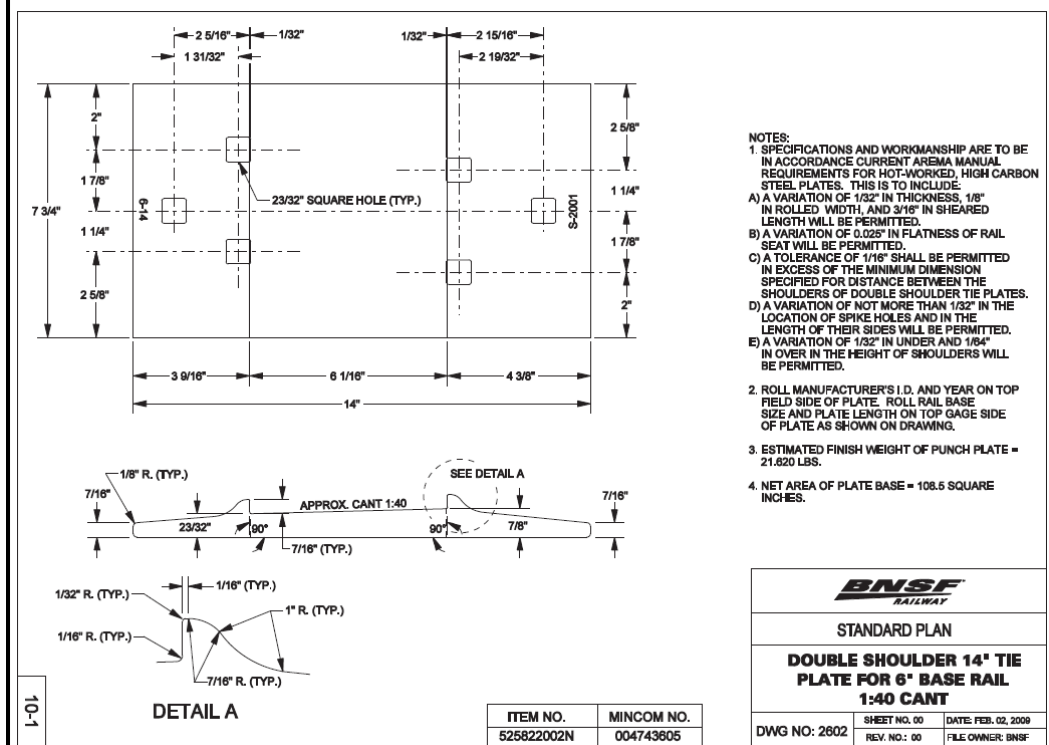
Wood Ties

19 1/2" spacing

7" x 9" x 8'-6"

Cut Spikes

Unit V Common Anchor

Curve block all curves,
every 3rd tie

14" BNSF plate

Step and Half Treating
Process (6 lbs creosote
and 1 lb borate)

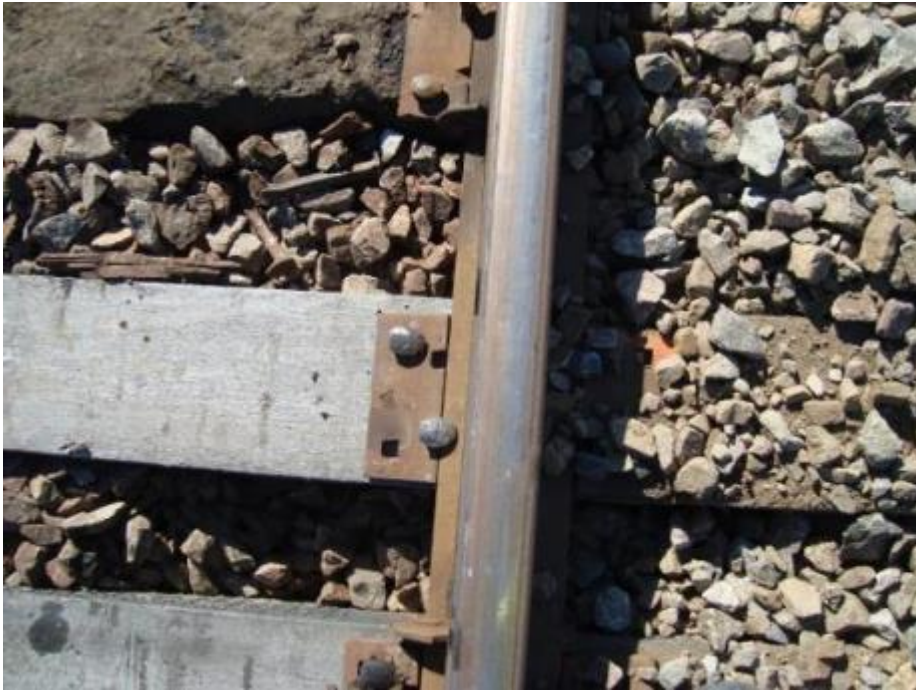
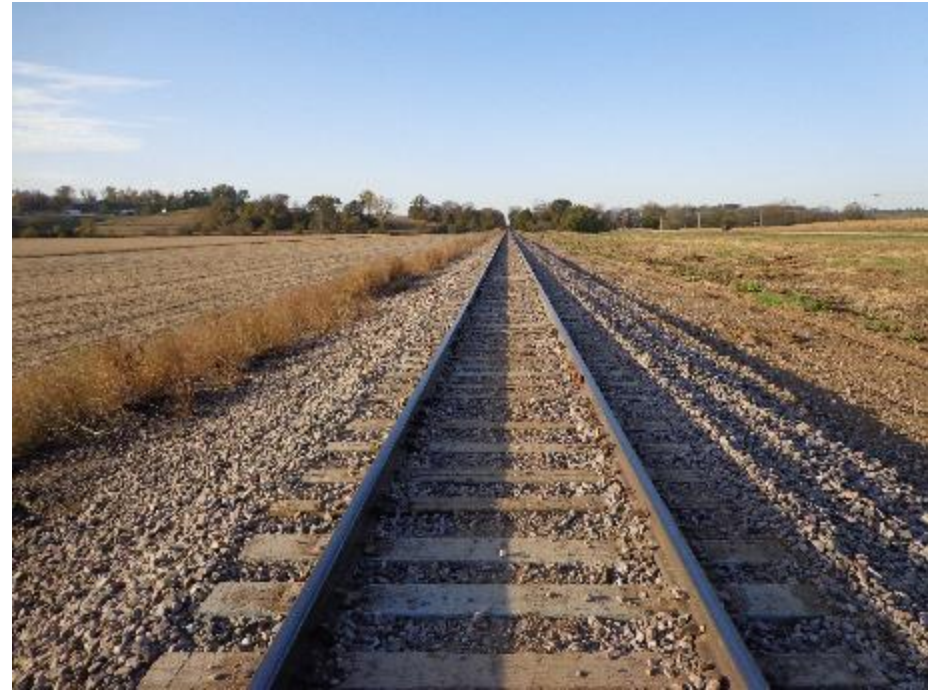
Composites

Continued testing by our TR&D Dept and field trials.

5,000 tie install on the Bayard Sub.

Best Practice to Predrill.

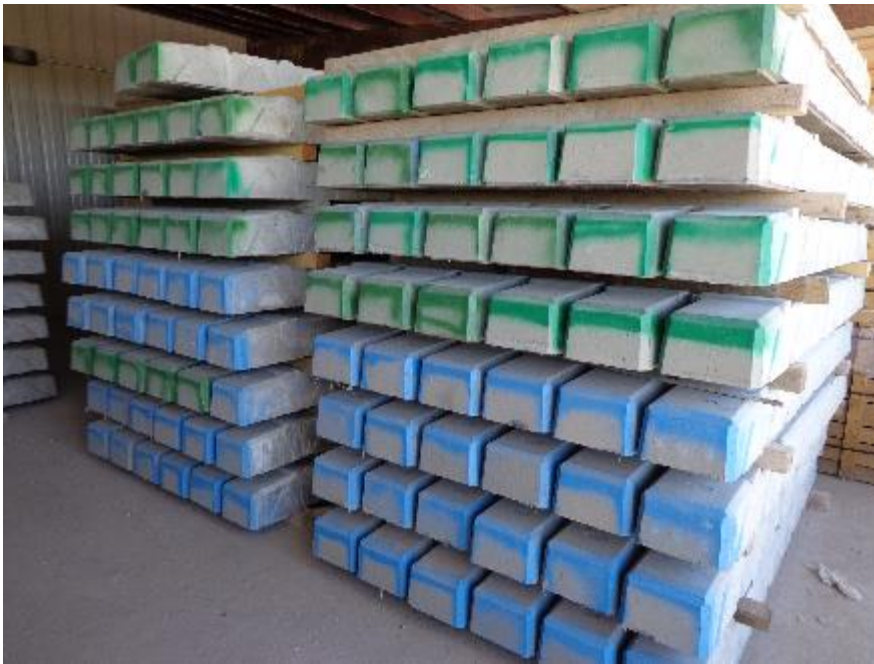
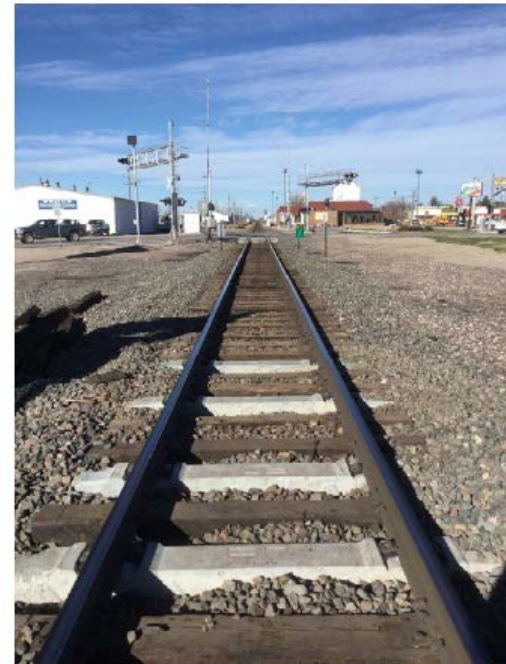
MRT (Maintenance Replacement Tie)

Field trials – “Flexible” Italian made Concrete Ties which behave like wood ties.

For use as maintenance / replacement ties to intersperse with wood ties. Testing on the Powder River Division.

Main Issue – Variable Gage.

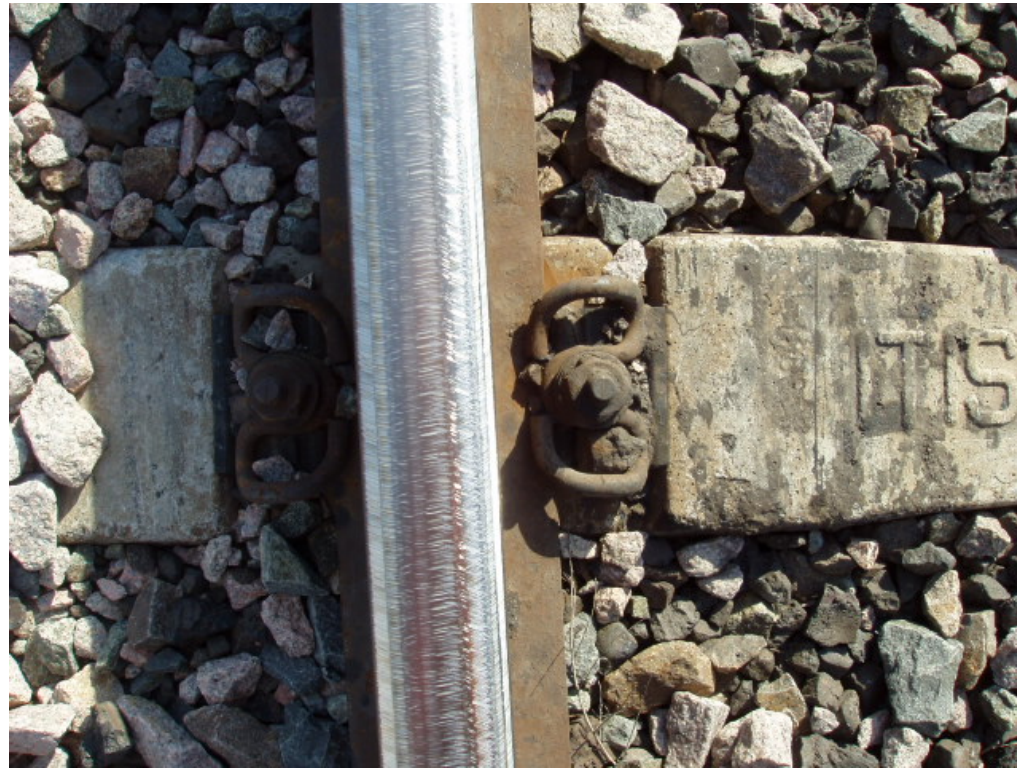
1st Known SKL Fastener in N. America

UPRR – Dragoon, AZ - 1987 C1053, 2-D curve, 30MGT DBL TRK

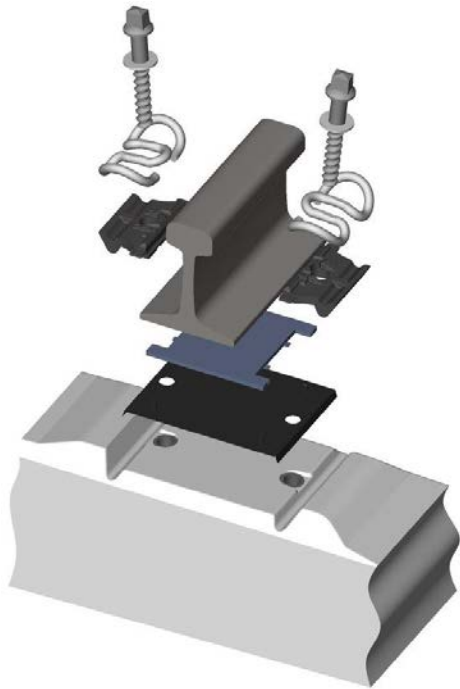
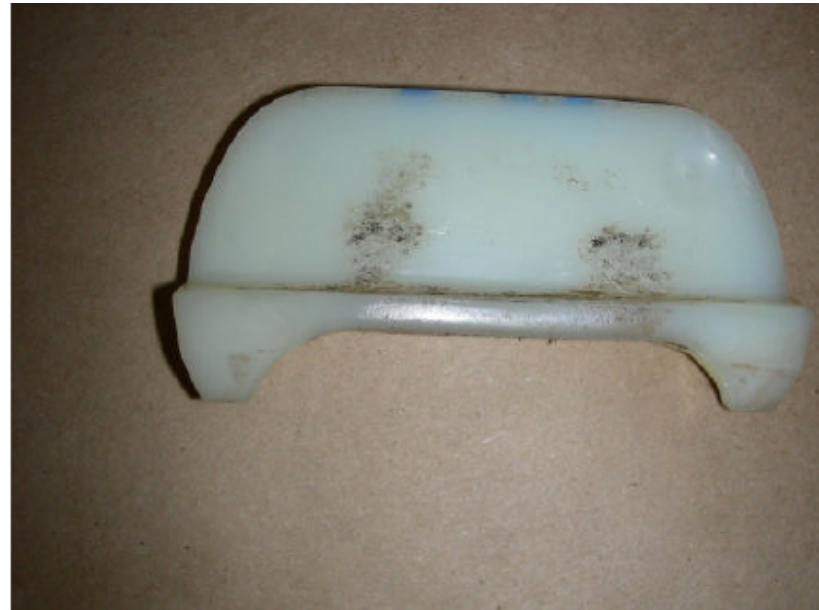
Why SKL Fastening?

SKL standard guide plate has 225 percent increase in bearing area beyond Safelok: 58mm vs. 130mm

BNSF's SKL field guide plate is 190mm that is a 328 percent increase in surface area from 58mm Safelok insulator.

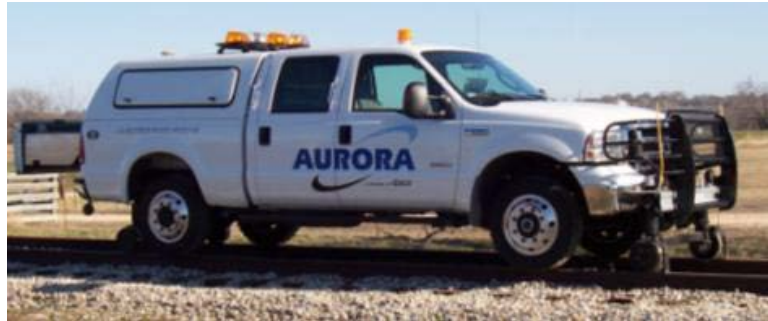
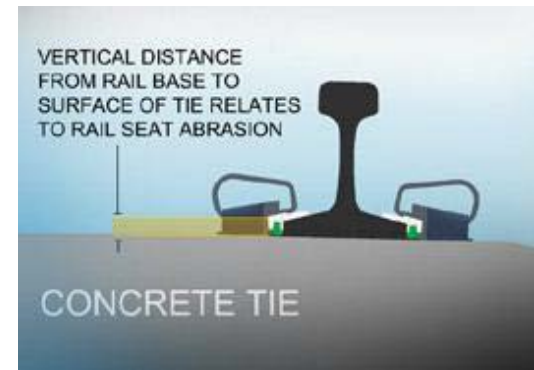
RSD – Inspection and Repair

In addition to hy-rail inspection and geometry car trips, Aurora looks specifically for RSD

Aurora provides accurate hy-rail inspection capability of RSD on concrete ties

- Able to travel at 30mph
- Optically measures difference between the base of the rail and the top of the tie to determine the differential between the two
- Accurate to 1/32”
- This differential correlates directly to RSD

Annual 175 to 250 Linear Miles of Repair

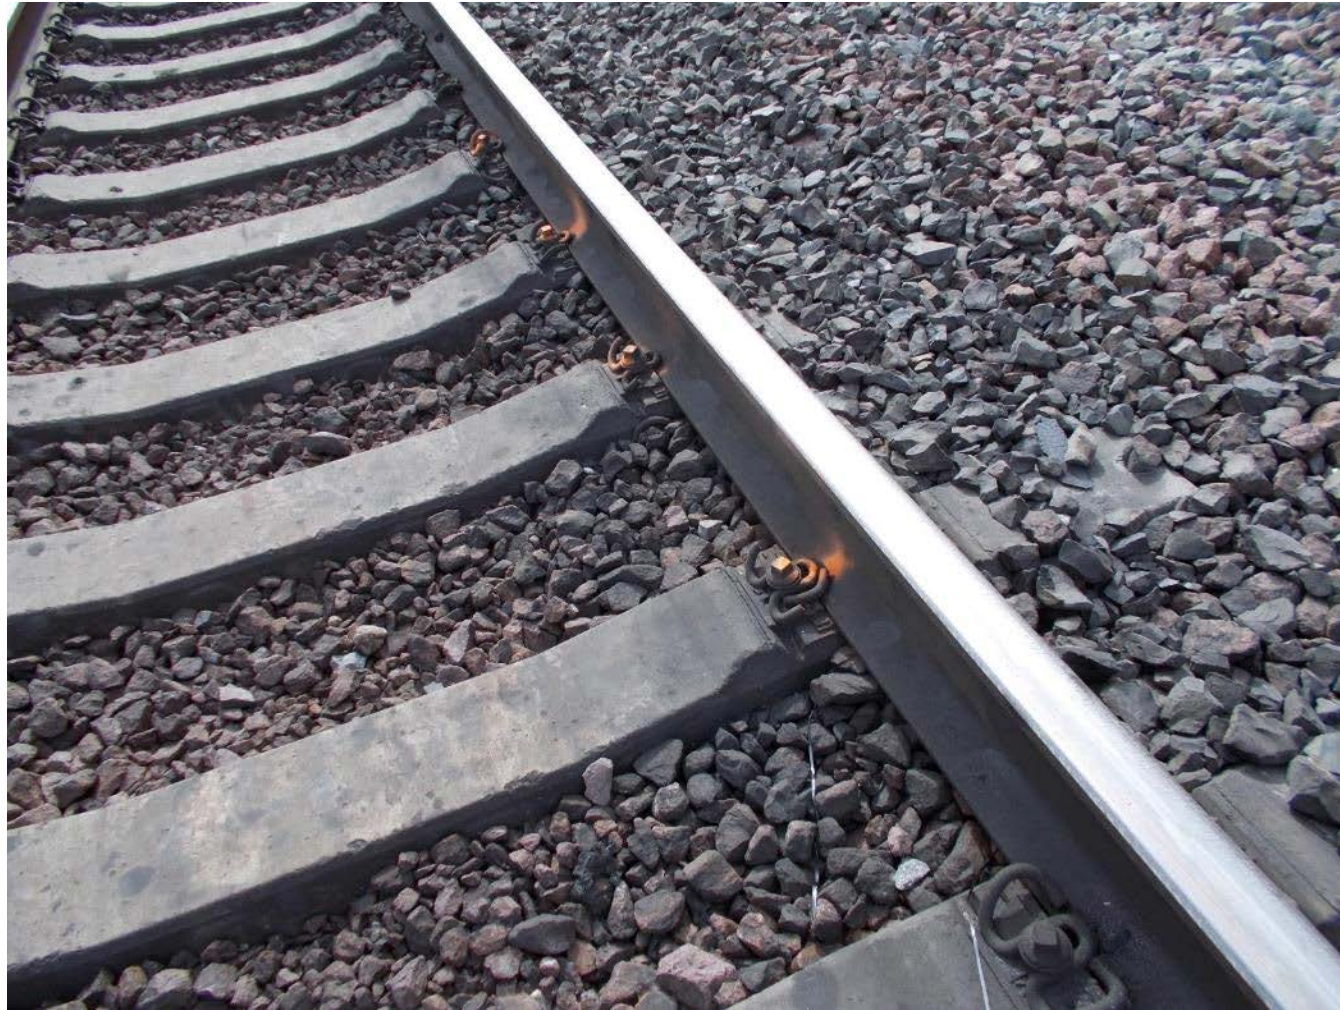
Broken Clamps (Prior Generation) Cajon Pass

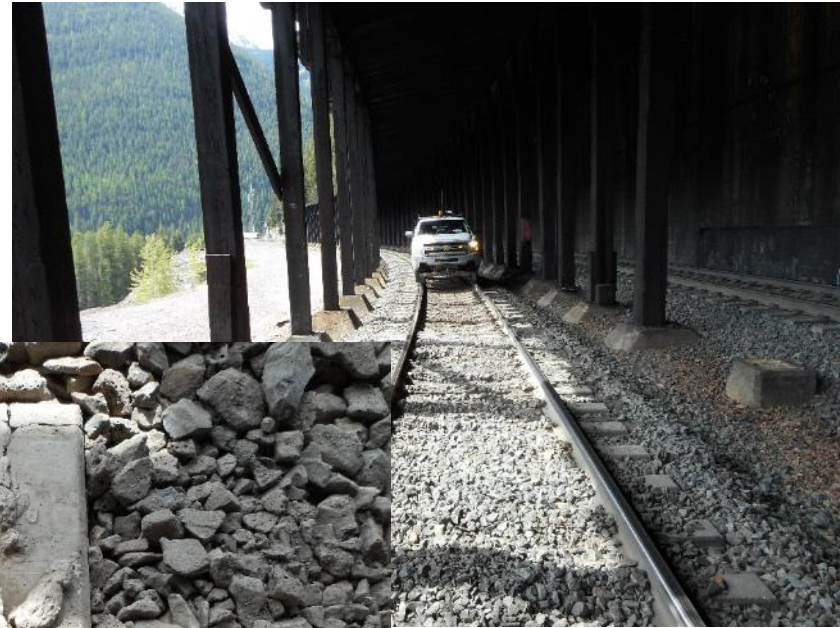
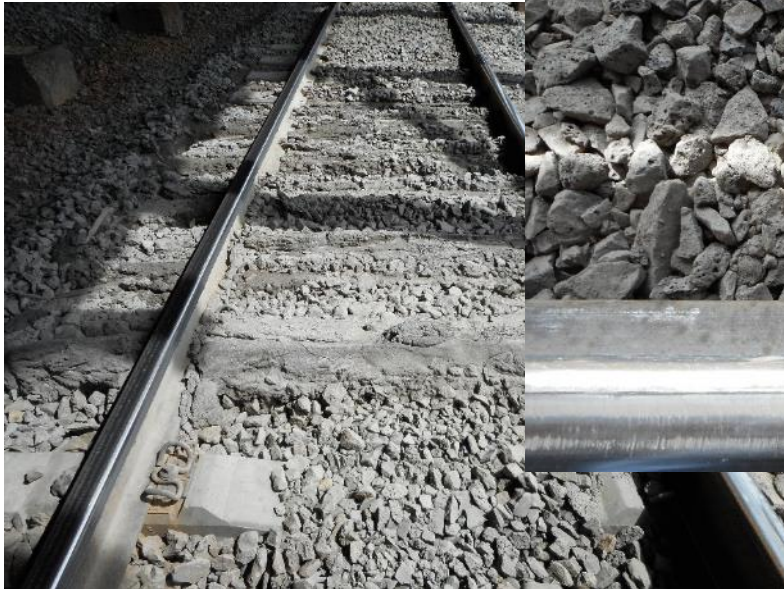
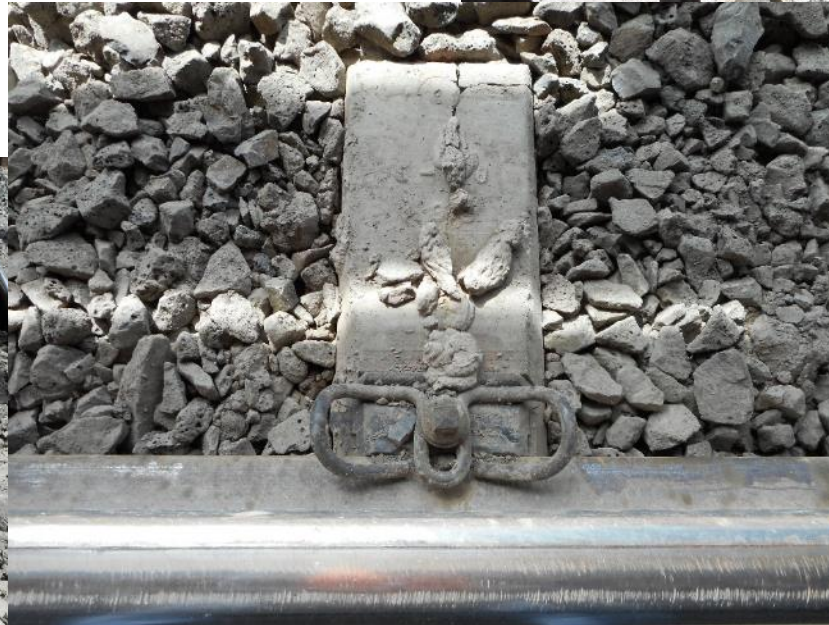
Fouled Ballast Conditions

Snow Shed - Montana

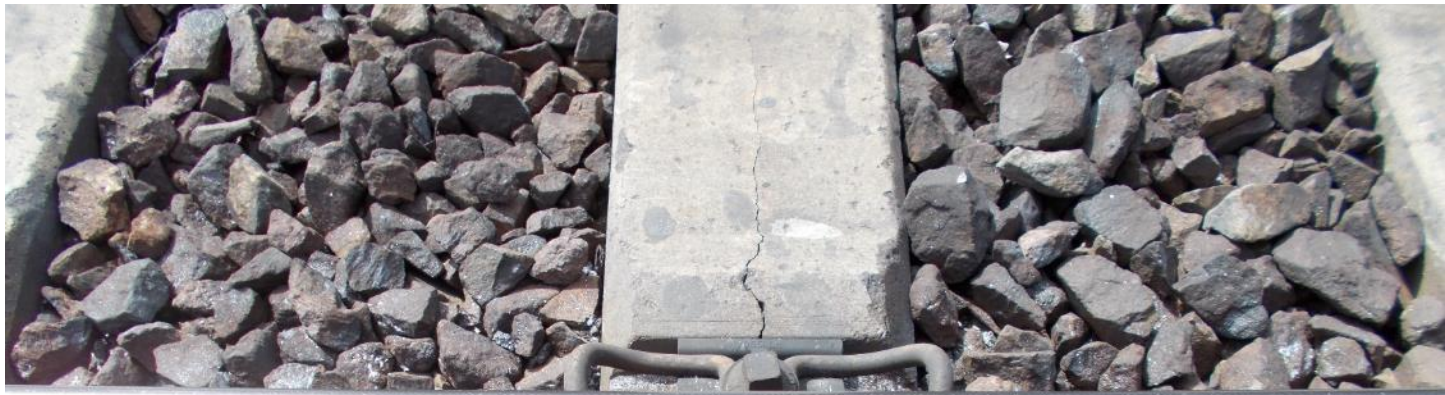
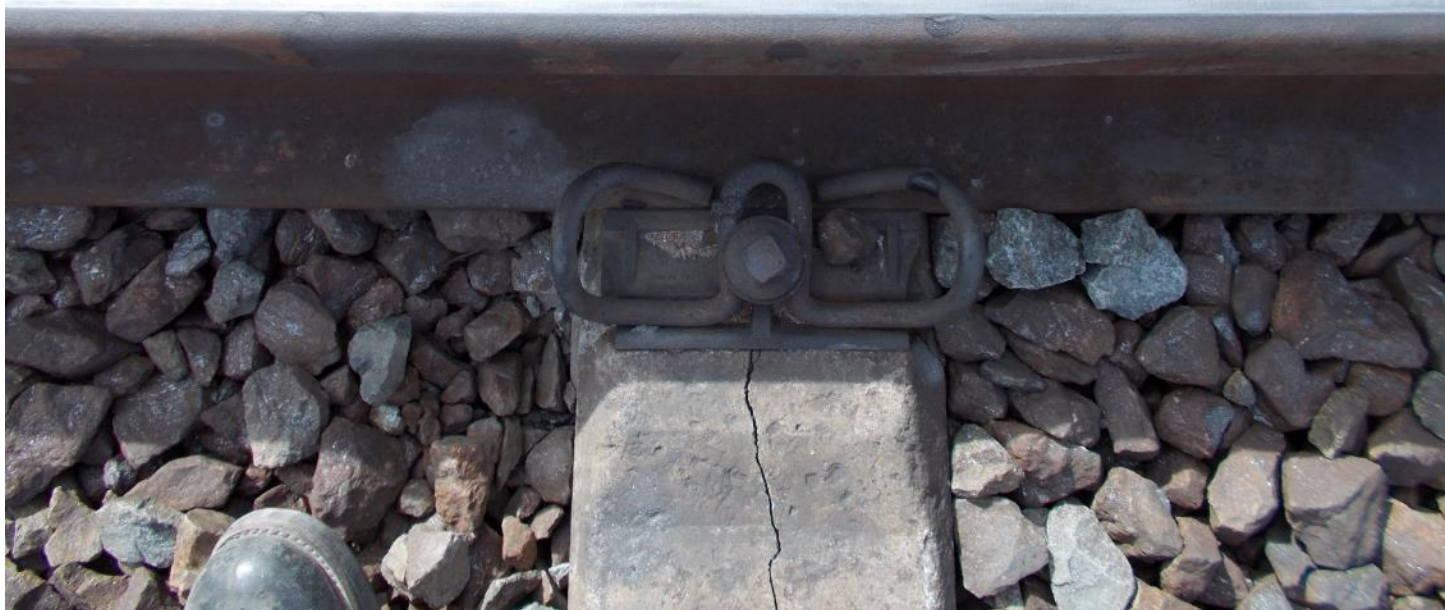
Tie Splitting – Dowel Reinforcement

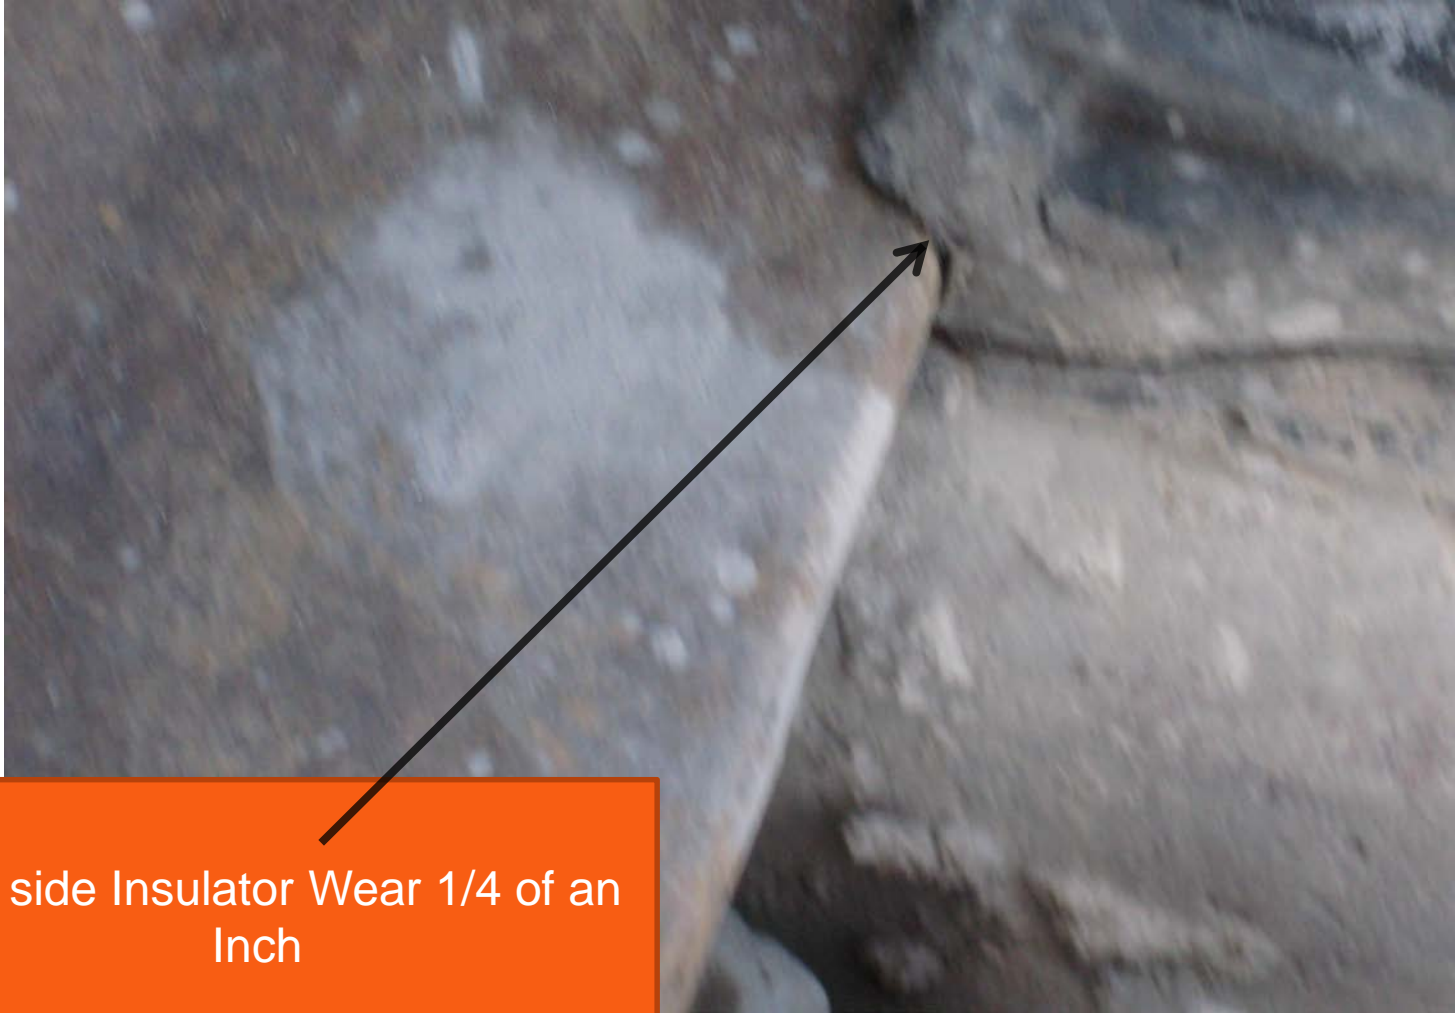
Guide Plate Wear – Extreme Condition

Field side Insulator Wear 1/4 of an
Inch

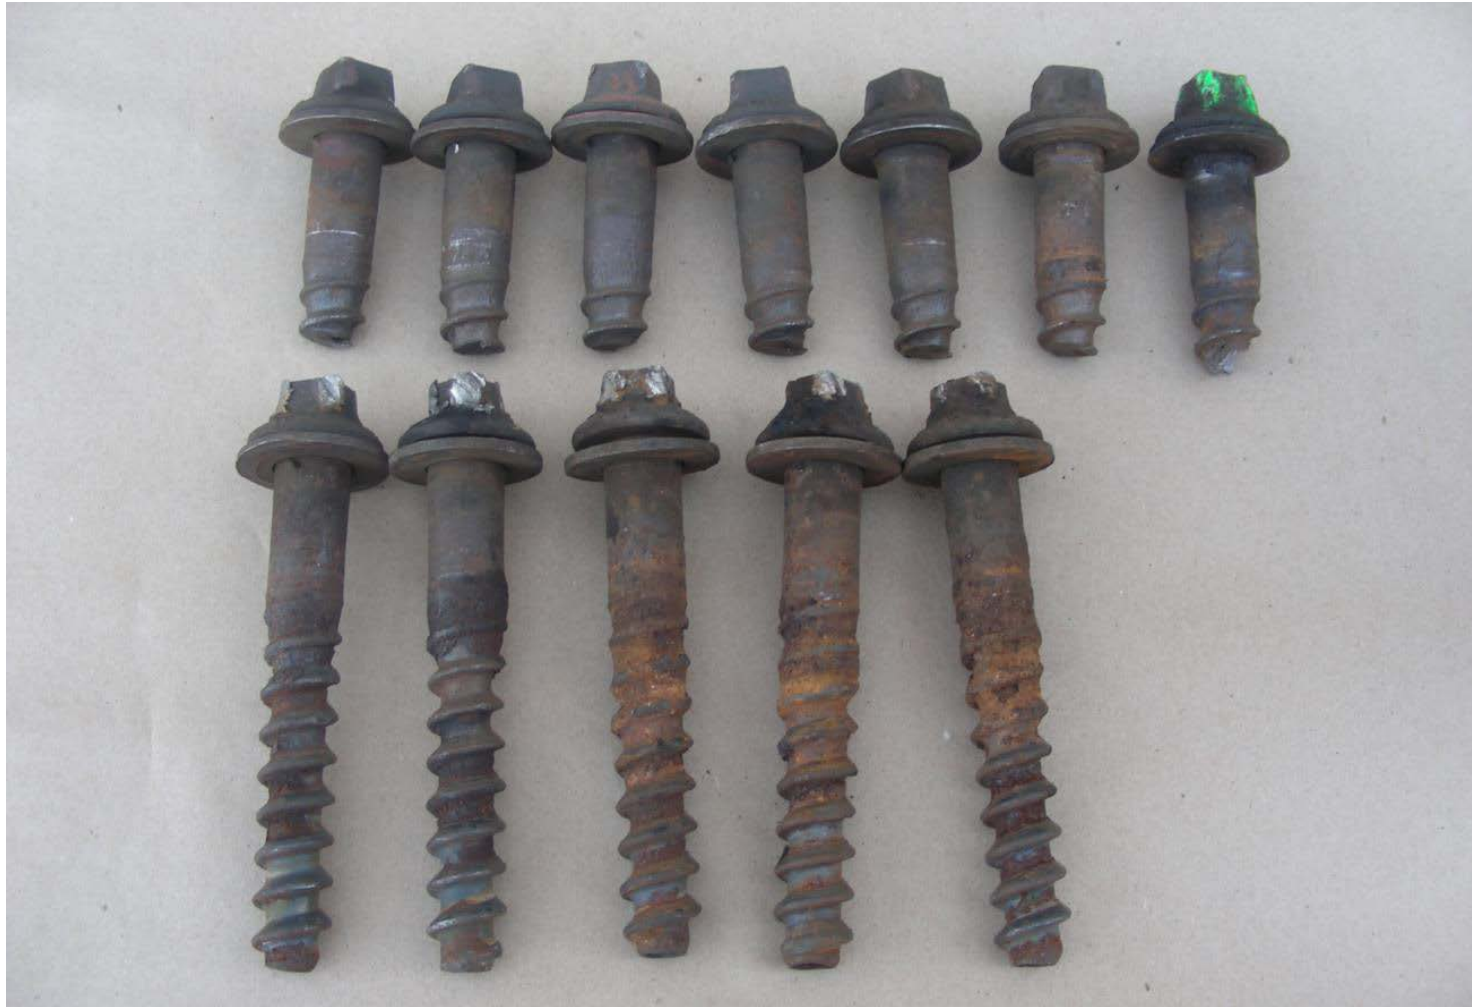
Broken Lags - Cajon Pass Testing Lubricant in 2016

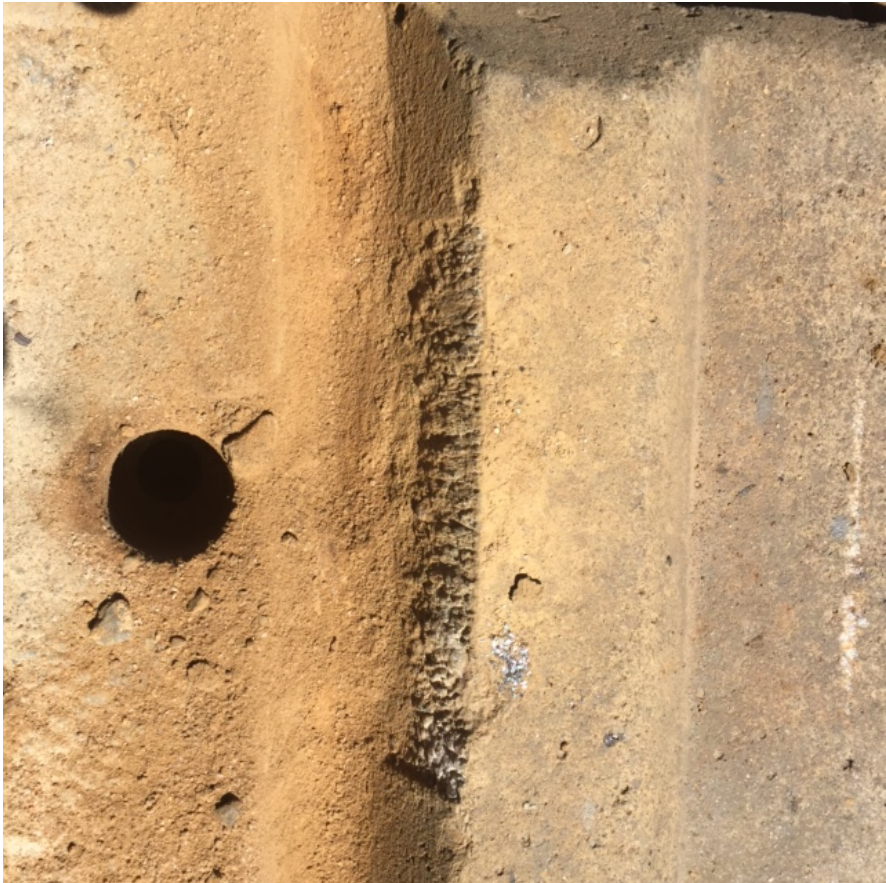
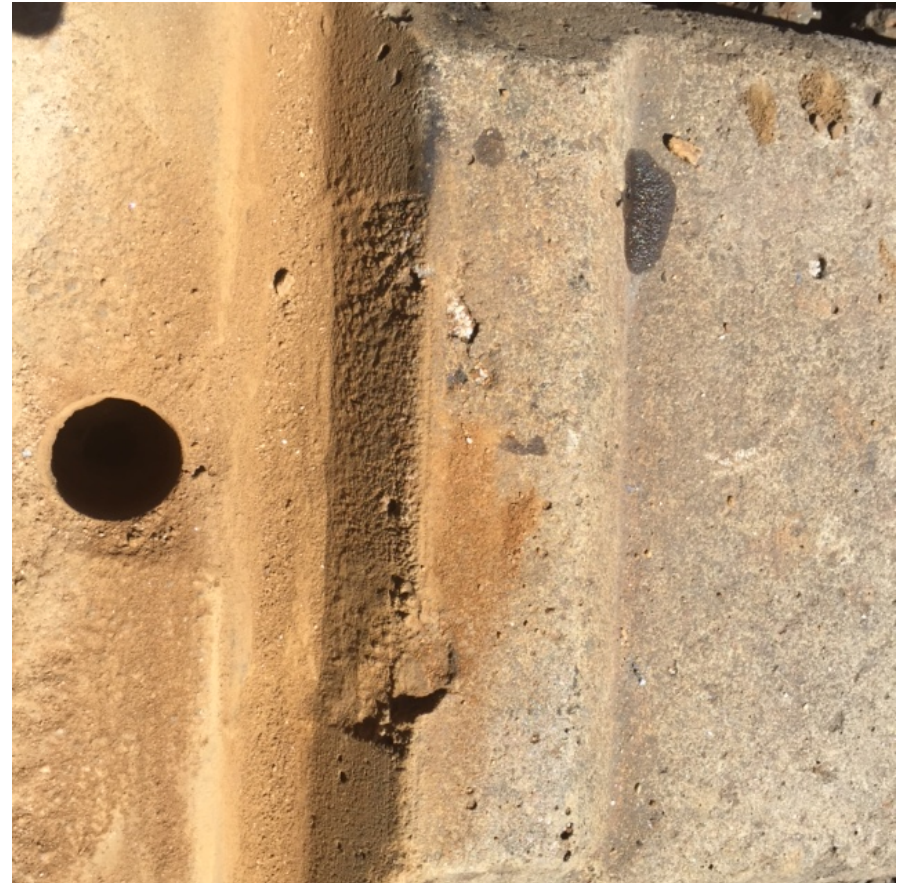
Rail Seat Abrasion

11/64" Abrasion 1st generation SKL fastener Ties Montana 2008 Install.

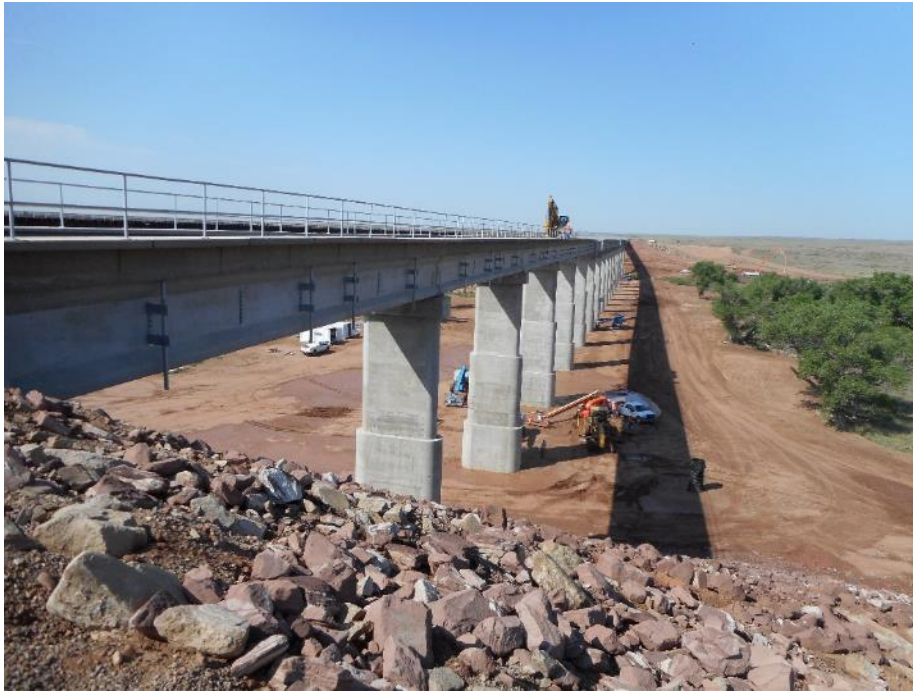
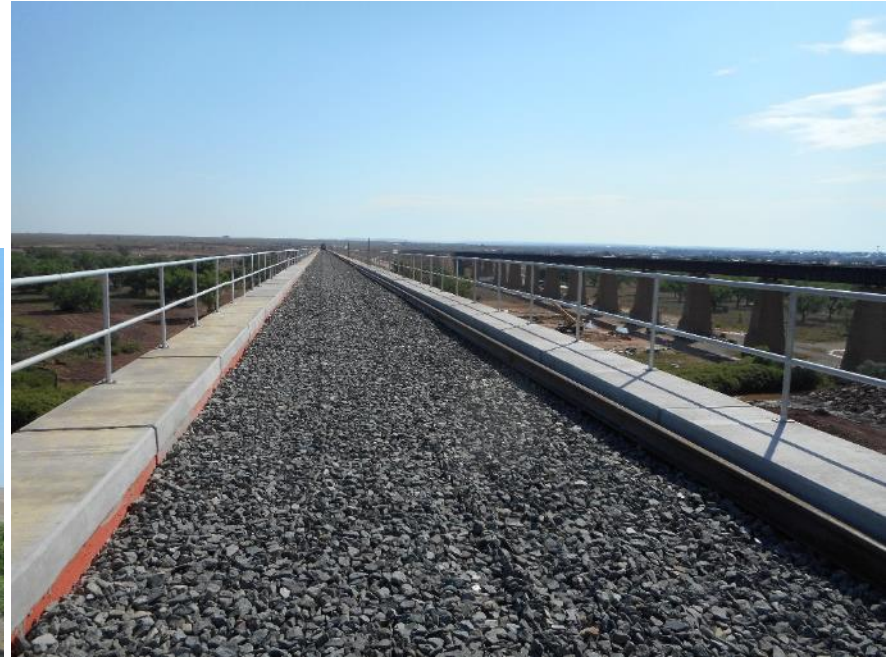
Ballast Mat, Pecos River Bridge – Ft. Sumner, NM

This segment of double track will be completed by this summer leaving 4 miles of single track left to complete. (2,200 mile route between Chicago and LA) Concrete ties were laid across this bridge yesterday.

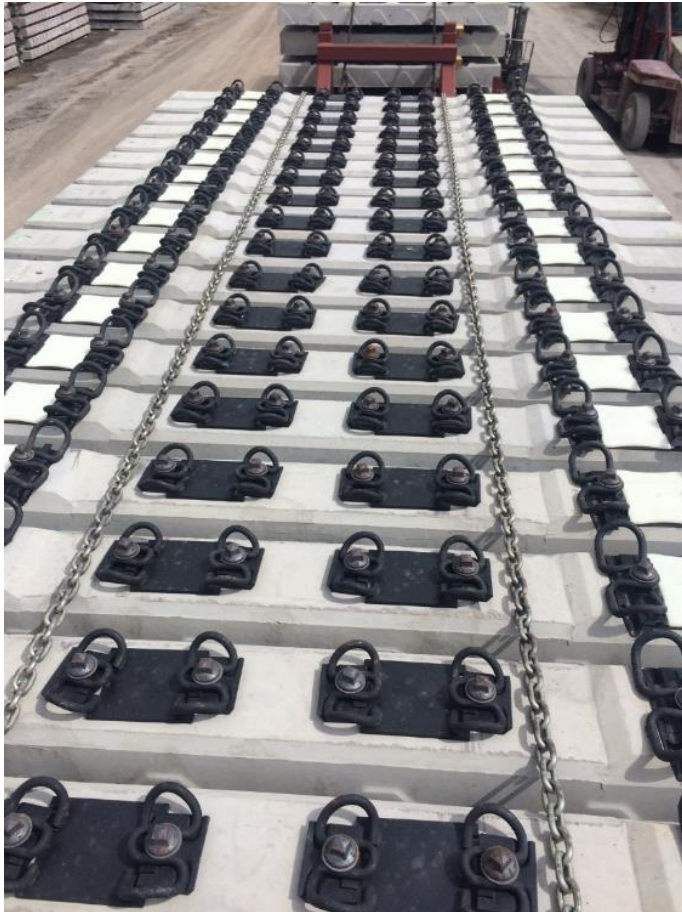
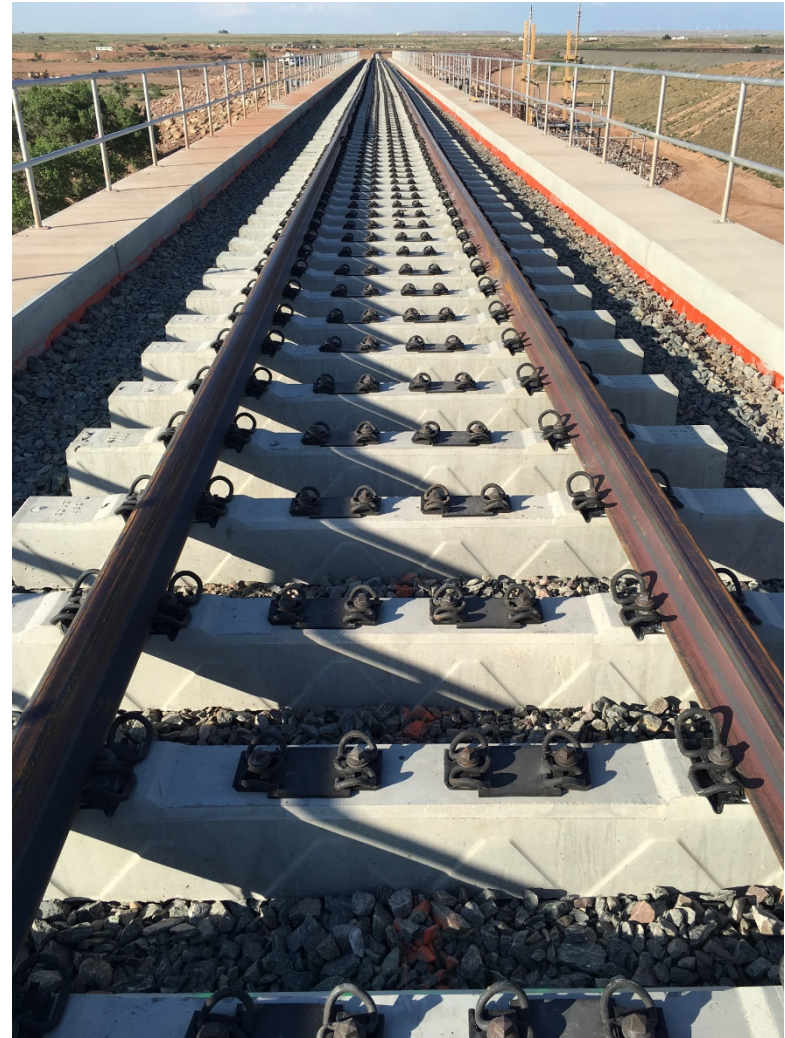
IGR Ties – Pecos River Bridge

Rocla IGR Ties @ Pueblo

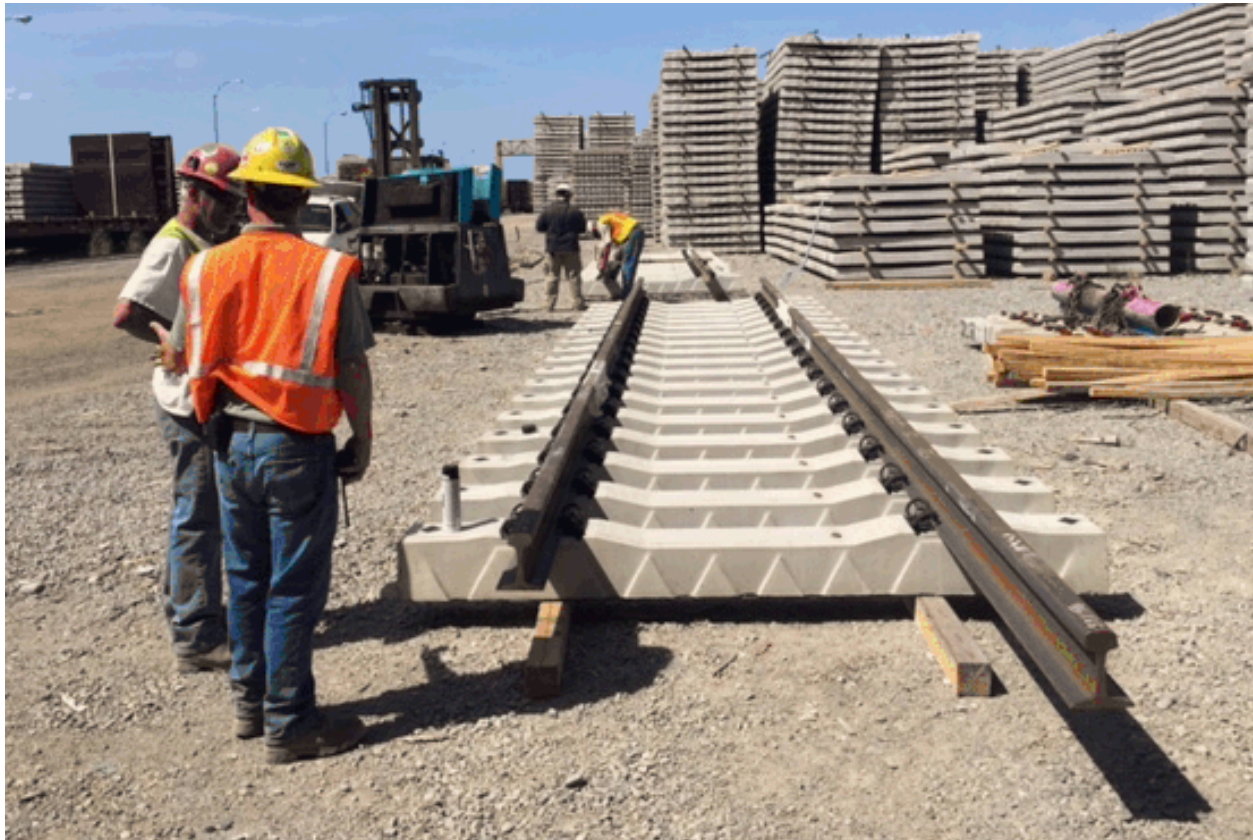
Padded Ties – Insulated Joint Panels

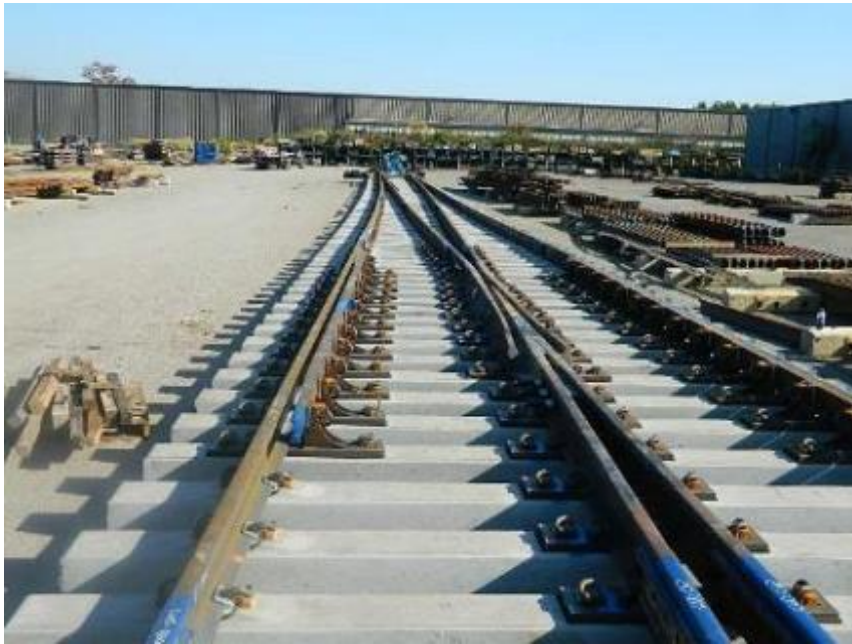
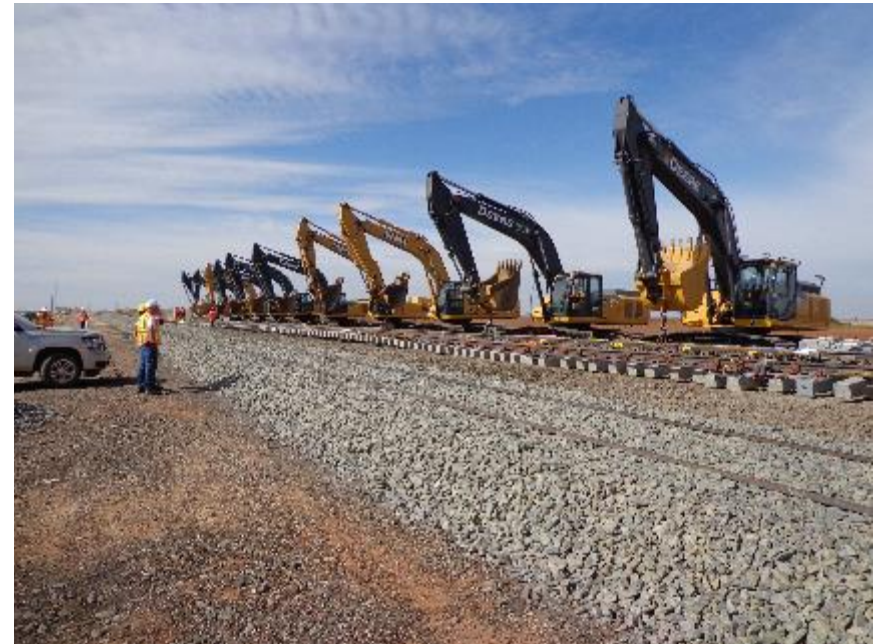
Concrete Tie Turnouts

Evaluating new concrete turnout designs:

5 turnouts installed in 2015 including a double #24 x-over at Noel, OK on the Southern Transcon

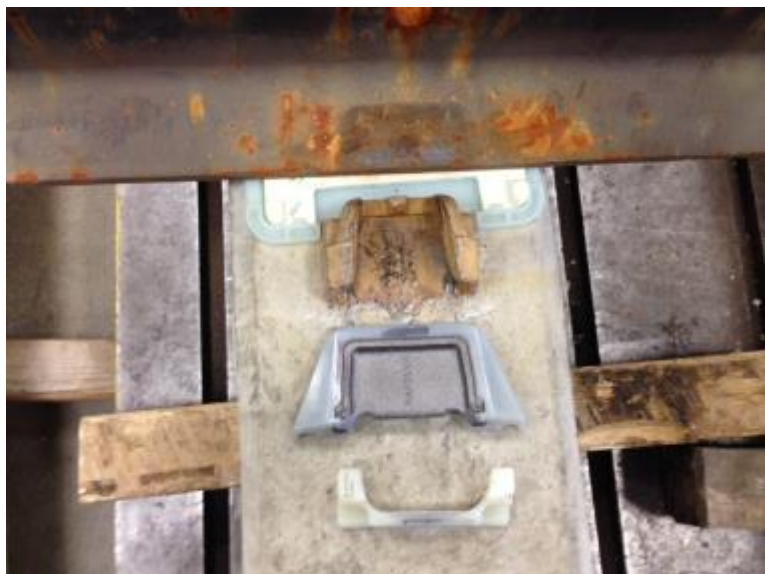
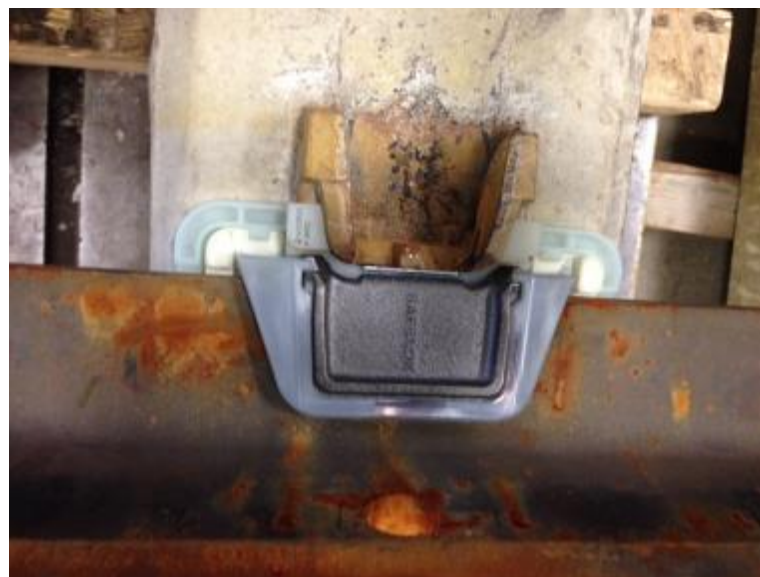
Two Part Insulator Safelok I

1. Test product in 2015
2. Improved post wear performance, less breakage.
3. Develop product with a snap in side post for less handling.

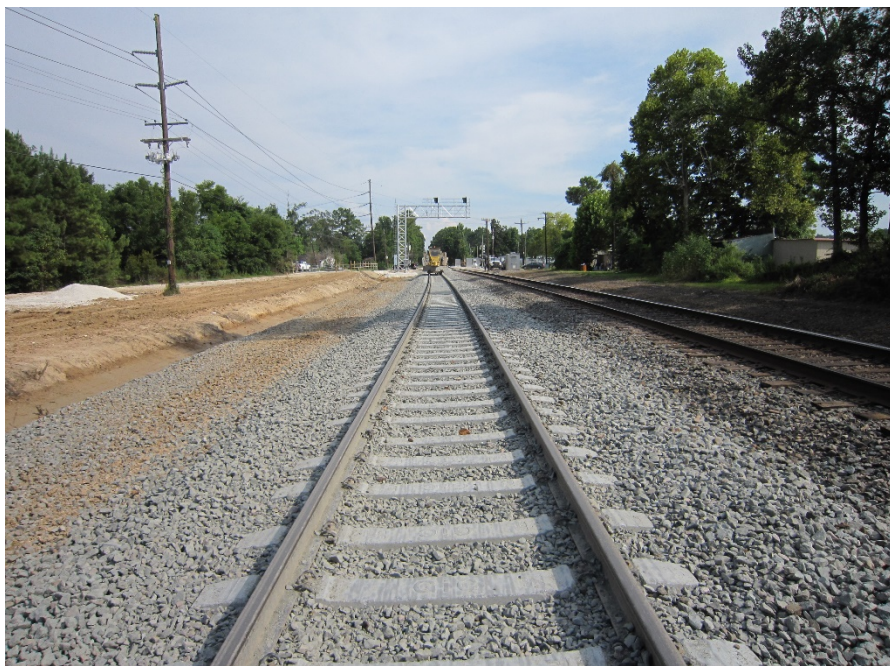
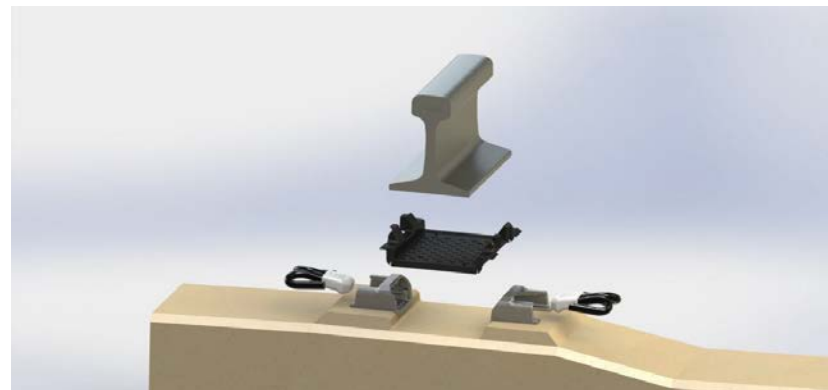
Continue to Evaluate New Designs

Pandrol Fastening Right
GIC Tie Below

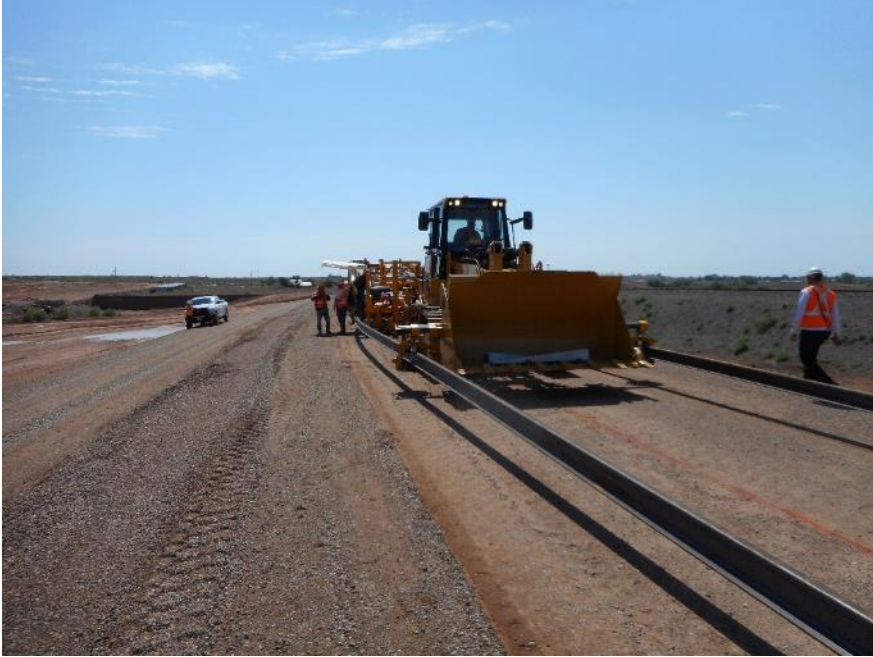
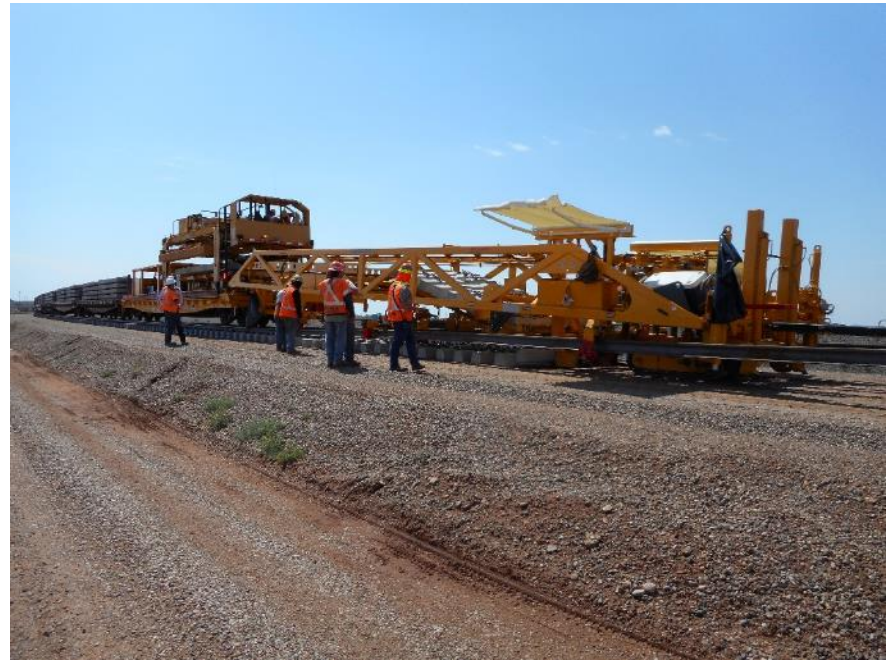
New Track Installation -TLM Track Laying Machine
