Building a New Railroad Track through a Superfund Site

October 2014
Railroad Environmental Conference

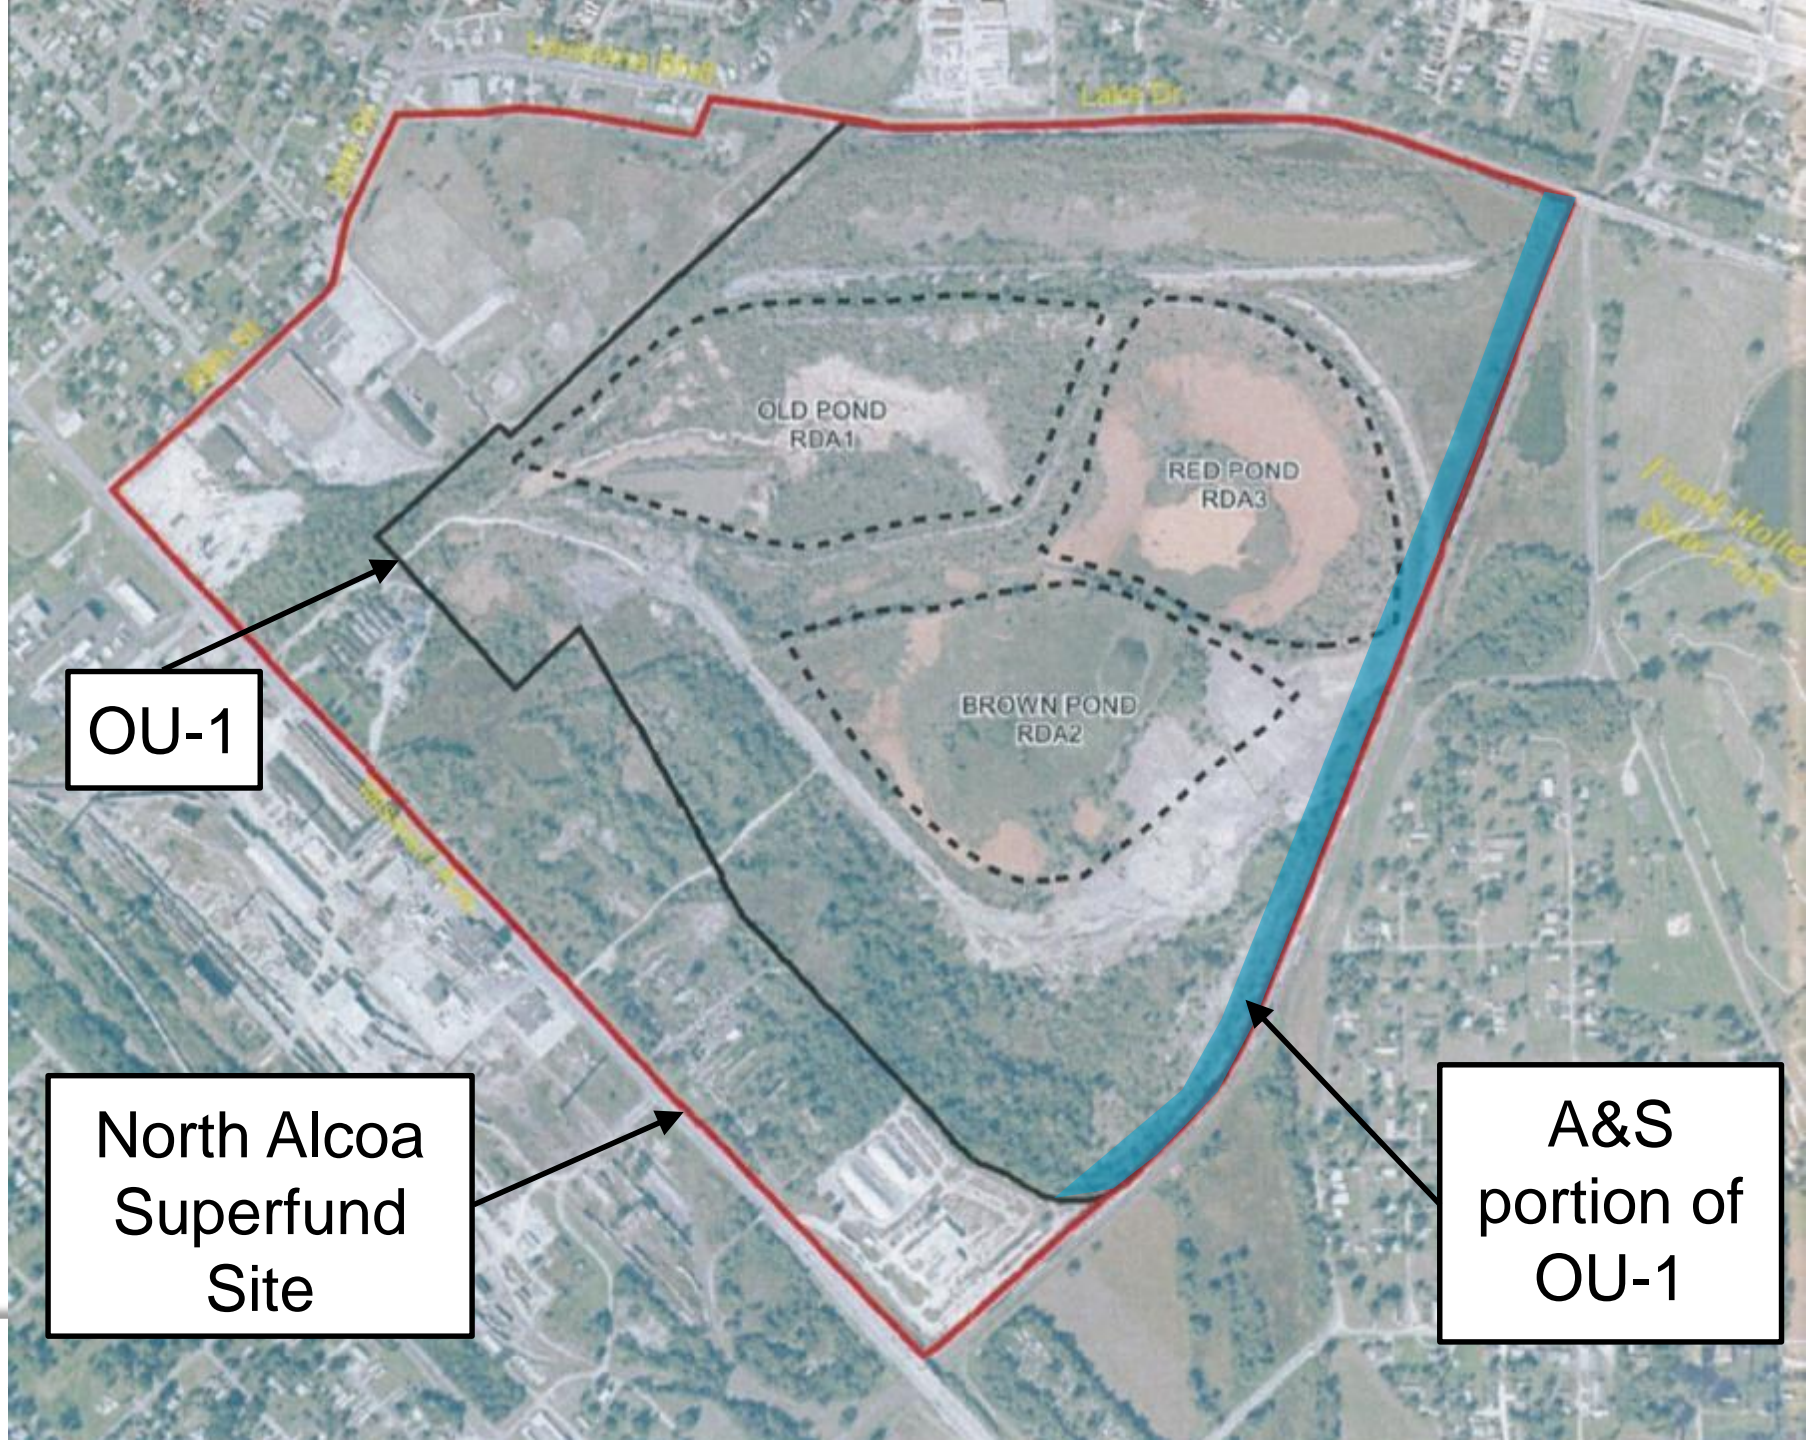
OU-1

North Alcoa
Superfund
Site

A&S
portion of
OU-1

OLD POND
RDA1

RED POND
RDA3

BROWN POND
RDA2

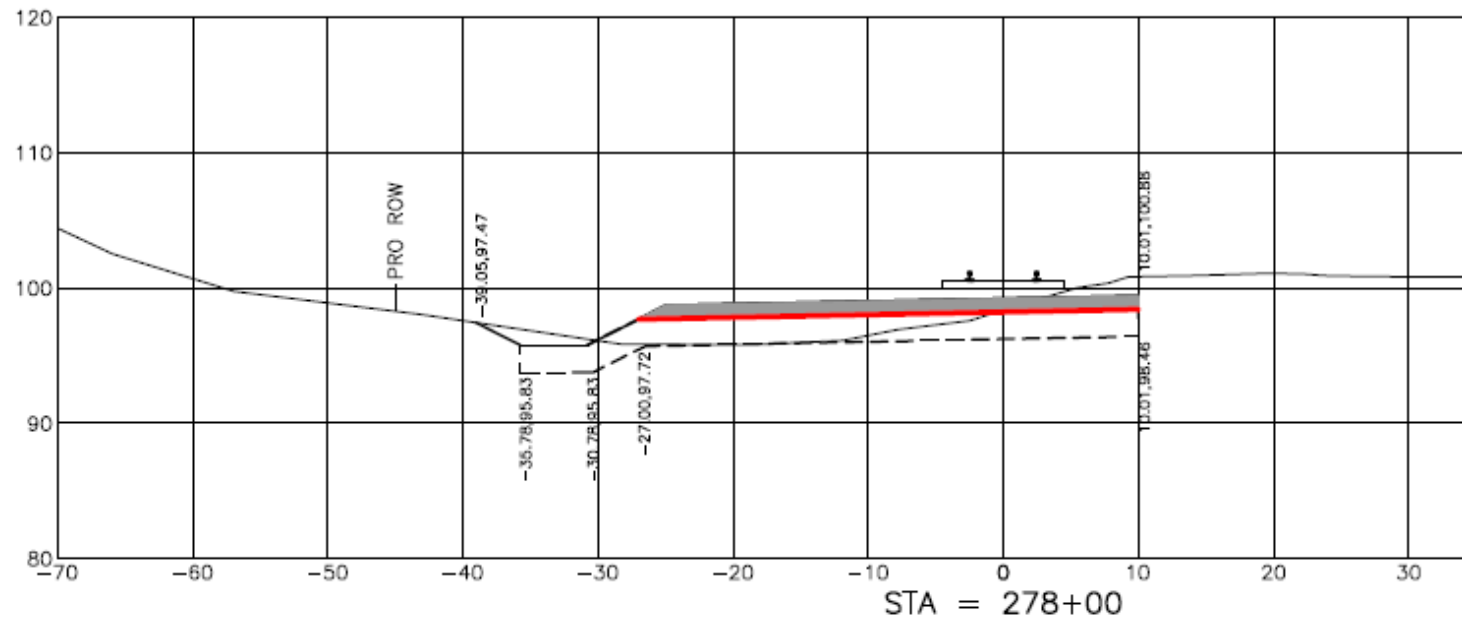
Technical Challenge: Beyond Typical Track Construction

- Waste material excavation
- Import clean soil cover
- Geotextile between soil cover & track sub-ballast
- Contingency plans for unsuitable material and voids

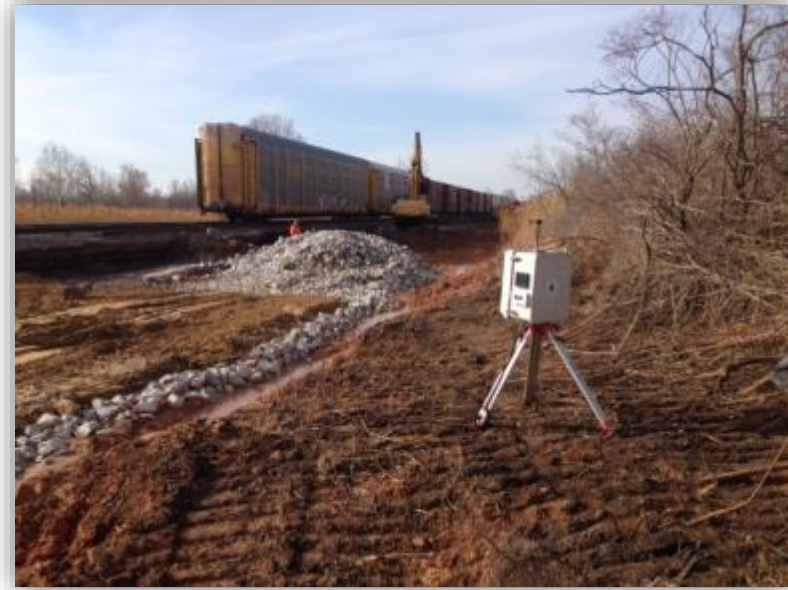
- Level-C for the first week until air samples could be collected and analyzed for worker protection

- Real-time dust monitoring
- Perimeter air monitoring
- Real-time radiological surveys
- Radiological exposure monitoring

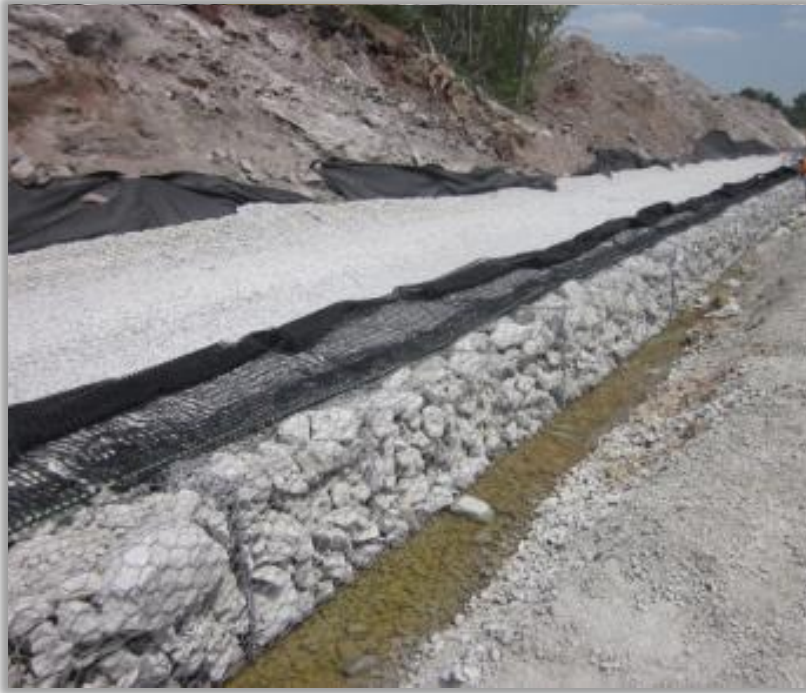
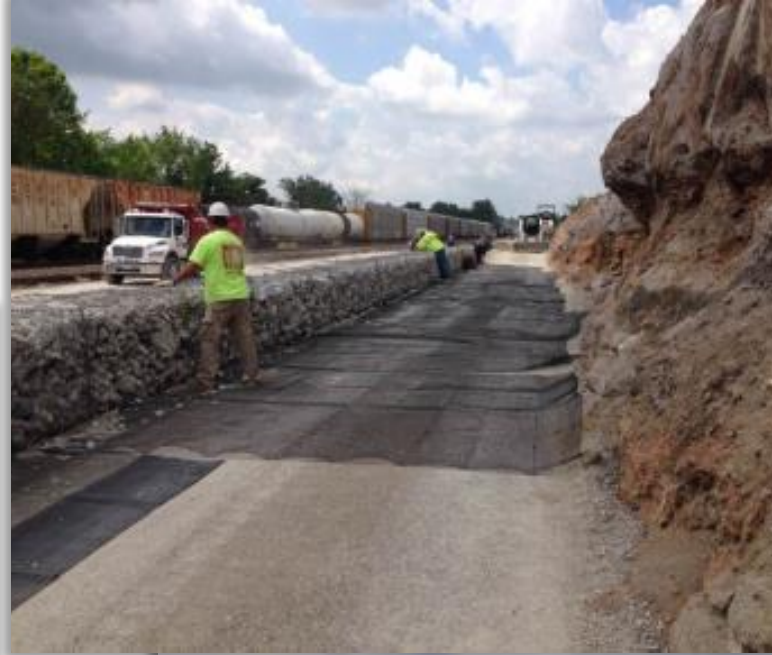
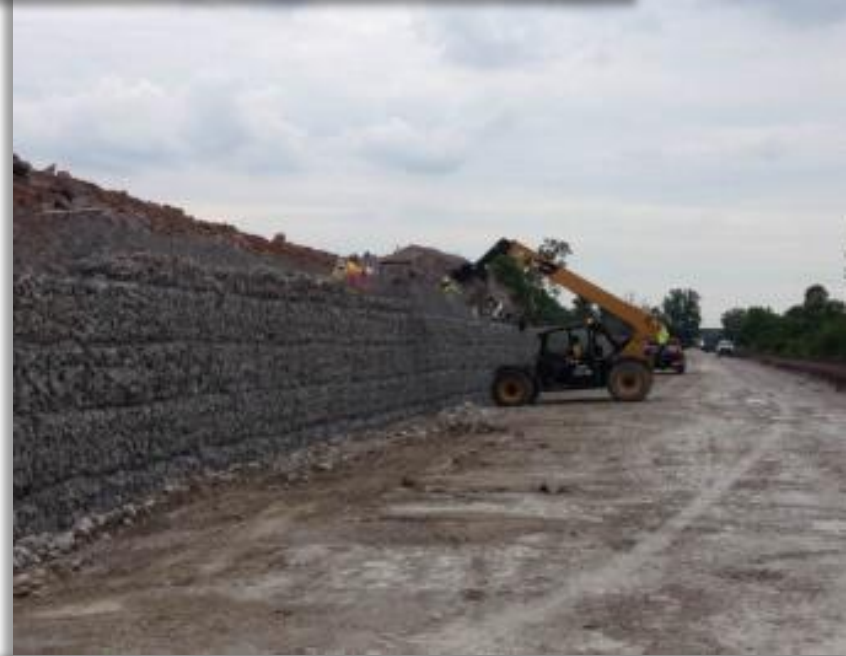
Gabion Wall

- Gabion retaining wall
- Soil Cover
 - Remove 2-feet of soil including any waste material
 - Import 2-feet of clean soil
 - Install geotextile fabric
 - Stabilize soil cover

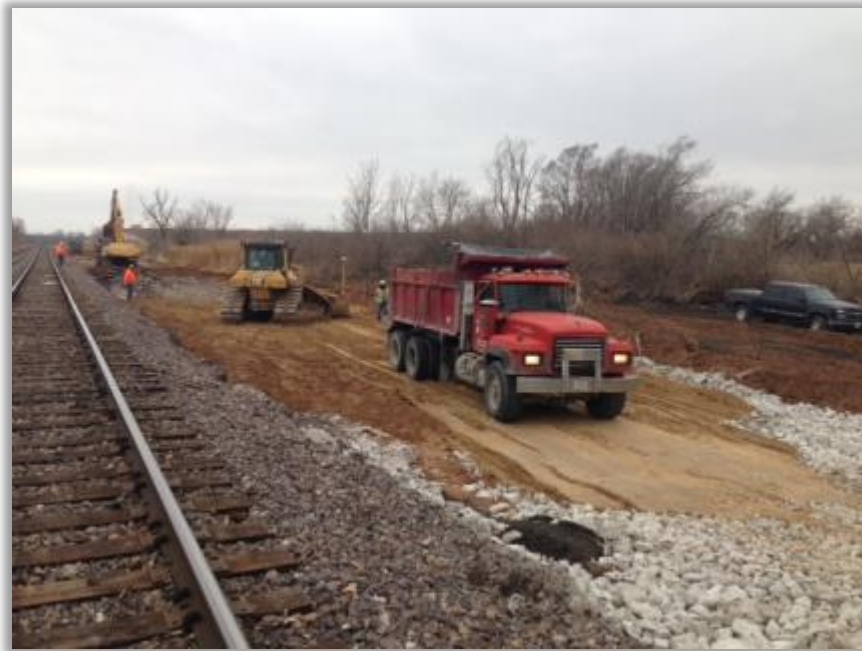
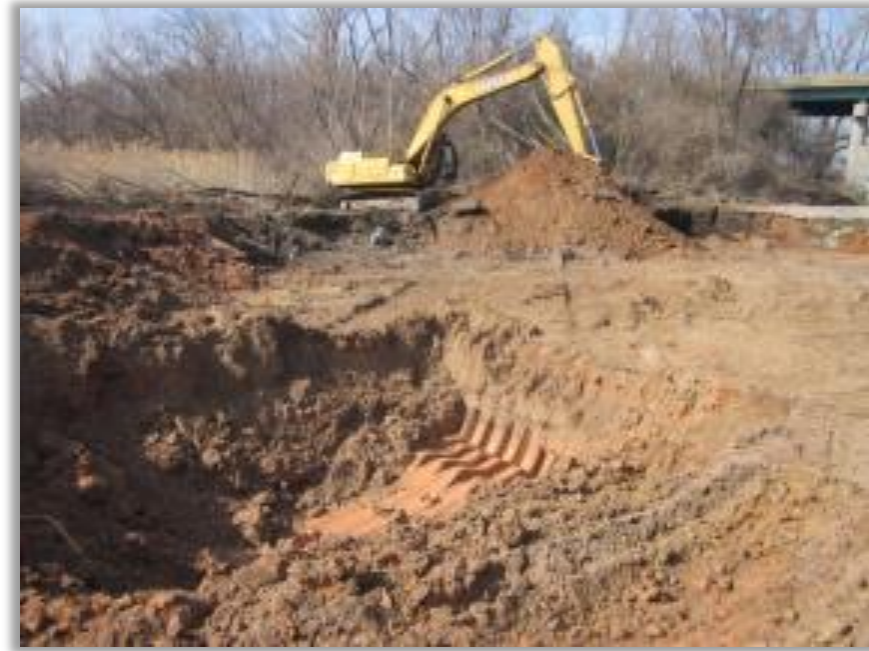
Construction Challenges: Unsuitable Material

- Placement of gravel under gabion wall instead of soil to obtain needed compaction
- Over excavation of waste material unsuitable for track construction and placement of gravel for stabilization

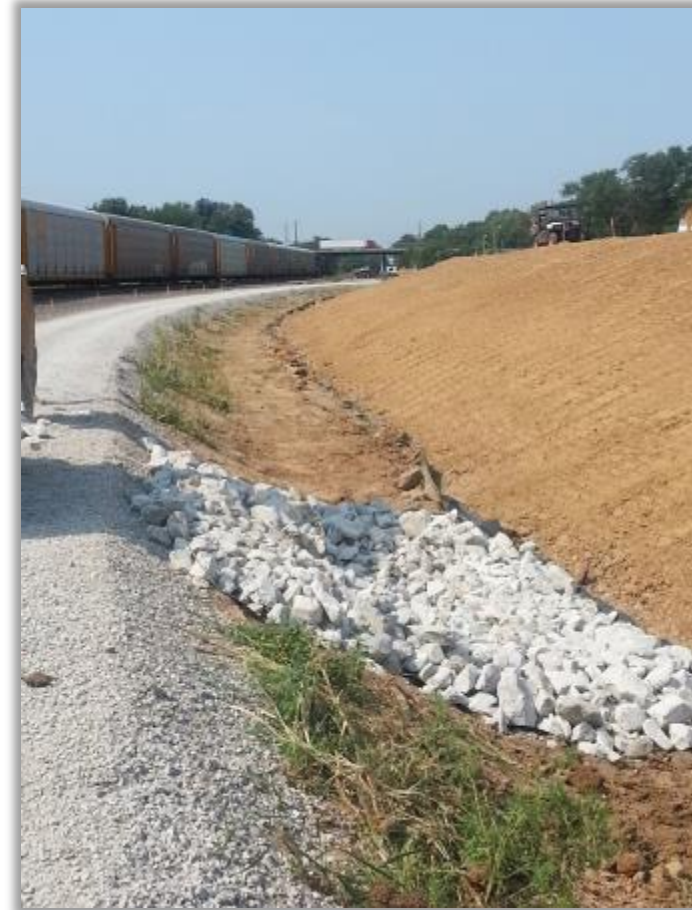
Construction Near Completion!

- 3rd Rail track in full operation
- Site restoration activities outstanding
- Operation and maintenance will continue to ensure remedy integrity
