Maintaining Environmental Compliance during a Natural Disaster: CSX Transportation's Emergency Response to the Historic South Carolina Flooding

Presenters:
Lance Rasnake, Amec Foster Wheeler
Jacob Metcalf, CSX Transportation, Inc.

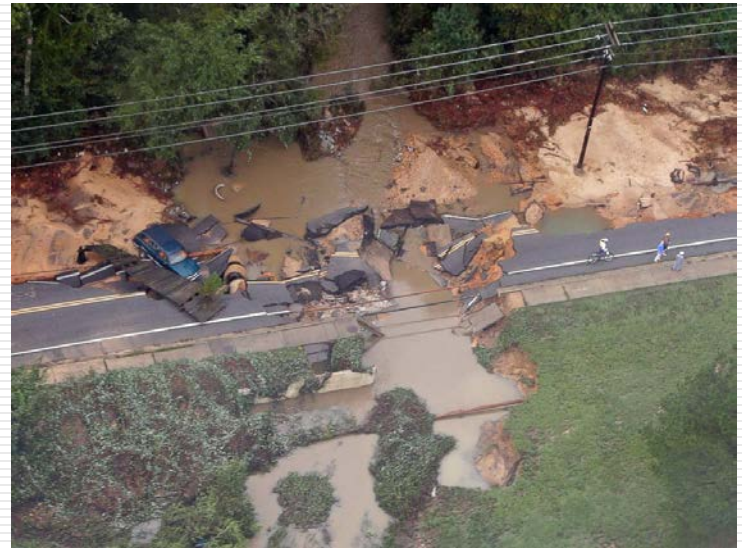
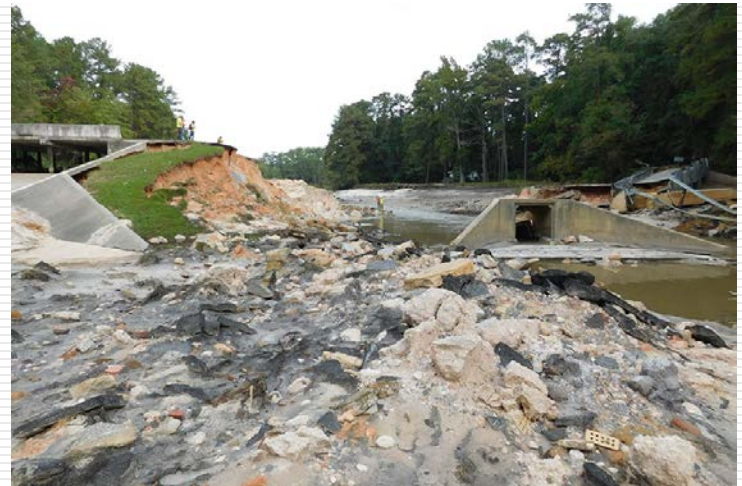
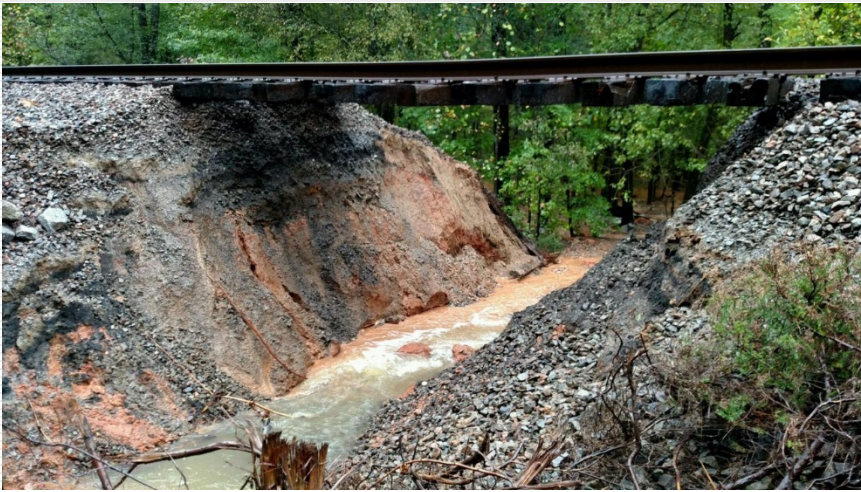
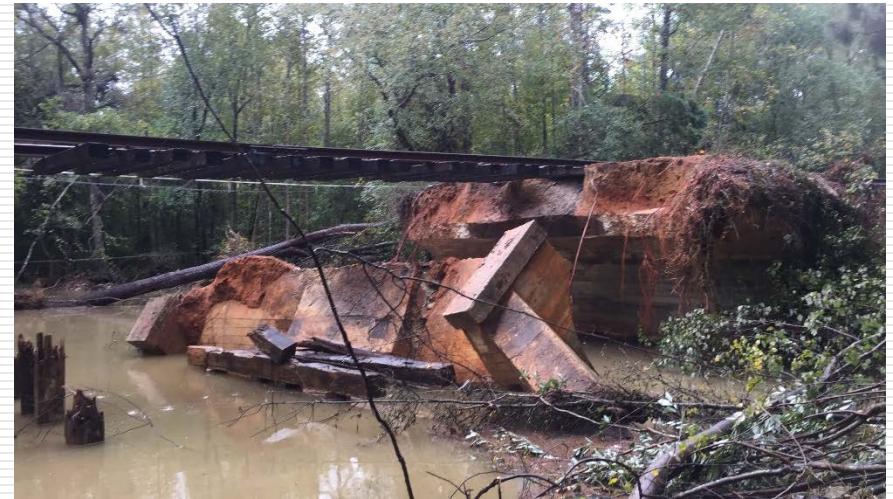
- Over 100 damage locations to CSX's rail system identified on 8 subdivisions. Over 50% of these reporting severe damage.
- Damage varied from minor embankment washout to complete bridge collapse.
- Eastover Subdivision was worst hit.

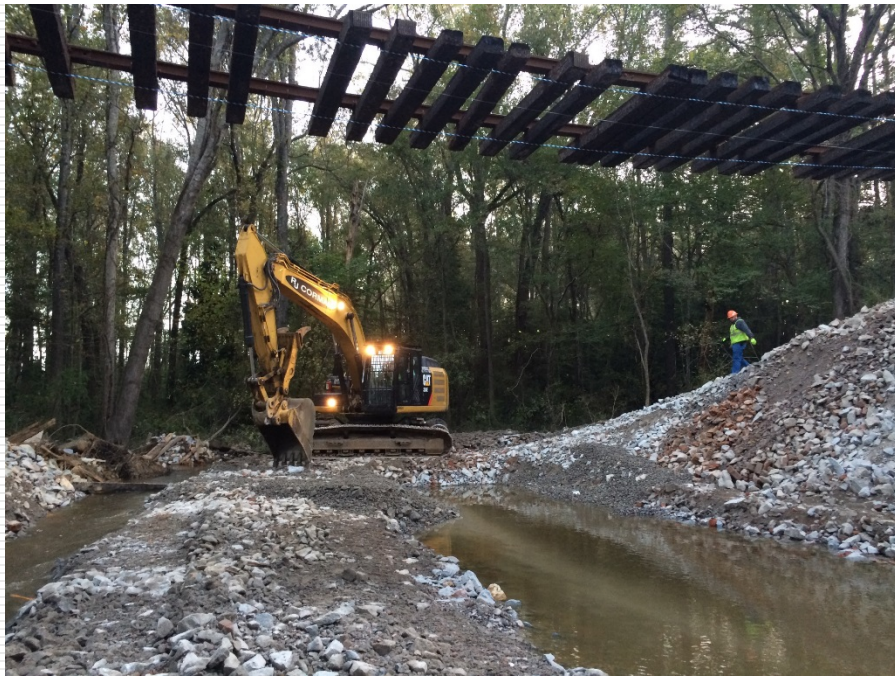
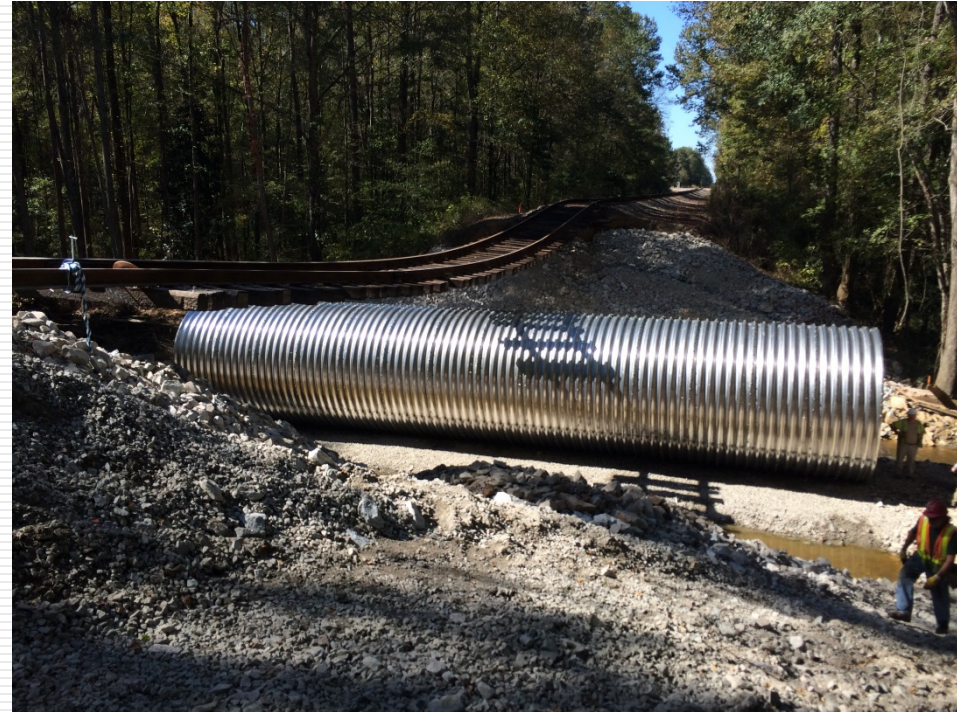
AKA 366.1 – Mill Creek

Pre-Storm – 10' Brick Arch
Post-Storm – 12' Multi-Plate Pipe

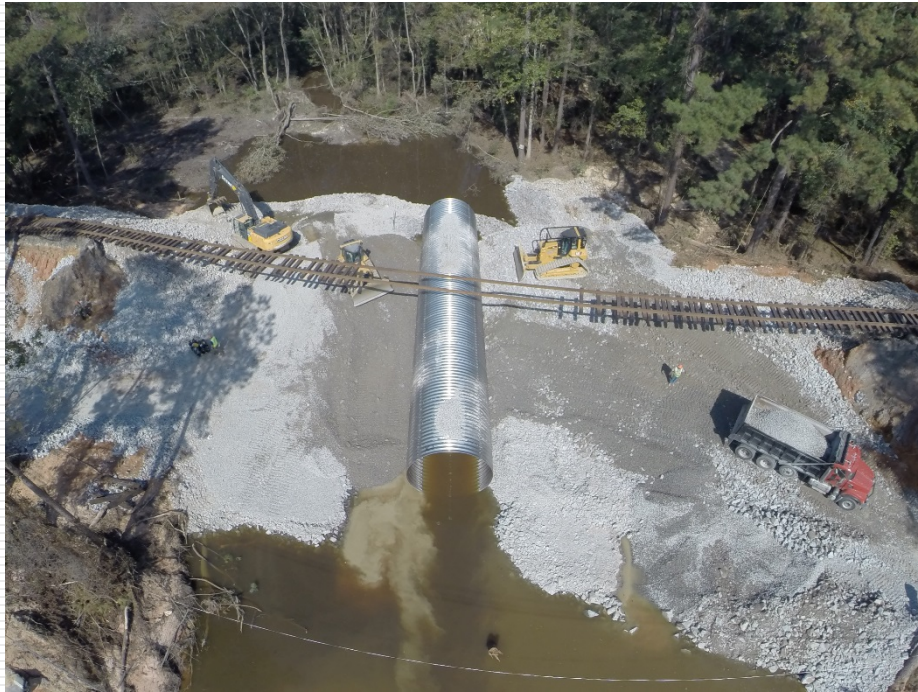
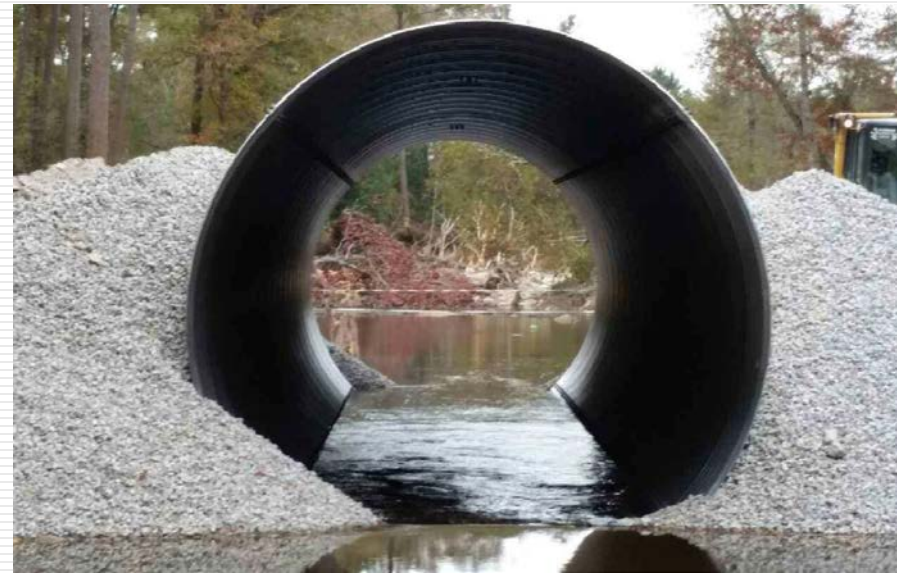
AKA 360.3 – Cedar Creek

Pre-Storm – 12' Brick Arch
Post-Storm – 14' Multi-Plate Pipe

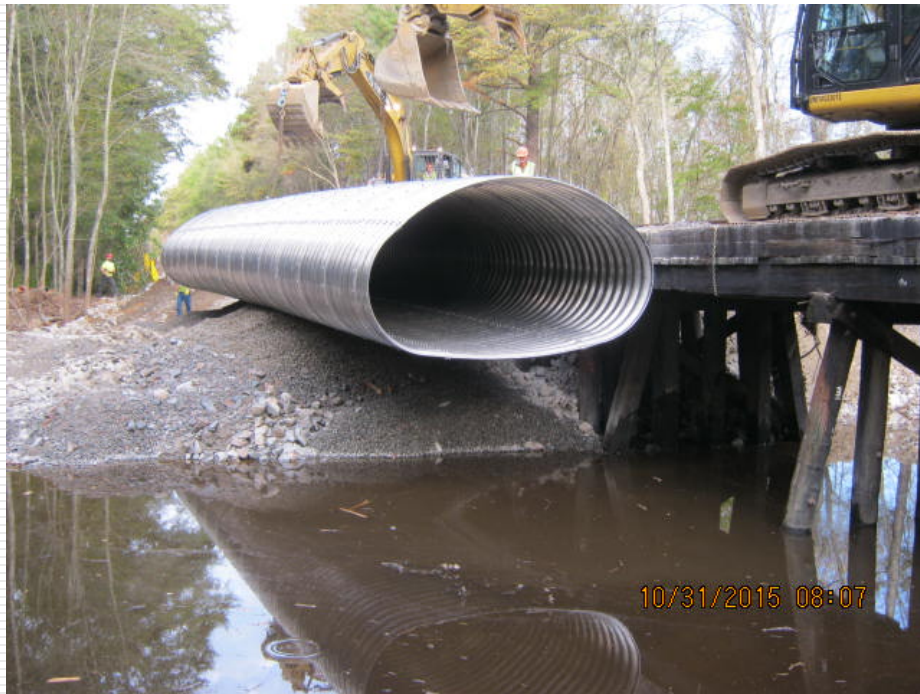
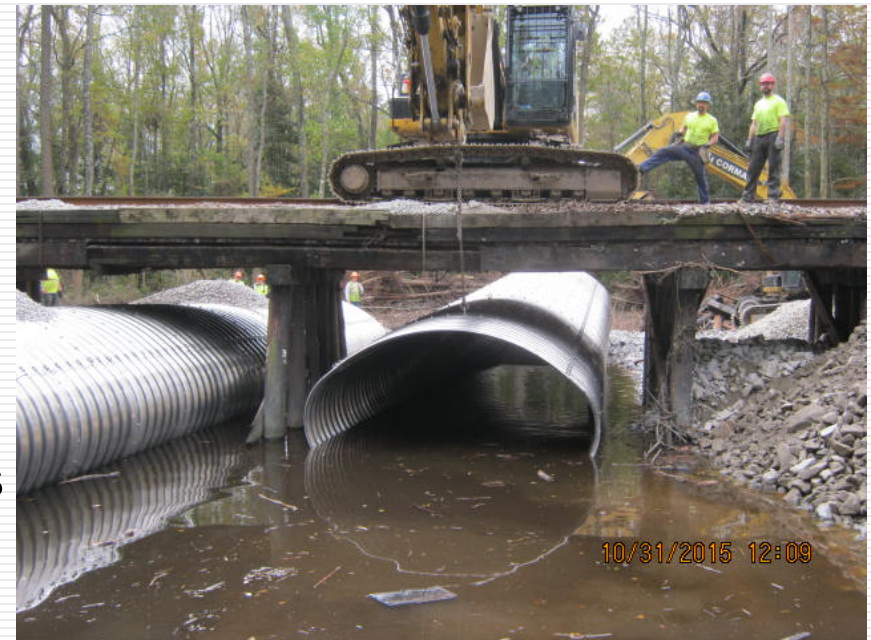
AKA 356.6 – Toms Creek

Pre-Storm – 90' Timber Bridge
Post-Storm – (2) 7'6" x 12'11" Pipe Arches
