Systematic Evaluation of Concrete Ties Removed From Track After Many Years of Service

**Dr. Robert Peterman
Kansas State University
Department of Civil Engineering**

Work is part of a larger project funded by FRA titled “Developing Qualification Tests to Ensure Proper Selection and Interaction of Pretensioned Concrete Railroad Tie Materials”

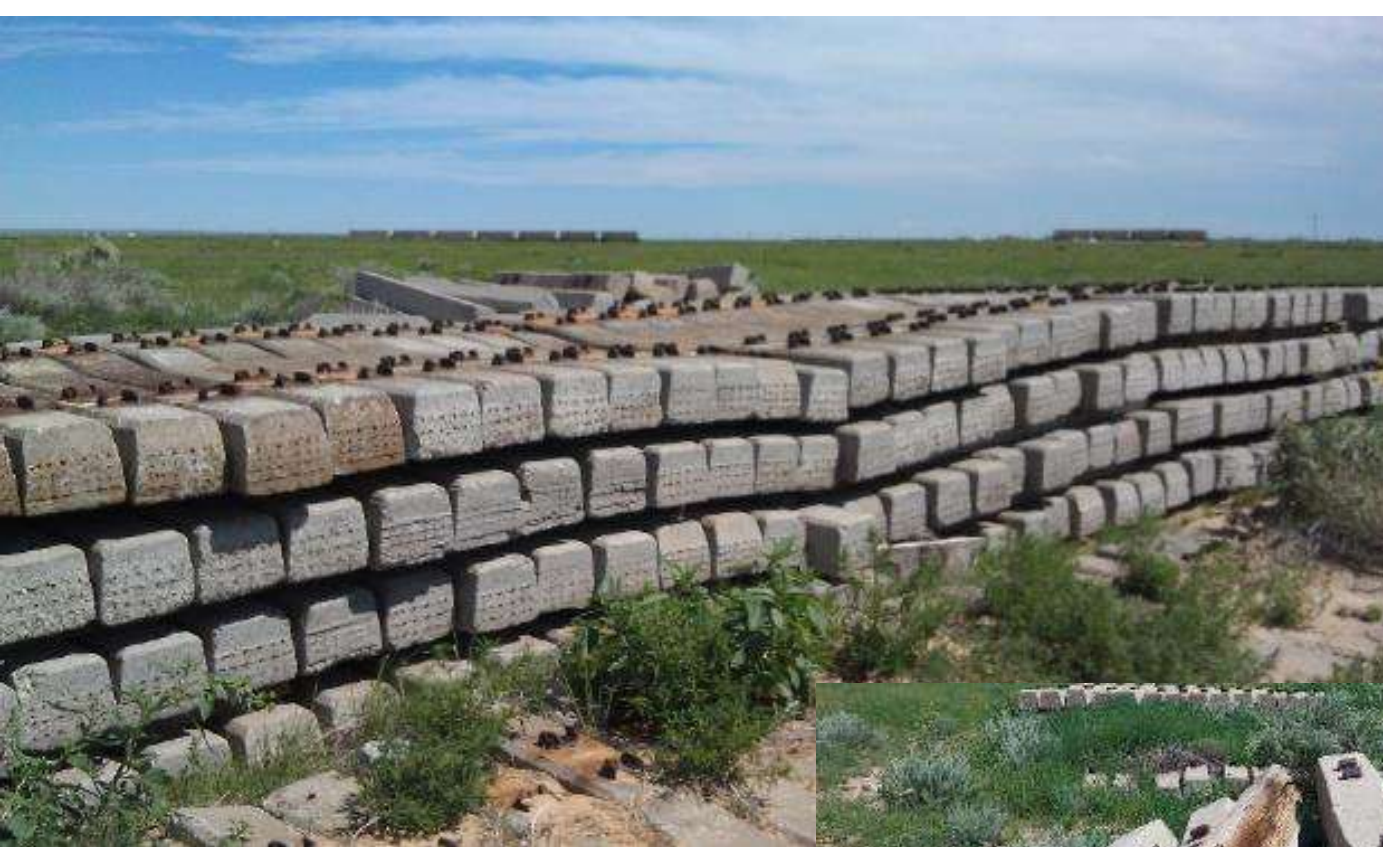
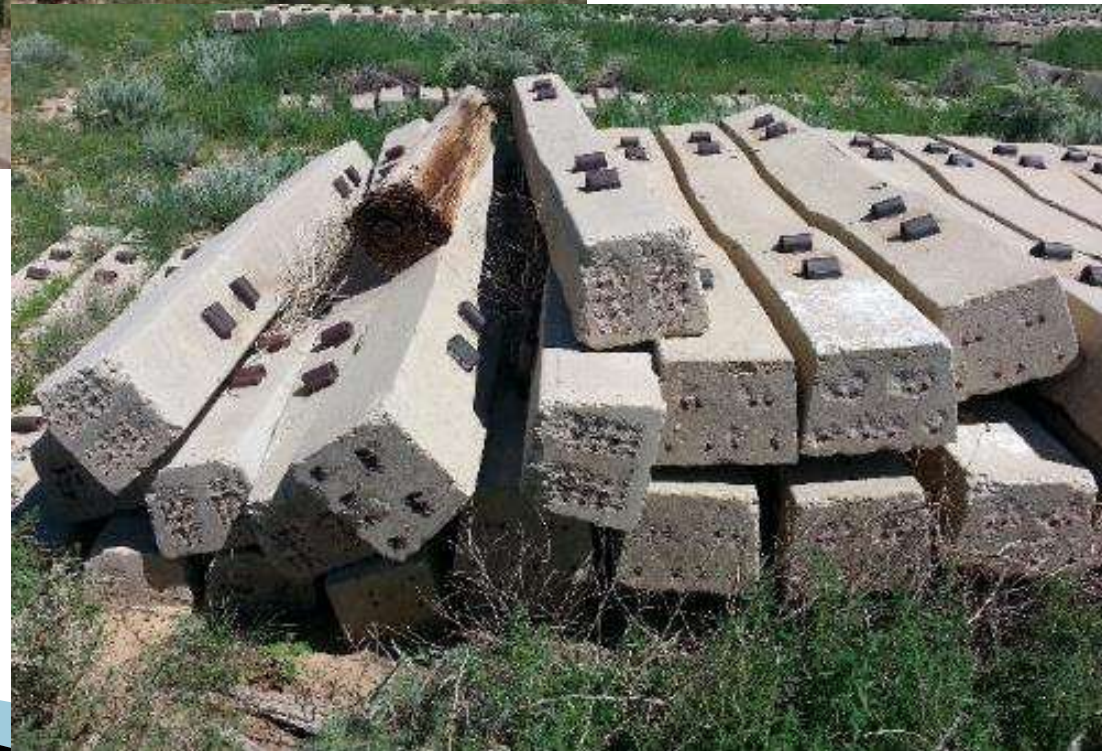
Obtaining Old Ties

- ▶ In May 2015, KSU team members Bob Peterman and Kyle Riding, along with project partners Steve Mattson (Nortrak) and Rusty Croley (Rocla) selected over 100 ties from the TTCI tie boneyard in Pueblo Colorado to be shipped to Manhattan, KS for detailed analysis.

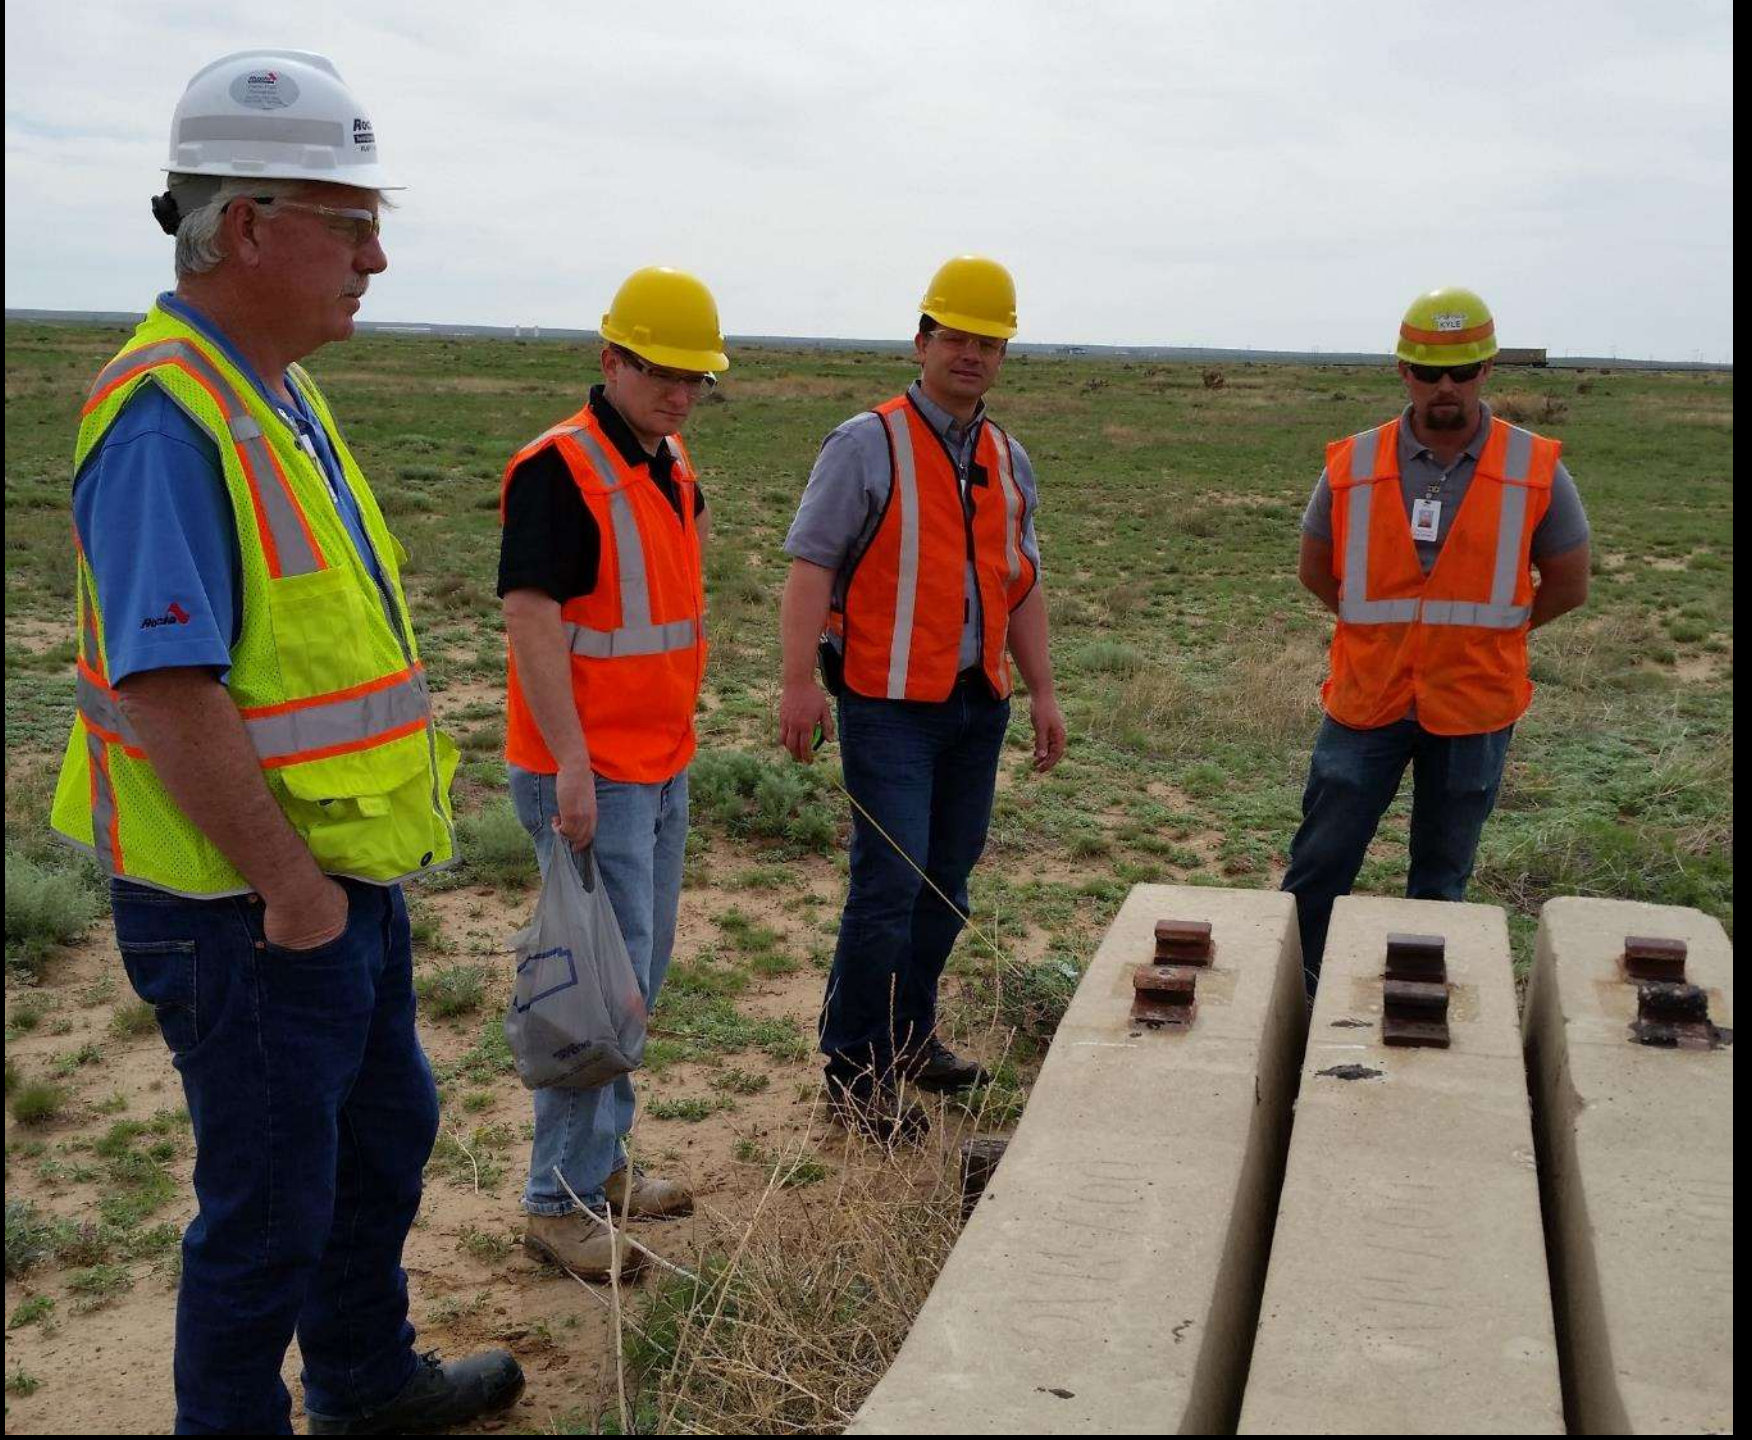
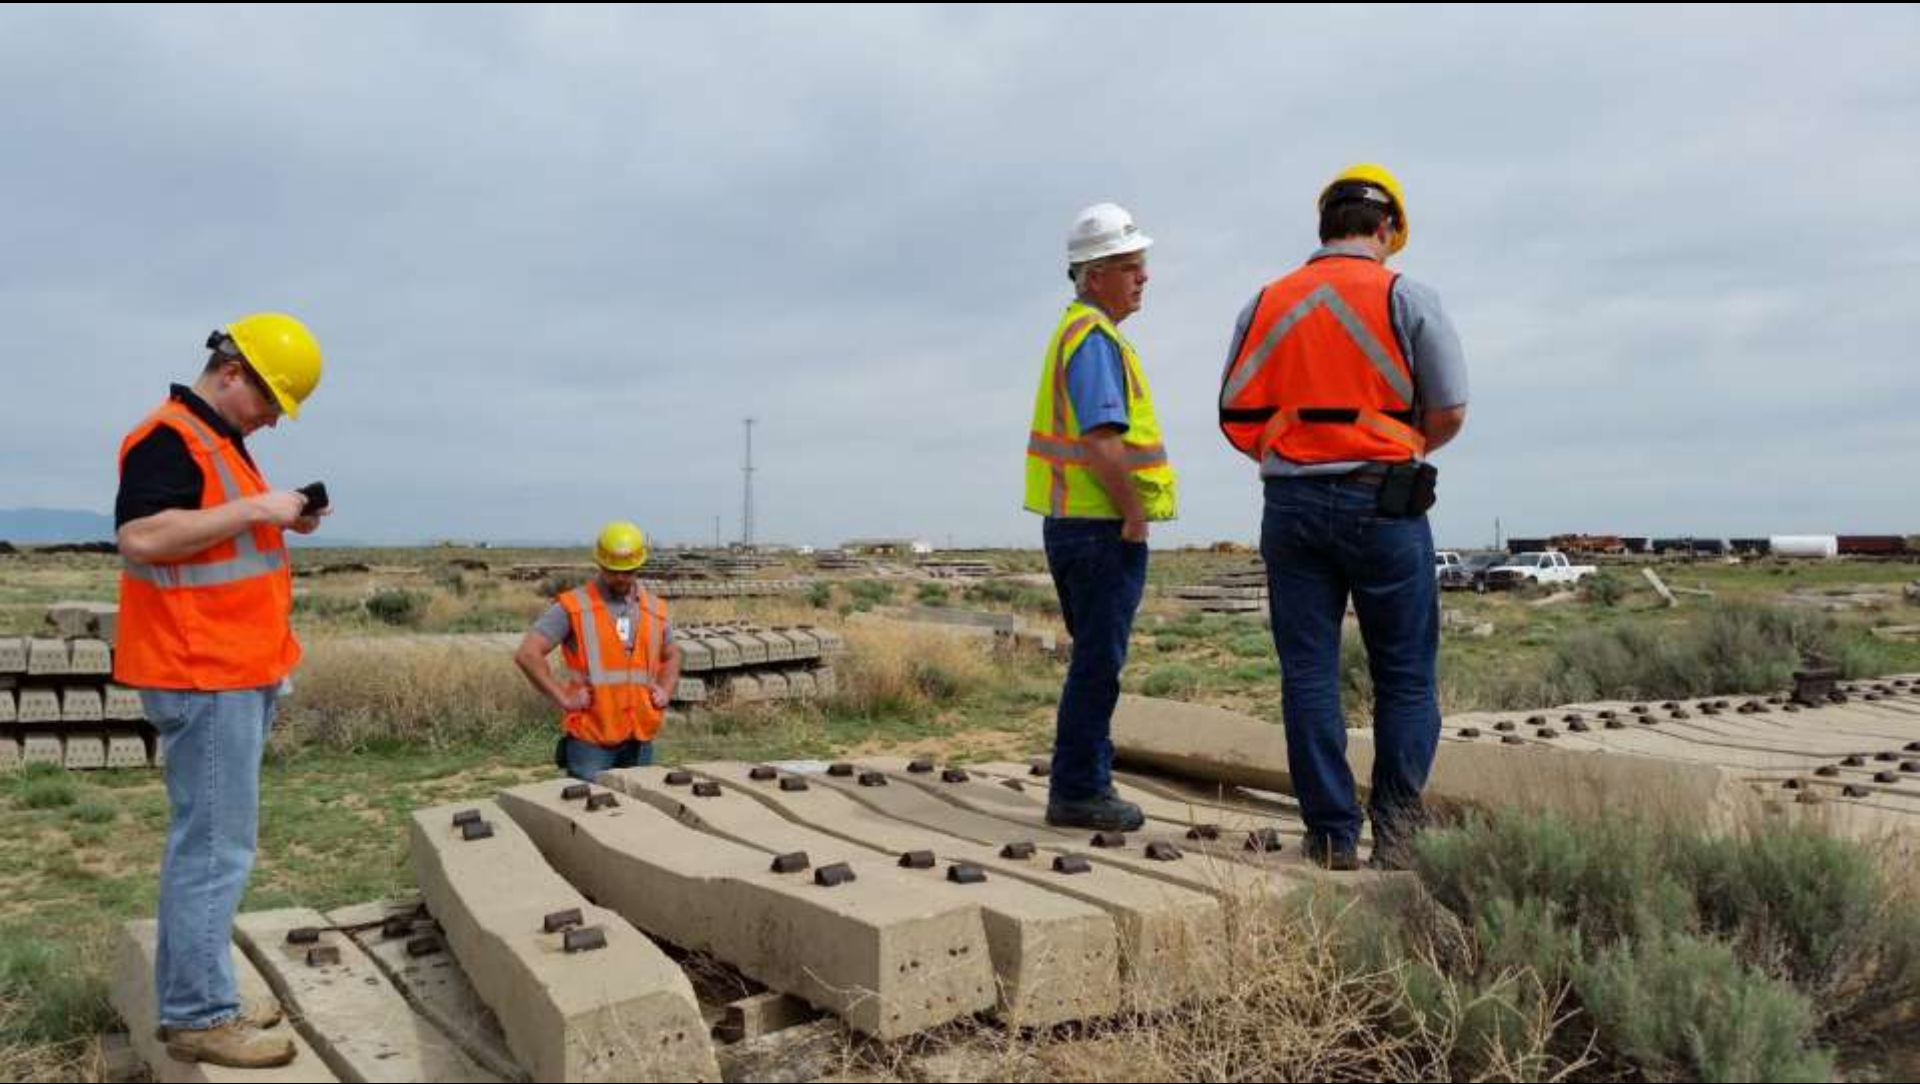
Ties Selected

- ▶ Six (6) matching ties representing major design types that were commonly used by Class 1 railroads since the 1970's were selected and marked for shipment

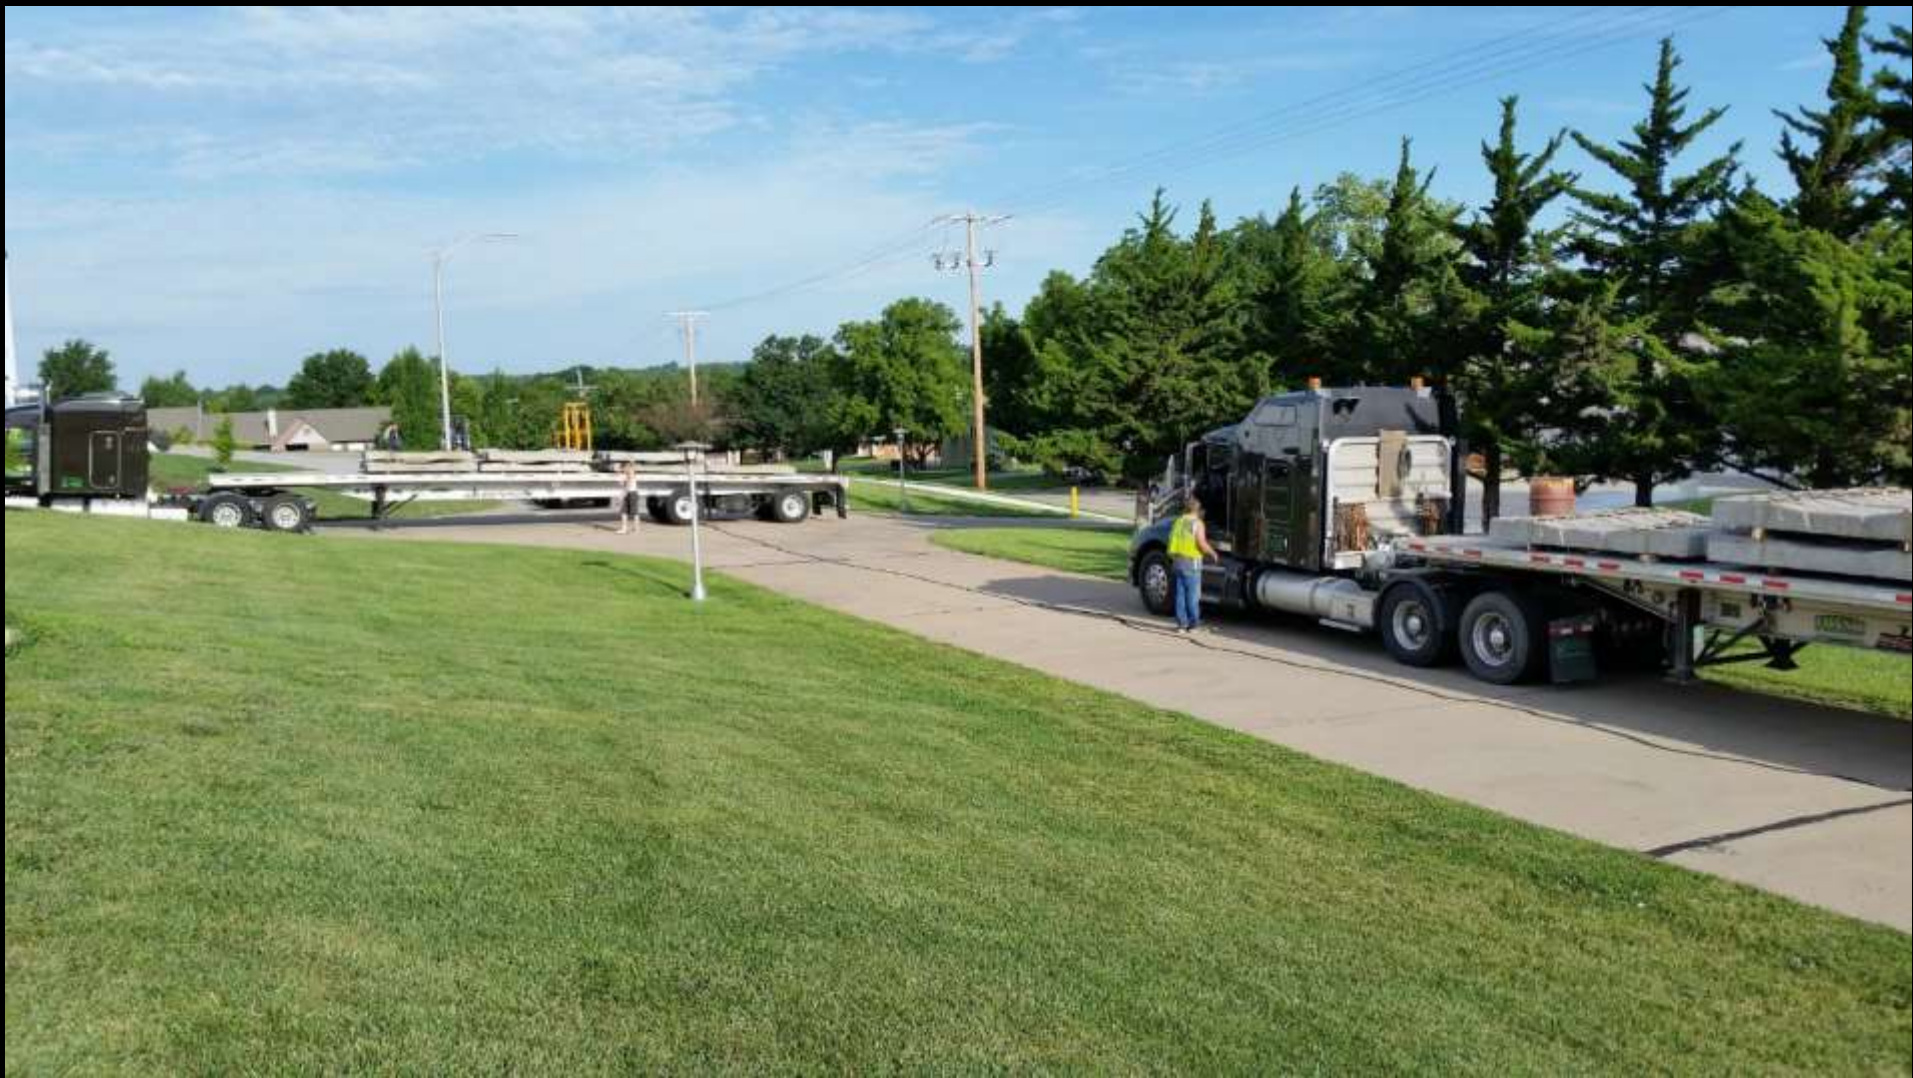
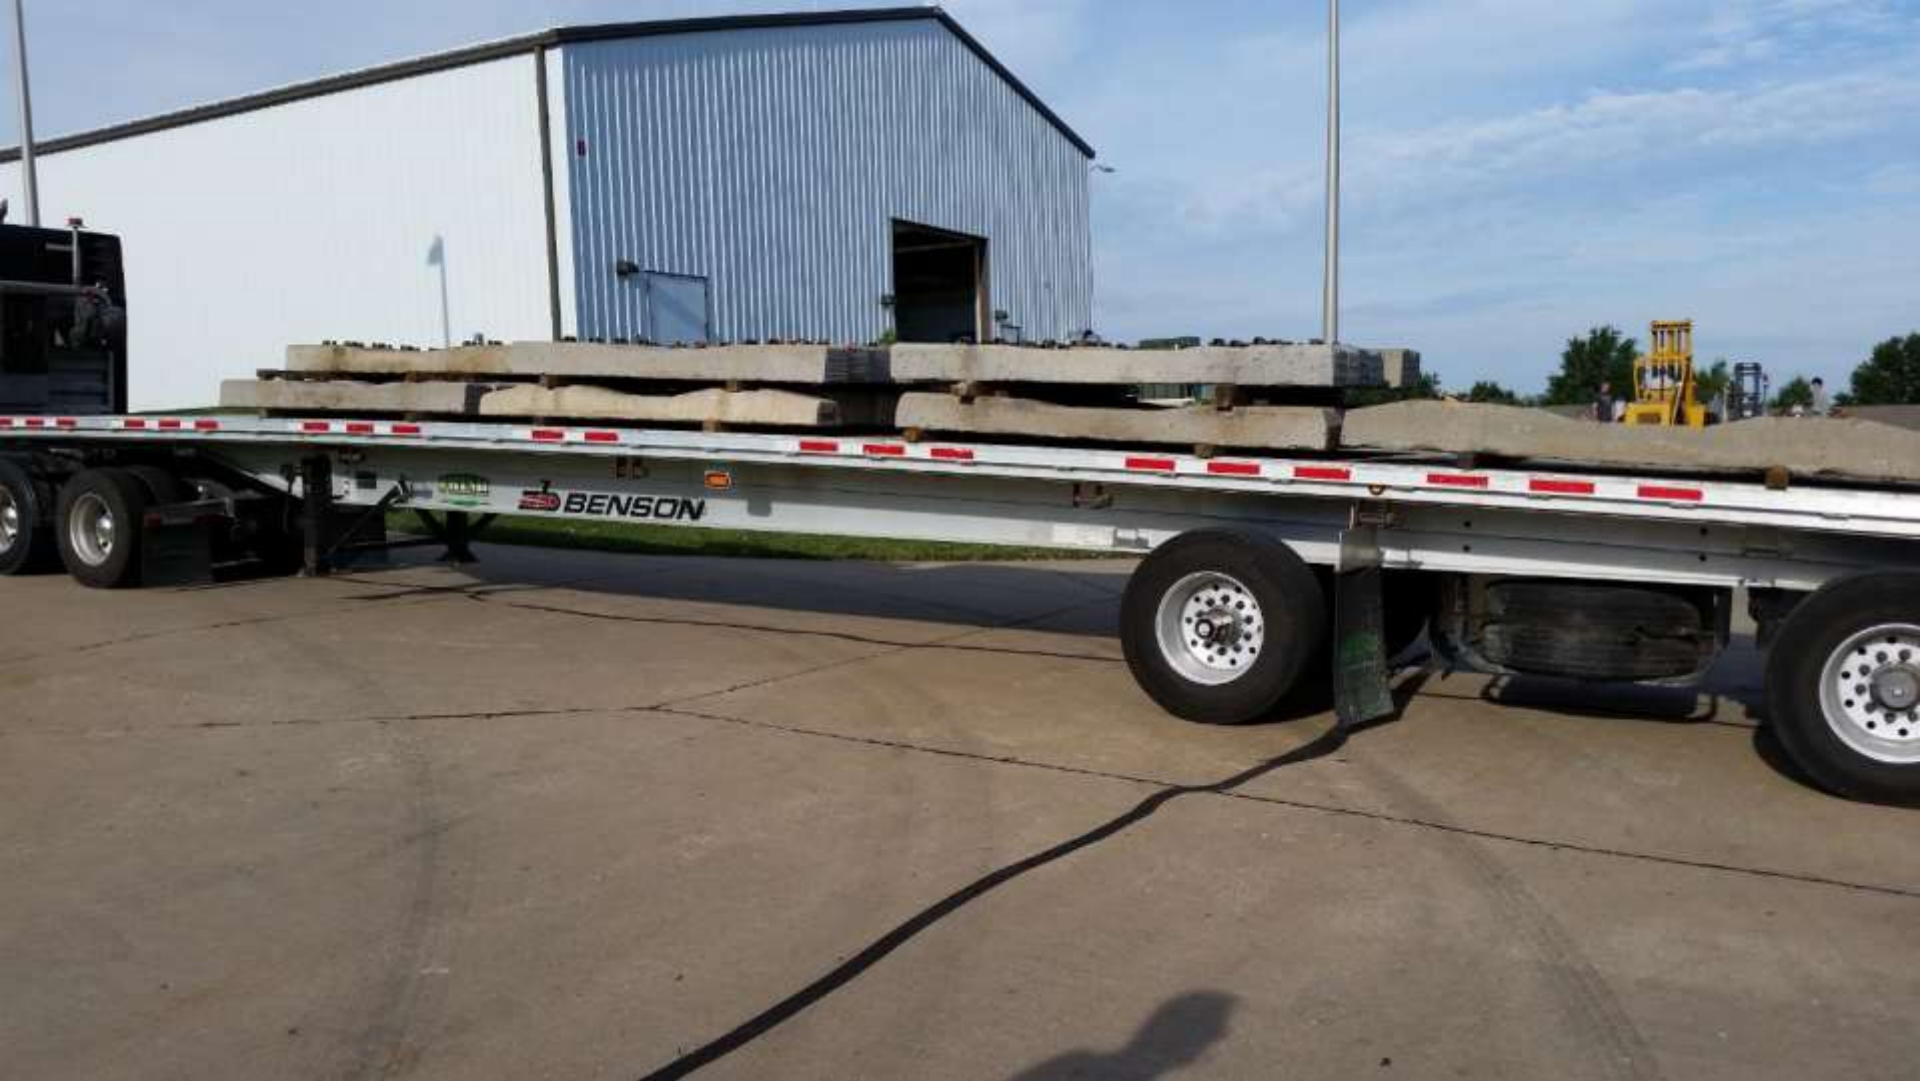
Shipment to KSU

- ▶ Two semi-trailer loads of ties were shipped to the USDA ARS Lab in Manhattan Kansas in July 2015 where the initial visual inspection and 3D scanning is being conducted.

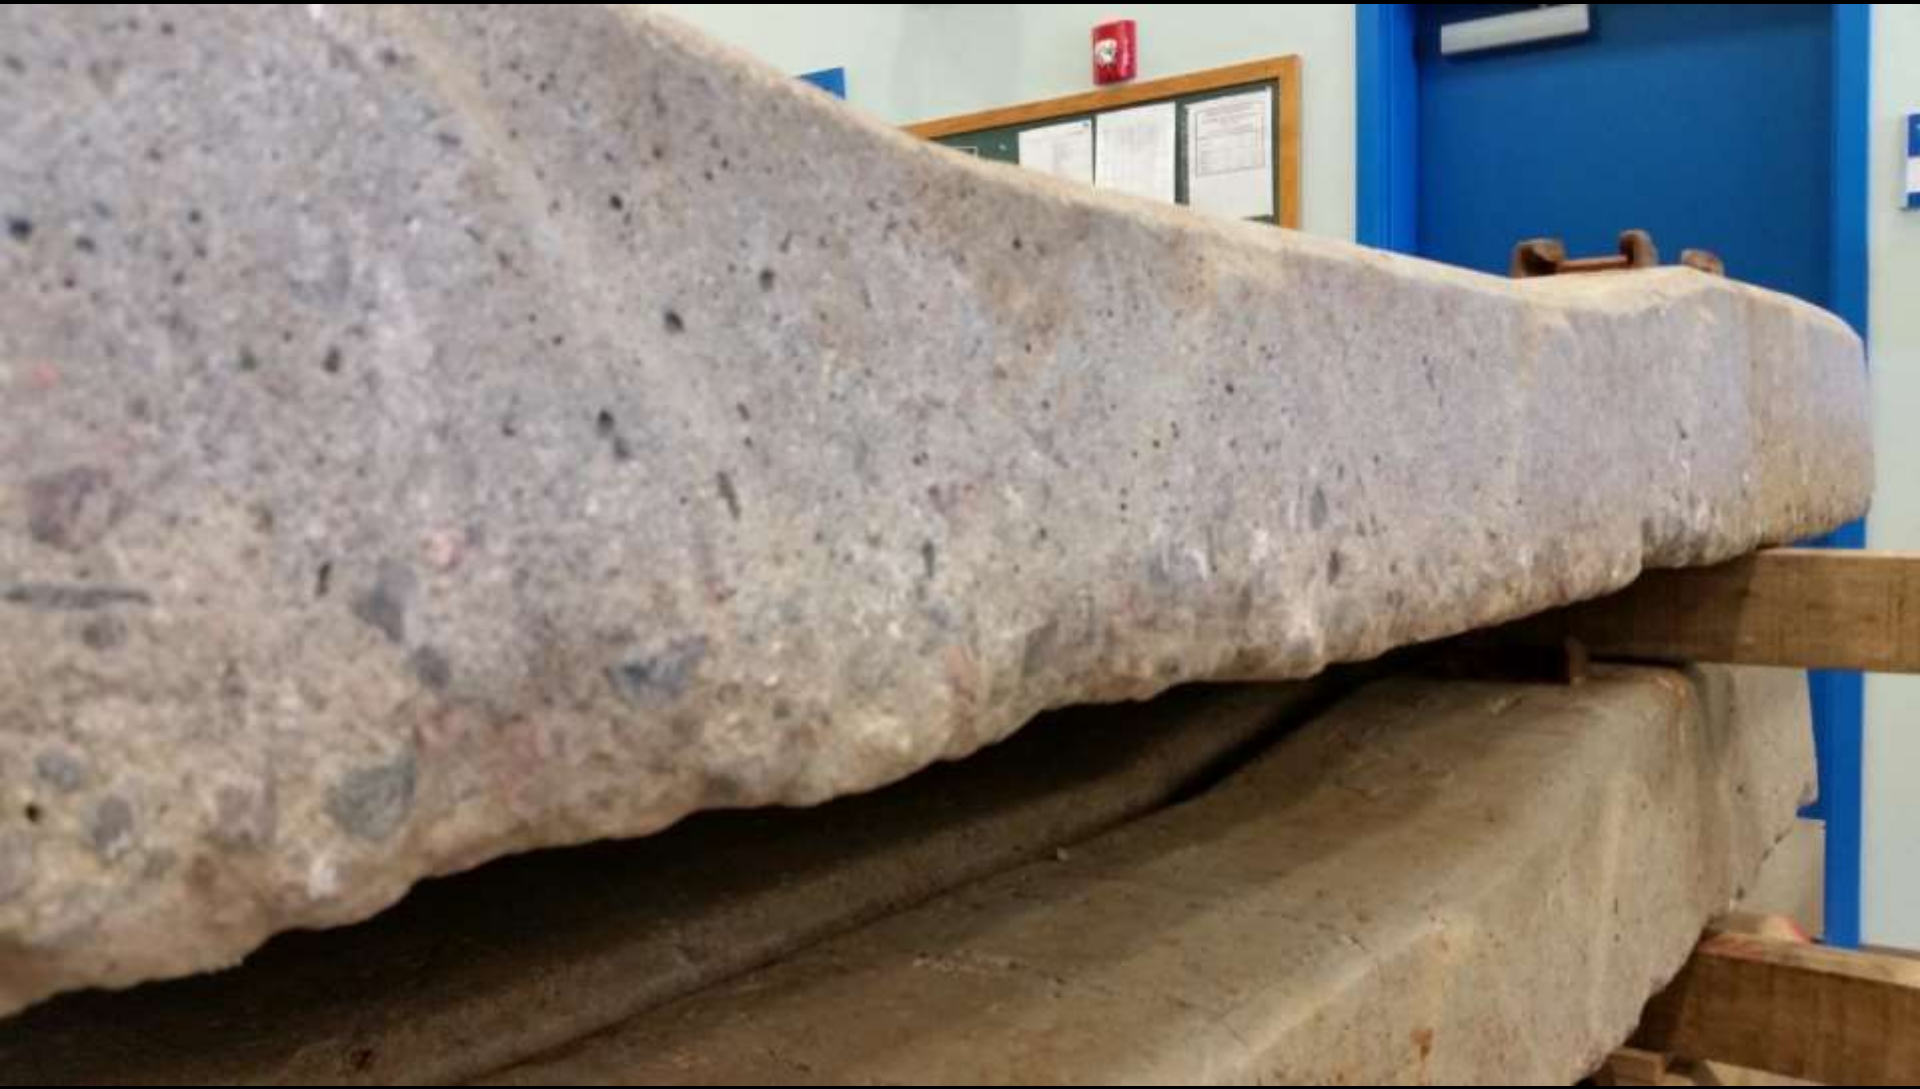
Other Ties

- ▶ In addition to the ties from TTCI, KSU is receiving old ties from our railroad partners (Amtrak, BNSF, CSX, and Kansas City Southern) as well as new ties from our tie producer partners.
- ▶ If any of you are aware of additional ties that we should include in this study please contact us.

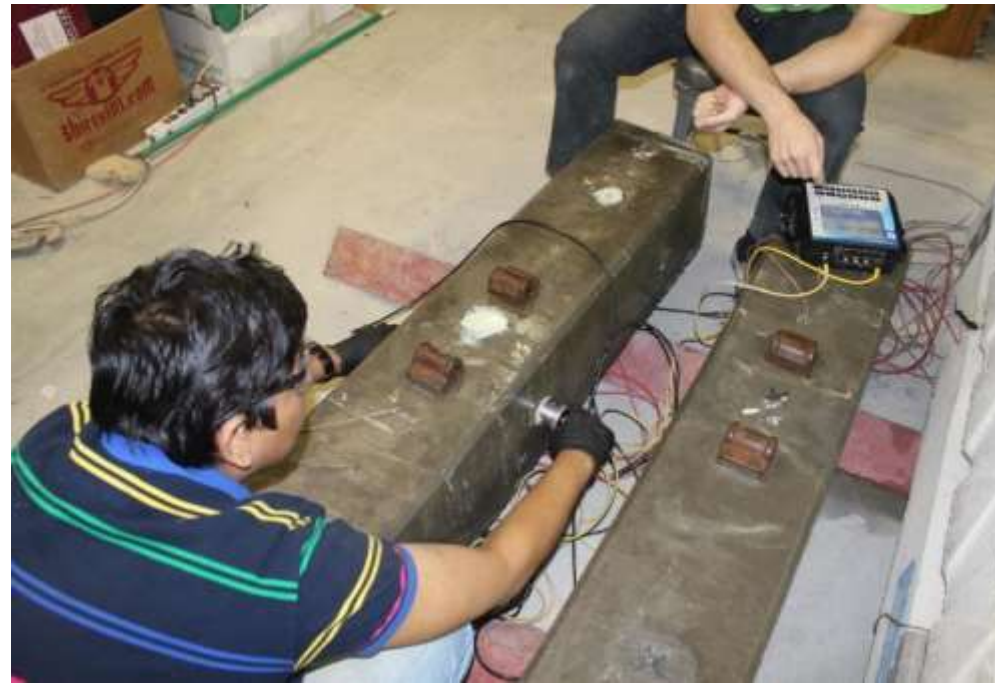
Damage Detection

- Ultrasonic pulse velocity
 - Micro-cracking slows wave propagation in concrete
 - Measurements taken at different locations in the ties to measure deterioration at different locations

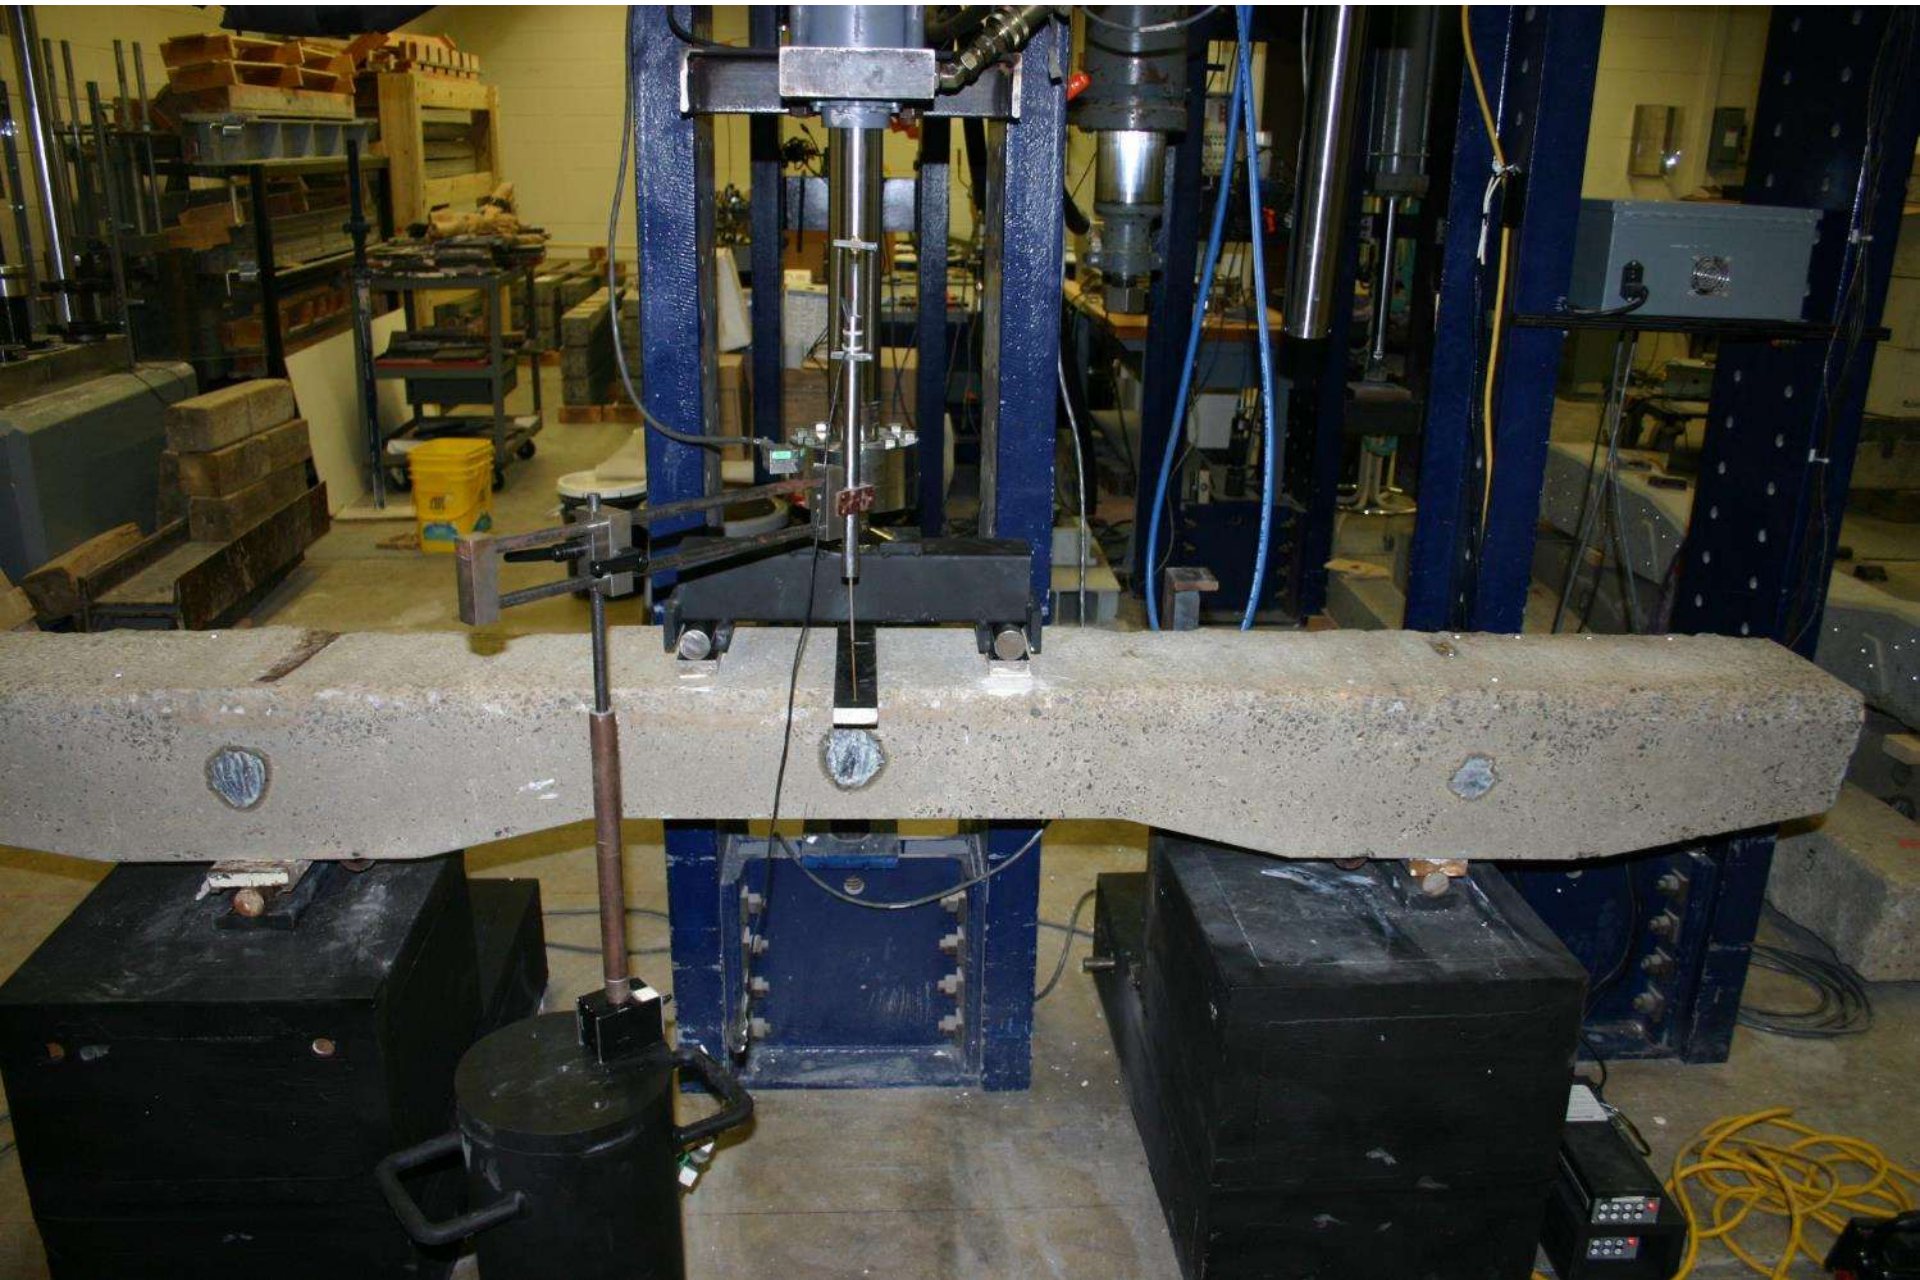
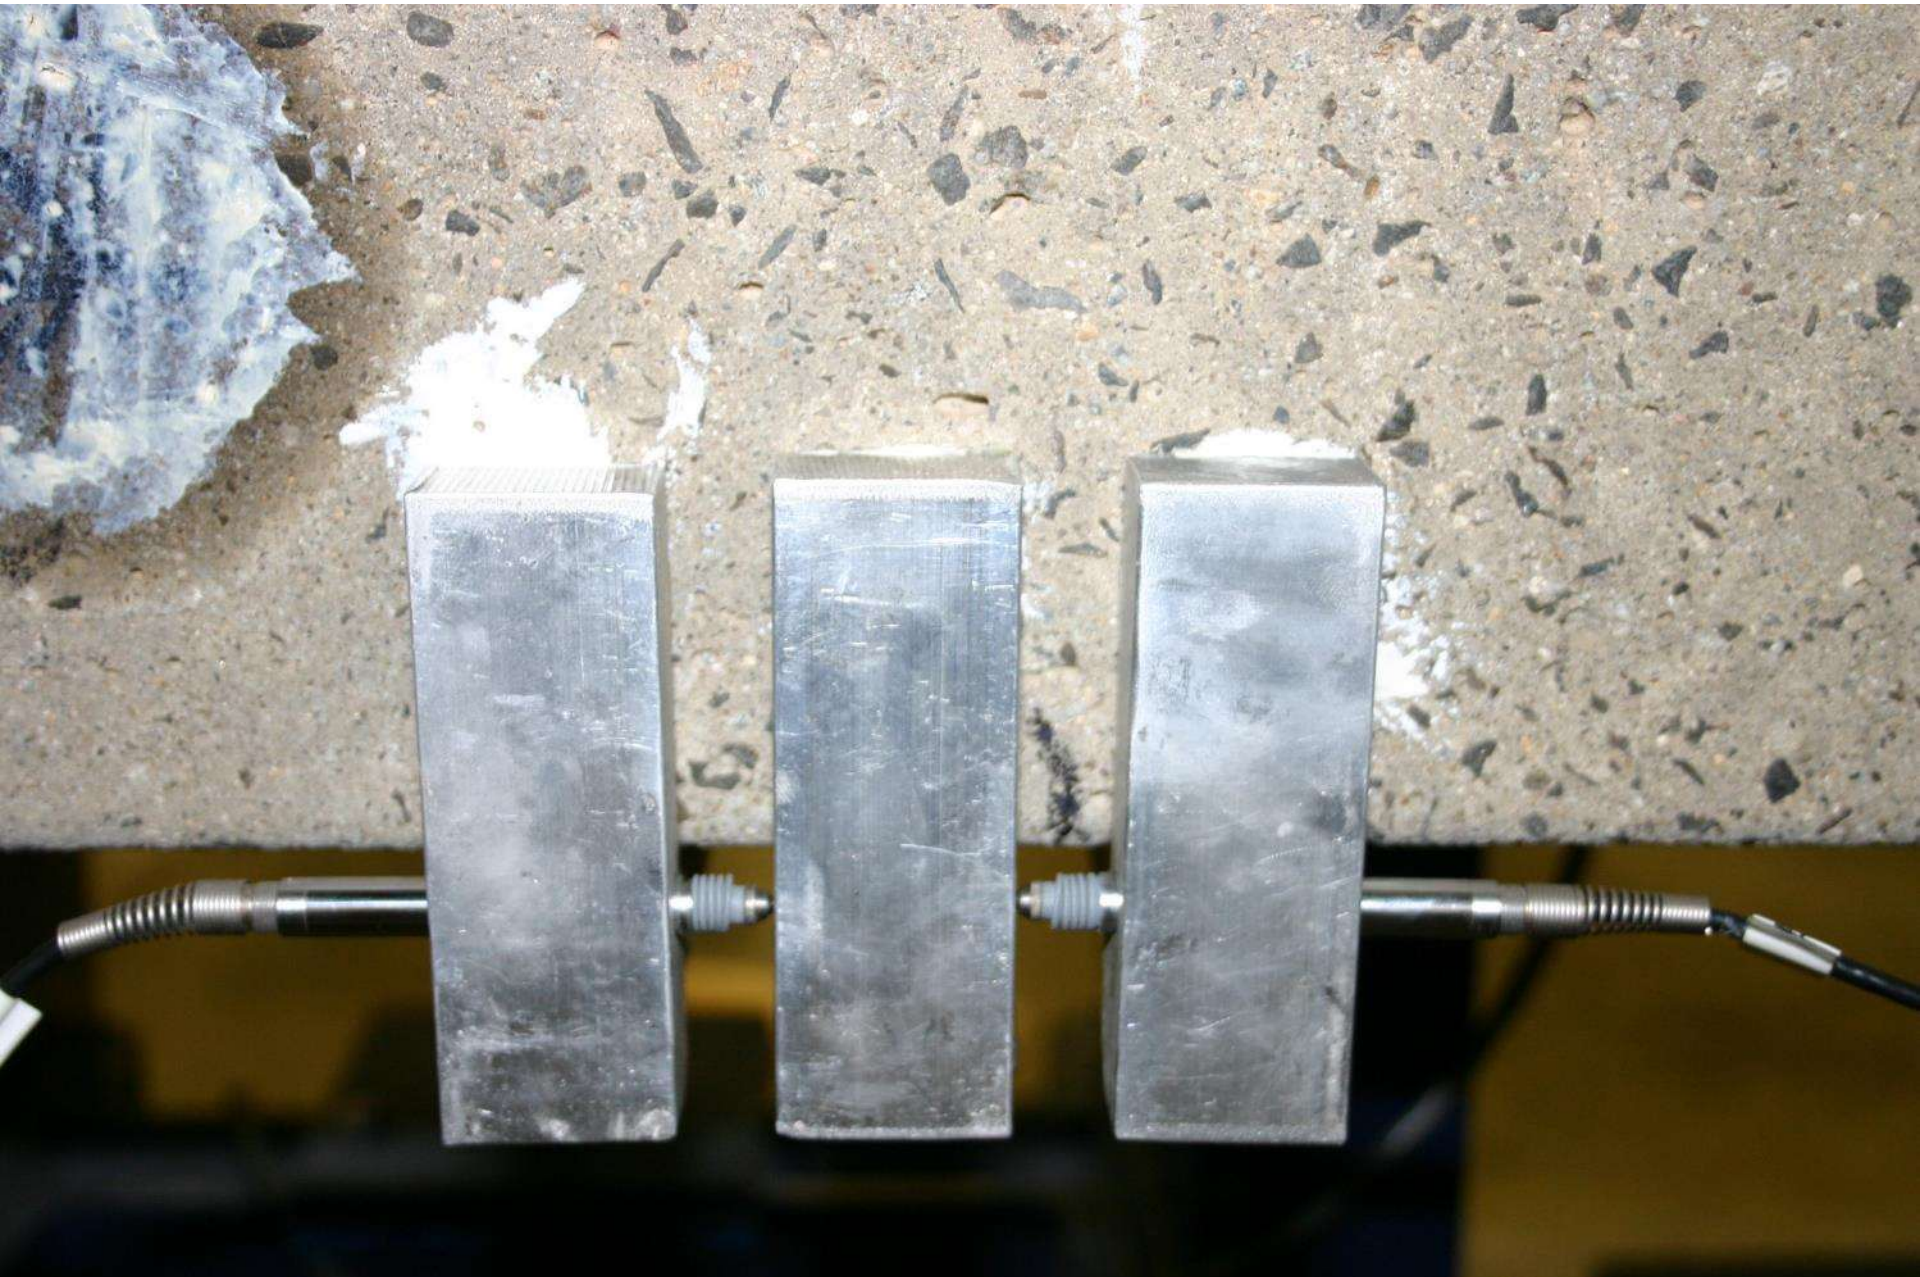
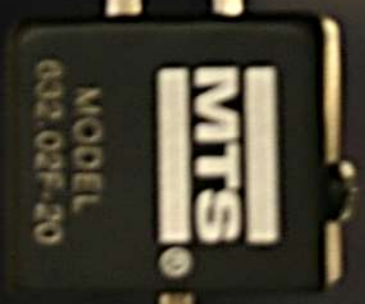
Crack Load = 9780 lbs
M = 110025 lb-in
y = 3.62 in
A = 69.06 in²
I = 275.3 in⁴
e = 0.457 in

- ▶ Support tie upside—at rail seat and load at center until cracking.
- ▶ Unload tie and apply instrumentation across crack.
- ▶ Re-load and establish the crack-opening load
- ▶ Calculate the prestress force from statics (knowing the detailed geometry and cross-section)

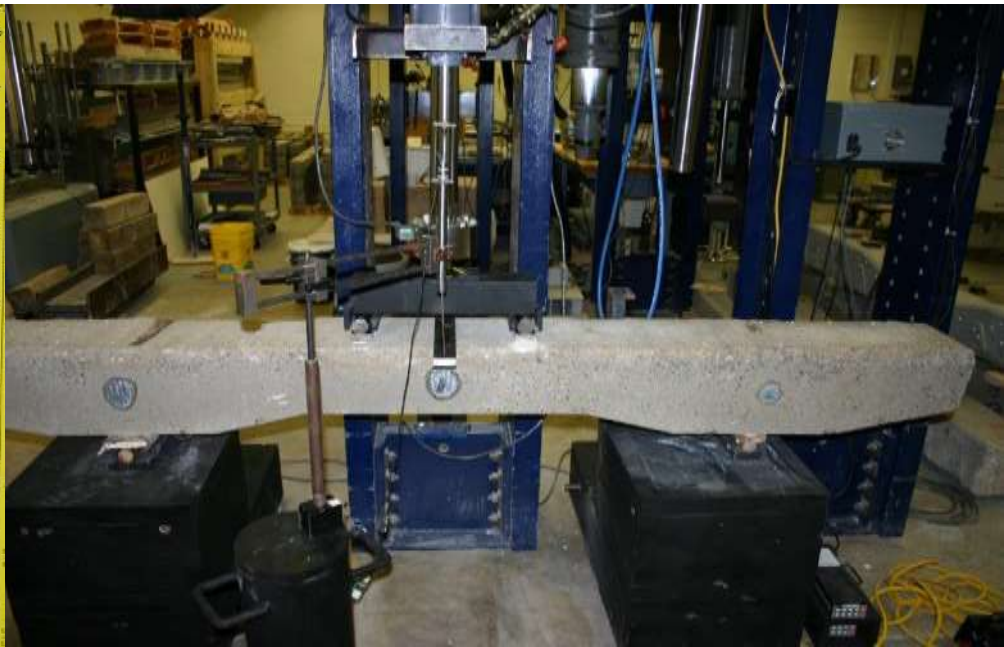
Determination of Remaining Prestress Force in Tie B-2

P = 70610 lb
P = 70.6 kip

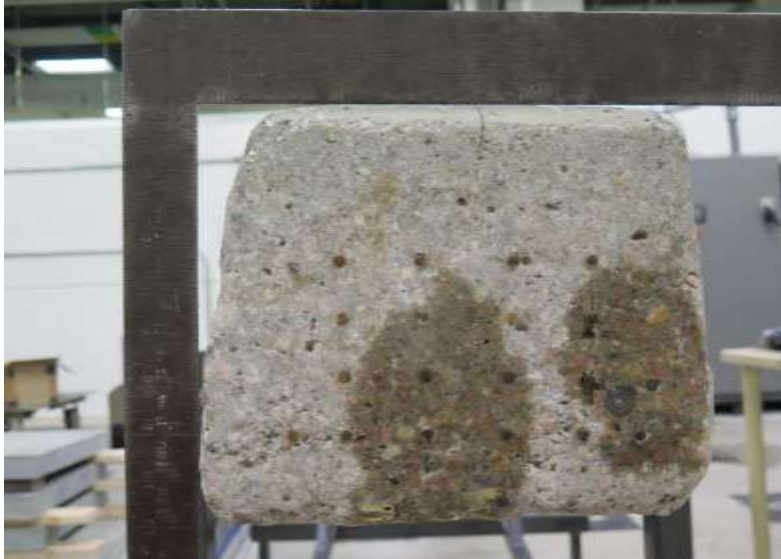
Determination of Remaining Prestress Force in Tie E-4

Load = 12630 lbs

M = 142087.5 lb-in

y = 3.4 in

A = 62 in²

I = 225 in⁴

e = 0.21 in

P = 111235 lb

P = 111.2 kip
