# SALMON RIVER RAILWAY BRIDGE EXPANSION

2017 Railroad Environmental Conference

October 24, 2017

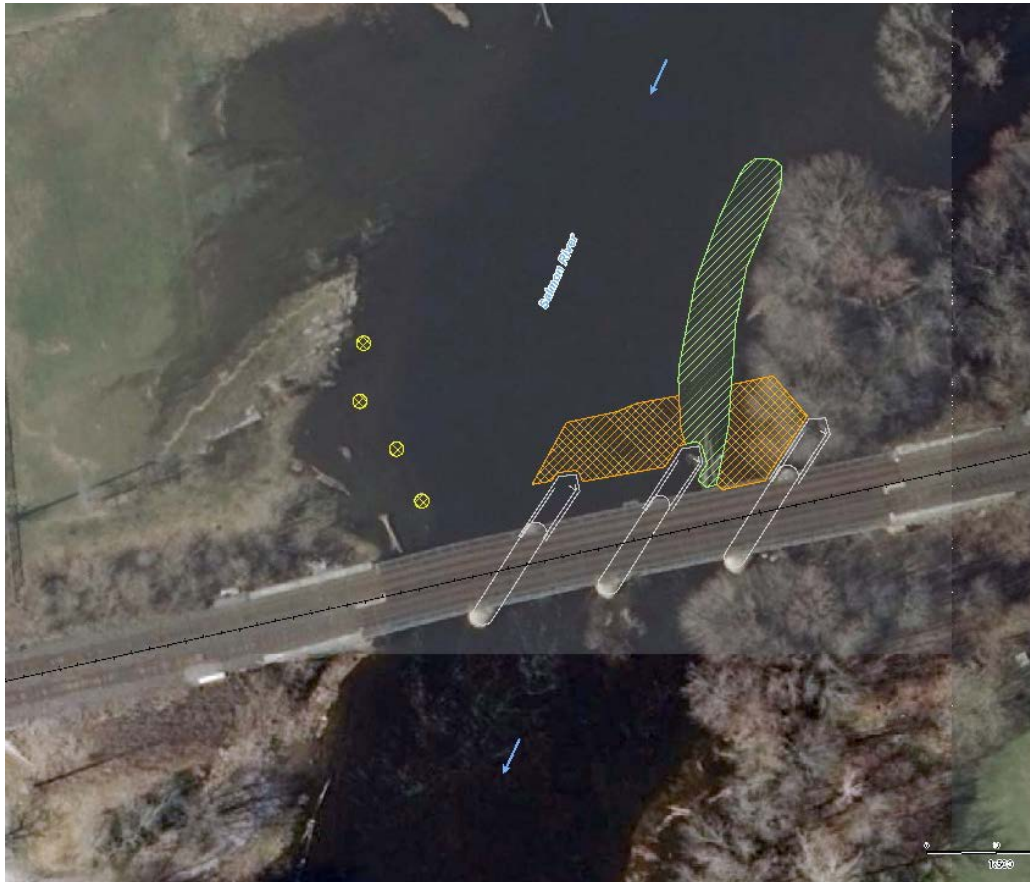
# Preferred Mitigation Option – #4: Create Habitat for Rainbow Mussel Host Species

- Rainbow mussel require fish species to host larval stage:
  - Smallmouth Bass
  - Rock Bass
  - Yellow Perch
- Create areas of clean gravel with boulders for bass spawning
- Increase in-water cover with large woody debris
- Enhance flooded vegetation areas to provide higher quality spawning and nursery habitat.
- Maintain offsetting measures within CN ROW and on participating landowner property

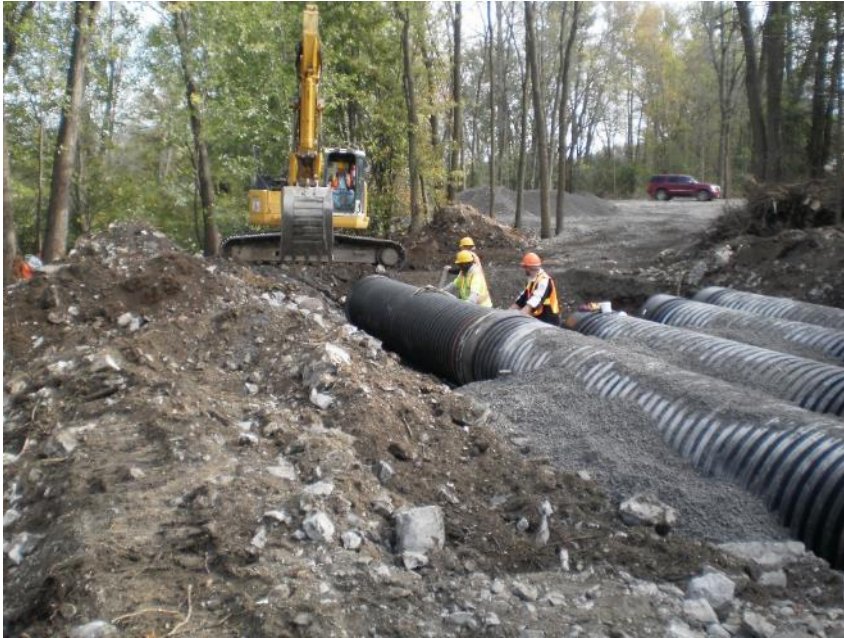
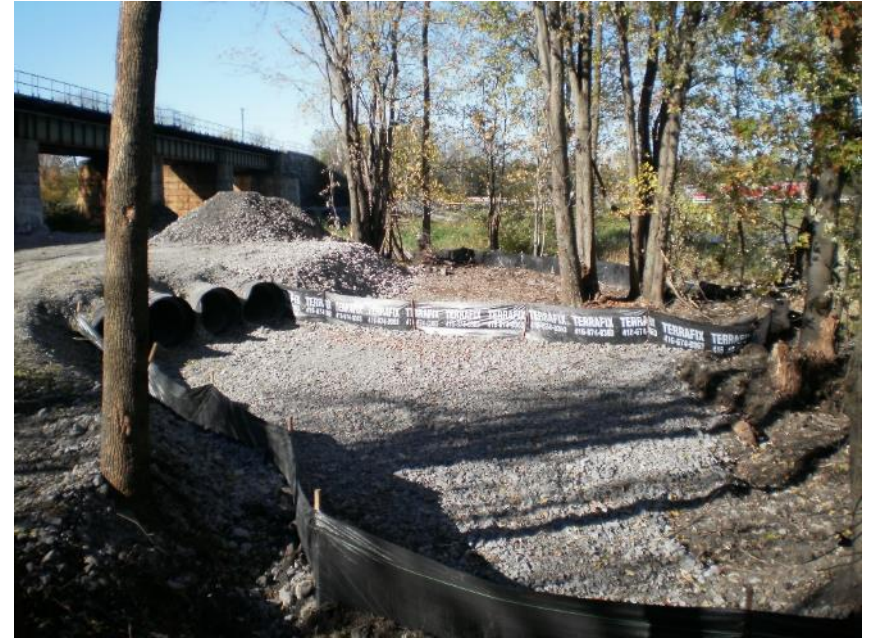
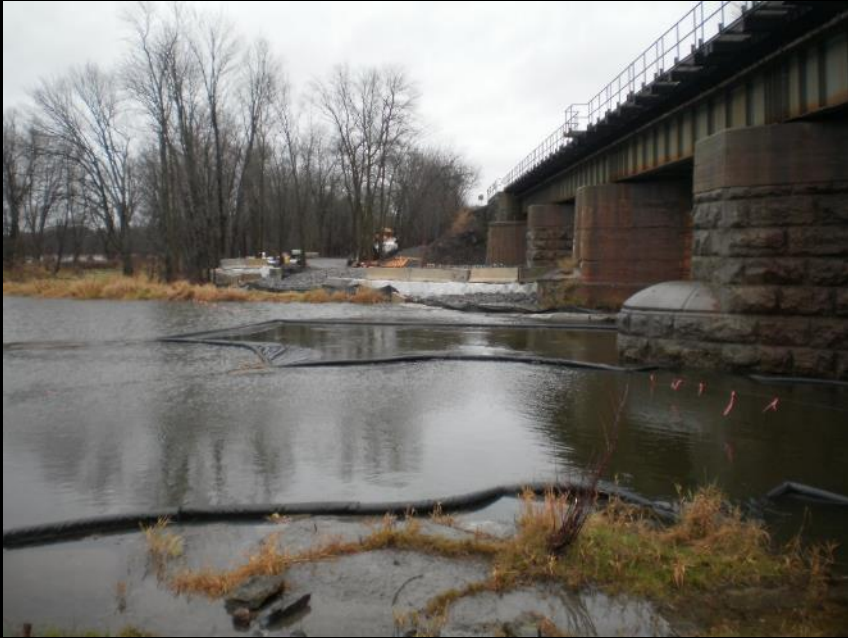
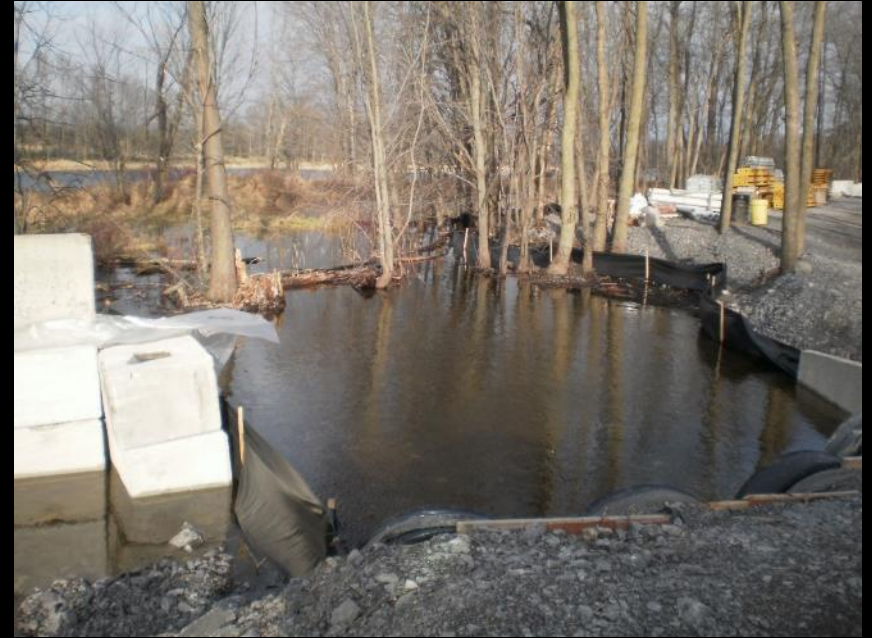
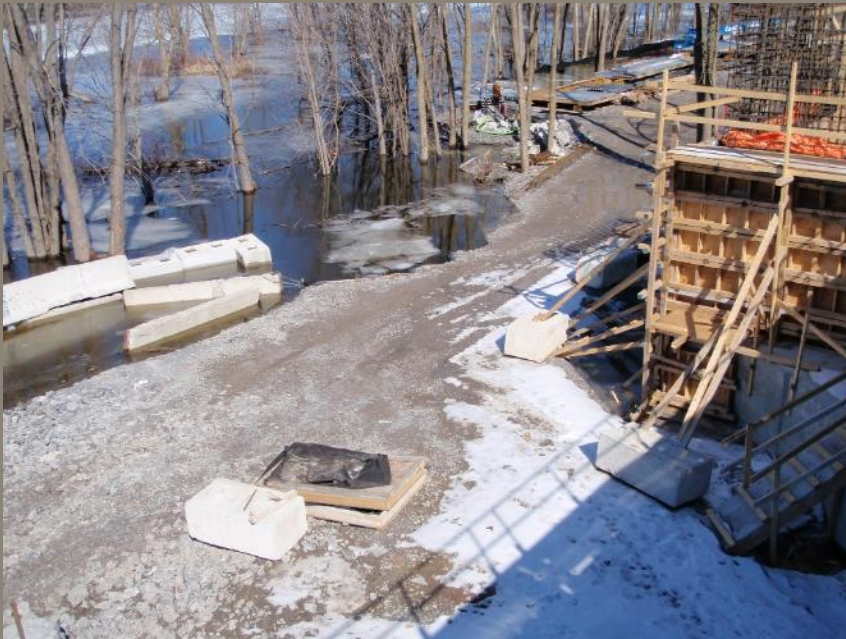
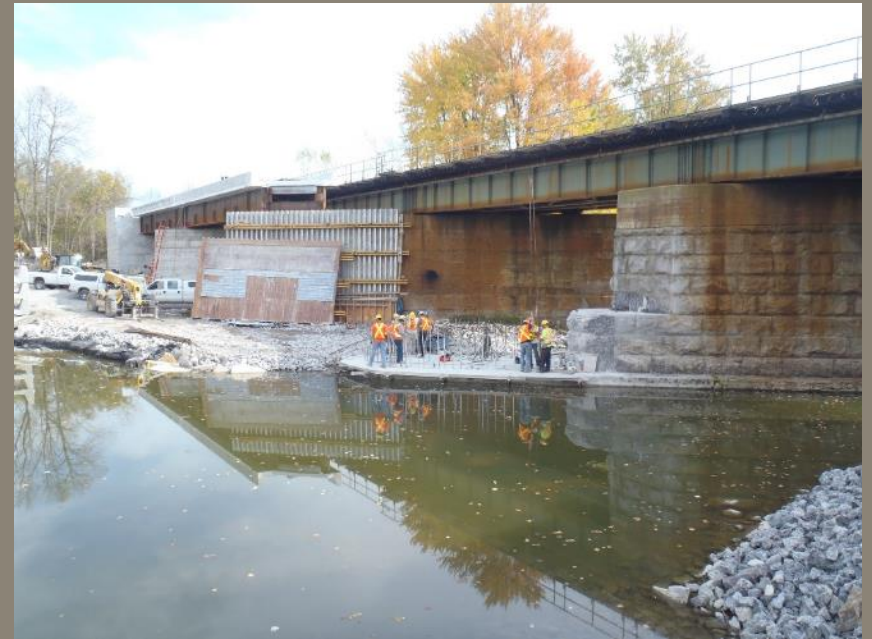
# Construction Access

Install and remove temporary access for construction

✓ Designing access and work area isolation measures to 10-year storm event ensured that high water events did not cause delays to construction (difficult to design but no delays)

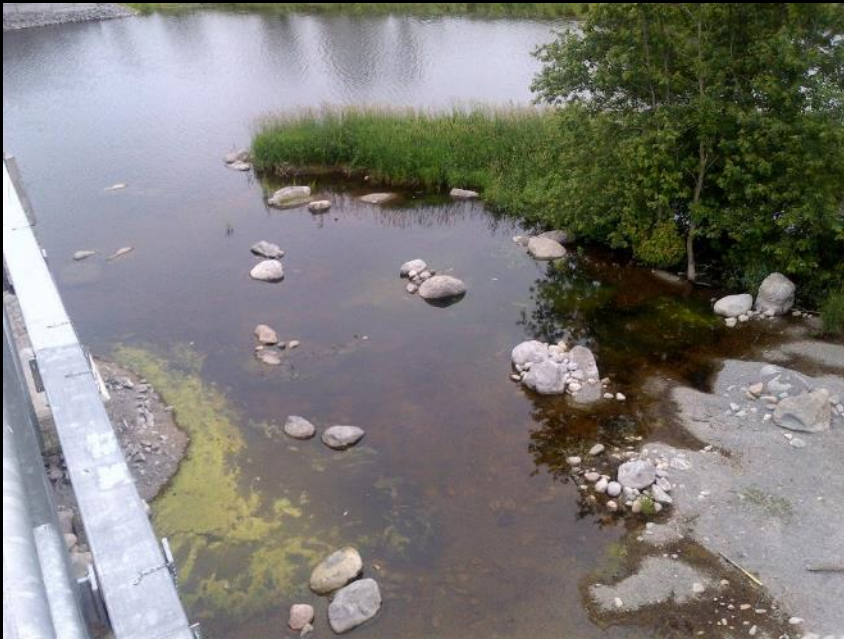
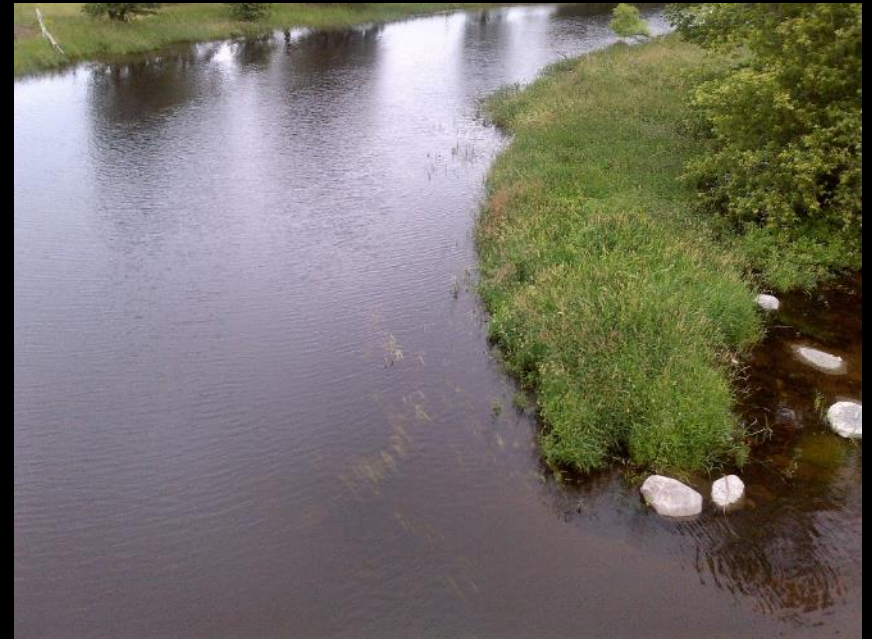
# Monitoring Results – Year 1

Compensation measures have remained in place and are functioning as designed

*Centrarchid* nests have been found in gravel habitats when submerged during spring

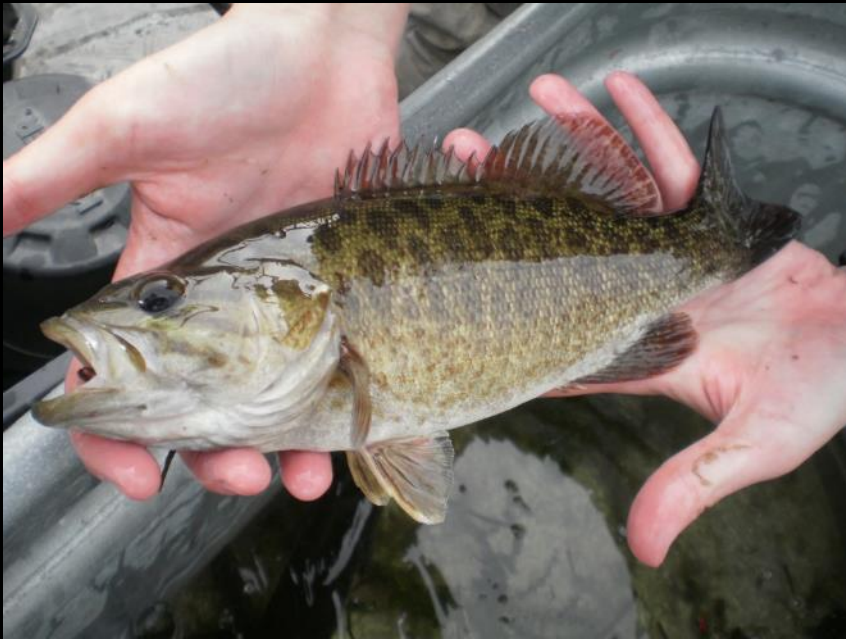
Smallmouth Bass

# Monitoring Results Fish

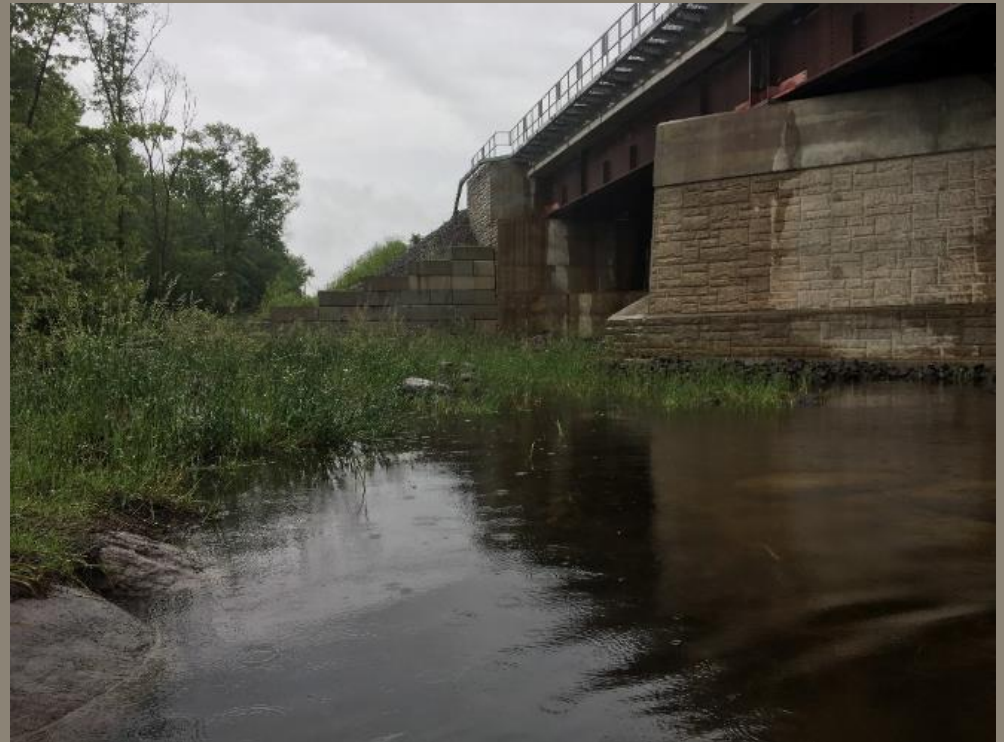
- Mitigation measures on east side of bridge have resulted in:
  - Addition of spawning habitat upstream and under bridge where suitable habitat did not exist prior to construction
  - Improved nursery habitat quality provided with diversified submergent aquatic vegetation upstream of bridge and spawning habitat

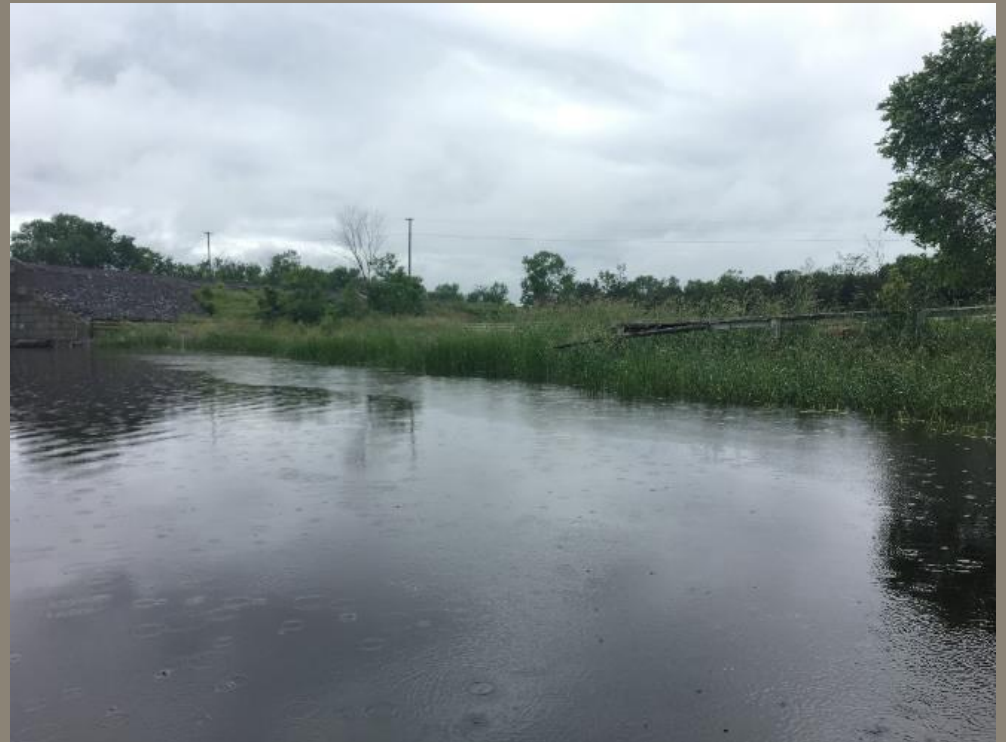
- Mitigation measures on west side of bridge have resulted in:
  - Improved in-water cover provided by addition of large woody debris in form of root wads
  - Improved bank stability through vegetation plantings and root wad installation
