How tomorrow moves [CSX]

Geometry Detector Teardown Results
September 10, 2010
Kim Bowling

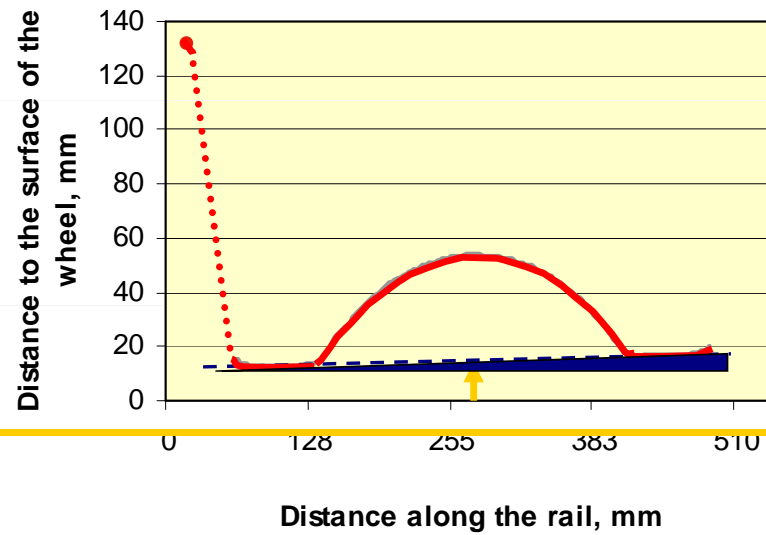
Principle of Operation

- *Angle of Attack (mrad)*
- *Tracking Position or TP (mm)*

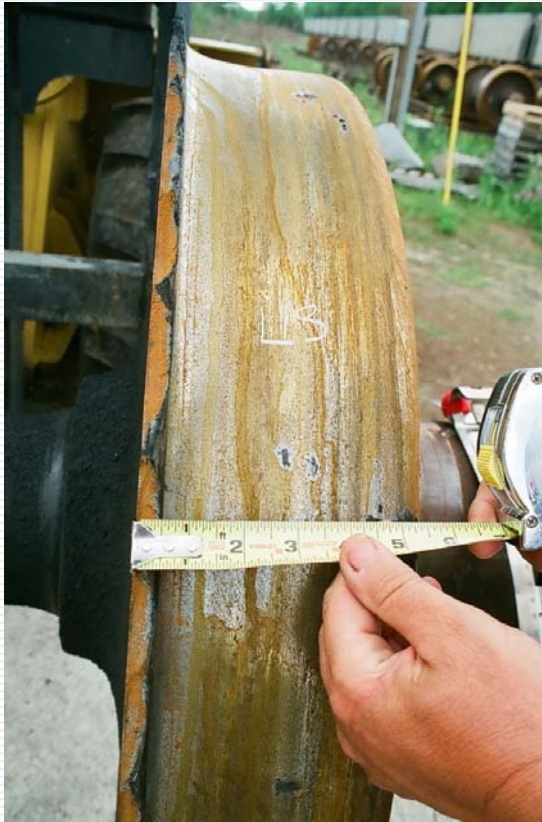
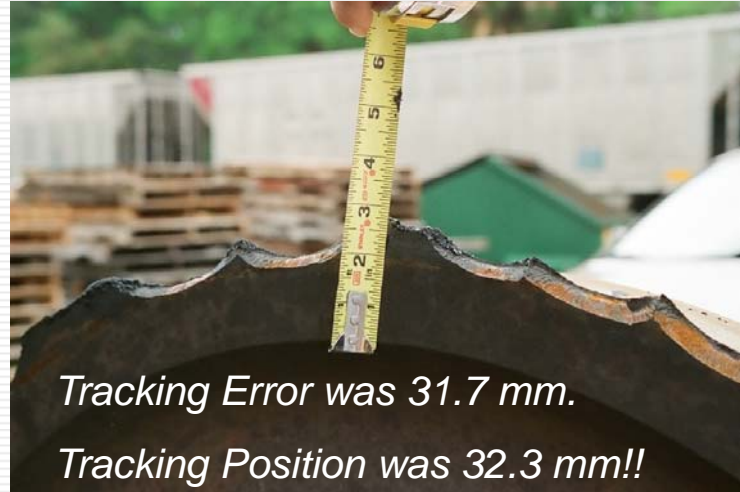
Pattern #3: Individual Axles

- Car D (T104) with S-2-C trucks
 - B Truck Tracking Error = -31.1 mm (1.2 in)
 - Axle 1's Tracking Position was 2.3 mm
 - Axle 2's Tracking Position was -28.8 mm (1.1 in) and had a condemnable thin flange
- Turned wheels had been applied in 2008
- After #2 axle was replaced, its Tracking Position dropped to -6.2 mm

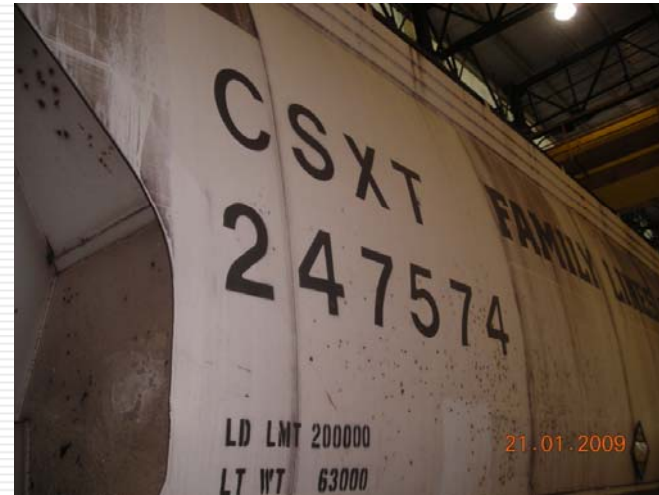
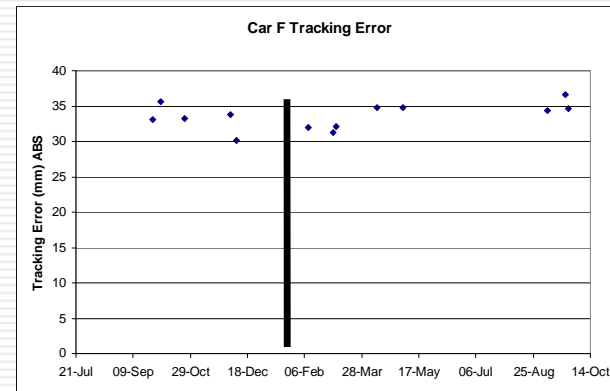
What doesn't fix Tracking Problems?

- Car F (C113) with S-2-C trucks
 - B Truck Tracking Error = 33.3 mm
 - Axle 3 Tape Differential – 3.5 tapes
 - Axle 4 Tape Differential – 3.5 tapes

- Car was Retrucked – with reconditioned castings, new springs, new friction castings and the SAME MISMATCHED WHEELS.

- B Truck Tracking Error *after* repair shop: 33.8 mm!

- **New Trucks do not fix Tracking Problems!**
