Steelton Hill in Duluth, MN

Steelton Hill Double Track

Superior subdivision capacity upgrade project

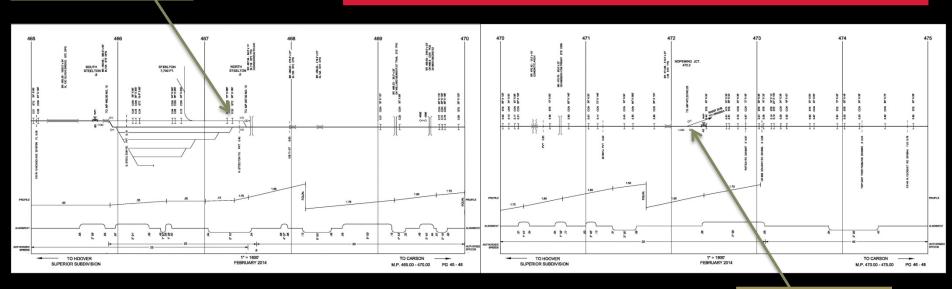
The track elevation climbs steadily from south to north with grades ranging from 1.50 to 1.90%

The 4.7 mile length of track has 10 curves, two are 5 degrees and one is 4 degrees.

Traffic volume: 62 MGT

Trains per day: 24

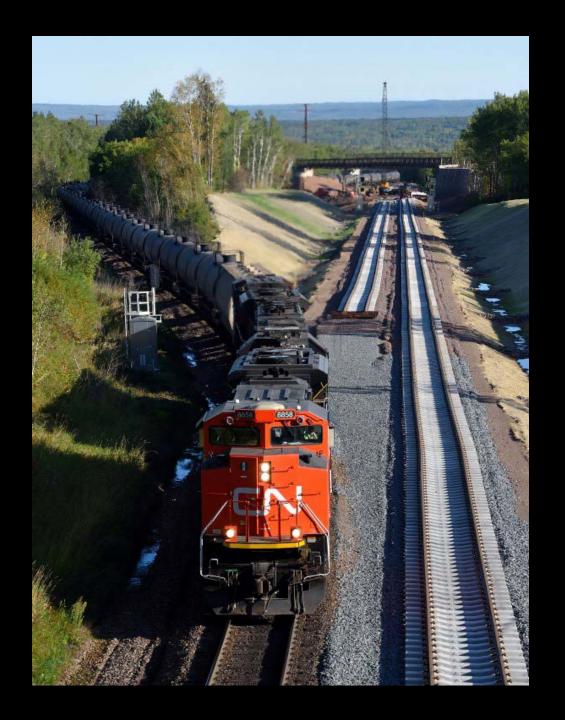
Steelton Hill operations

- Due to topography, long trains must stop in Steelton before ascending grade
- Extra engines are attached to rear of train (shovers)
- Once train reaches Nopeming Jct, the shovers are decoupled and must travel back down the hill
- Even with extra engines, long trains can stall
- In event of a stall, all traffic through Steelton Hill is halted until stalled train can reverse down hill back into Steelton
- Steelton siding capacity only 7700 ft

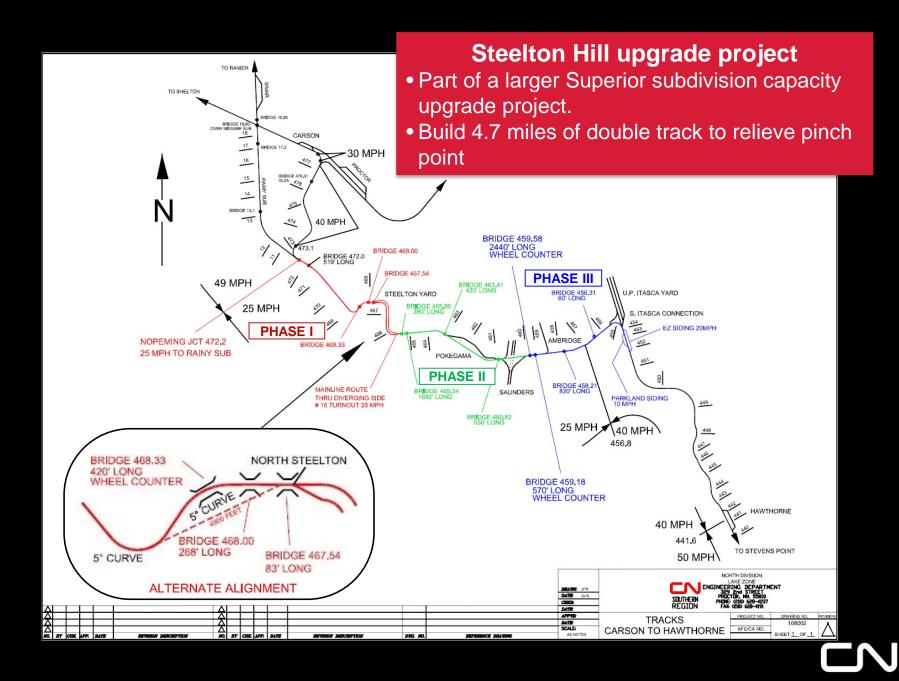
- New track construction 32,261 TF
- Embankment fill 680,611 CY
- Bridges (4) 816 LF
- Overhead bridges (2)
- Culvert installations (16)
- Rail 136 lbs 64,522 LF (2,924,997 lbs of steel)
- Ties (concrete) 16,000
- Ballast 50,000 TN
- Turn-outs (6)
- New control points (3)
- Budget \$56.0M

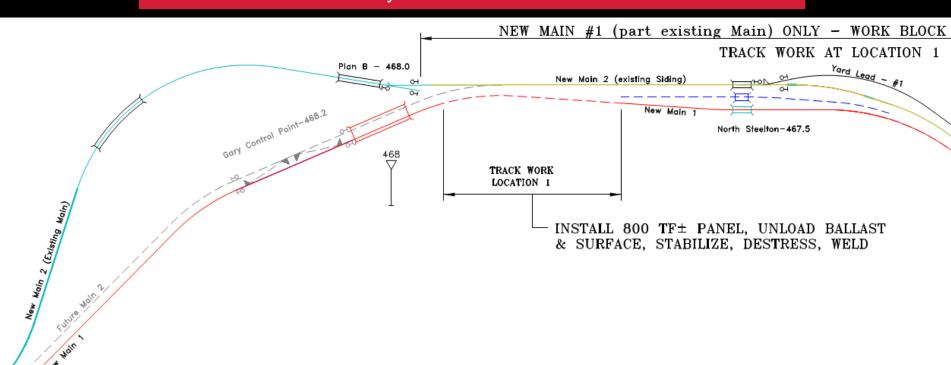
Steelton Hill cut-overs 3 & 4

- Stage 3 24 hrs cut-over existing main to new alignment Raise track by ~3 ft
- Stage 4 12 hrs cut-over of existing siding to new alignment Move Gary CP

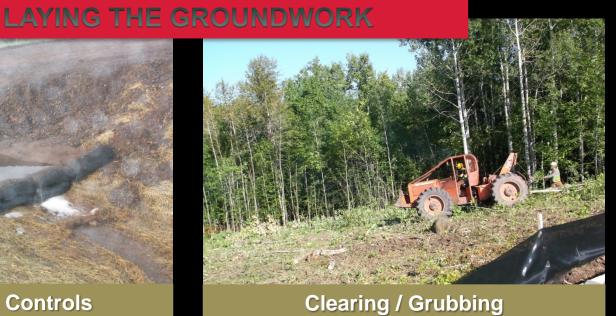
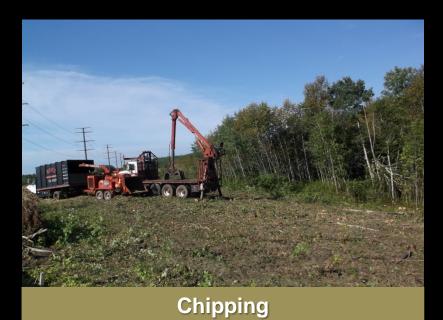
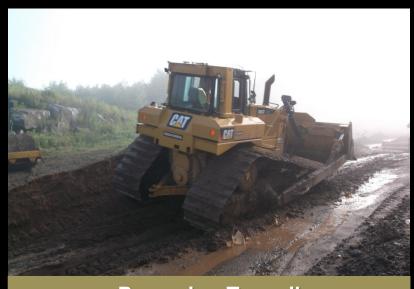
Environmental Controls

Removing Topsoil

Culverts - Jack & Bore

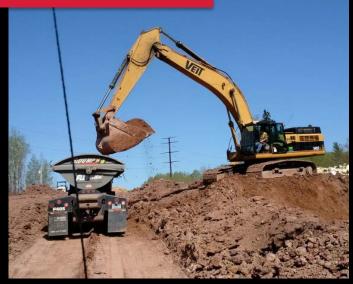
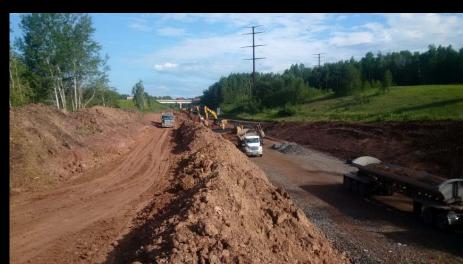
Grading

Over 30 pieces of equipment (dozers, rollers, excavators, back hoes, etc)

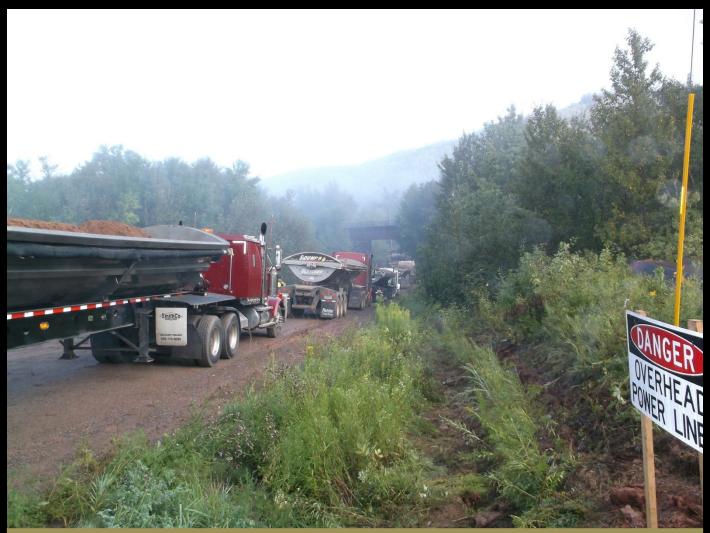
Grading

Over 50 trucks per day – average cycle time of 2.2 min

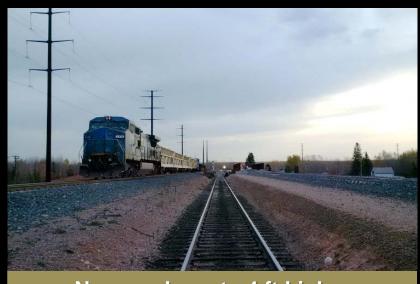
New grade up to 4 ft higher

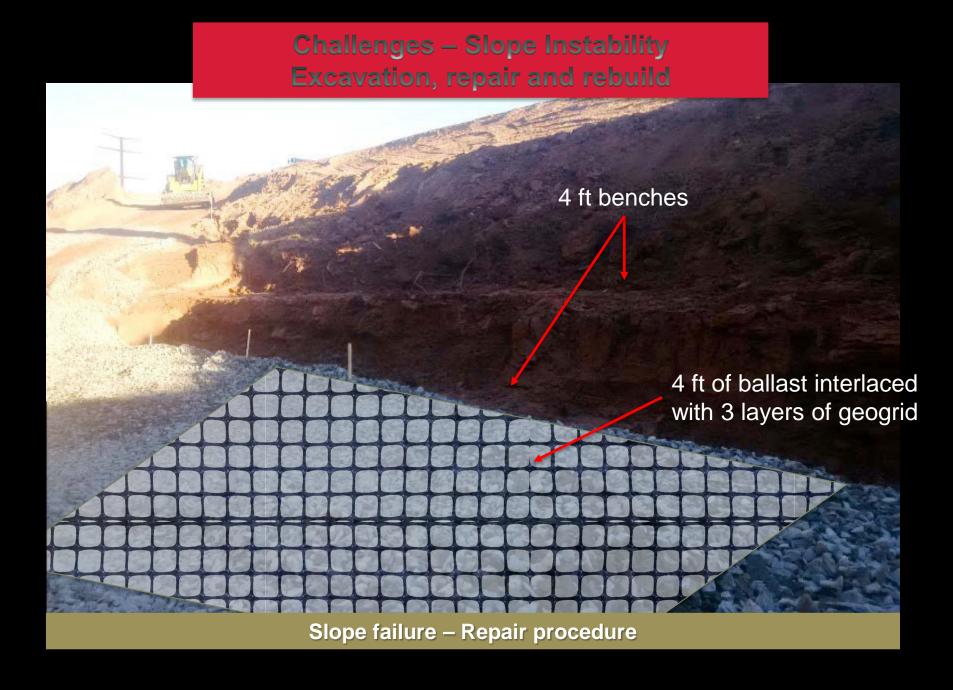
Slope failure analysis

Challenges – Slope Instability 2 ft high scarp appears overnight Slip plane

Slope failure – 300 ft long, 30 ft high

Challenges - Slope Instability **Unit Weight** Material Name Strength Type (lbs/ft3) (psf) Mohr-Coulomb Clay None Sand Fill Mohr-Coulomb 34 Mohr-Coulomb 200 225 250 25 50 75 125 150 175 275 100 STEELTON HILL DOUBLE TRACK EMBANKMENT STABILIZATION WISCONSIN CENTRAL LIMITED NEW DULUTH, MN CONSULTANT 2015-02-17 CONDITIONS AT FAILURE SRV TOTAL STRESS PARAMETERS STA 1515+45 KSC FIGURE PROJECT No. CONTROL 13-03084

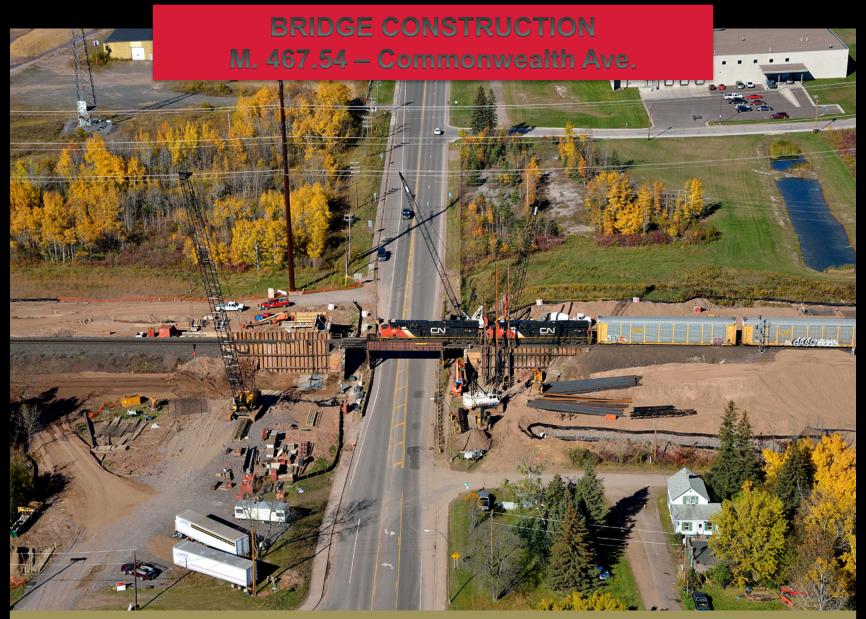
2 through plate girder bridges, 1 span each, 120 ft long

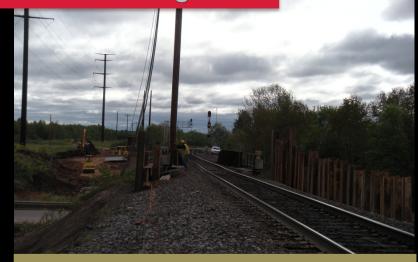
Bridge Construction - Shoring Ferrome Clear for trains Sheets are 12 1

Sheets are 12 ft from track centre

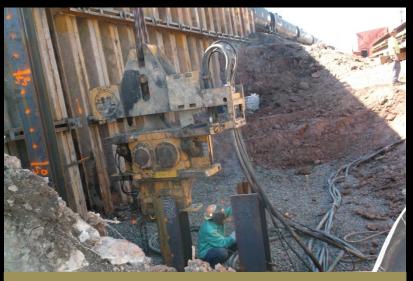
Shoring height = 24 ft

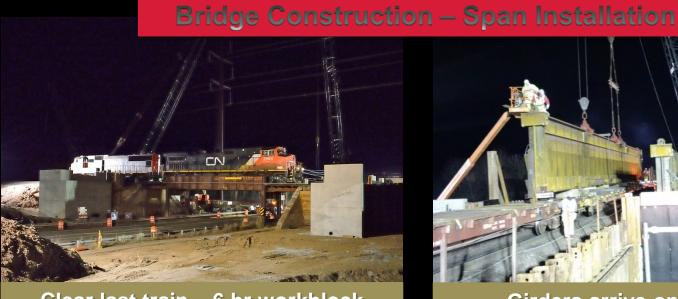
Clear last train – 6 hr workblock

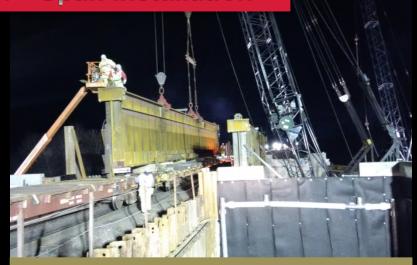
Girders arrive on railcars

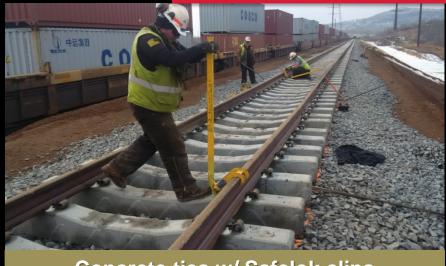
Concrete ties w/ Safelok clips

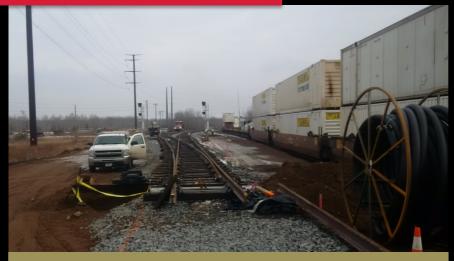
New power switches

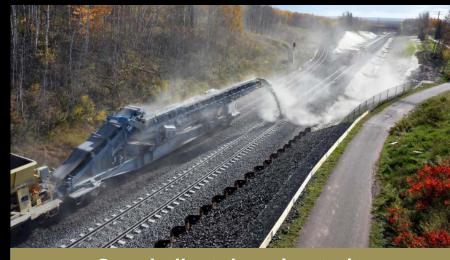
Grex ballast dumping train

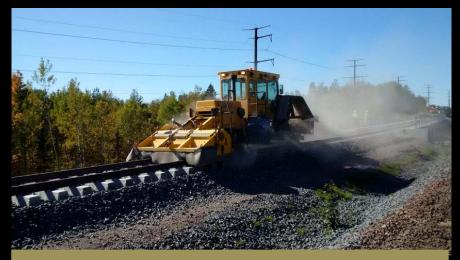
Ballast regulator

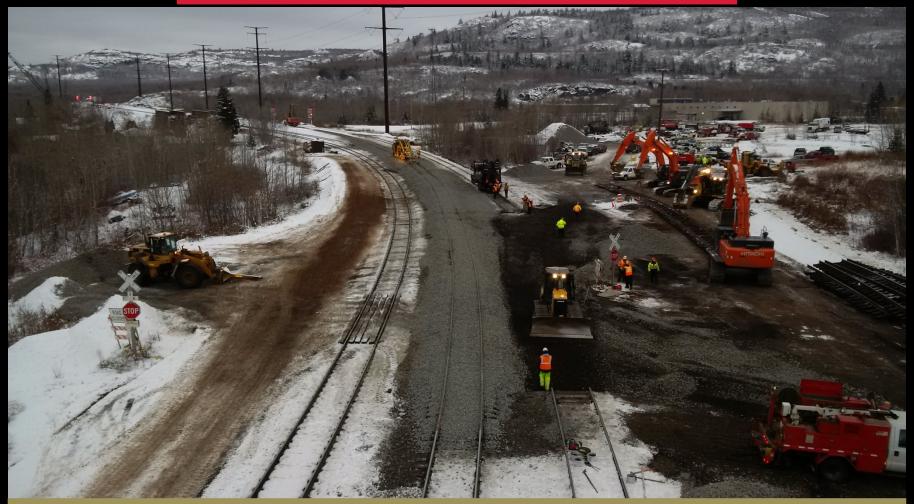
Dec. 8th - 12 hour workblock Track re-alignment, build 800 ft of new track, put new CP into service

2 tampers, 2 ballast regulators, 3 hi-rail dump trucks, 4 large excavators, 2 speed swings, 2 TFO trucks, 1 boom truck, 3 front-end loaders, 45 trackmen

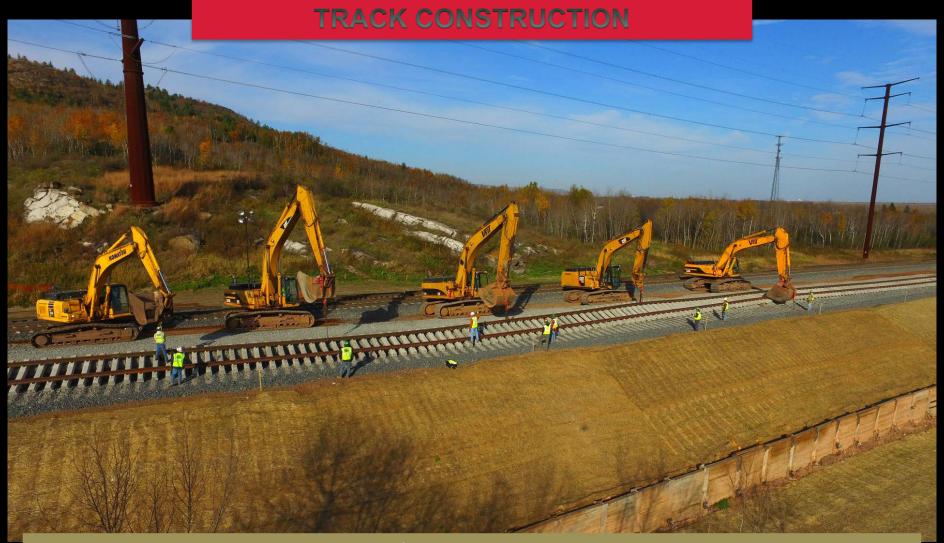
Oct. 19th - 24 hour workblock Build new grade, shift 1400 ft of track, put new CP into service

2 tampers, 2 ballast regulators, 8 large excavators, 2 rollers 4 welding trucks, 1 boom truck, 3 front-end loaders, 60 trackmen

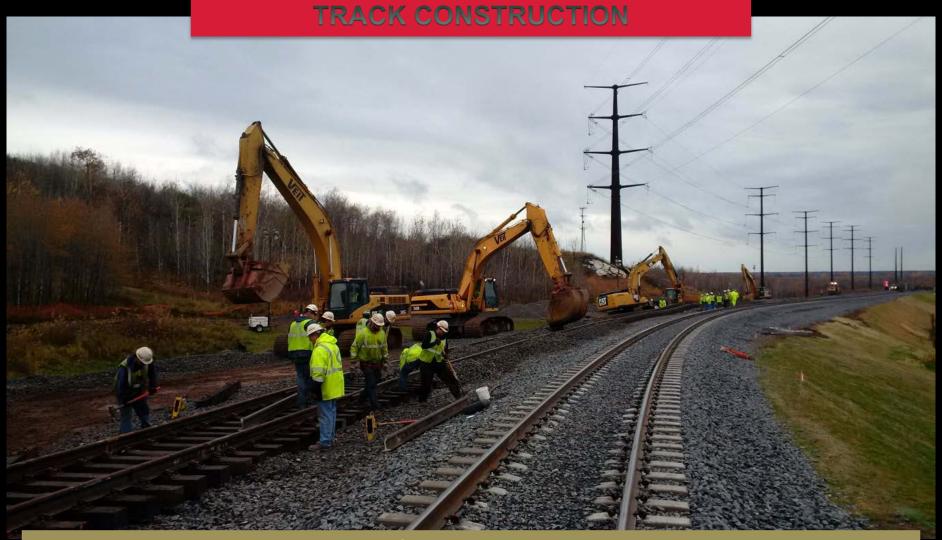
Oct. 26th - 12 hour workblock Build new grade, shift 800 ft of track, put new CP into service

2 tampers, 2 ballast regulators, 5 large excavators, 2 welding trucks, 1 boom truck, 2 front-end loaders, 20 trackmen
