RECENT RESEARCH TO BETTER UNDERSTAND WHEEL RIM AXIAL RESIDUAL STRESS AND VERTICAL SPLIT RIM WHEEL FAILURES

November, 2012

Amsted Rail bringing heavy haul freight rail transportation to the World

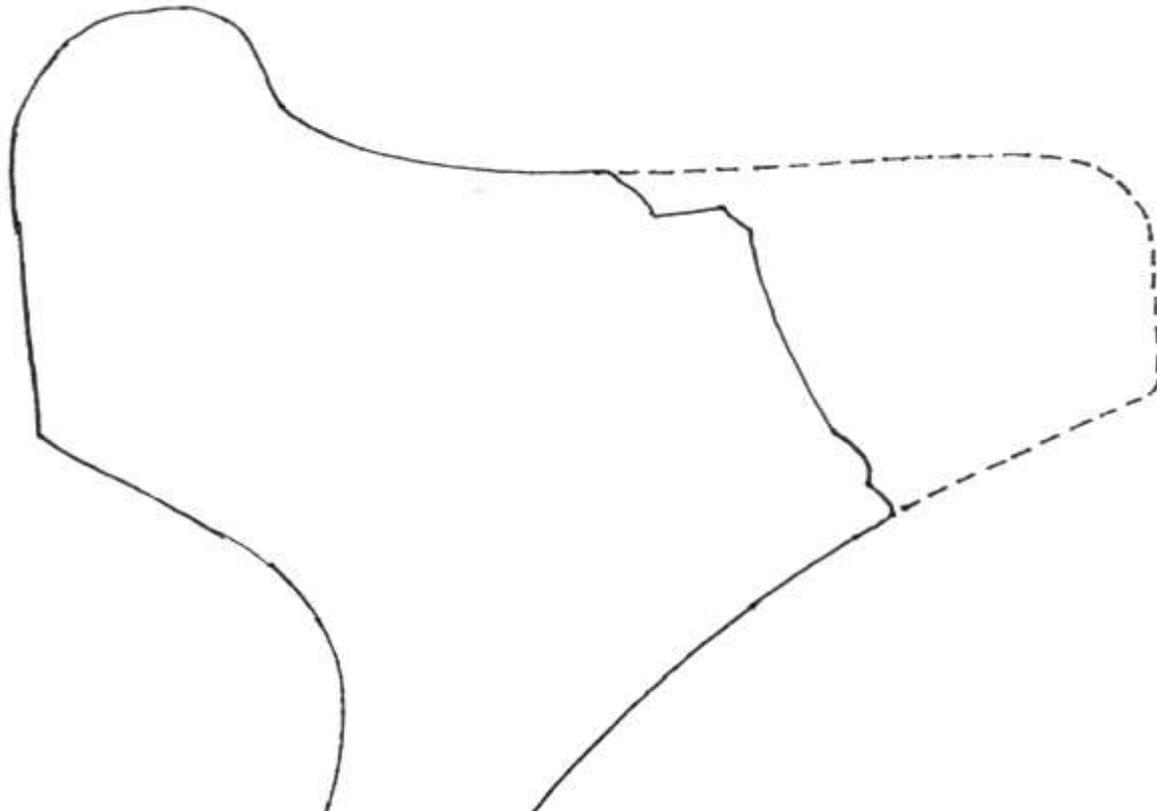
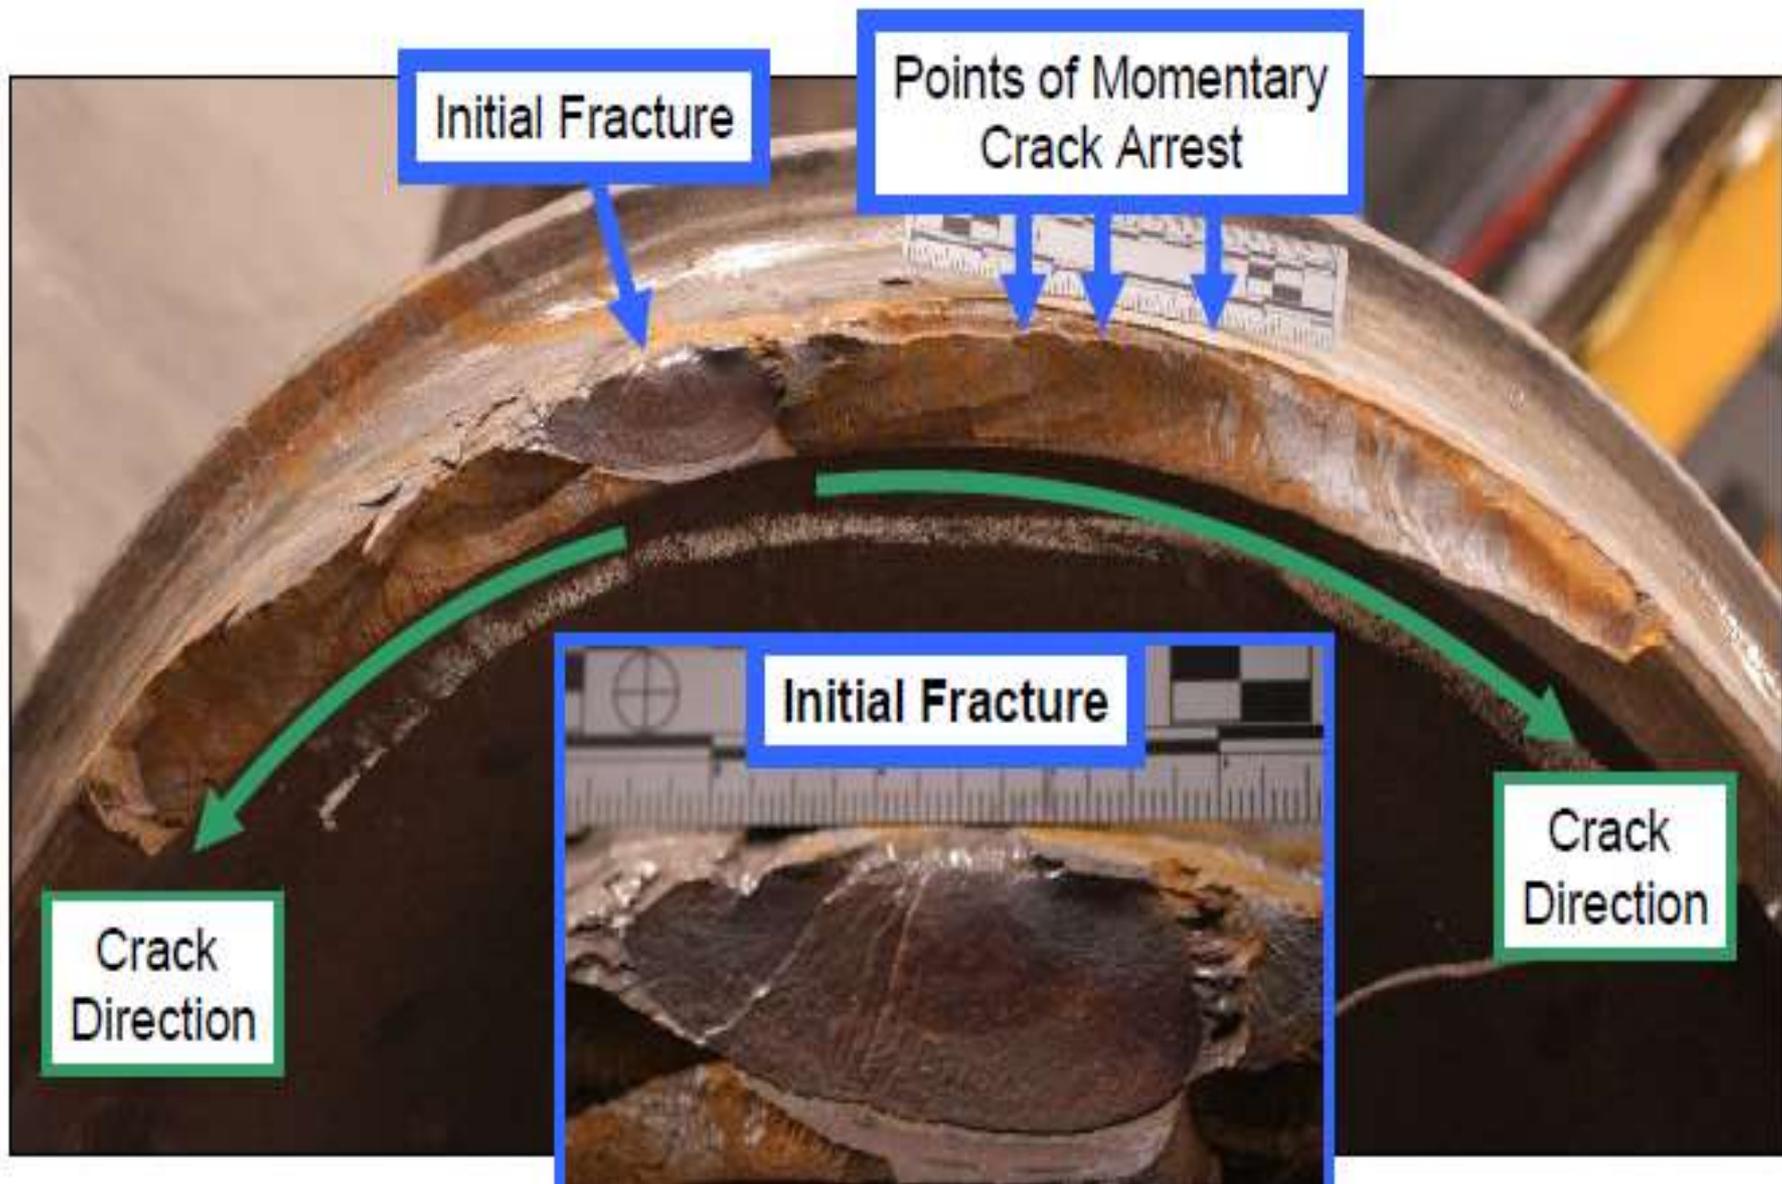
Vertical Split Rims

- VSRs start almost exclusively at tread damage
- Typically, a circumferential section of the front rim face breaks off, and wheel can drop into gage

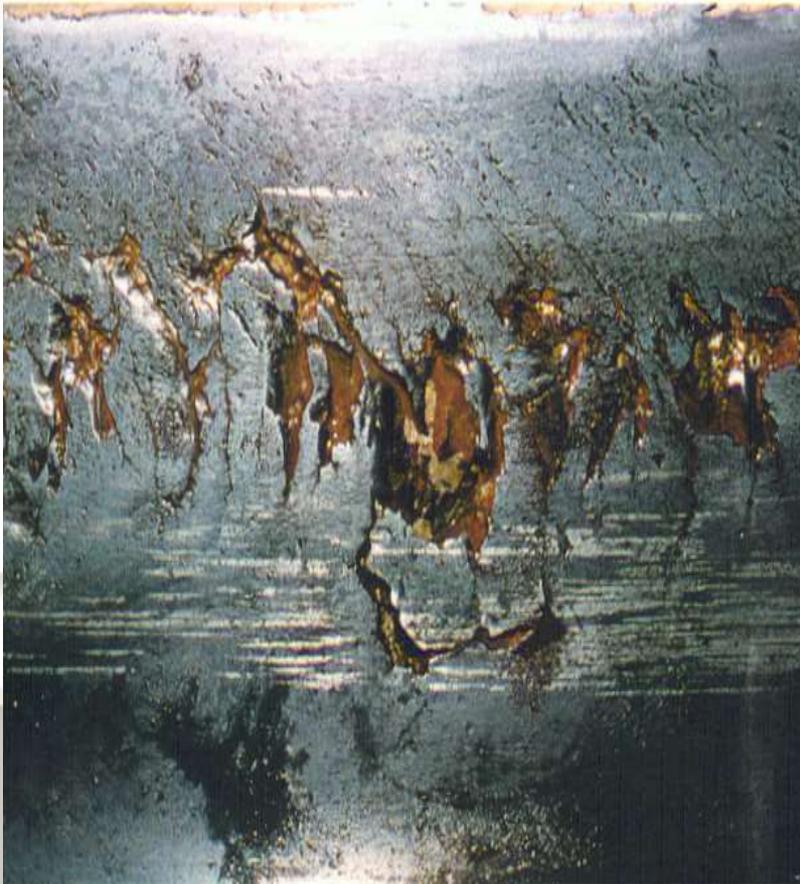
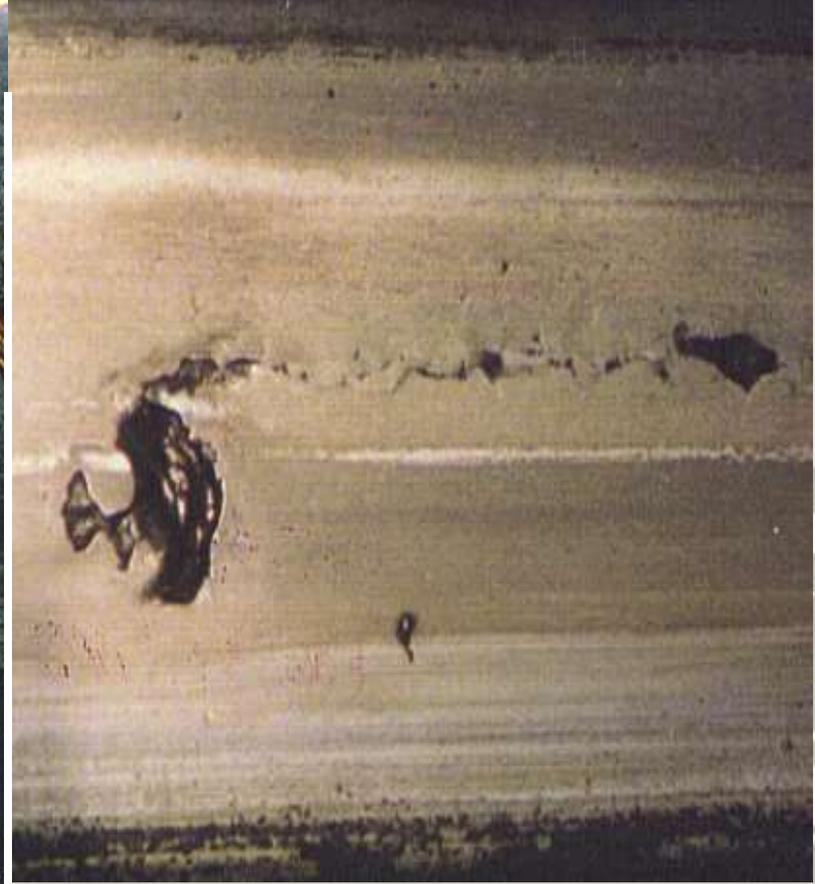
Tread Damage

Observations on VSRs by Dick, et al. on 68 wheels

- VSRs length is typically 15 cm to entire circumference
- Typically VSR is 25 to 70 mm from wheel's front rim face
- 263K GRL and 286K GRL cars have similar number of VSRs
- Covered hoppers had most VSRs with 15/17 on B end
- 62/68 wheels were 36" or 38", only 6/68 were 33"
- Not all were thin rimmed wheels
- Most VSRs had hollow tread wear
- VSRs more common in winter months
- Most VSRs were impacting before failure
- Both forged and cast wheels have VSRs

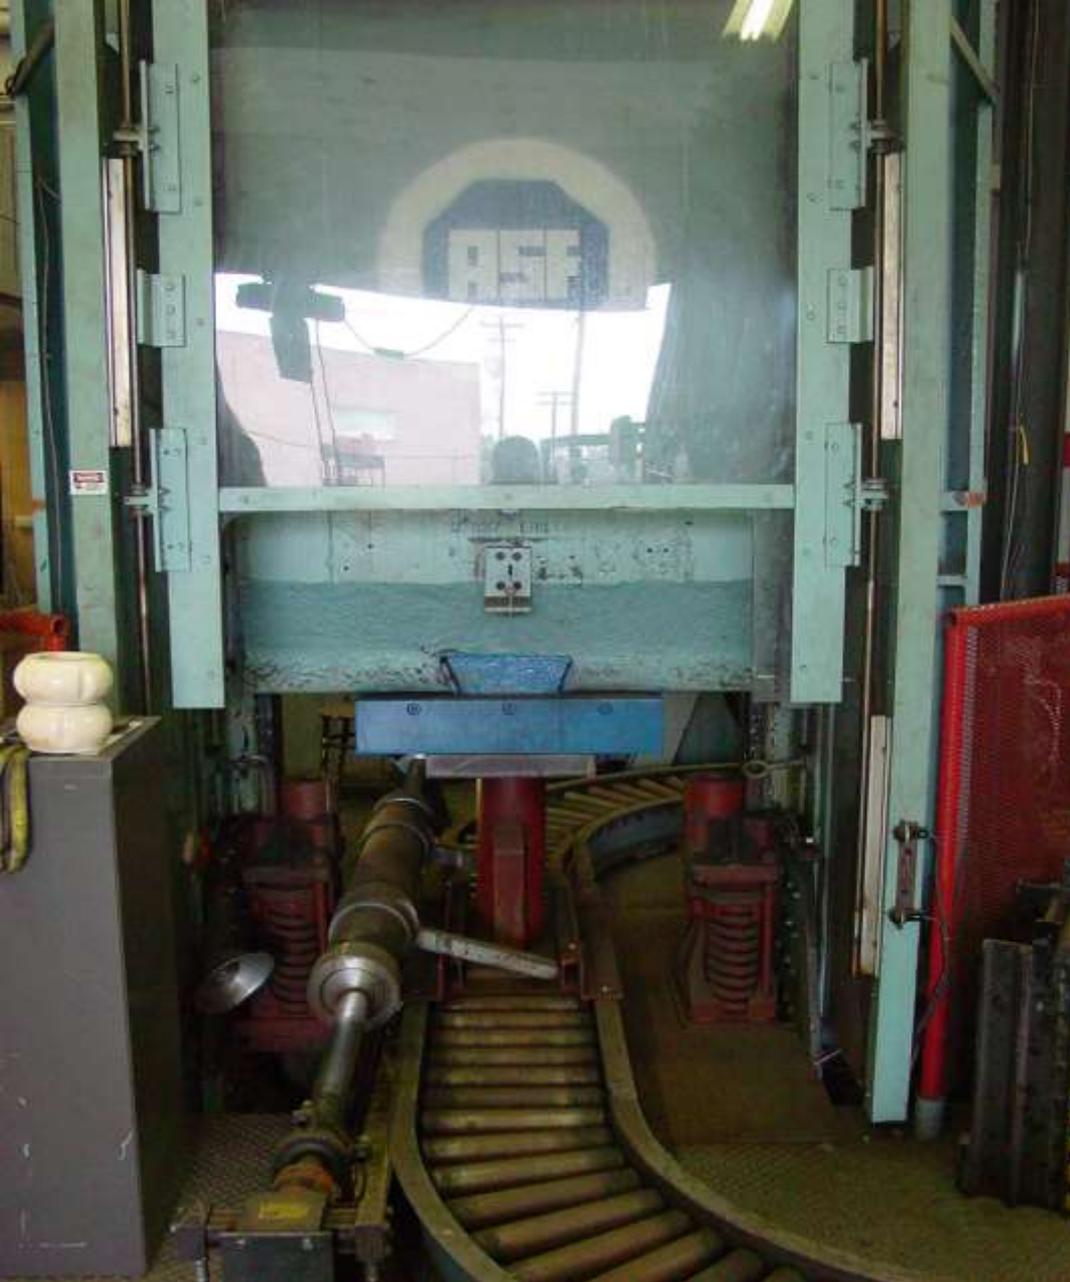
**ASF Keystone
drop hammer can
impart dynamic
loads up to 2,000
kips – well in
excess of 200 kips
occasionally seen
in service.**

- Tried to create a VSR in lab setting
- Found tread damaged wheelsets that could be susceptible to impact damage
- Used ASF-Keystone drop hammer, Camp Hill, PA, on wheel tread to simulate service impact load
- Goal – Determine critical impact load and load location
- Tread damaged wheel hit more than 31,000 times in a drop hammer with 250-300 kips impact load
- Did not create VSR but wheel rim was severely deformed

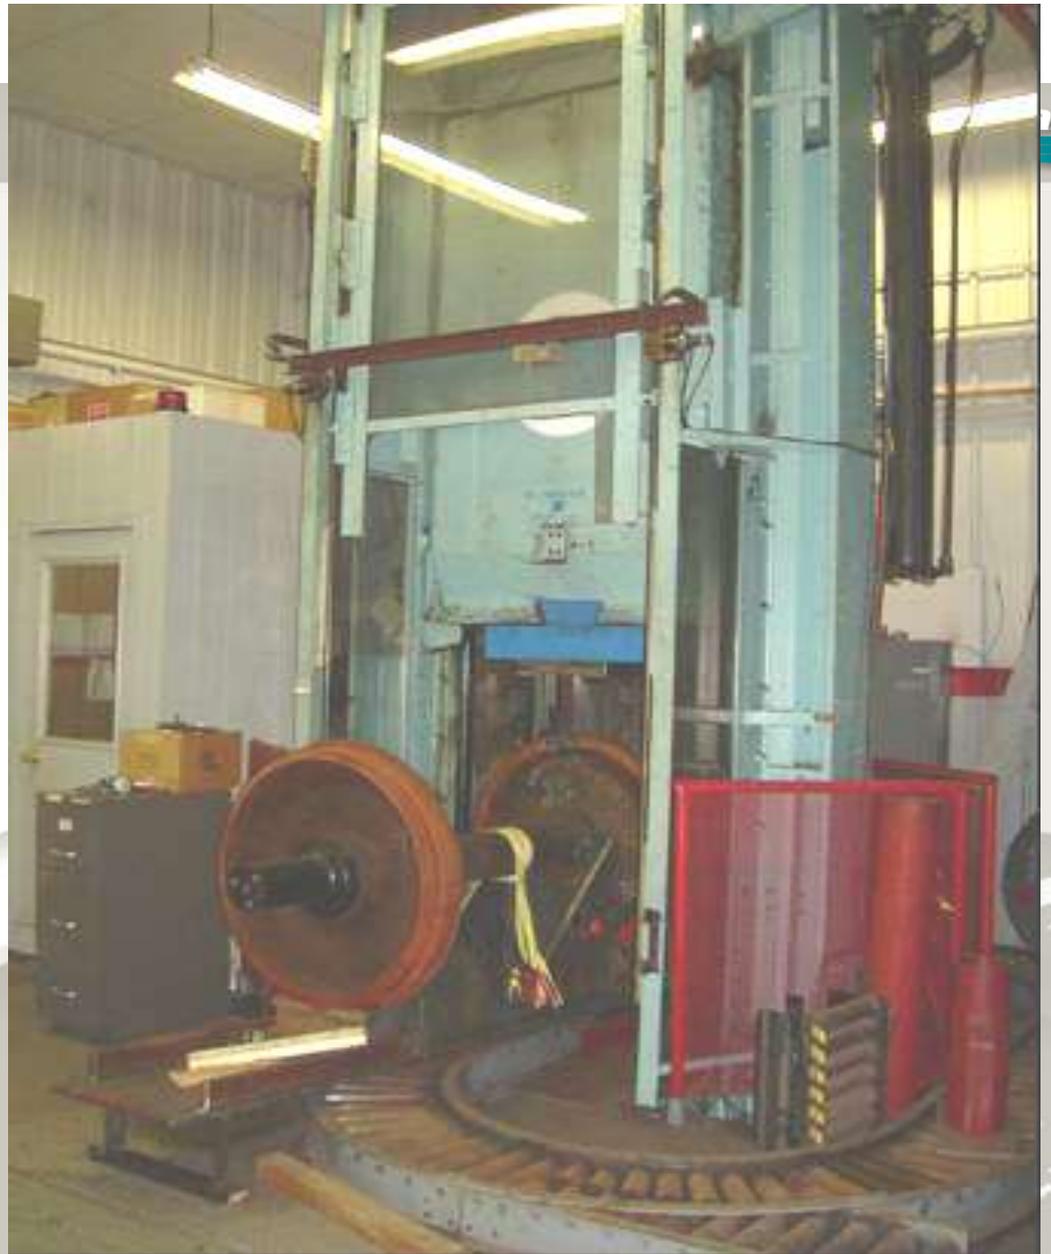
ASF-Keystone
Drop Hammer
was modified
to accept a
wheelset for
impact testing

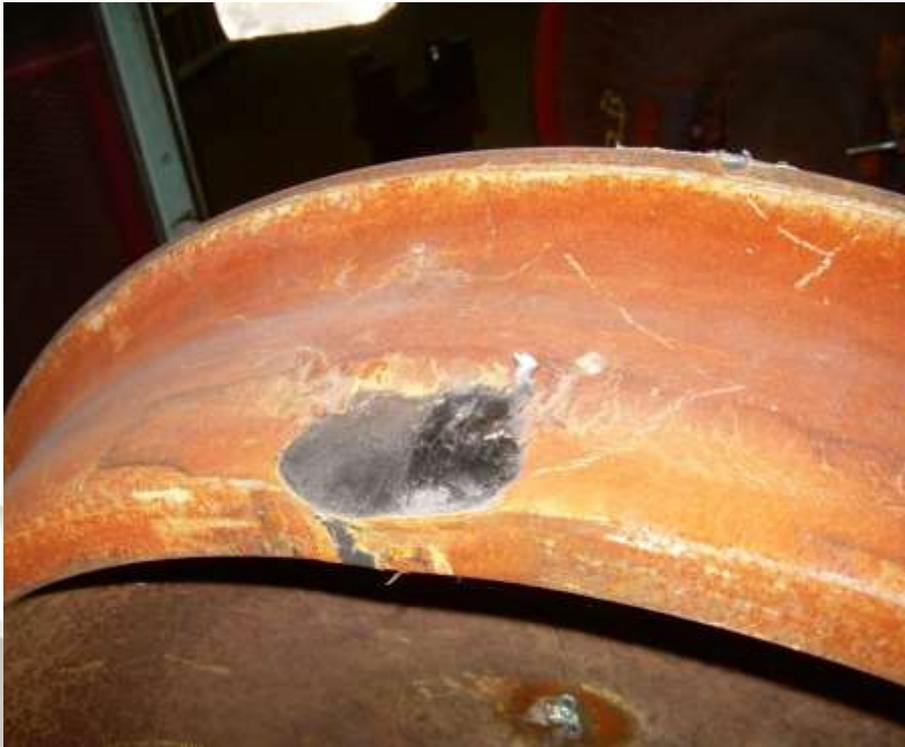
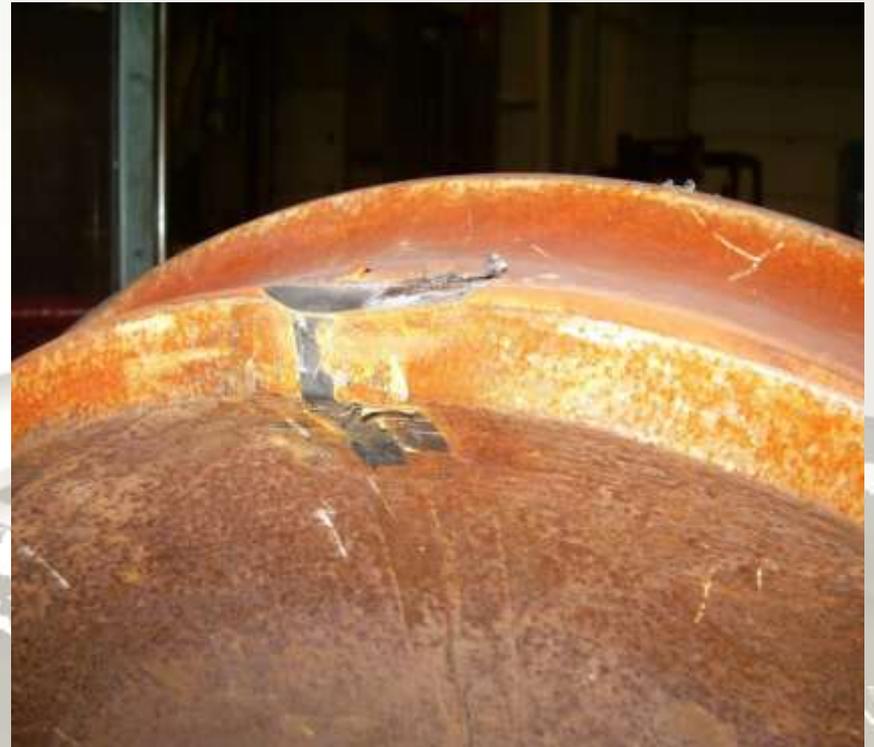
Rim Edge Deformation At 28,500 Drop Hammer Hits

- 54 miles of service given wheel circumference
- Cracks noted below tread damage
- FEA work with condemnable wheel rim thickness 7/8", and 100 kip point load 1" from front rim face showed 28.5 ksi axial stress at tape line
- Also the hoop stress at the front rim face to plate fillet was 28.8 ksi - this helps to explain why VSR's propagate the way they do, especially under high impact loads

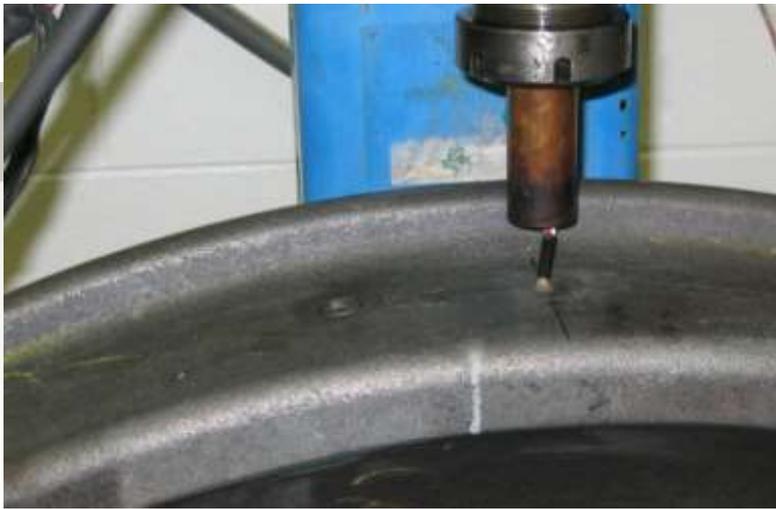
- Contacted Lambda Research in Cincinnati
- Started with x-ray diffraction and core drilling from the tread surface
- Axial residual stress measurements (not hoop, not radial)
- Initial testing to see if there were differences between new and VSR wheels

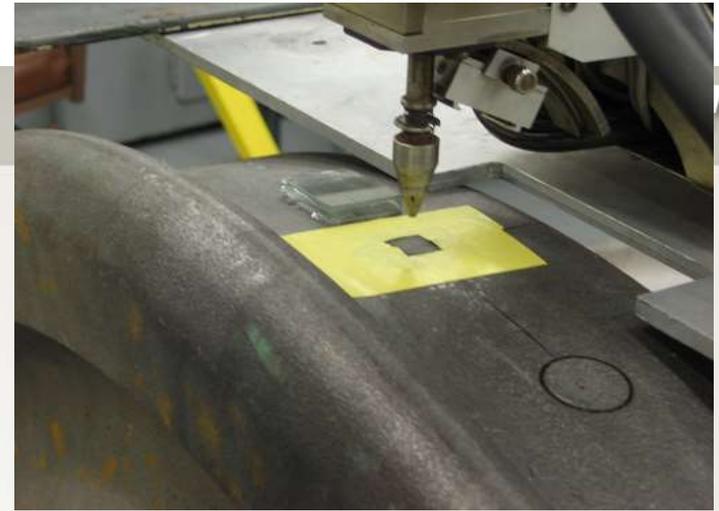
Core
drill
from
tread
surface

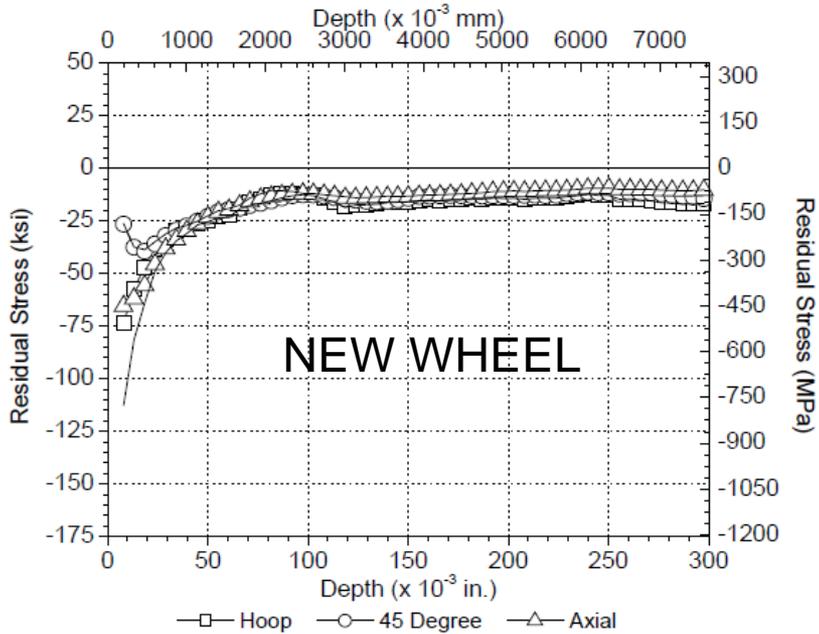
RESIDUAL STRESS DISTRIBUTION

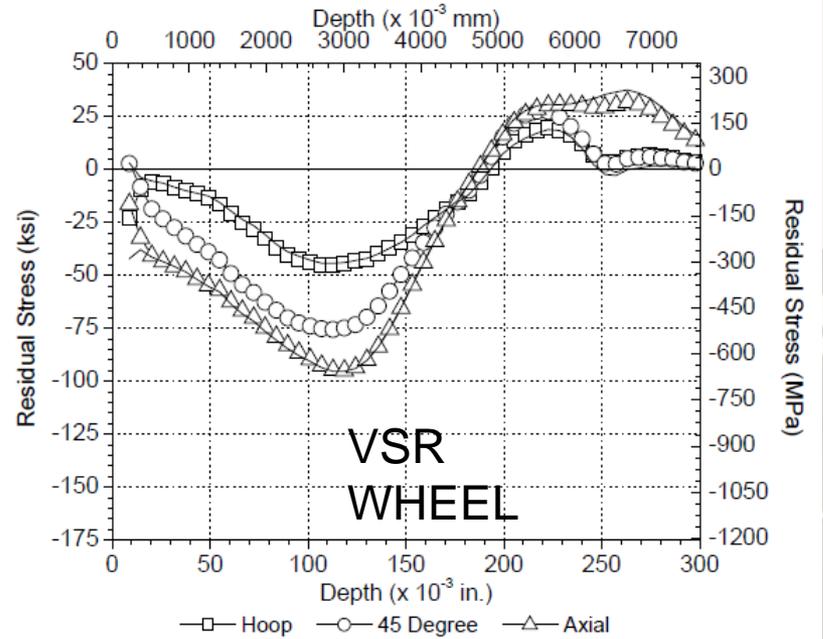
RESIDUAL STRESS DISTRIBUTION

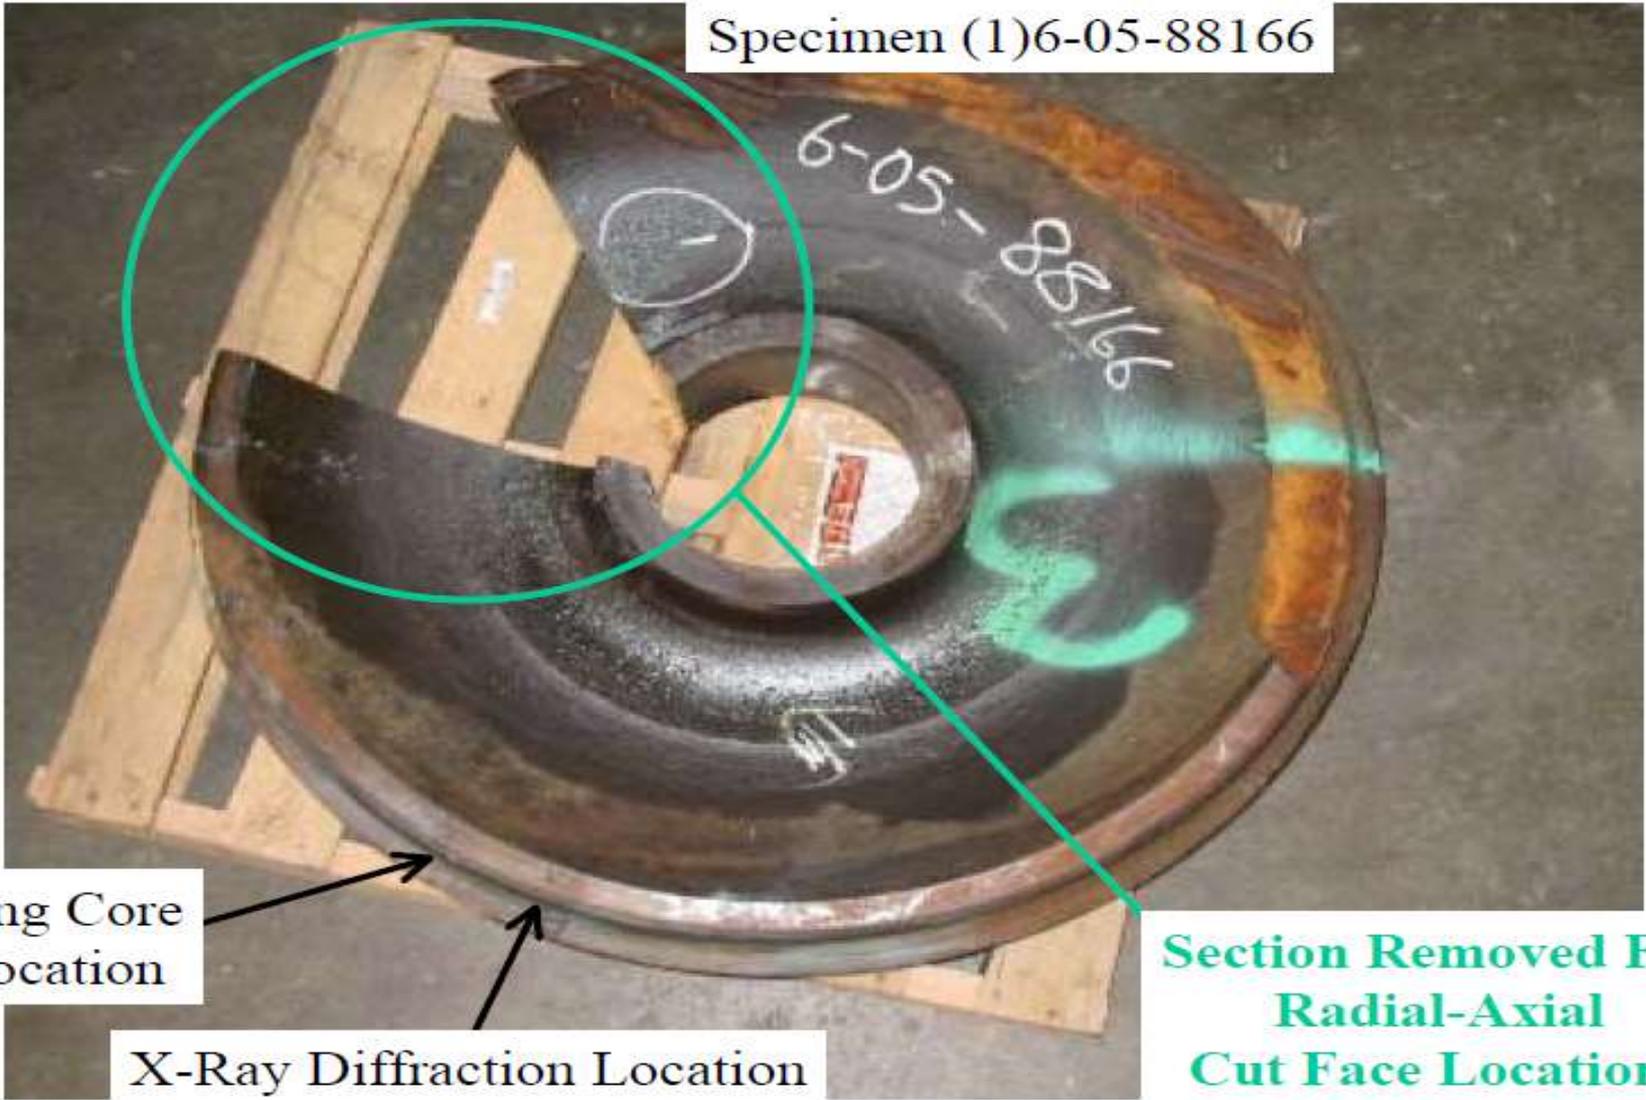
Specimen (1)6-05-88166

Ring Core Location

X-Ray Diffraction Location

Section Removed For Radial-Axial Cut Face Locations

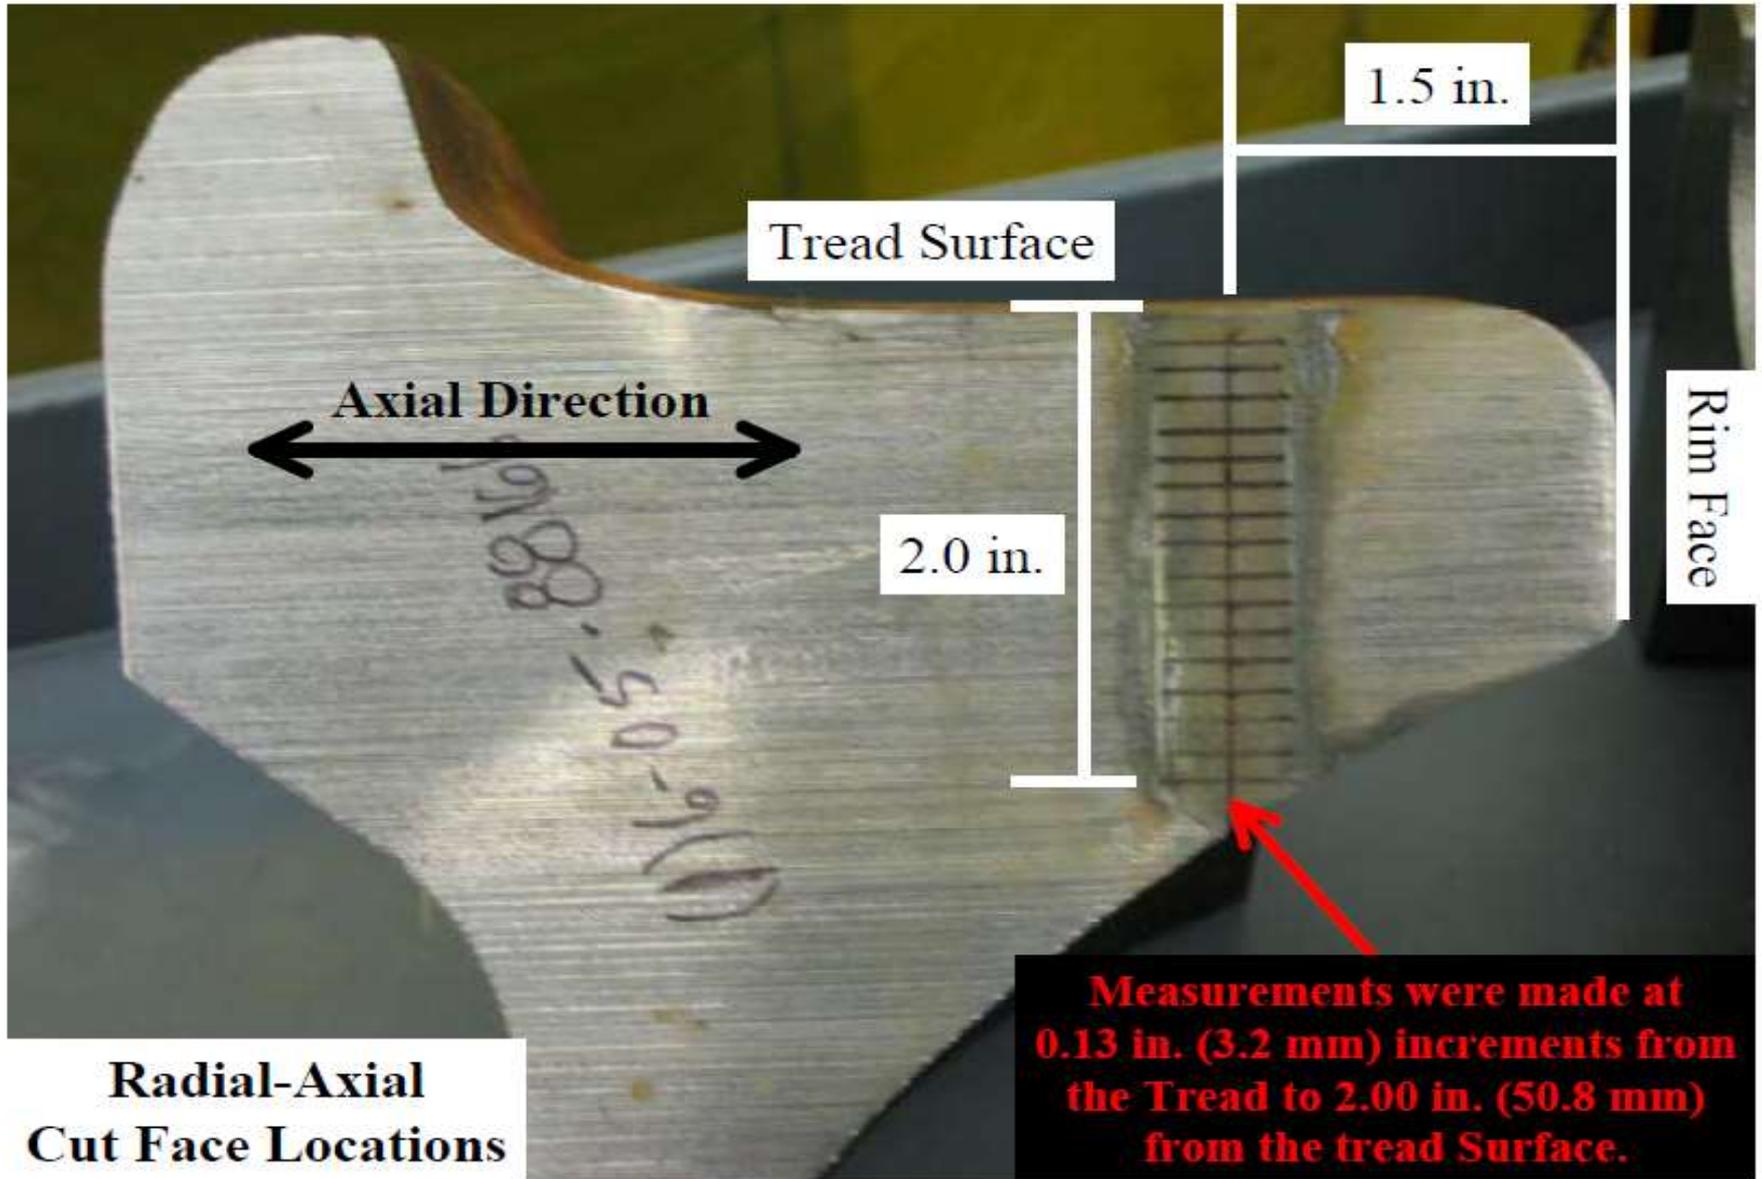
**Radial-Axial
Cut Face Locations**

**Measurements were made at
0.13 in. (3.2 mm) increments from
the Tread to 2.00 in. (50.8 mm)
from the tread Surface.**

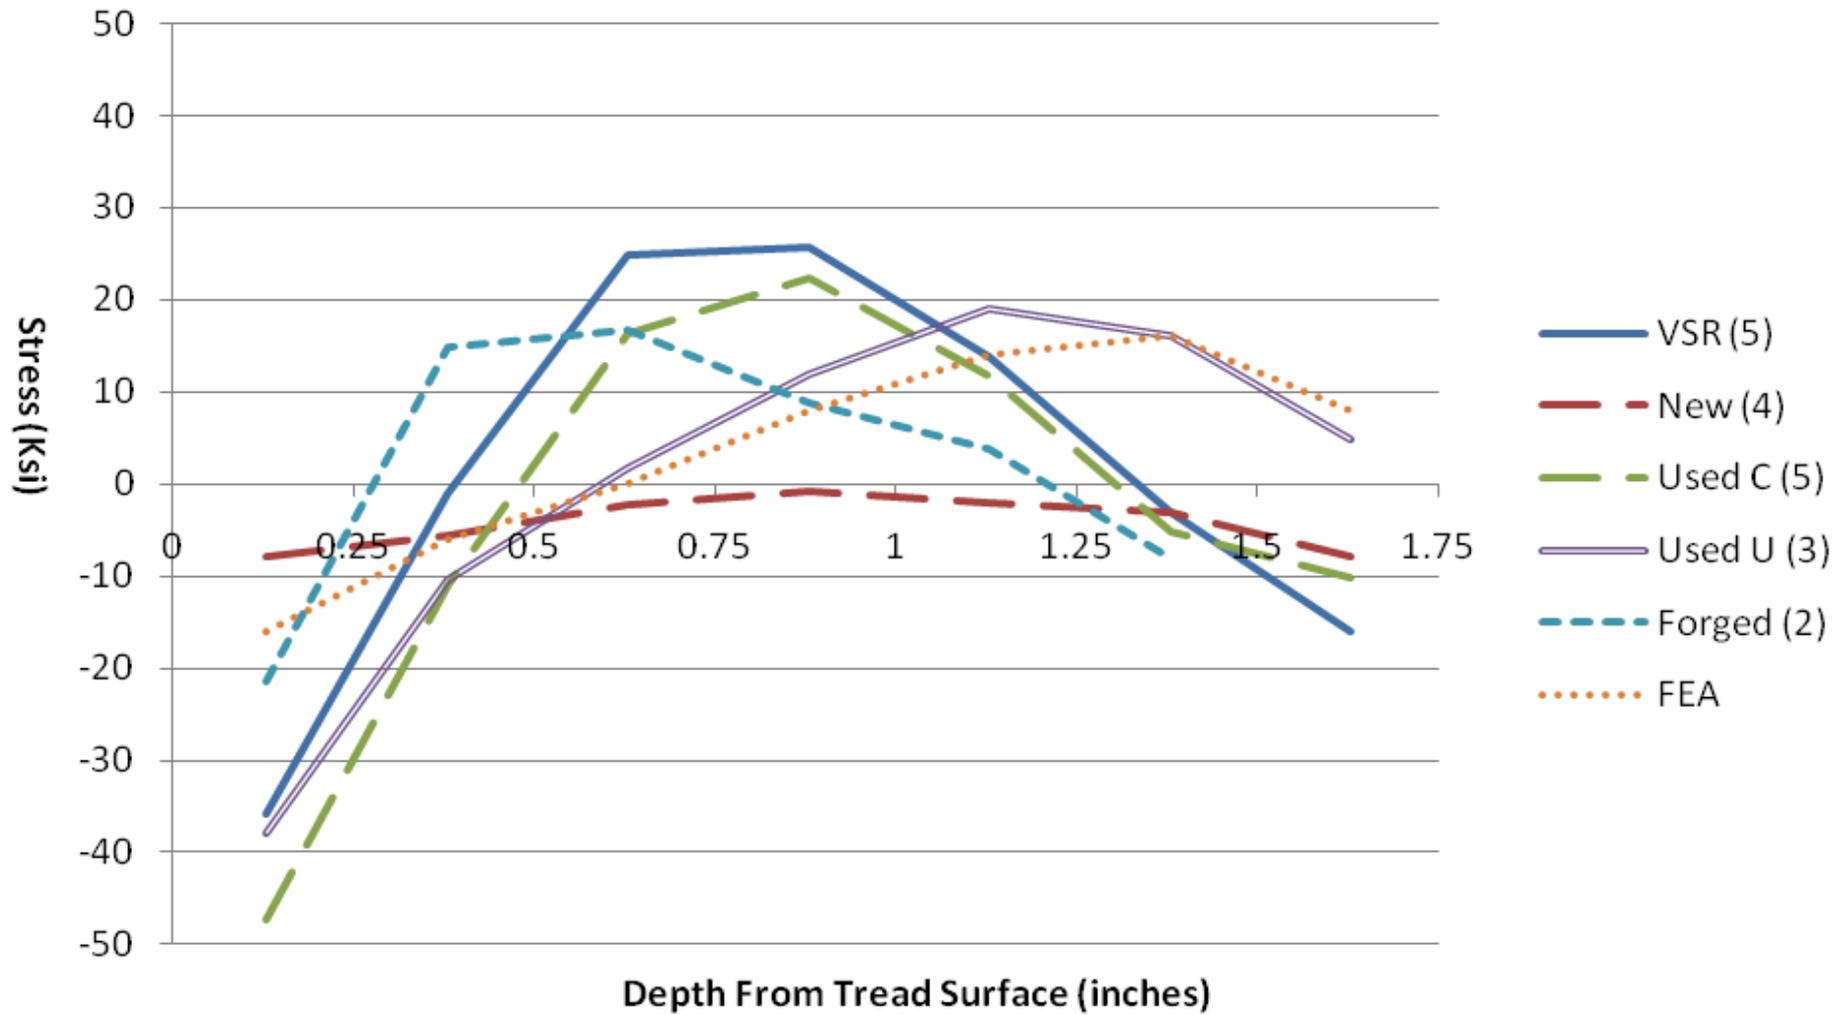
Axial Residual Stress 1.5 inch From Front Rim Face

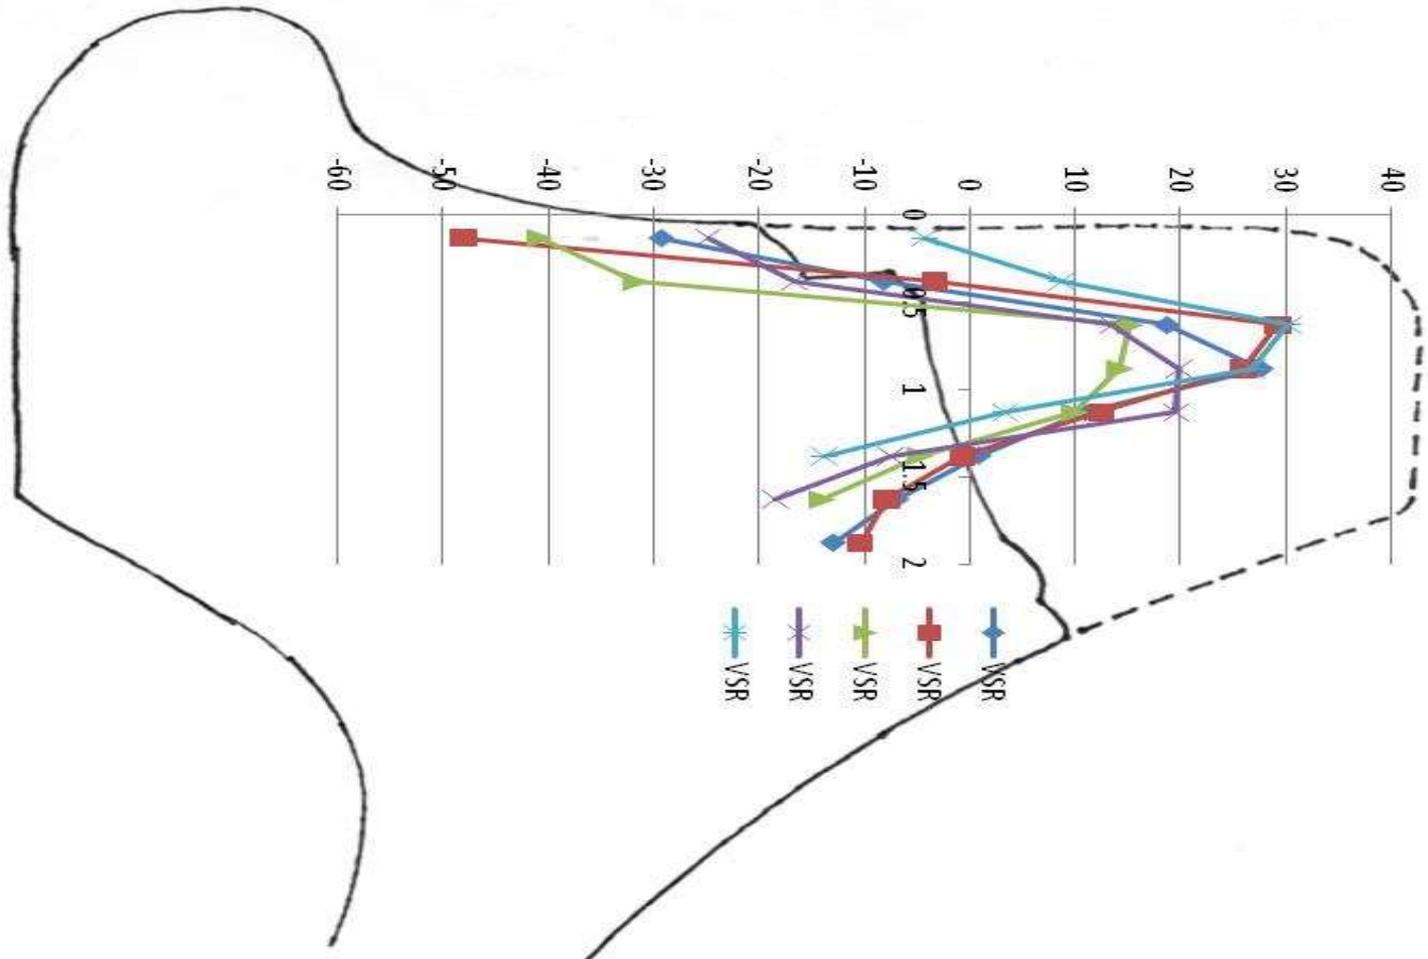
VSR Profile With Results Superimposed

- Tread damage occurs due to shelling (RCF/thermal-mechanical shelling) or spalling (wheel slides)
- Cracks propagate under rolling and pounding loads
- Highly compressive layer at tread surface must be balanced by tension deeper below the surface
- When cracks propagate into this tension zone, cracks can rapidly change direction in service, making VSRs more likely
- Class U wheels had the tension zone much deeper below the tread surface – this, and lower loads, meant that U wheels did not often suffer VSRs

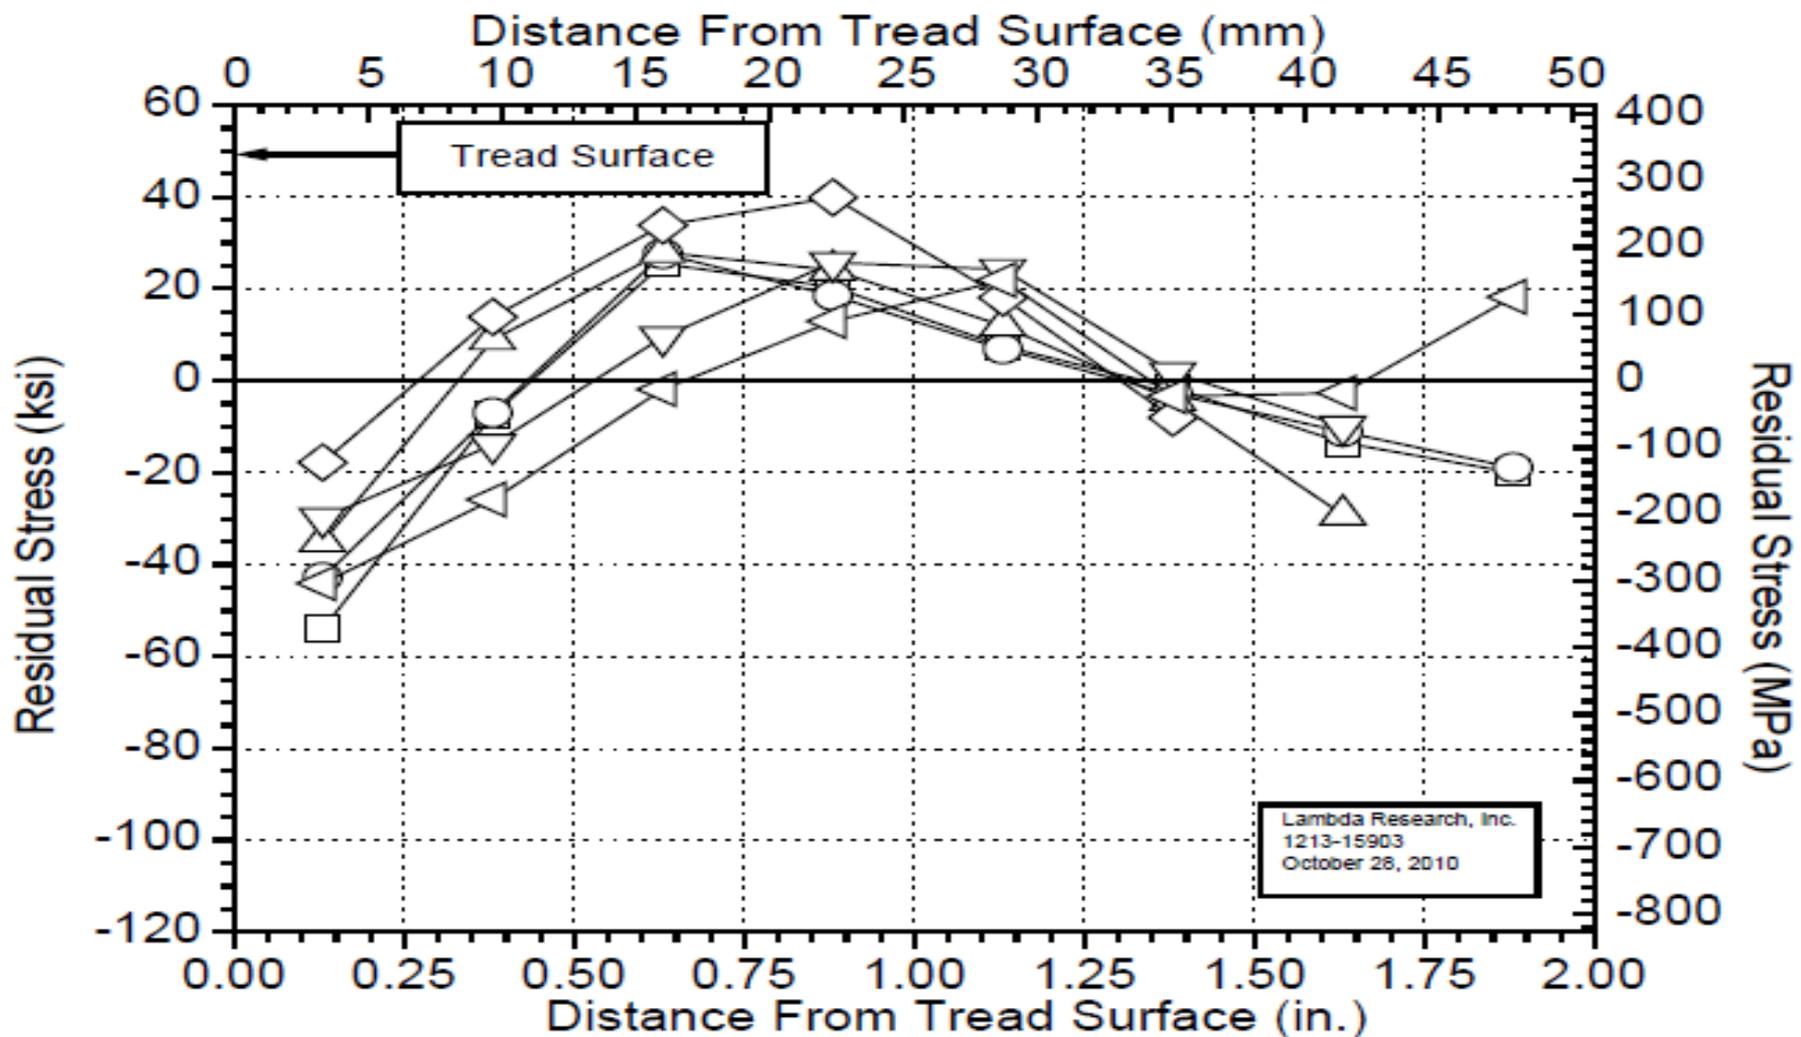
AXIAL RESIDUAL STRESS DISTRIBUTION

- 3/98 90100A Away From The Failure
- 3/98 90100A Near The Failure
- △— 11-99-82576 GK CH36
- ▽— 7-96-70824 GC CH36
- ◇— 12-05-03938 CH36 GK
- ◁— Drop Hammer (8-1-97835)

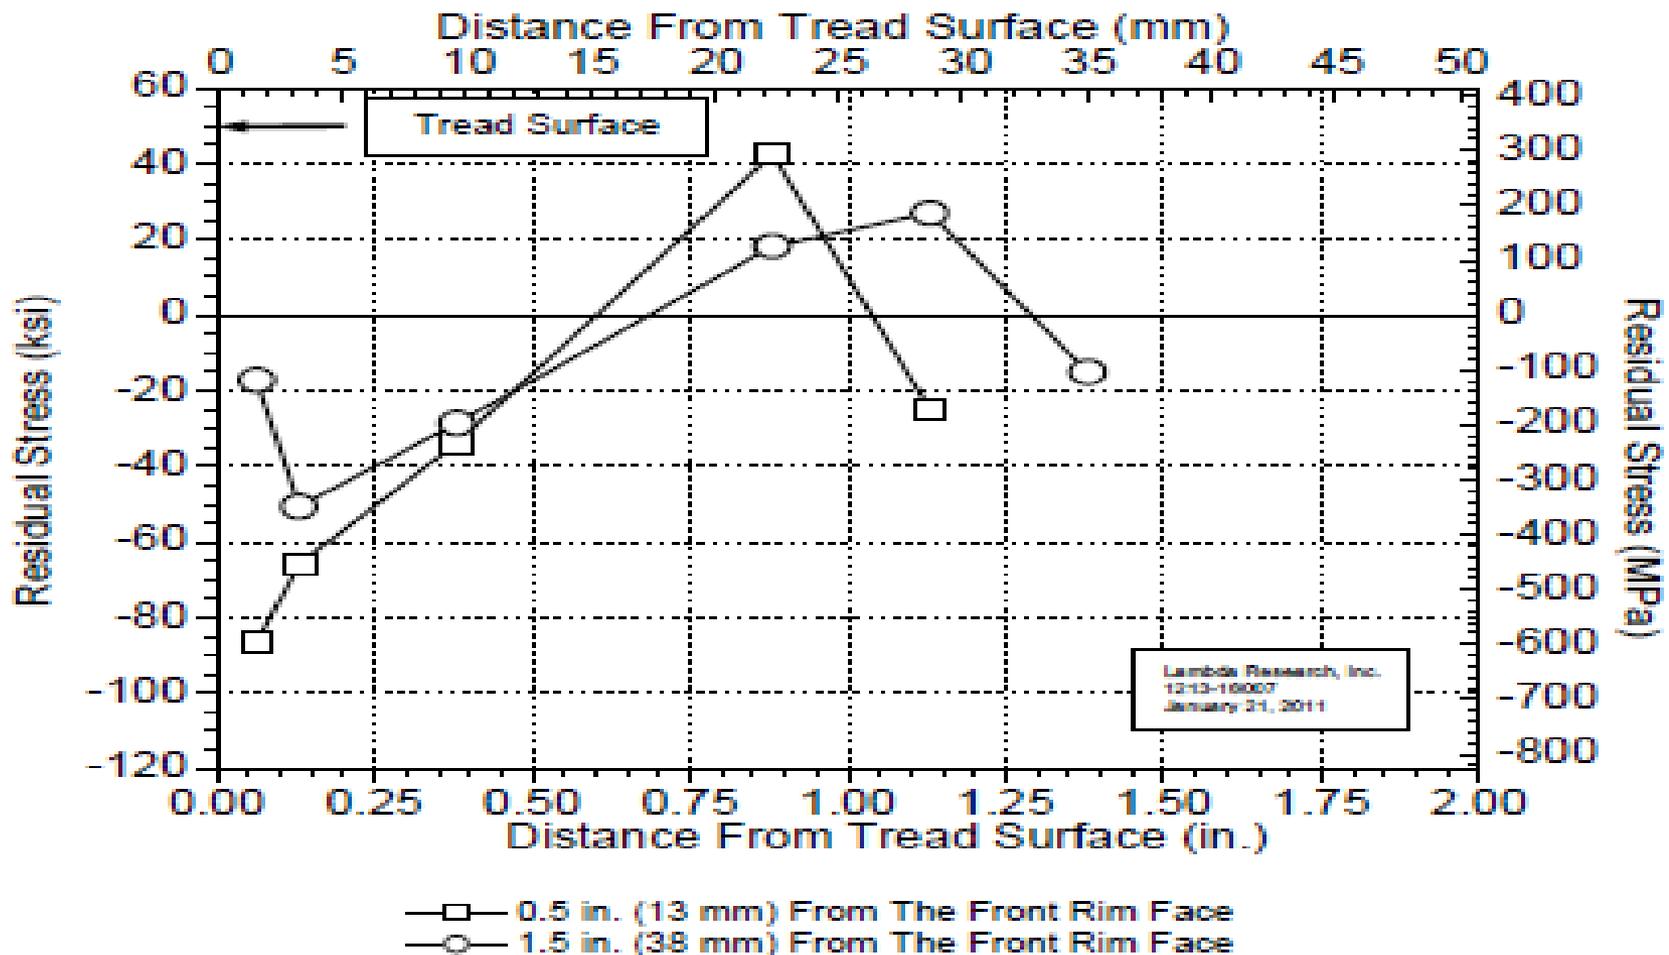
Drop Hammer Test Wheel

31,000+ hits, 250-300 kips

AXIAL RESIDUAL STRESS DISTRIBUTION
