RECENT RESEARCH TO BETTER UNDERSTAND WHEEL RIM AXIAL RESIDUAL STRESS AND VERTICAL SPLIT RIM WHEEL FAILURES

November, 2012

Amsted Rail bringing heavy haul freight rail transportation to the World

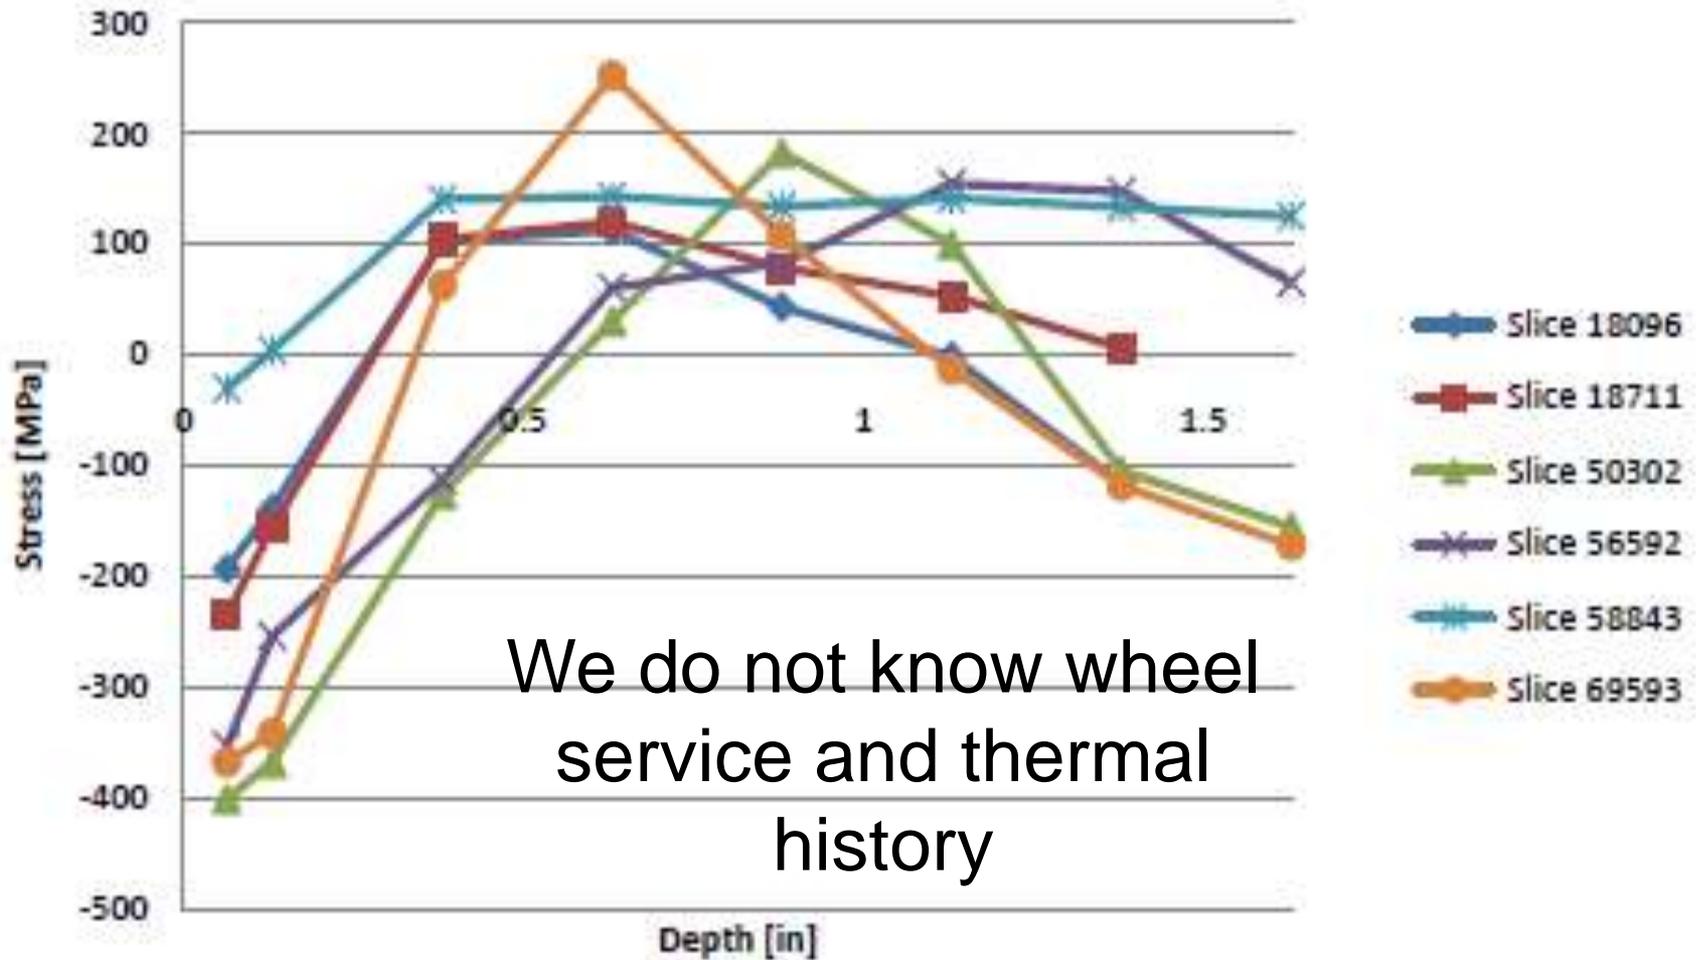
Axial Residual Stress Data – Used Wheels

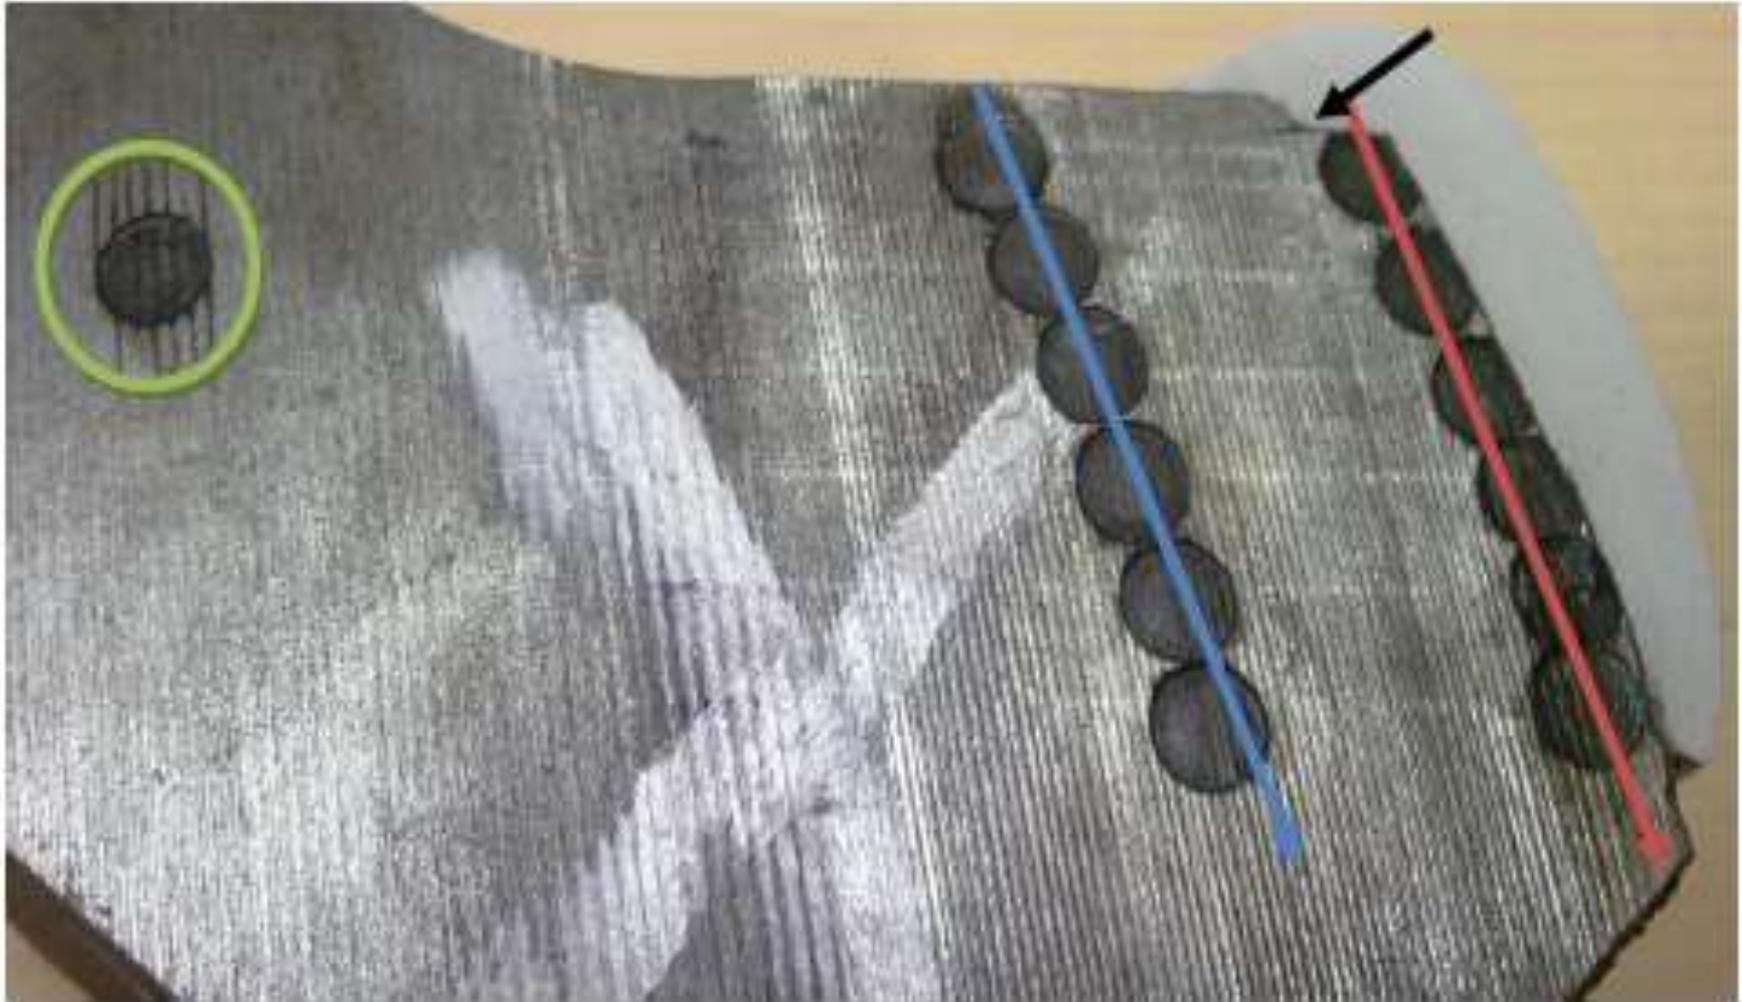
Testing At & Away From VSR

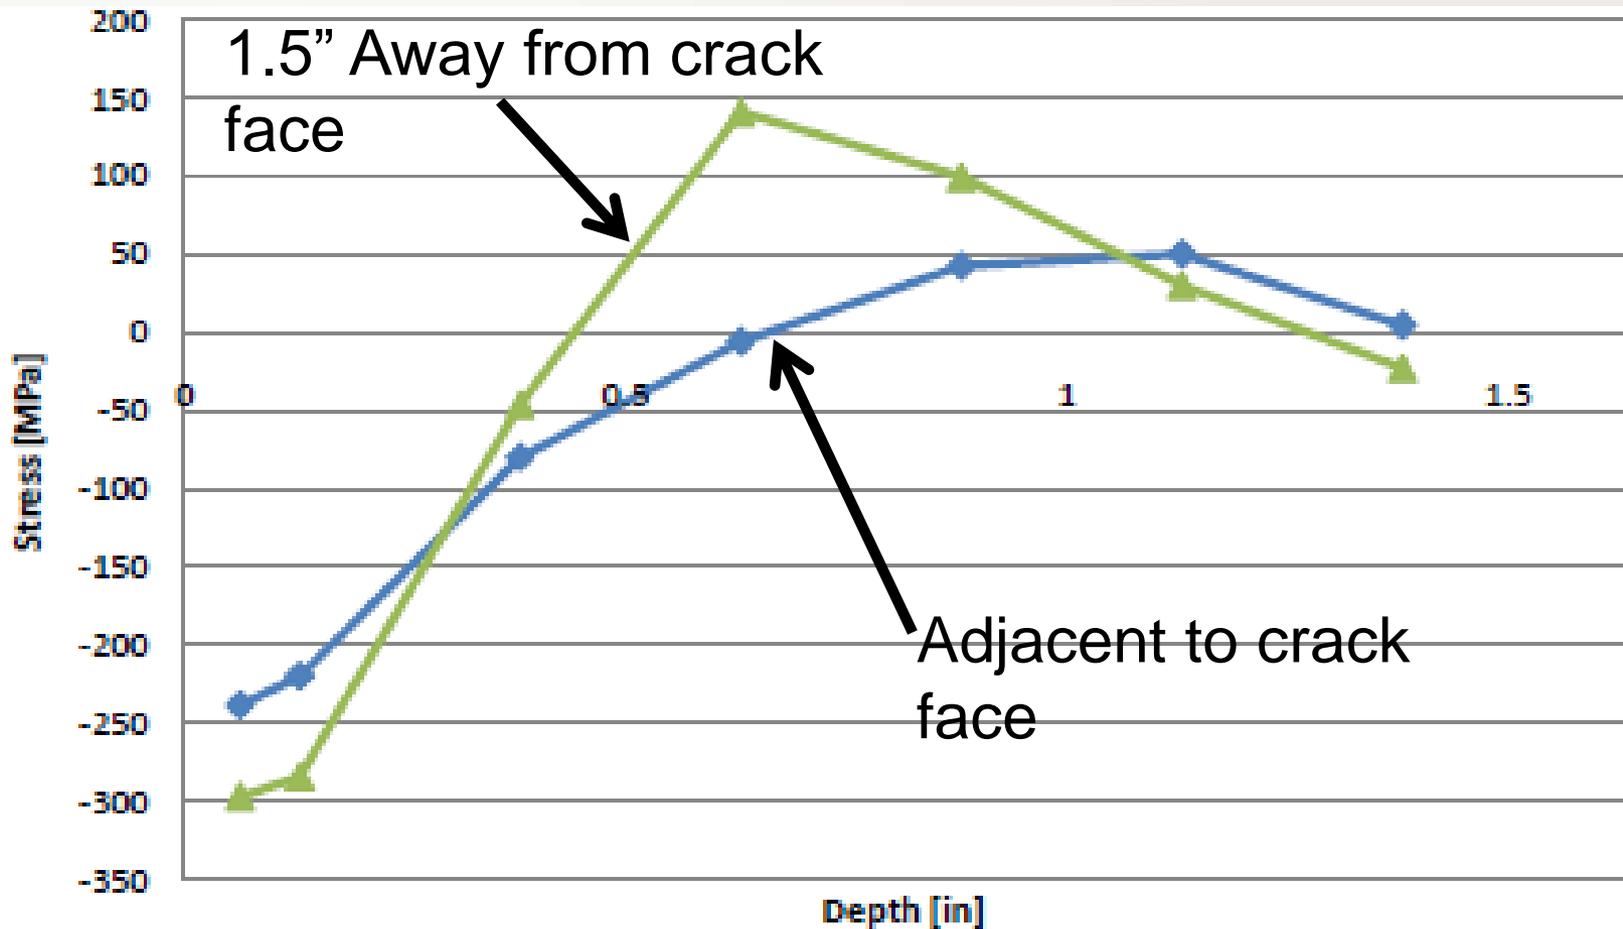
Axial Residual Stress At and Away From Failure Edge

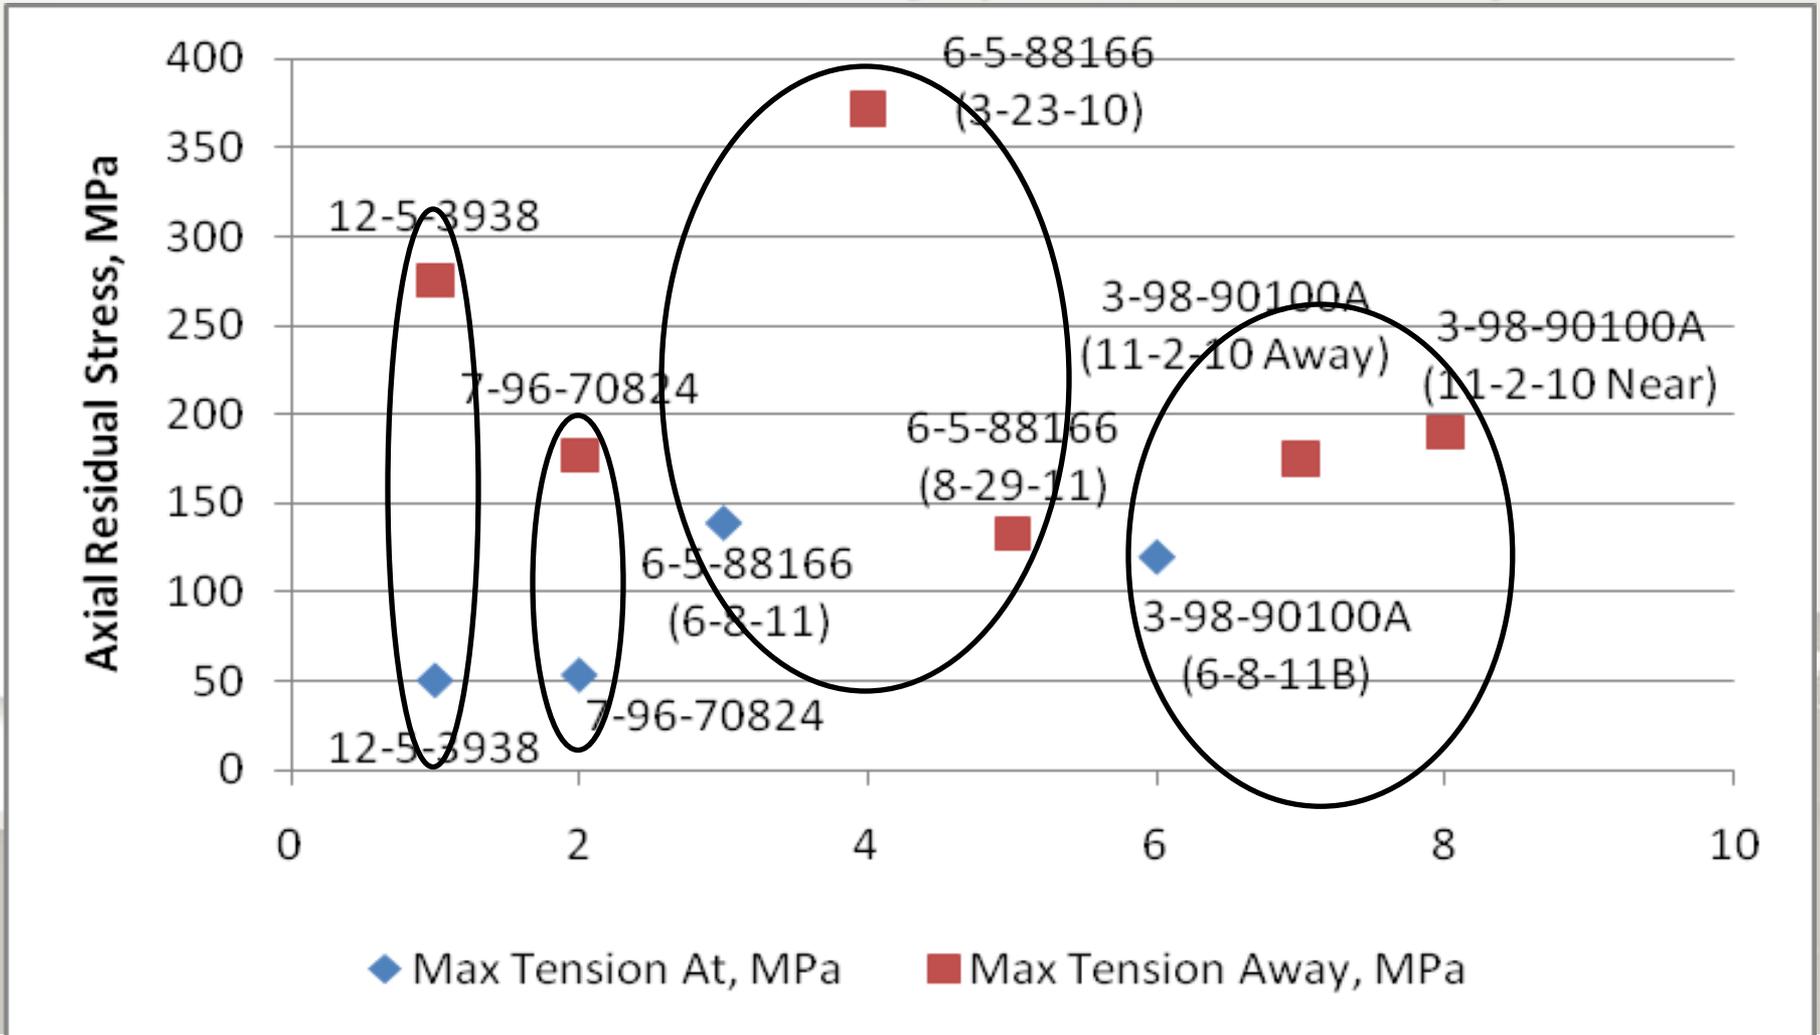
Max Axial Tensile Stress Values For Slices Tested At and Away (1.5" from FRF)

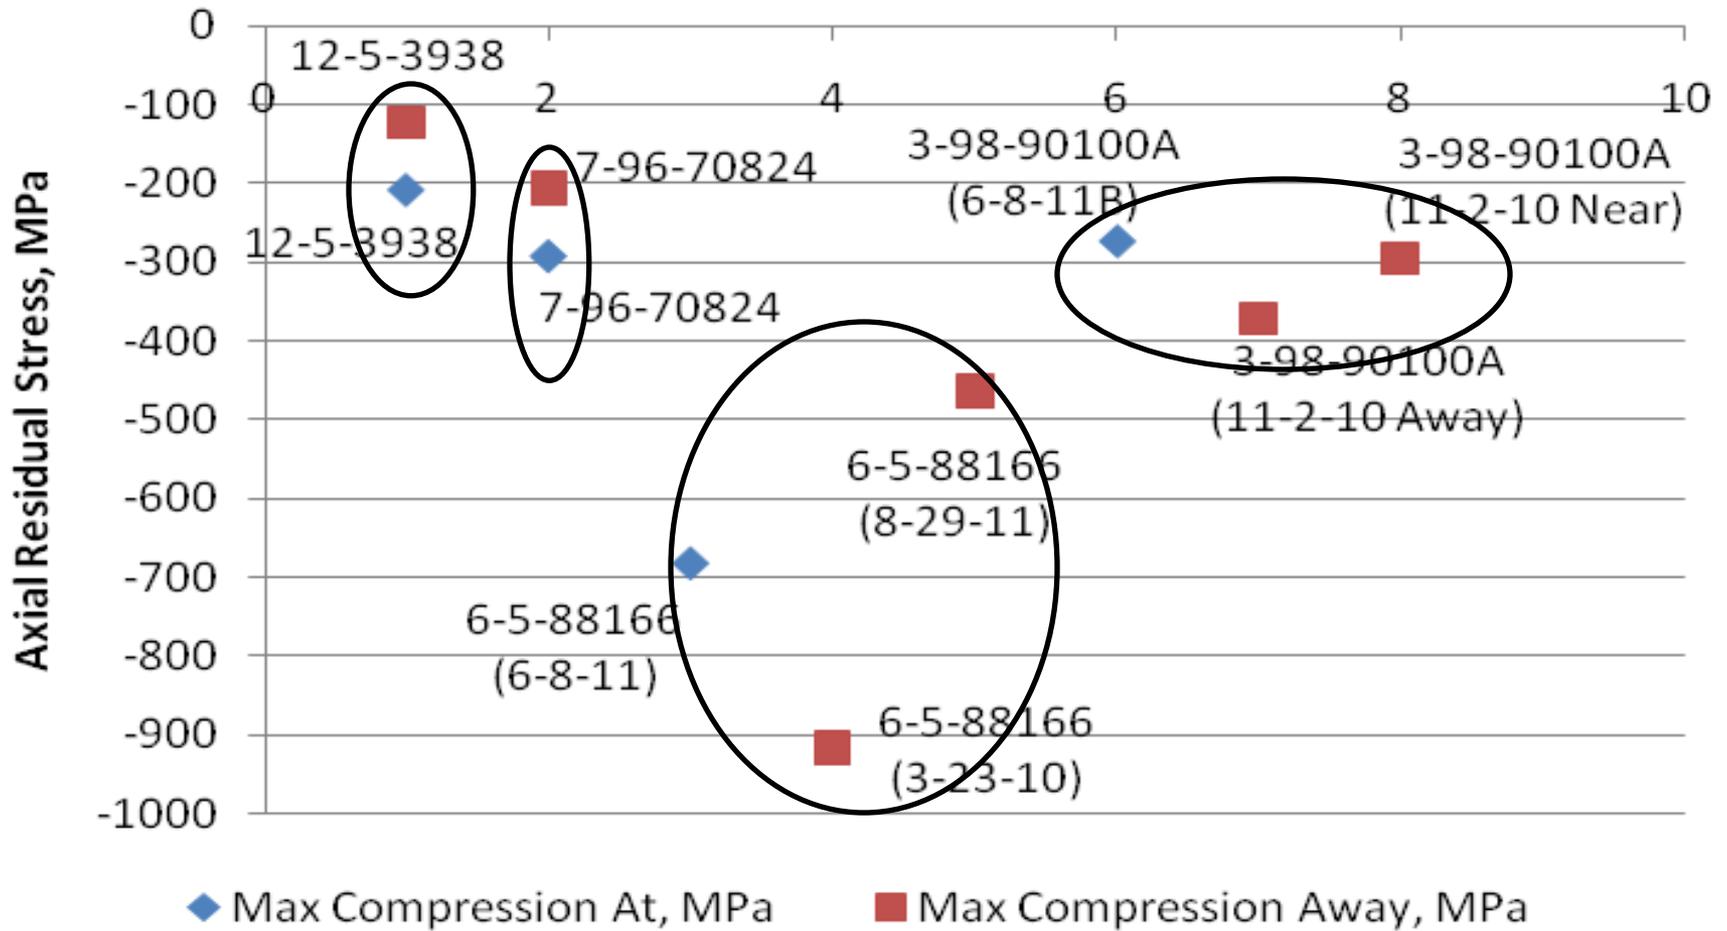
Max Axial Compressive Stress Values For Slices Tested At and Away (1.5" from FRF)

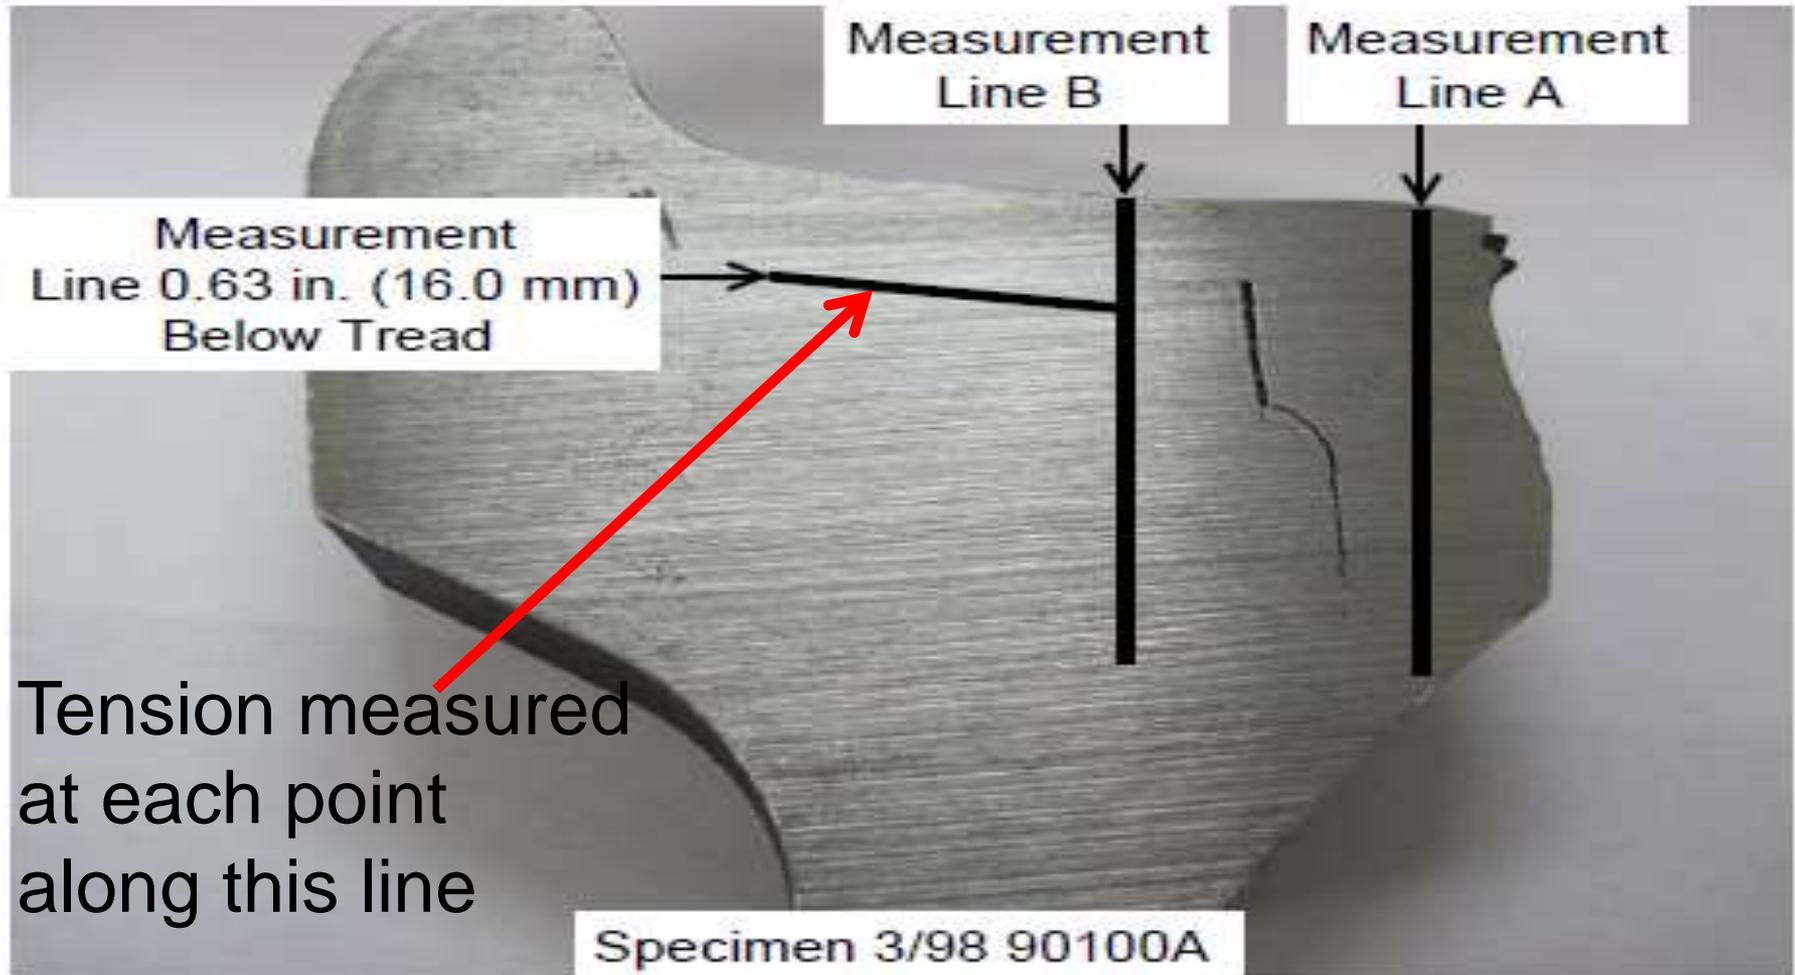
Two Adjacent VSRs, Axial Residual Stress Measurement Pattern

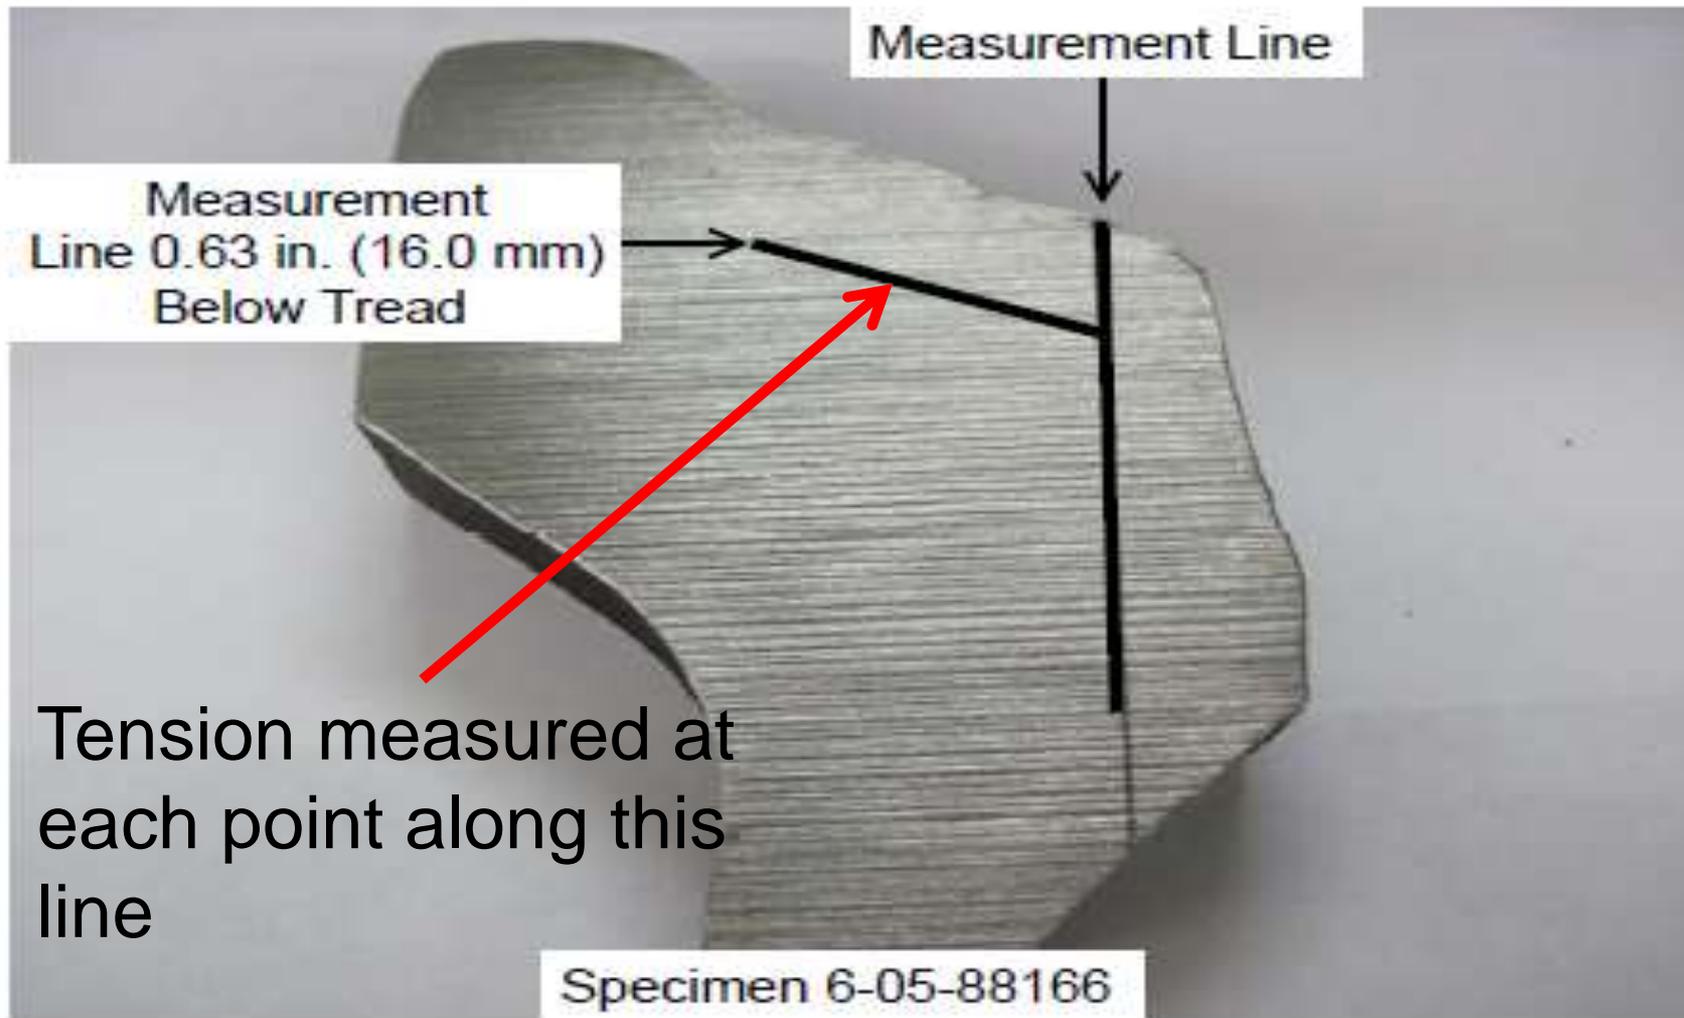
Radial Slice Cut at VSR Origin

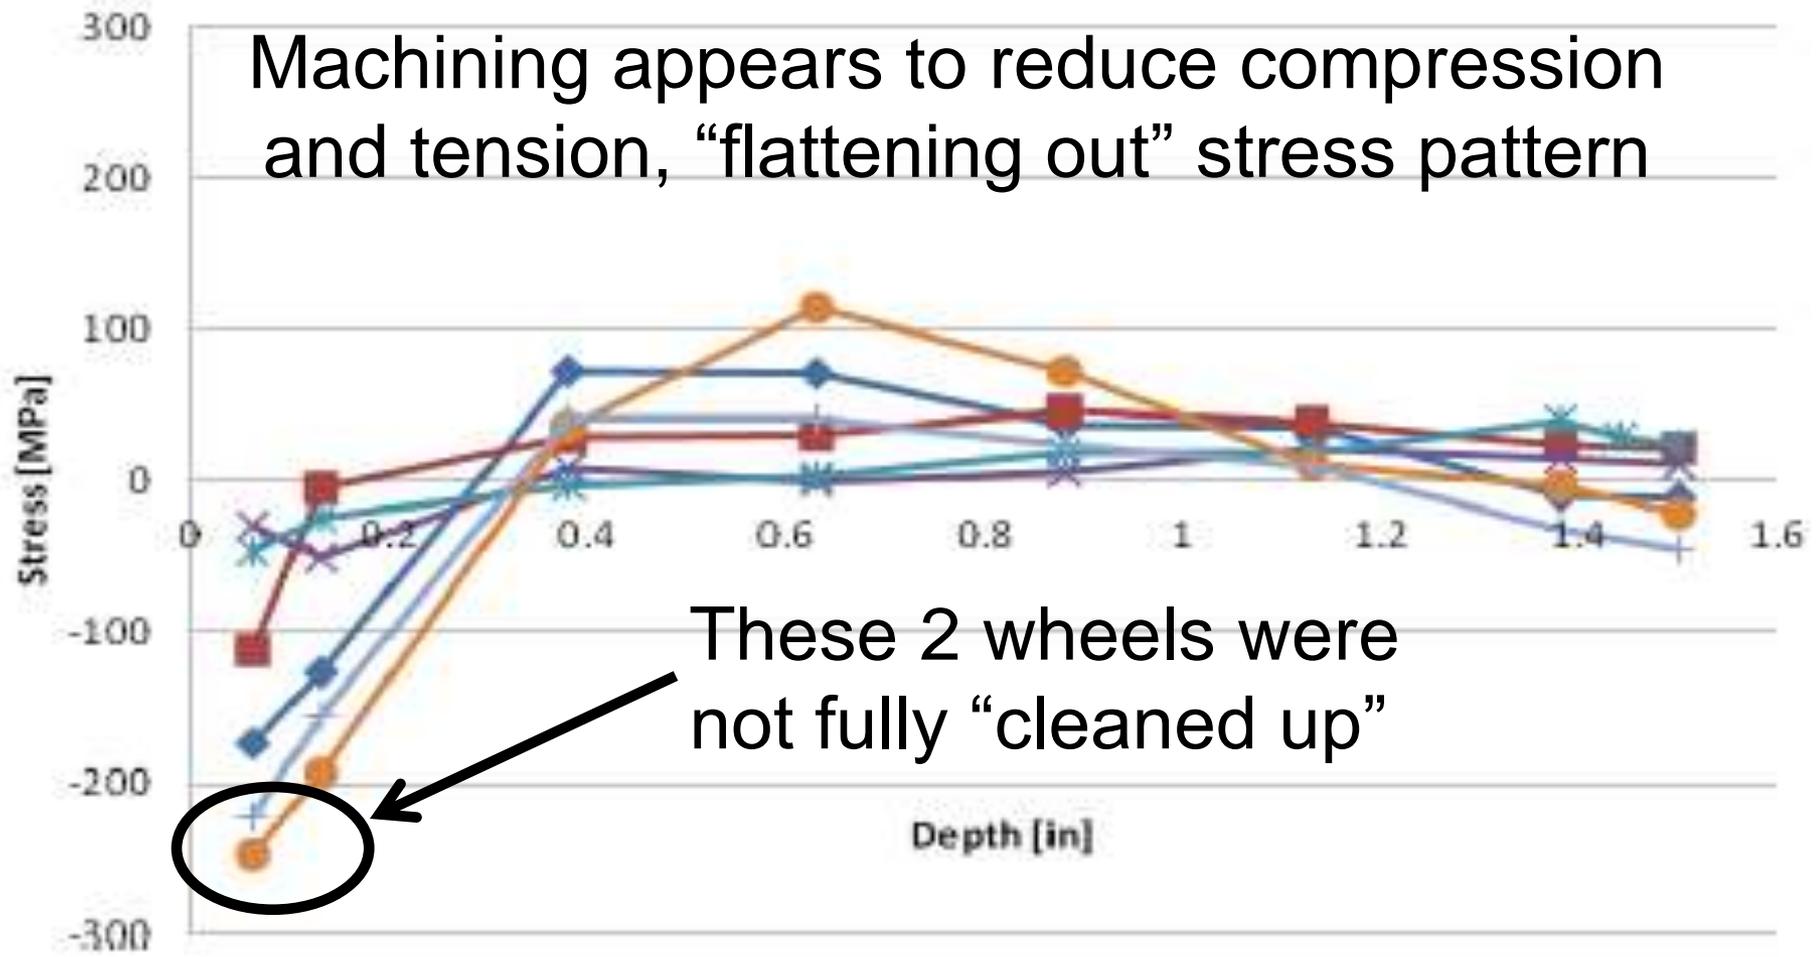
Role of Wheel Truing on Axial Residual Stress in Used Wheels

Wheel truing not only corrects tread/tread profile and removes tread damage, it reduces the magnitude of sub-surface axial tensile stress

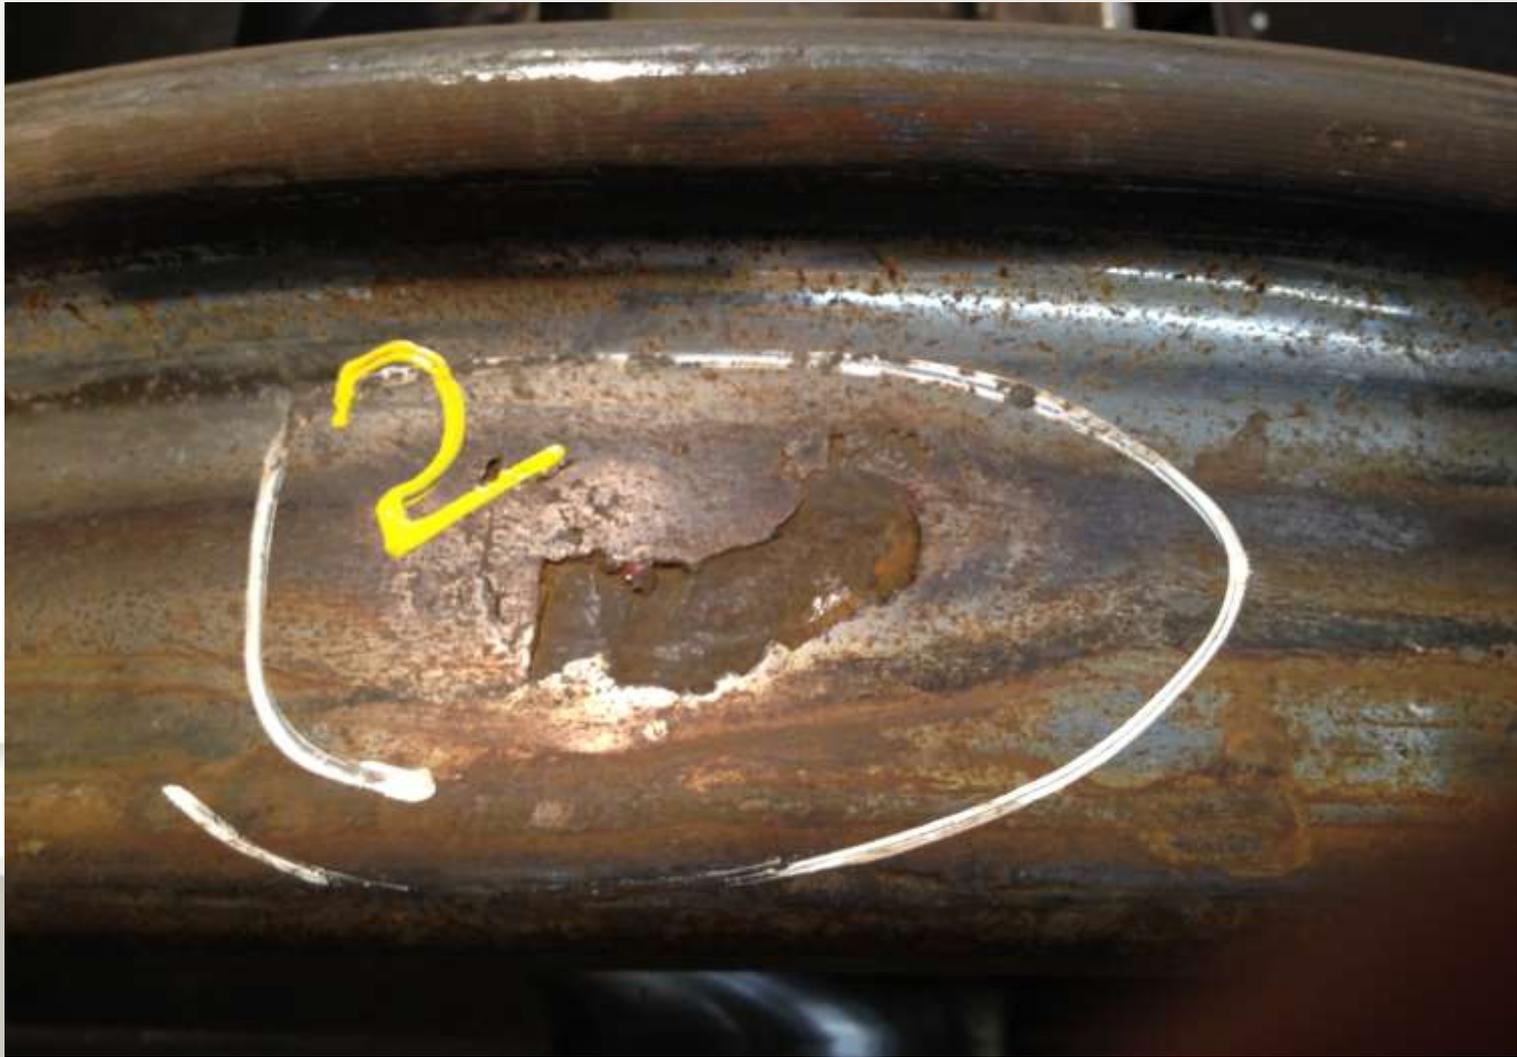
Examples of Tread Damage, Wheel 2

All machined to remove tread damage

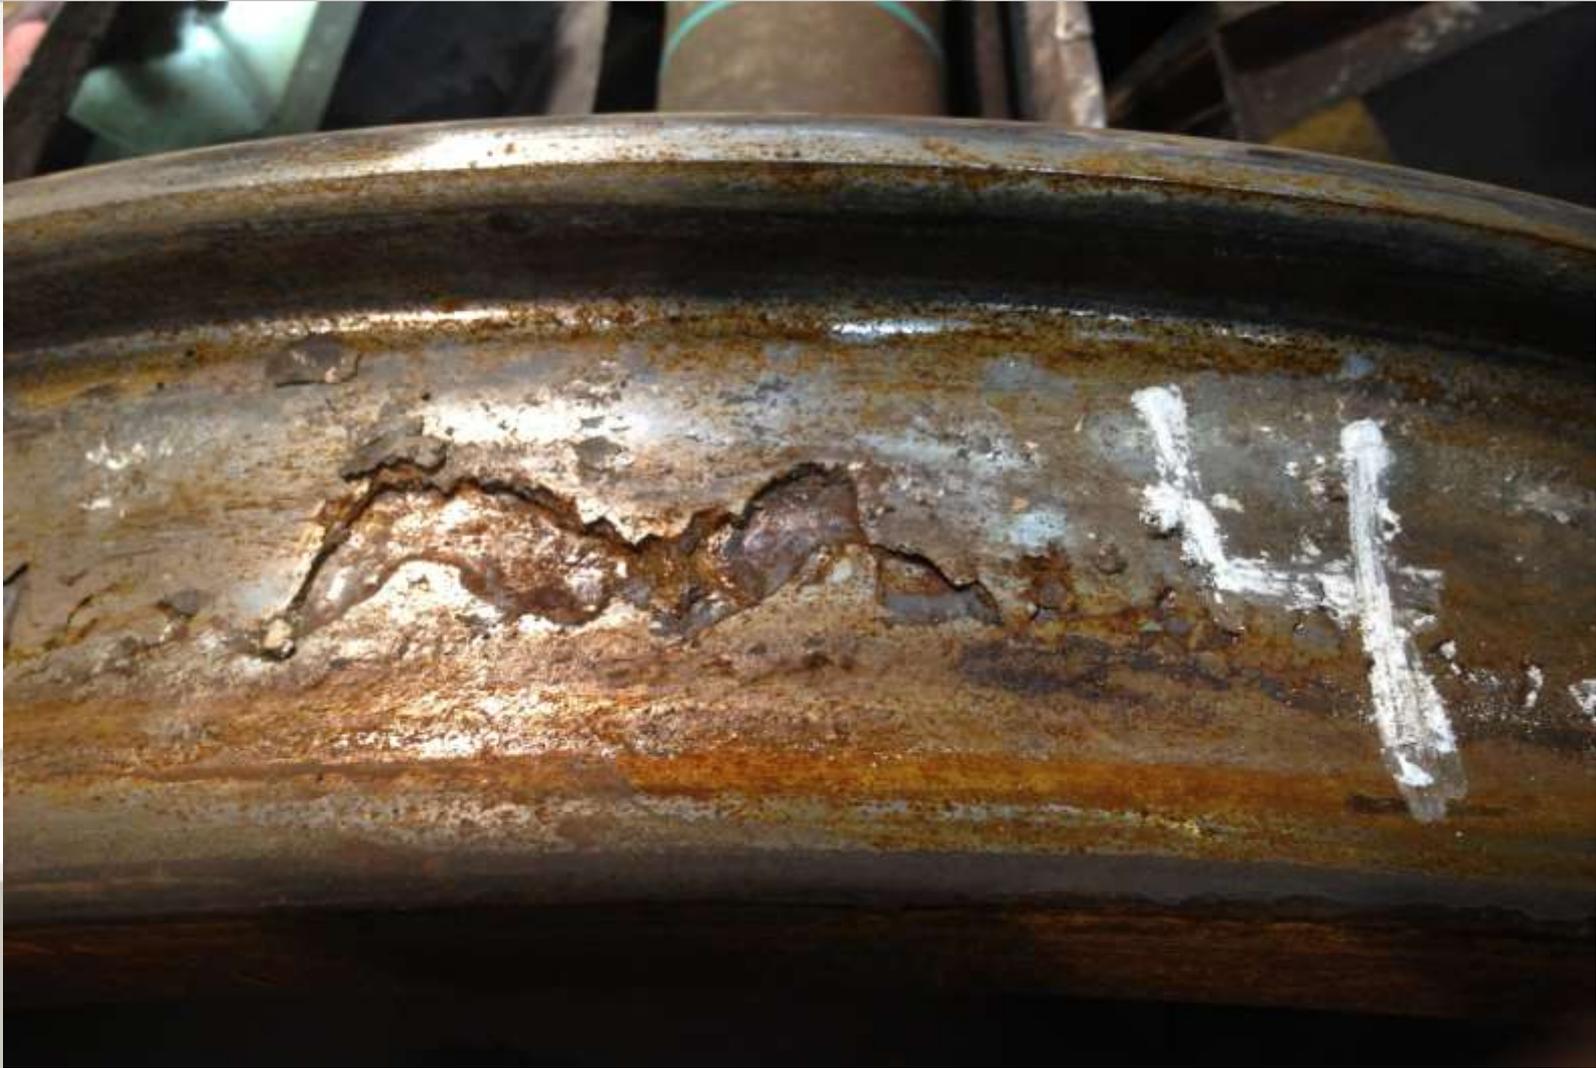
Example of Tread Damage

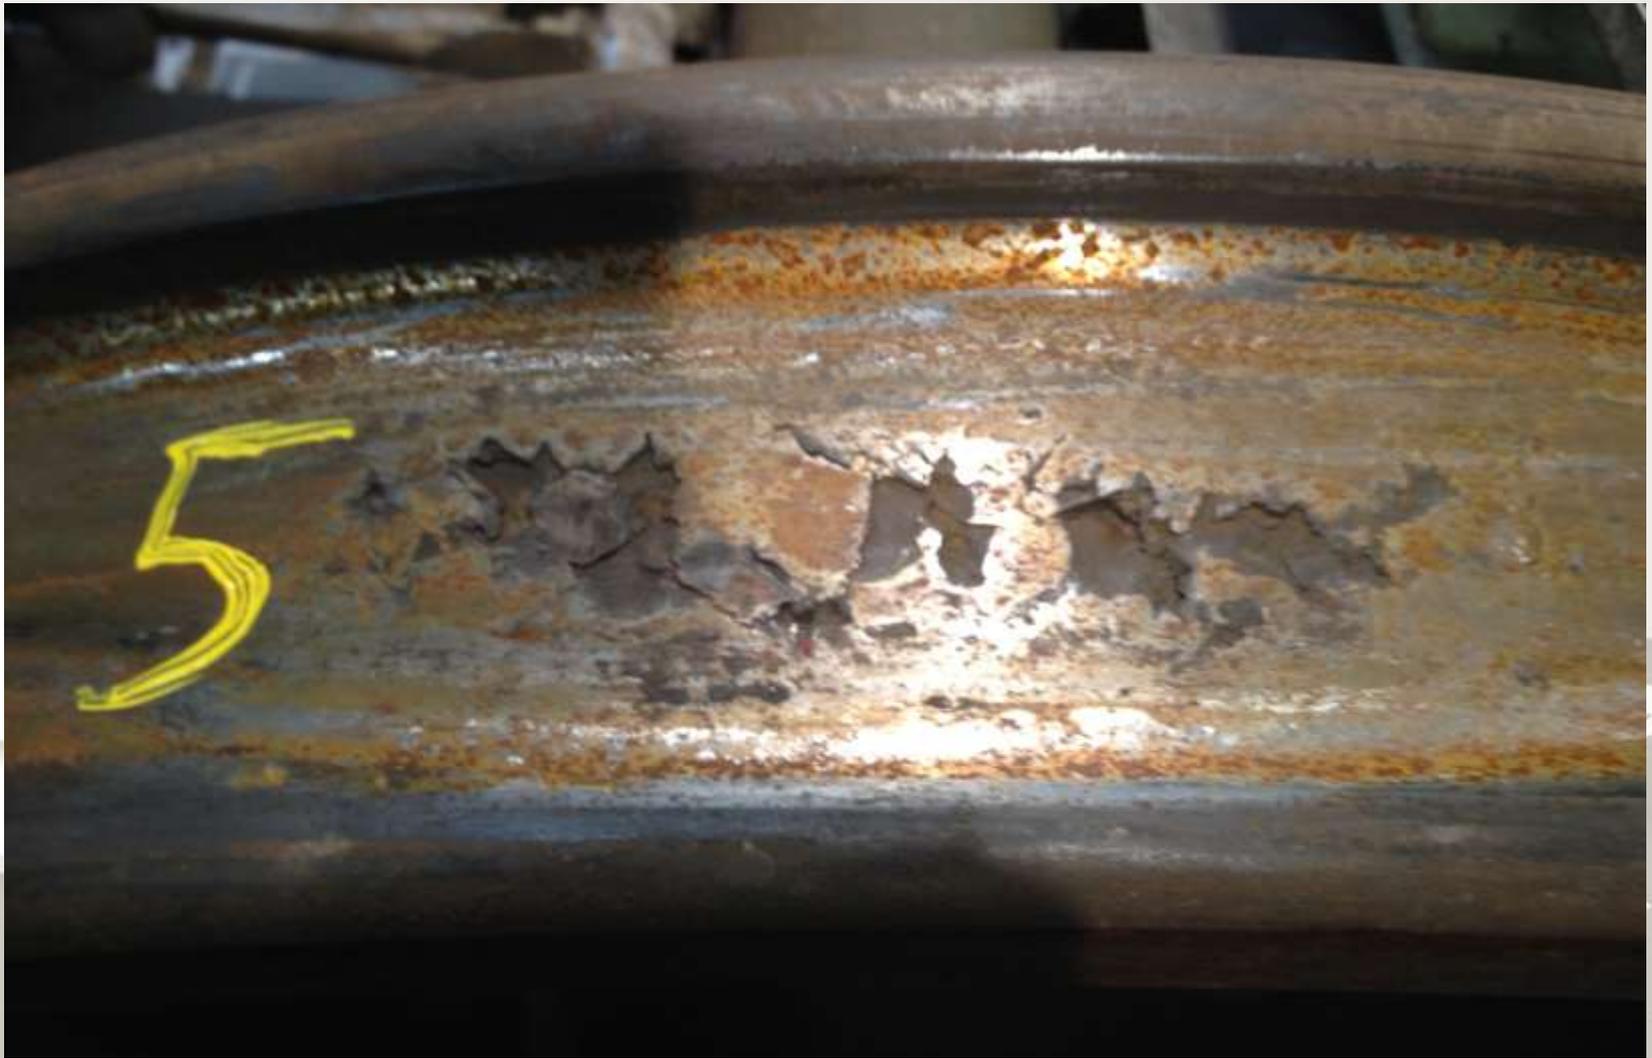
Examples of Tread Damage, Wheel 5

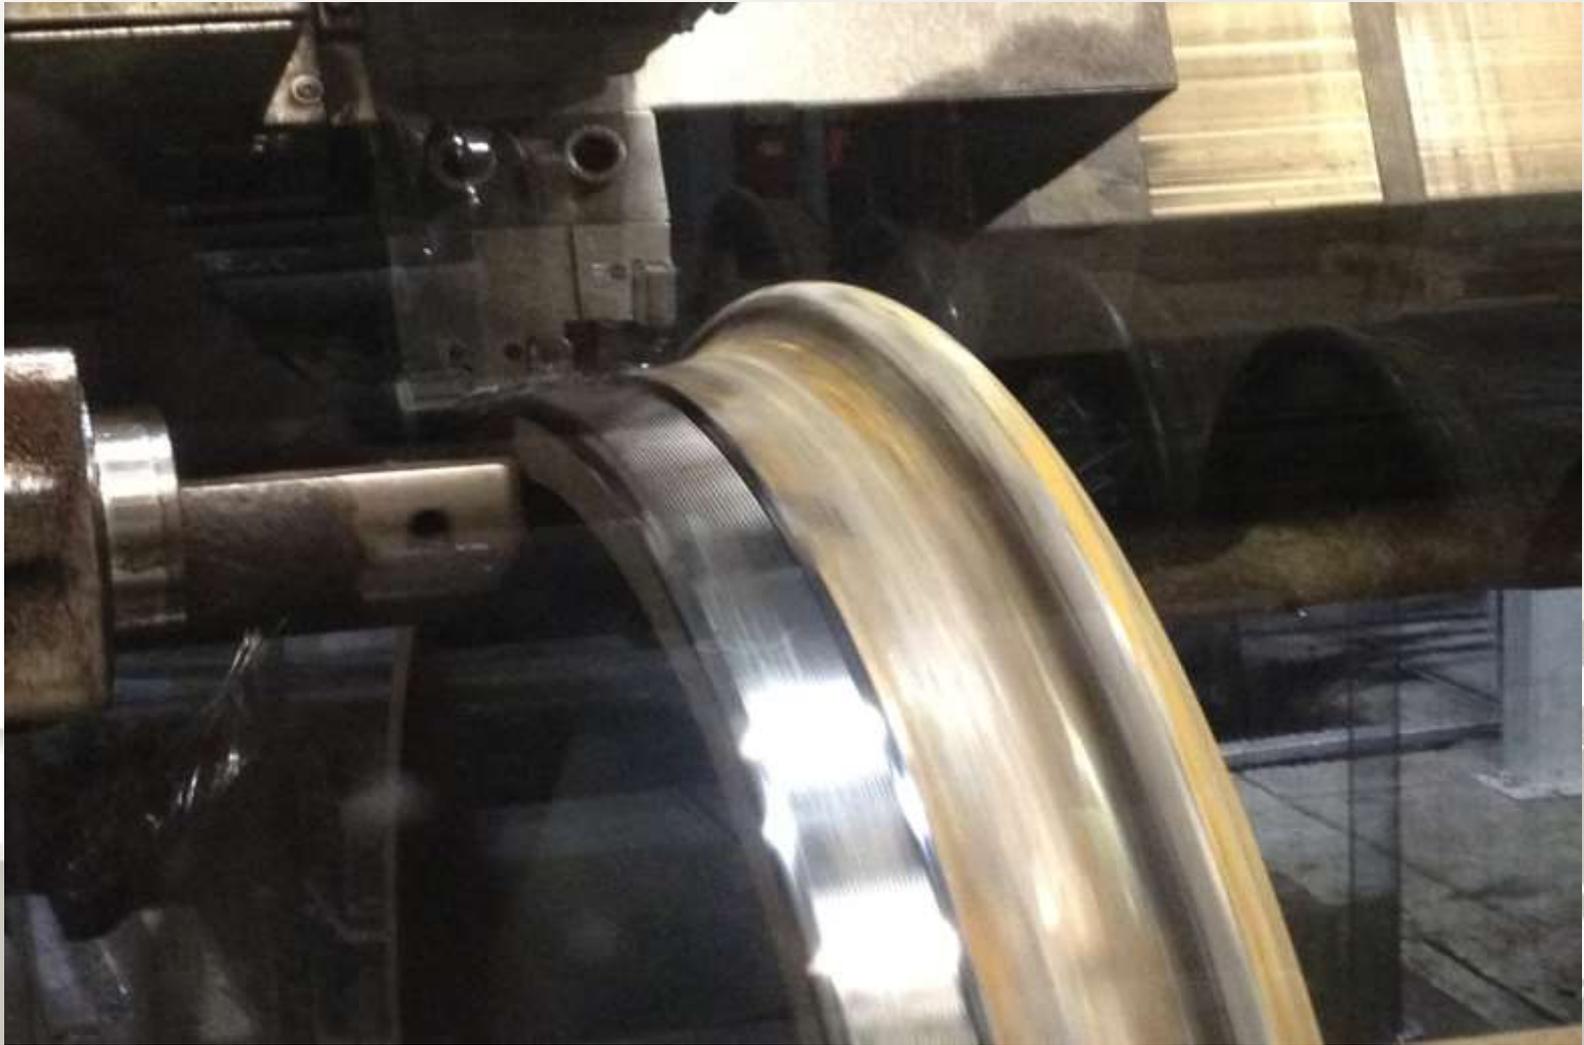
Wheelset Machined at BNSF Havelock

Amount of metal removed recorded: 1 - 6/16, 2 - 8/16, 3 - 6/16, 4 - 6/16, 5 - 6/16, 6 - 3/16

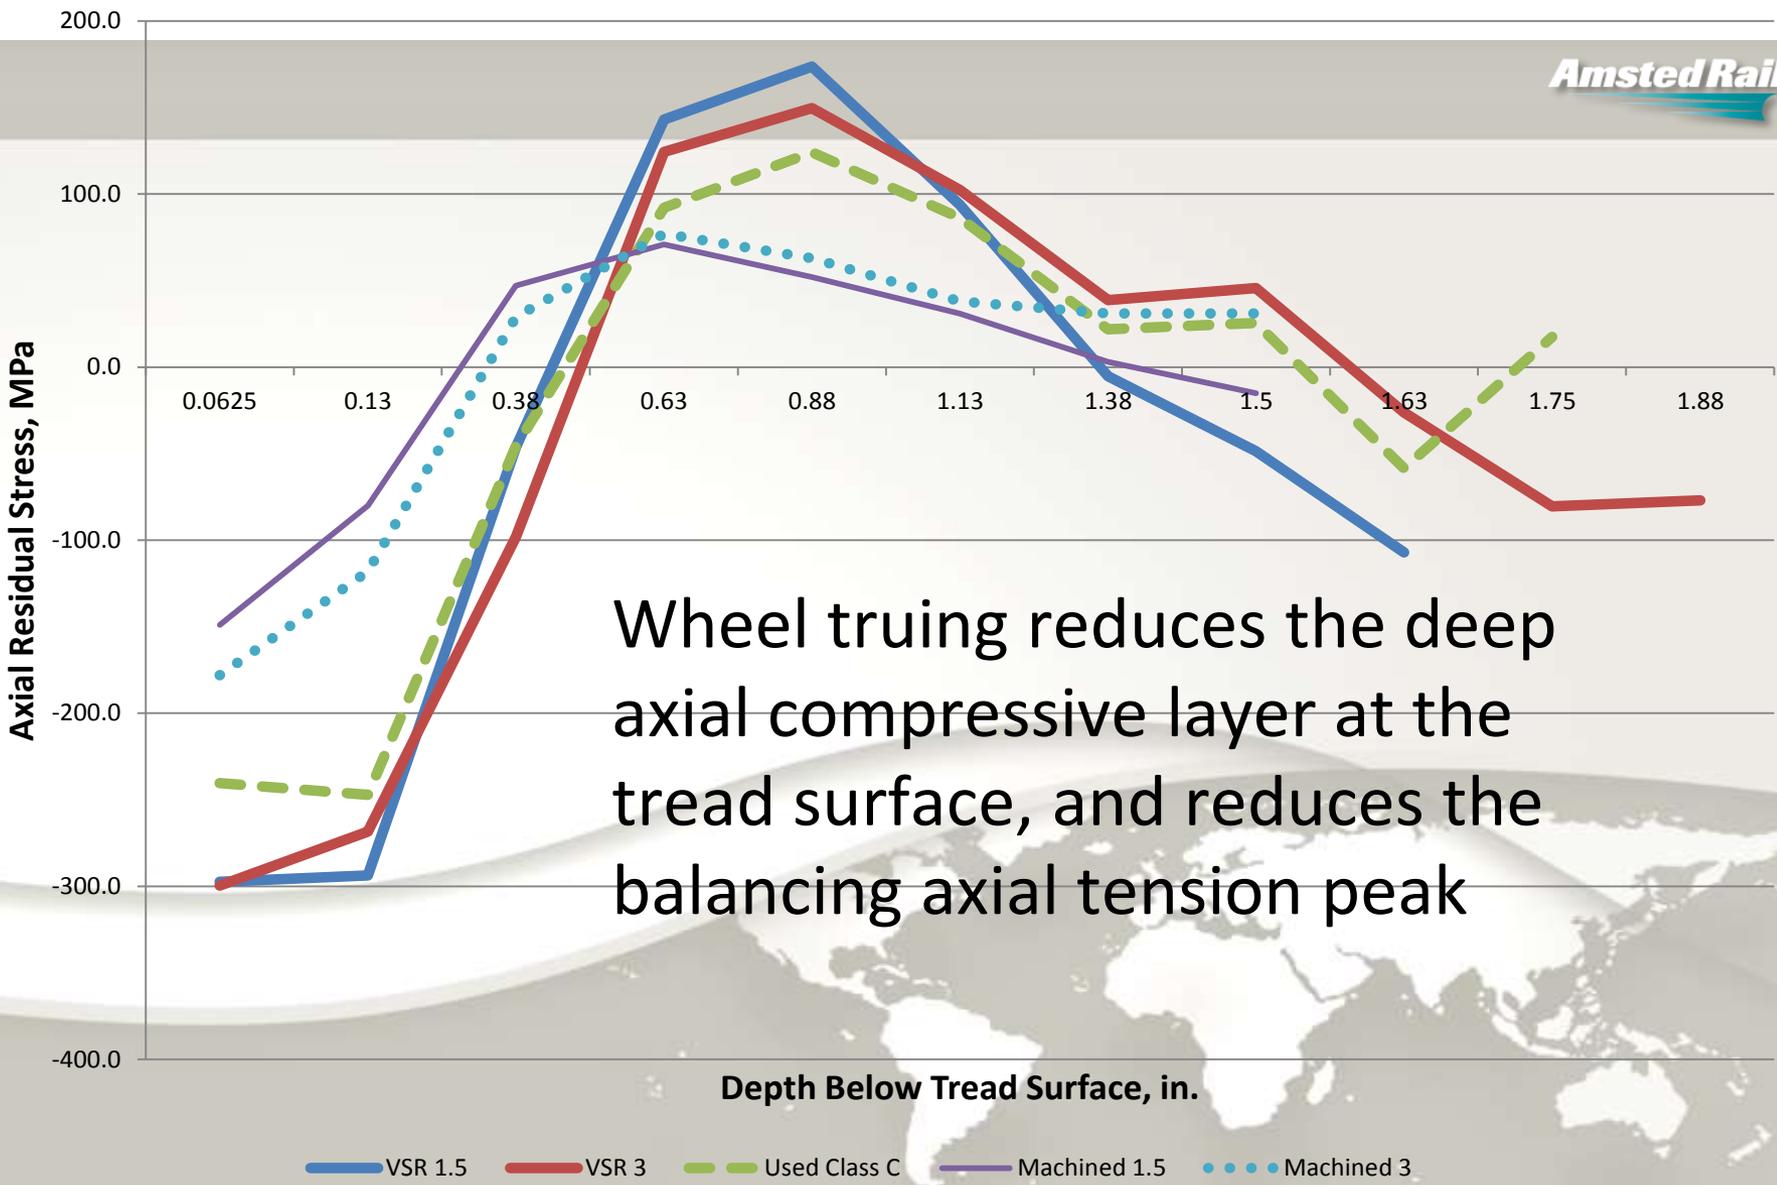
Average Axial Stress Values - Machined

- “VSR 1.5” average is made up of 26 data sets from 21 different wheels
- “VSR 3” average is made up of 19 data sets from 14 wheels
- “Used Class C” average is made up of 22 data sets from 13 wheels
- “Machined 1.5” wheel average is made up of 28 data sets from 28 wheels
- “Machined 3” wheel average is made up of 24 data sets from 24 wheels.

Wheel truing reduces the deep axial compressive layer at the tread surface, and reduces the balancing axial tension peak

For VSR wheels, average axial tensile stress was around 25 ksi (172 MPa) on the 1.5" line of x-ray shots

Maximum axial residual tensile stress seen in machined wheels was about 120 MPa, or 17.4 ksi
