1
2
3
4 **Railroad Concrete Tie Failure Modes and Research Needs**

5
6 Hailing Yu¹, David Jeong, Brian Marquis, and Michael Coltman
7 Structures and Dynamics Division
8 John A. Volpe National Transportation Systems Center
9 55 Broadway
10 Cambridge, MA 02142
11

31
32
33
34 Submitted to: 2015 Transportation Research Board 94th Annual Meeting
35

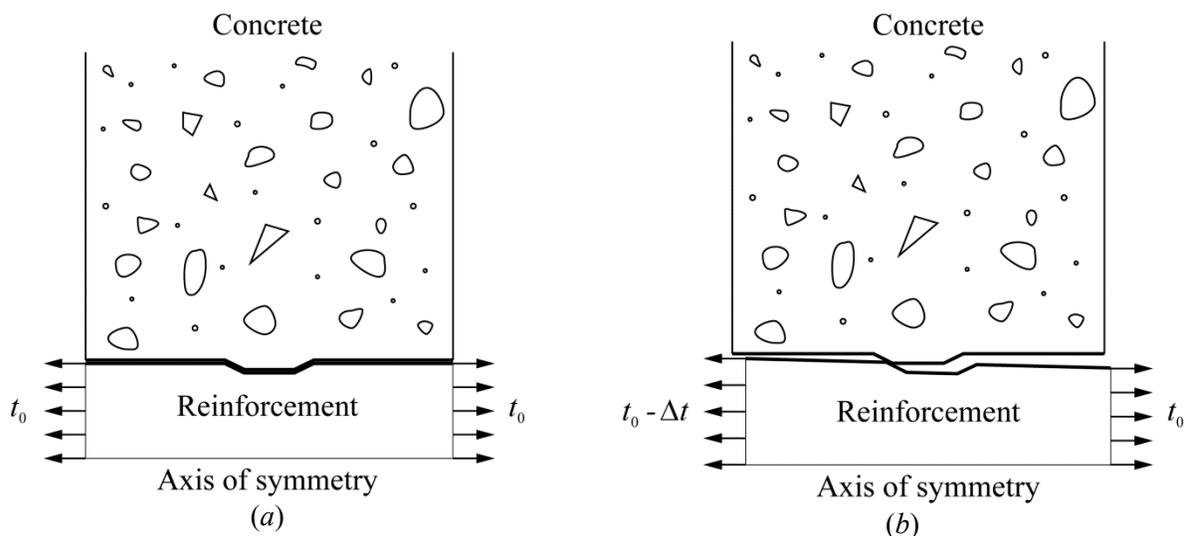
137 **FIGURE 1 Relative slip and dilation of an indented reinforcement-concrete interface as the**
 138 **concrete tie changes from (a) the pretensioned phase to (b) the pretension released phase.**

118 For indented wires as well as strands with natural spiral surfaces, additional radial dilation is
 119 produced via mechanical interaction with the concrete. As shown in Figure 1, as the reinforcement slips
 120 relative to the concrete, the surface mismatch between the two materials also leads to radial dilation
 121 resulting in additional radial (normal) pressure on the concrete’s inner wall. These pressures can split the
 122 concrete longitudinally, creating splitting/bursting cracks especially near the ends of the concrete ties.
 123 Figure 2 shows some splitting/bursting cracks that NDT Corporation has attempted to detect and assess
 124 using the sonic/ultrasonic pulse velocity method (6). Typically, these cracks originate near the tie ends at
 125 the reinforcement-concrete interfaces. As they propagate toward the rail seats, the cracks reduce in
 126 number and eventually coalesce to form horizontal or even vertical cracks.

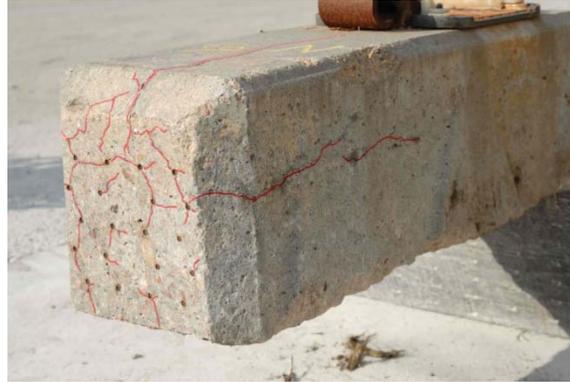
FIGURE 2 Splitting/bursting cracks (6).

330 Indented wires can improve the bonding quality with concrete and thus reduce the transfer length.
331 However, it has been observed that splitting/bursting cracks are more likely to occur with some surface
332 indent geometries, probably due to increased dilatational interactions in the reinforcement-concrete
333 interfaces. Additional research is needed to better understand the relationship between wire indent
334 geometry and concrete splitting propensity. This may require detailed (or micro-scale) FE simulations of
335 wire-concrete interfaces in addition to the ongoing bond modeling work at the Volpe Center. Research
336 results can provide recommendations to the ASTM standard that specifies prestressing steel wires for use
337 in railroad concrete ties (31).

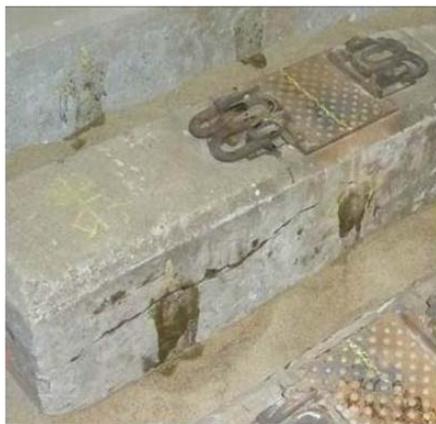
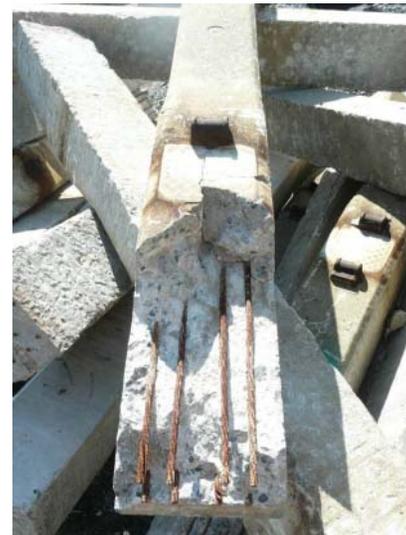
FIGURE 3 Horizontal cracks observed on the Northeast Corridor (7).

127 There was a widespread horizontal cracking pattern observed in concrete ties installed during the
 128 1994-98 period on the Northeast Corridor (Figure 3). It was generally believed that the splitting/bursting
 129 mechanisms contributed to the formation of these cracks (7). However, the strong preference in
 130 orientation (horizontal cracking) and location (along the top row of the strands) indicates that other
 131 mechanisms might have been at work as well. Two other possible contributing factors are: (1) the
 132 specific design of the tie, and (2) initial stresses surrounding the fastener shoulders as a result of the
 133 fastener force application. The splitting/bursting and horizontal cracks are grouped into “prestressing cracks,”
 134 because they are believed to result mainly from the prestresses generated during manufacturing and/or
 135 installation processes of concrete ties.

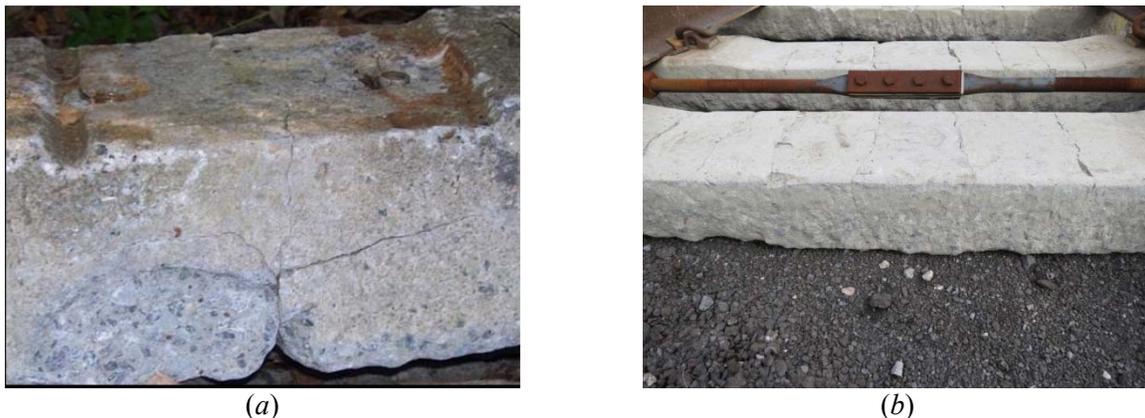
181 **FIGURE 4 Examples of flexural cracks: (a) rail seat positive crack (δ), and (b) center negative**
 182 **cracks on concrete ties with abraded bottom.**

Flexural cracks can develop from the bending of a tie. With relatively good ballast support and under high rail seat positive moments, rail seat positive cracks can develop at the bottom of concrete ties. These cracks may propagate upward and then longitudinally, leading to premature tie failure. Figure 4(a) shows the example of a severe rail seat positive crack (8). Cracks seen on top of rail seats may be referred to as rail seat negative cracks as they are likely related to negative bending moments in local rail seat areas.

173 Figure 4(b) illustrates multiple center negative cracks observed on some concrete ties. The
 174 bottoms of the ties also appear to be abraded significantly from dynamic interactions with ballast. Both
 175 tie abrasion and ballast pulverization contribute to the uneven voids or gaps formed between the ties and
 176 the ballast. The detrimental effects of tie abrasion in this case are twofold: (1) it worsens the center
 177 binding support conditions, and (2) it reduces the bending moment capacities of the ties making them
 178 more prone to failure. The phenomenon of tie abrasion from repeated dynamic interactions with ballast
 179 may be treated as an additional concrete tie failure mode worthy of additional research.
 180

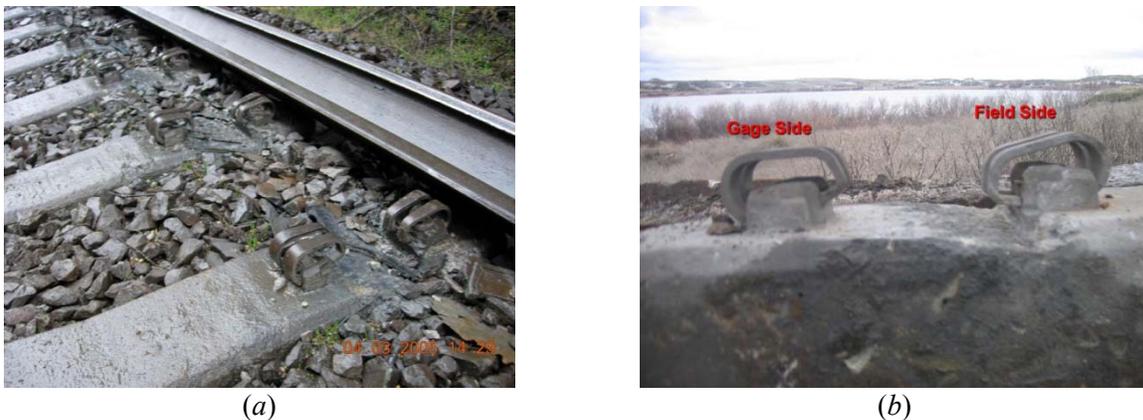
216 **FIGURE 5 Deteriorated rail seat surfaces with reverse cant (12).**

192 RSD surfaces may be uneven, as is the case with the concrete ties involved in the derailment in
 193 Home Valley, Washington (11). Figure 5 shows the rail seats of these ties with reverse cant indicating
 194 increased risk of wide gage (12). Alternatively, RSD may degrade the concrete surfaces more uniformly
 195 resulting in “vertical deterioration” of the rail seats. Factors contributing to RSD include: presence of
 196 water, high tonnage, steep track grades, track curvature greater than two degrees, etc. Concrete ties in
 197 regions with freeze-thaw cycles may experience RSD at accelerated rates due to increased paste
 198 deterioration below the rail pads.

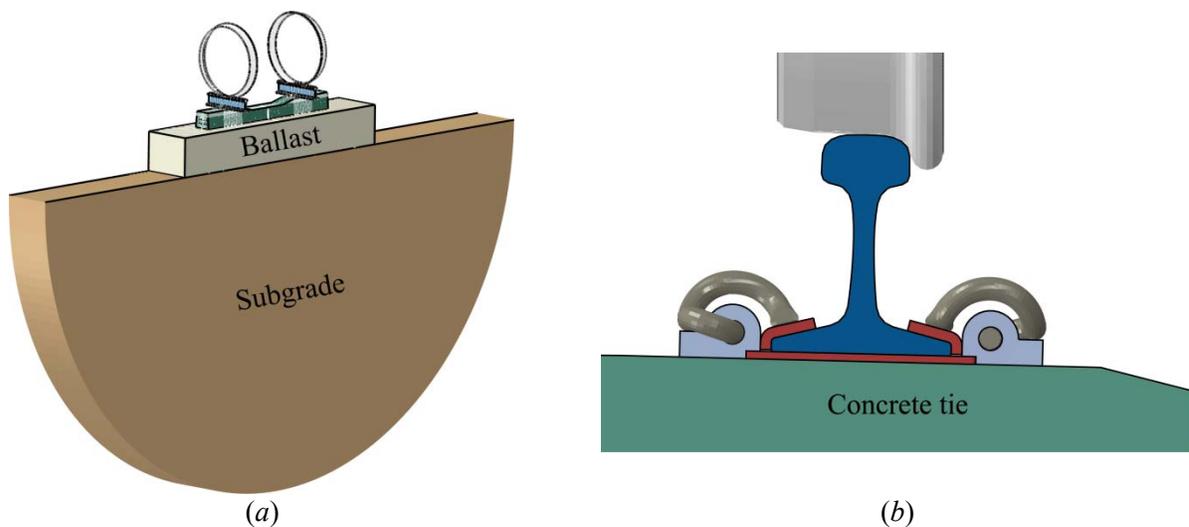
271 **FIGURE 6 Track FE model: (a) full view, and (b) rail fastening system.**

244 The Volpe Center has been developing computational FE models to examine the structural performance
 245 of concrete ties under various ballast support and track loading conditions (17-22). As shown in Figure
 246 6(a), our track FE model, currently covering one tie's space, has fully defined super- and substructures.
 247 The concrete tie is supported by ballast and subgrade. A rail fastening system that includes clips,
 248 shoulders, insulators and pads can be included in modeling, as shown in Figure 6(b). The wheel passes
 249 vertical and lateral loads to the rail and then to the fasteners and the concrete tie. Complete modeling of
 250 the fastening system is necessary when the complex stress states in the rail seats and the fasteners are
 251 needed to predict, e.g. fastener failure and RSD. When the vertical track loads are of primary interest, the
 252 fastening system may be omitted and the loading simplified as rail seat pressures.

349 To assess concrete crushing and pad deterioration as possible contributing mechanisms to RSD,
350 complete rail, fastener and concrete tie models, as shown in Figure 6(b), will be subjected to realistic
351 dynamic track loading, and the resulting multi-axial stress states in the rail seats will be examined. The
352 FE analysis is expected to provide additional insight into RSD failure.

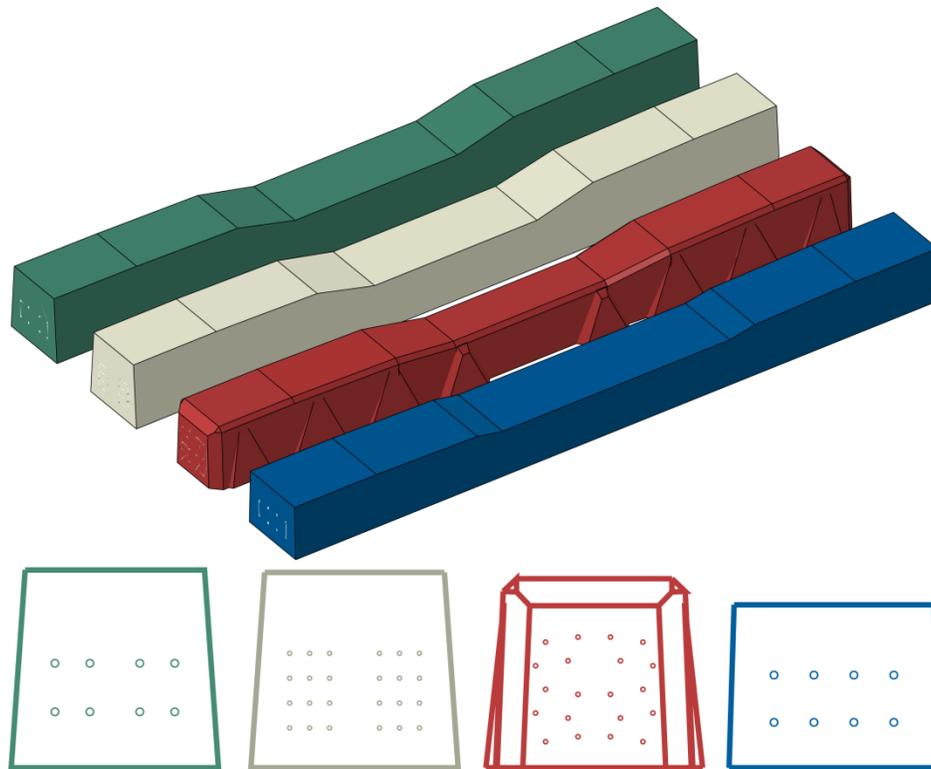
FIGURE 7 Concrete tie models developed at the Volpe Center.

253 Figure 7 shows four concrete tie models developed at the Volpe Center with different geometries
 254 and varying wire/strand configurations. Concrete ties are modeled as a heterogeneous medium composed
 255 of prestressing wires/strands, concrete and their interfaces. A damaged plasticity model available in
 256 commercial FE software has been applied in the material modeling of concrete. The model defines
 257 different concrete behaviors in tension and compression and uses tensile and compressive damage
 258 variables to monitor the respective strength degradations (23). The constitutive equations and material
 259 parameters needed to apply this model are described in detail in previous publications (17-18).

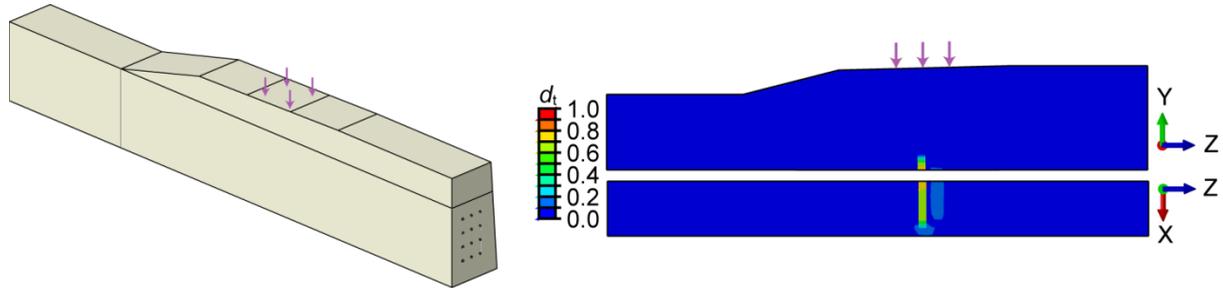
306
 307 **FIGURE 8 Prediction of the onset of rail seat positive cracking with a quarter symmetric concrete**
 308 **tie model (17). The tensile damage variable d_t indicates the extent of tensile strength degradation.**
 309

285 As discussed, the ballast support condition significantly influences the flexural failure mode of a
286 concrete tie. With completely defined concrete tie and substructure models, the effect of ballast support
287 can be further examined. Figure 8 shows the quarter symmetric FE model of a concrete tie supported by a
288 uniform and homogeneous ballast layer (the ballast model is similar to that shown in Figure 6) and the
289 tensile damage variable contour when the tie model is subjected to rail seat pressure. The analysis
290 indicates that a rail seat positive crack initiates at the tie bottom under the rail seat when the rail seat
291 loading is sufficiently large (17).

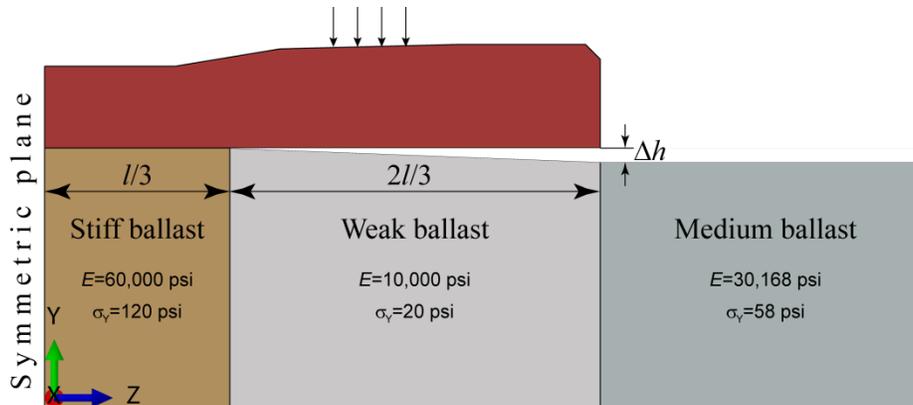
310
 311 **FIGURE 9 A simulated center binding condition with deteriorated ballast support.**
 312

292 A recent study (22) simulated center negative cracks under two assumed center binding
293 conditions: the center negative moment test specified in the American Railway Engineering and
294 Maintenance-of-Way Association (AREMA) manual (29), and an assumed scenario with deteriorated
295 ballast support shown in Figure 9. In the latter case, a gap (or void) is assumed to exist between the
296 concrete tie and the ballast. The gap is assumed to initiate at 1/3 of the half tie length from the tie center
297 and grow linearly toward the tie end. The maximum gap is Δh at the tie end. Figure 10 shows the center
298 bound cracking patterns predicted by FE simulations of both scenarios. Figure 11 shows the equivalent
299 wheel load-relative rail seat displacement curves obtained from the simulations. The equivalent wheel
300 load is calculated based on the assumption that a single rail seat carries a maximum of 50% of the wheel

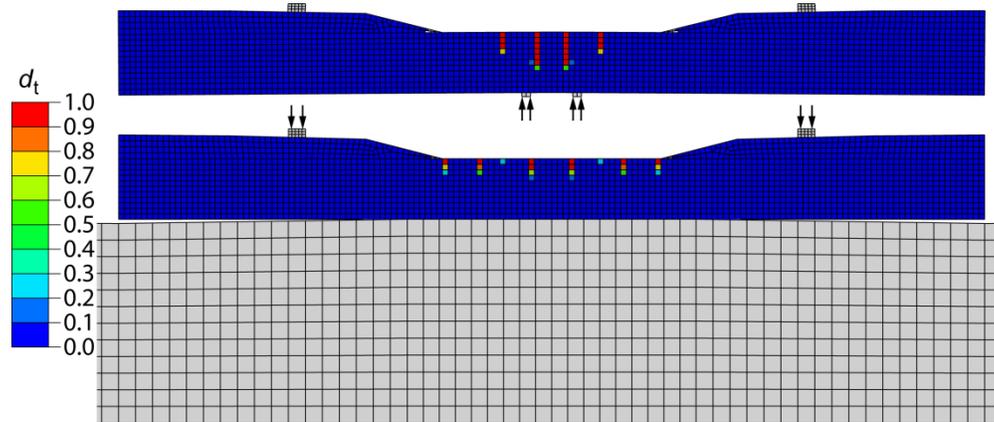
313
 314 **FIGURE 10 Center negative cracks predicted by FE simulations of two assumed center binding**
 315 **conditions: AREMA center negative moment test (top) and a scenario with deteriorated ballast**
 316 **support ($\Delta h=0.5$ in., bottom).**
 317

302 Two observations are made based on the simulations: (1) fewer cracks form in the AREMA test than
 303 under deteriorated ballast support (Figure 10), and (2) the AREMA manual specifies a much lower
 304 pass/fail load than commonly observed loads in the field (Figure 11).
 305

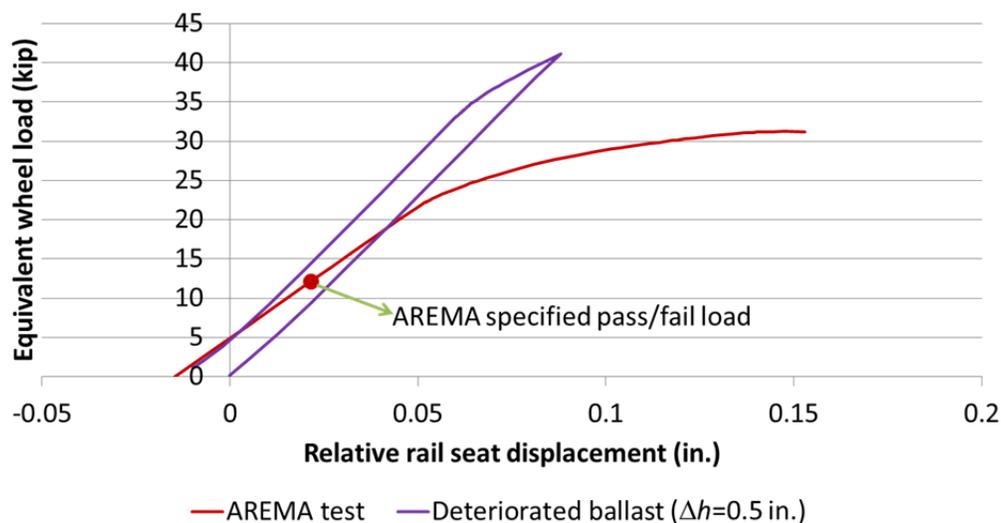
318
319 **FIGURE 11 Equivalent wheel load-relative rail seat displacement relations obtained from FE**
320 **simulations of center binding scenarios.**
321

301 load. The average rail seat displacement is calculated relative to the displacement of the center of the tie.
