Effects of Ballast Degradation on Shear Strength Behavior from Large-scale Triaxial Tests

Yu QIAN^a, Erol TUTUMLUER^{a,1},
Youssef M.A. HASHASH^a, and Jamshid GHABOUSSI^a
^a*University of Illinois at Urbana-Champaign*

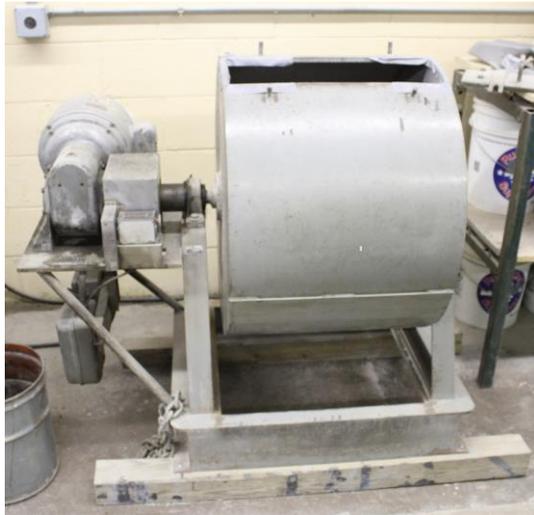
Figure 1. Photo of Los Angeles (LA) abrasion test equipment

The ballast material used in the laboratory was a 100% crushed limestone, which adequately met AREMA No. 24 gradation requirements. Approximately 10 kilograms of clean ballast materials were placed in the LA abrasion drum (see Figure 1) together with 12 steel balls, which are typically used in the LA abrasion test (AASHTO T 96 or ASTM C 131). The drum was set to rotate on the average 50 turns per minute and for a total drum turns of 1,500 times to reach the fully fouled condition with a Fouling Index (FI) of 40. After finishing 1,500 turns, the drum was allowed to stand still for 10 minutes to let dust settle before the tested material was poured out. In order to minimize loss of fine materials, both the inside of the drum and the steel balls were carefully hand brushed after the test. All particles above 25.4 mm or 1.0 in. sieve were also brushed to collect dust and fine material before sieving. The above outlined procedure was repeated until enough materials were generated for conducting large-scale triaxial tests and all the generated degraded ballast material were evenly mixed before preparing the triaxial test specimens. Further details on generating degraded ballast material through LA abrasion tests have been provided elsewhere [6].

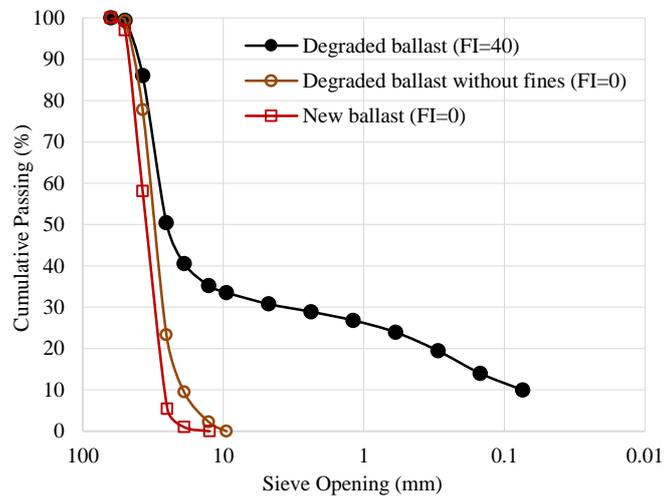
Figure 2. Gradation of ballast materials before/after degradation

The gradations of clean and degraded ballast specimens (after 1500 turns of LA abrasion test) are shown in Figure 2. Another gradation curve, which represents the gradation of the degraded coarse aggregate fraction, is also given in Figure 2. The specimen of the degraded coarse aggregate fraction after the LA abrasion testing excluded in that case particles smaller than 9.5 mm or 3/8 in. size.

The tested ballast specimens were prepared by compacting ballast materials in four lifts. The appropriate amount of ballast material was prepared carefully according to the gradation requirements as indicated in Figure 2. Before making the triaxial test specimen, the ballast material was mixed thoroughly and divided into four parts evenly to minimize segregation. The height of each lift after compaction was 15 cm (6 in.). For each lift, the compaction applied with the same electric jack hammer was set to 4 seconds to ensure the same compaction energy was applied to all the test specimens in a consistent manner. The total weights of the test specimens and the weights of each lift for different ballast materials were predetermined by a trial and error process. The other details of specimen preparation can be found elsewhere [9]. Table 1 summarizes the aggregate shape properties and the triaxial test specimen details.

the preliminary results from this study showed the degraded ballast and coarse aggregate fraction of degraded ballast yielded higher strength than the clean ballast specimen. Comparing the gradations of the three ballast materials (see Figure 2), the coarse aggregate fraction of degraded ballast comprised higher number of smaller particles and was more “well” graded than the clean ballast material, which satisfied AREMA No. 24 uniform gradation specification. The smaller particles within the degraded ballast matrix can potentially help stabilize the aggregate skeleton by minimizing/filling the voids and thus resulting in higher shear strength. Moreover, from the imaging-based shape properties listed in Table 1, particles of the degraded ballast coarse aggregate fraction have significantly lower Angularity Index (AI) values, and also they tend to be more cubical and smoother and hence less susceptible to abrading of sharp corners and edges during strength testing when compared to clean ballast particles. Accordingly, more cubical degraded ballast particles with smoother surfaces can attain a denser packing configuration leading to higher densities for the specimens. This results in higher peak deviator stress values achieved during shear strength testing.

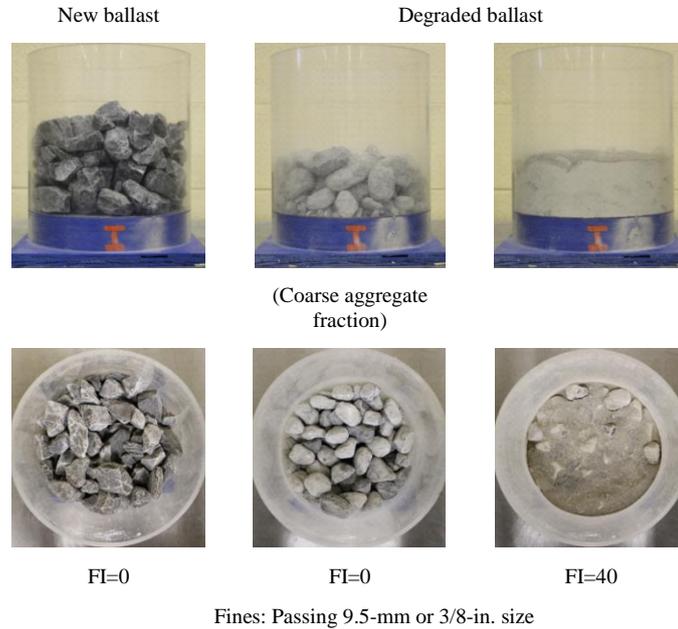
Figure 3. Photos of side and top views of aggregate packing [7]

It is not obvious how to relate gradation information to ballast layer functional characteristics and the governing mechanisms that would impact ballast layer structural and drainage behavior. To investigate particle contact and particle packing characteristics before and after degradation, approximately 10 kilograms of ballast material, obtained from the before and after 1,500 turns in LA abrasion tests, were poured into an acrylic chamber having dimensions of 25.4 cm (10.0 in.) in diameter and 25.4 cm (10.0 in.) in height. Figure 3 presents the side and top views of aggregate packing photos taken before and after degradation with the corresponding FI values. Photos of the degraded ballast without fines case are also shown in Figure 3 for comparison. It is clearly seen that after 1,500 turns, the same weight (ten kilograms) of degraded ballast occupied less volume as compared to the new ballast in the acrylic chamber. However, for the same weight of degraded ballast, the specimen height remained nearly the same with or without fine particles, as shown in Figure 3. Basically, the fine particles generated during degradation occupied the voids created by

the large particles. As FI approached 40, nearly all the voids created by the large particles were filled with fine particles.

For the specimens prepared with the degraded ballast, fines (material finer than 9.5 mm or 3/8 in.) filled the voids created by larger particles (see Figure 3), thus helping to stabilize the aggregate skeleton. However, presence of excessive fines in the aggregate matrix results in the loss of contact between large particles, thus making it easier for the large particles to reorient and rearrange. This in turn can lead to significant reductions in the specimen shear strength. The fine particles thus present a “stabilizing” effect in the specimens prepared with the fouled ballast. This could be the reason why degraded ballast (FI=40) had less strength than coarse aggregate fraction of degraded ballast but higher strength than clean ballast. This could also be the reason why the

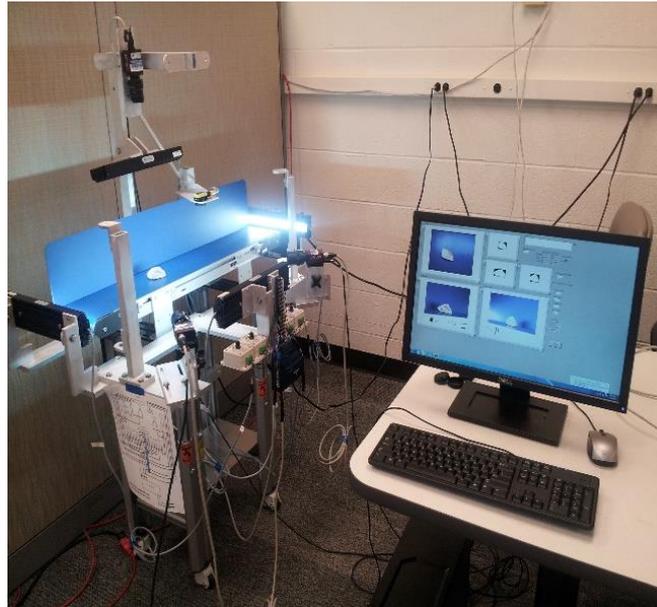
Figure 4. Photo of Enhanced University of Illinois Aggregate Image Analyzer

Besides the grain size distribution, aggregate shape properties, especially the flat and elongated (F&E) ratio, the angularity index (AI), and the surface texture (ST) index, are key indices quantified by the University of Illinois Aggregate Image Analyzer (UIAIA). After the LA abrasion tests, aggregate particles larger than 9.5 mm or passing 3/8-in. sieve were hand collected to conduct image analyses using the recently enhanced University of Illinois Aggregate Image Analyzer (E-UIAIA) (see Figure 4) to quantify the shape property changes of ballast particles after degradation. Details of image analyses of aggregate particle shapes before and after the LA abrasion tests can be found elsewhere [8]. These shape indices have been successfully used as the essential morphological data to generate ballast aggregate particle shapes as three-dimensional (3D) polyhedron shaped discrete elements for a recently developed ballast model for analyzing the assembly behavior using the Discrete Element Method or DEM [9-10].

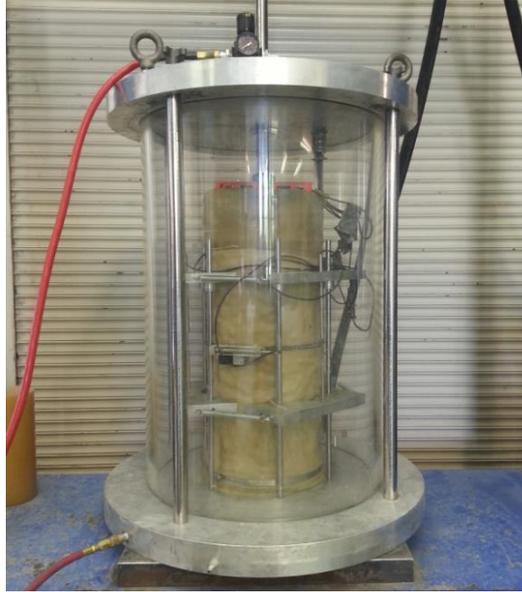
Figure 5. Photo of University of Illinois Ballast Triaxial Tester

A large-scale triaxial test device has recently been developed at the University of Illinois for testing specifically ballast size aggregate materials (see Figure 5). An internal load cell (Honeywell Model 3174) with a capacity of 89 kN (20 kips) is placed on top of the specimen top platen. Three vertical LVDTs are placed around the cylindrical test sample at 120-degree angle between each other to measure the vertical deformations of the specimen from the three different side locations. Other details about the large-scale triaxial test device have been provided elsewhere [11]. In order to

prevent damage to LVDTs due to excessive bulging of specimen during monotonic shear strength test, the axial strain was calculated based on the vertical movement of loading actuator and the LVDTs were not used during the tests.

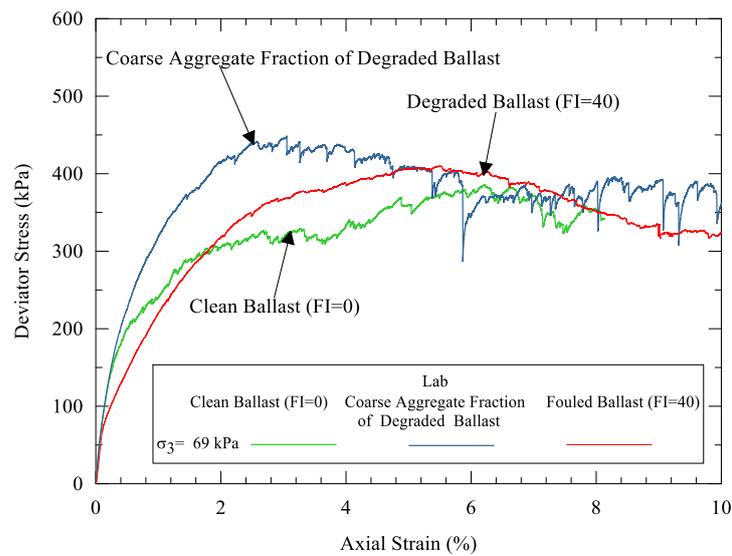
Figure 6. Repeated load triaxial test results for permanent deformation accumulation

Figure 6 presents the monotonic shear strength test results on the new and degraded cylindrical specimens of a limestone type ballast material for up to 10% axial strain. Interestingly, particle degradation did not result in significant strength loss in the fouled ballast specimens when compared to the new clean ballast material. On the contrary,

degraded ballast had much smoother stress-strain curves during monotonic shear strength tests. However, all the test results presented here were under dry conditions, i.e., no added moisture was present in the test specimens. Upon introduction of moisture into the specimens, the shear strength behavior of ballast is expected to drop substantially.
