# Failure Mode and Effect Analysis of Concrete Ties in North America

**John C. Zeman, J. Riley Edwards, Christopher P.L. Barkan, and David A. Lange**  
**Railroad Engineering Program**  
**Department of Civil and Environmental Engineering**  
**University of Illinois at Urbana-Champaign**

**Summary:** A failure mode and effect analysis (FMEA) was applied to improve the design of concrete ties in ballasted track for North American heavy haul applications. A literature review was conducted on concrete tie failure modes, failure effects, and failure causes. A survey of railroads and transit authorities in North America provided a ranking of the most critical concrete tie failure modes. The most important problem for heavy haul service was found to be rail seat deterioration (RSD). The contributing factors, related failure modes, and deterioration mechanisms of RSD are discussed.

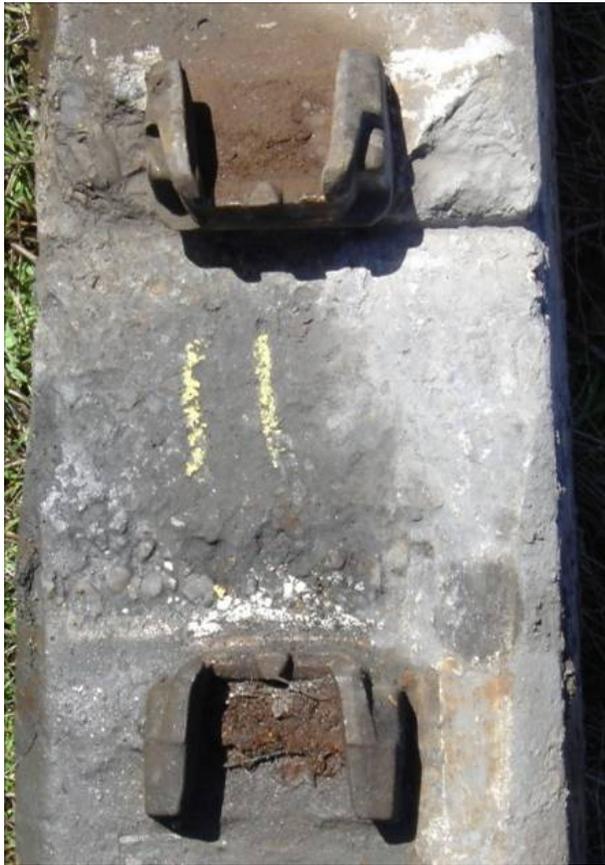
Aside from the fastening components, the concrete beneath the base of the rail can also deteriorate; this failure mode is commonly referred to in North America as rail seat abrasion or, more correctly, rail seat deterioration (RSD). Figure 1 shows RSD on a concrete tie removed from service. As with fastener wear, RSD may lead to loss of cant or loss of gauge. RSD and fastener wear are often concurrent failure modes.

**Figure 1: Concrete tie rail seat deterioration (RSD)**

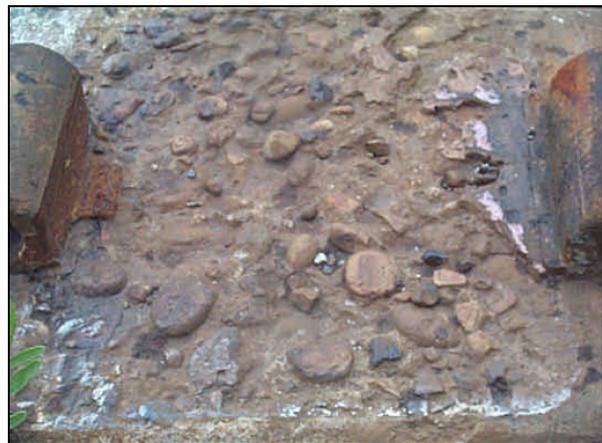
The wear patterns observed in track vary from wear of the cement paste that exposes the coarse aggregate to wear of all concrete components, and from flat wear that begins on the perimeter of the rail seat to a triangular pattern that wears the field side of the rail seat on the high side of a curve [9, 10, 11]. Figures 2 and 3 illustrate the range of RSD wear patterns. The wear pattern in Figure 2 is horizontal with loss of the cement paste exposing the coarse aggregate, which is relatively intact. By contrast, in the triangular wear pattern in Figure 3, all the concrete components at the surface are equally worn.

**Figure 2: RSD, with horizontal pattern and cement paste wear [9]**

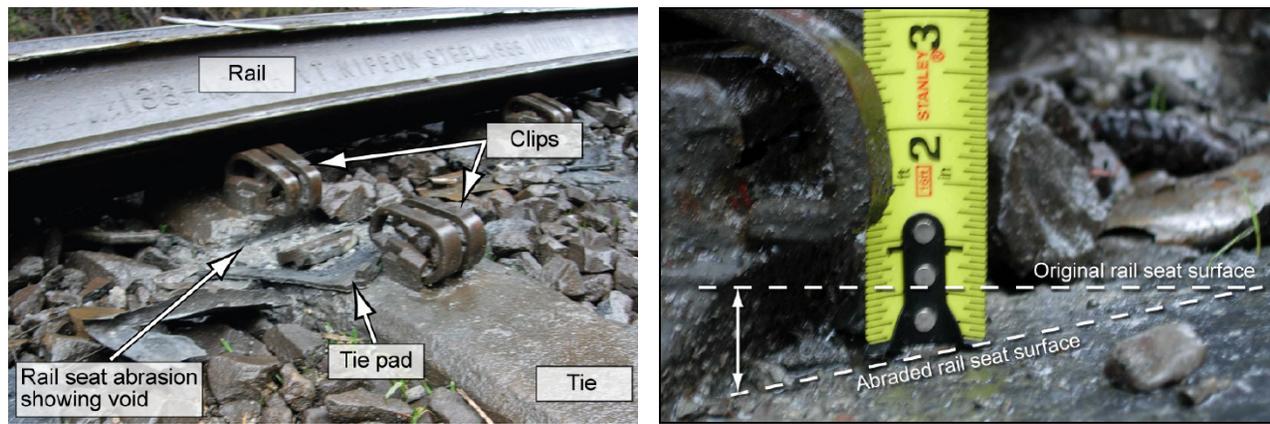
**Figure 3: RSD, with triangular wear of concrete surface toward the field side on the high side of a curve [12]**
