Investigating the Role of Moisture in Concrete Tie Rail Seat Deterioration

Proceedings of the 2009 Annual AREMA Conference

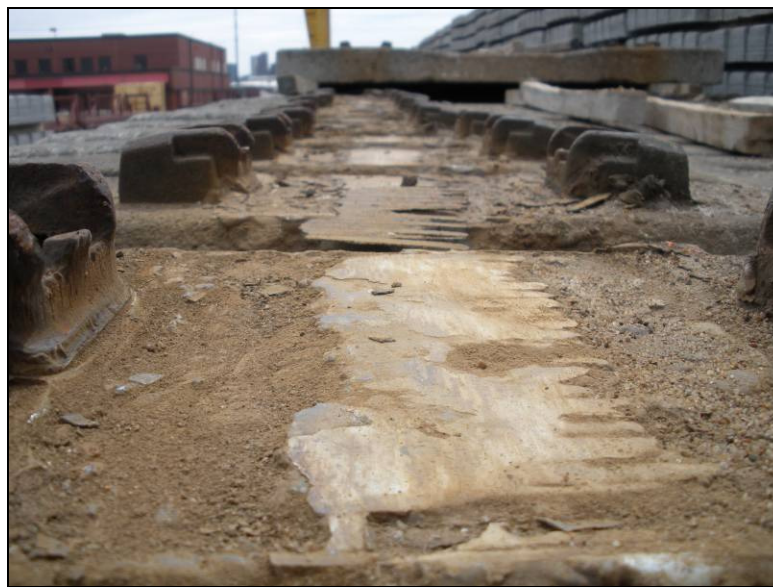
FIGURE 2. Service Example of Rail Seat Deterioration

Suggesting Loosened Fastening Components

The RSD wear patterns observed in track vary based on the specific climatic and traffic conditions and the location of the concrete tie in track. Figures 1 through 3 show three distinct examples of concrete rail seats that have been damaged in service. Figure 1 is a view looking downward at the top of the rail seat. This rail seat has worn more on one side because of its location in a curve, and the lateral forces caused deterioration to occur under the field side of the rail (the top of the image). The rail seat in Figure 2 appears to be crushed on both its gauge and field sides. This could be the result of the rail pivoting back-and-forth because of a loose fastening system. Figure 3 shows the concrete's coarse aggregate exposed after the mortar was worn away, leaving an appearance similar to a surface eroded by the movement of water.

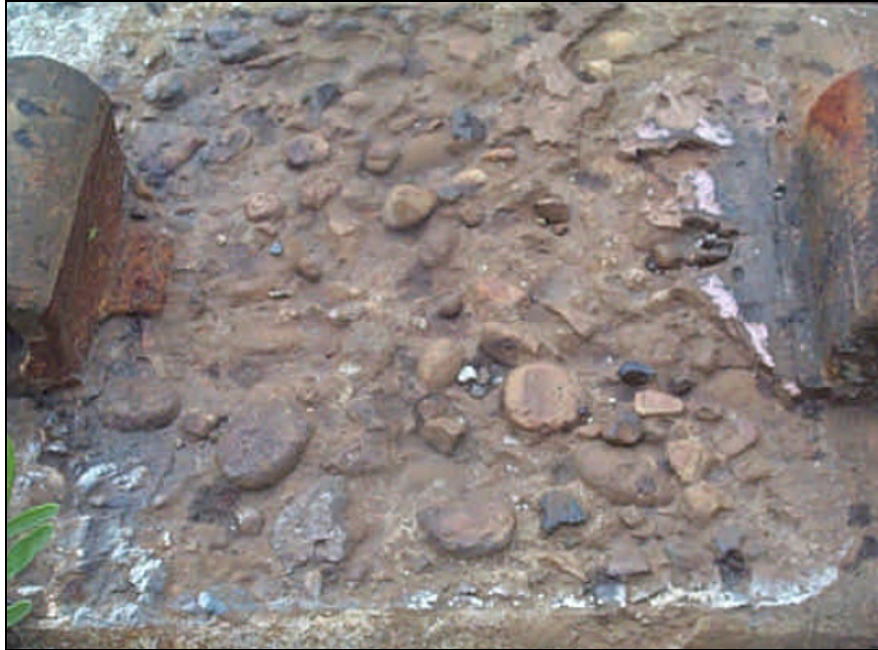
FIGURE 3. Service Example of Rail Seat Deterioration

Suggesting Erosion of the Cement Paste (5)

As part of an earlier investigation into the mechanics of RSD, Pandrol, Ltd. developed the Jetmil test to create cavitation erosion by spraying a test surface with water at a pressure of 6000 pounds per square inch (psi) from a set of rotating nozzles (5). Bakharev used the Jetmil apparatus on different concrete mixes and recorded depths of wear between 0.06 and 0.10 inch on a 5.25 inch-diameter surface after ten minutes. The Jetmil created surfaces that appeared similar to the RSD surfaces found in service (Figure 3), but at the microscopic level, the wear on new ties subjected to Jetmil tests was not consistent
