Investigation of Potential Concrete Tie Rail Seat Deterioration Mechanisms: Cavitation Erosion and Hydraulic Pressure Cracking 10-2411

Transportation Research Board 89th Annual Meeting

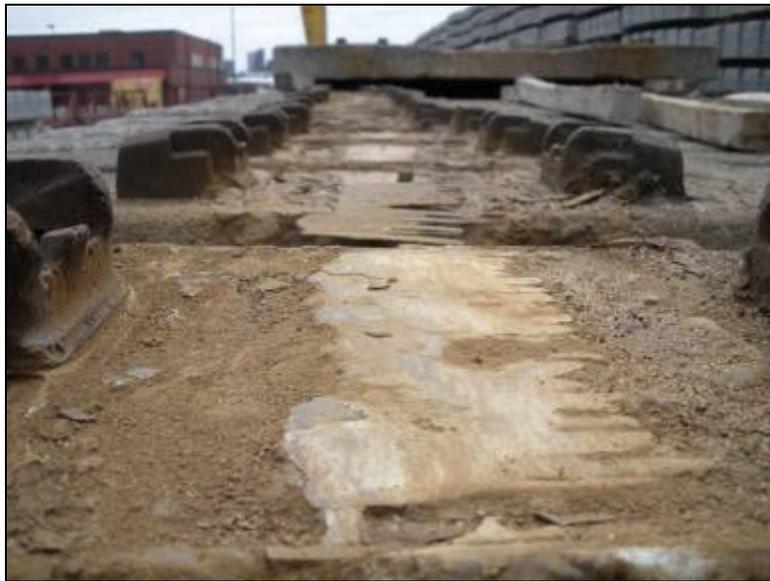
FIGURE 2. Service example of rail seat deterioration suggesting loosened fastening components

The RSD wear patterns observed in track vary based on the specific climatic, traffic, and track geometry conditions. Figures 1 through 3 show three distinct examples of concrete rail seats that have been damaged in service. Figure 1 is a view looking downward at the top of the rail seat. This rail seat has worn more on one side because of its location in a curve, and the lateral forces caused deterioration to occur under the field side of the rail (the top of the image). The rail seat in Figure 2 appears to be crushed on both its gauge and field sides. This could be the result of the rail pivoting back-and-forth due to a loose fastening system. Figure 3 shows the concrete's coarse aggregate exposed after the mortar was worn away, leaving an appearance similar to a surface that has been eroded by the movement of water.

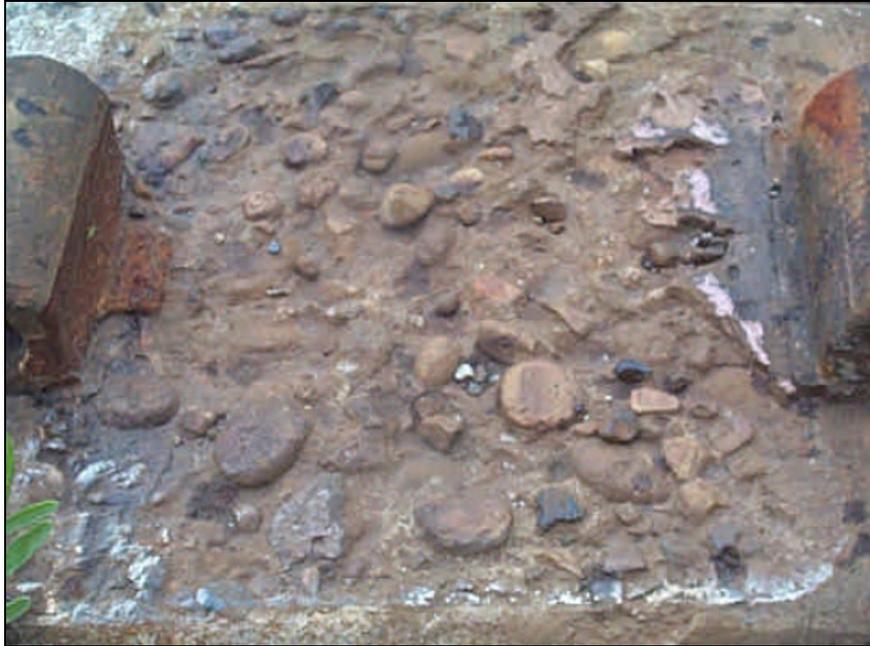
FIGURE 3. Service example of rail seat deterioration suggesting erosion of the cement paste (5)
