Field Measurements and Proposed Analysis of Concrete Crosstie Bending Moments

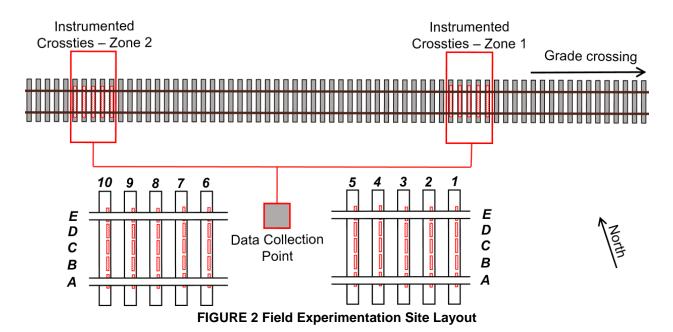
The east zone (Zone 1) consisted of Crossties 1-5 and served as the example for poor support. Zone 1 was located near a group of crossties that had chronic surfacing defects during geometry car inspections, which is an indicator for poor subgrade. These defects were repaired before the beginning of this experimentation, but it was believed that the issues could re-emerge. Additionally, all crossties in Zone 1 had some level of visible center negative cracking and displayed evidence of ballast pumping. The west zone (Zone 2) consisted of Crossties 6 - 10 and served as the well-supported or control zone. Crossties 6, 7, 8, and 9 showed some center cracking, but there was no visible pumping upon train passes. Furthermore, Zone 2 deflected noticeably less than Zone 1. Finally, there was a grade crossing located approximately 180 feet (55 meters) east of Zone 1. The track at this location consisted of 133RE rail and Safelok I fastening systems. Rail, fasteners, and crossties were all installed in 1999. As of early 2015, the track was last surfaced in an out-of-face fashion in 2011. The timetable speed at this site was 40 mph

(65 kmh), the predominant direction of the traffic on this track was eastbound, and the dominant type of railcar was loaded 286 kip (129.7 tonne) coal cars.

FIGURE 2 Field Experimentation Site Layout

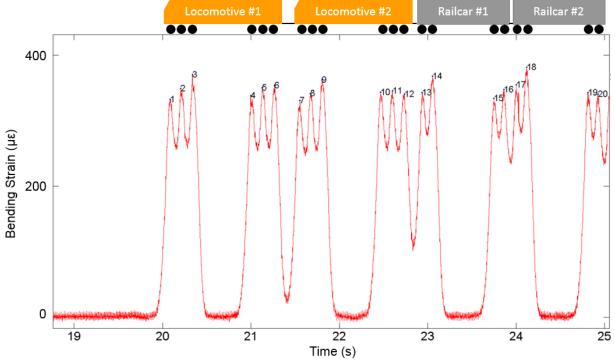
FIGURE 4 Typical Strain Signal Captured Under the Passage of a Loaded Train

To quantify the bending moments concrete crossties experience in revenue service, peaks in the strain gauge signal caused by crosstie bending due to an axle load must be extracted from the data stream. This was accomplished using the "findpeaks" function in MATLAB (9). To improve the performance of this function for this application, several of the built-in options were utilized. To ensure that the true peaks were being captured by the program, as opposed to false peaks that did not represent the extreme strain

reading for a given axle pass, a minimum spacing between the peaks was specified and a minimum value for all peaks was set. To improve this process, a simple algorithm utilizing a while loop was implemented, which used the number of axles on the train as an input. The number of axles were determined using either wheel impact load detector (WILD) data, visual inspection of the passing train, or a manually-adjusted findpeaks function.

Before these peaks were obtained, the strain signal was zeroed, smoothed using a moving average filter of five data points, and the baseline was corrected to adjust for any signal drift. To aid in signal processing, data collection was started several seconds prior to the arrival of the leading axle of the first locomotive into the experimental zone. This provided a stable zero point for the crosstie under no applied load. Additionally, the data collection was ended several seconds after the passing of the final axle of the train to serve as an end point for the baseline correction. Figure 4 shows an example of a typical signal for a center gauge with each peak labeled. Each peak was then stored in a column vector with one row for each axle on the train and one column for each crosstie, and the peak strains were eventually converted into bending moments using the calibration factors mentioned previously.

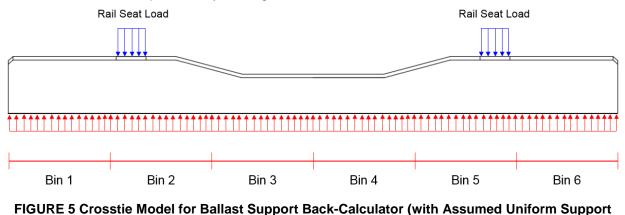
To quantify the ballast reaction below the crosstie, a ballast support back-calculator was developed in MATLAB. Figure 5 illustrates the 2-D crosstie model that the computation was based on. The crosstie was divided into 6 discrete bins of equal size, and within each bin, the ballast reaction force was assumed to be uniformly distributed. The rail seat loads were also assumed to be uniformly distributed over

6 in. (15 cm) on each rail seat, and the magnitudes of the rail seat loads can be calculated by using the formula from AREMA MRE with wheel load values obtained from the nearby WILD site. The goal of this back-calculator was to find a combination of reaction forces within the 6 bins that would generate bending moments at the 5 strain gauge locations along the crosstie similar to the values converted from the strain gauges themselves. Boundary conditions were set such that reaction forces added up from all bins should equal the sum of both rail seat loads and no bin can experience a negative value. Pareto distribution and simulated annealing were used in the computation algorithm, because they were proven to be effective at finding the global optimum (10, 11). The calculation was set to complete when the difference between the calculated moments and measured moments reached its minimum, and the calculator would output the reaction force within each bin. The reaction force distribution shown in Figure 5 is an assumed scenario when the crosstie experiences a uniformly distributed ballast reaction, and it is

not intended to represent any actual result from the back-calculator. The ballast reaction force could be later converted to ballast pressure by dividing the force over the width of the crosstie.

FIGURE 5 Crosstie Model for Ballast Support Back-Calculator (with Assumed Uniform Support Condition)

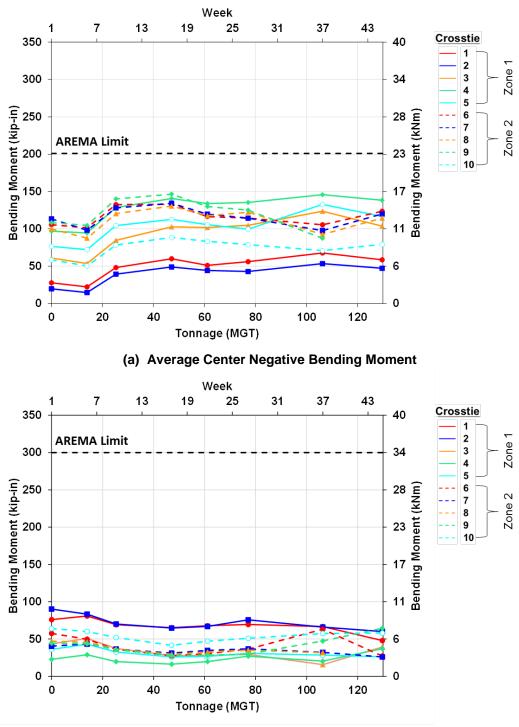
(b) Average Rail Seat Positive Bending Moment FIGURE 6 Effect of Tonnage on Average Crosstie Bending Moments

Over 120 million gross tons (MGT) of heavy-haul traffic had accumulated on the site since the first visit in March, 2015. Figure 6 (a) and (b) show how the average center negative bending moments and rail seat positive bending moments changed as tonnage increased. In general, average center negative bending moments exhibited a relatively steady trend, with the majority of the crossties experiencing a slight increase over the entire time (i.e. 10% for Crosstie 7 and 8) and a few crossties experiencing a slight decrease during a shorter period (i.e. 4% for Crosstie 9 and 5 % for Crosstie 10 from August to September). Average rail seat positive bending moments remained relatively steady as well, but overall showing a slight decrease (i.e. 9% for Crosstie 3 and 10). Furthermore, as average center moments increased, average rail seat moments tended to decrease, and vice versa. It is hypothesized that this behavior is explained by the re-distribution of ballast support below the crossties. For instance, if the ballast moved towards the center of the crosstie from its ends, a center binding support condition would develop, which would cause an increase in center bending moment and a decrease in rail seat bending moments.

It is noticeable that no crosstie's average bending moments reached the AREMA recommended design limit, especially at the rail seats, as their average moment values were less than one-third of the 300 kip-in (33.9 kNm) that AREMA recommends, meaning that AREMA recommendations might overestimate the flexural demand at the crosstie rail seat section (5). Compared to rail seat moments, average center bending moments were closer to the AREMA recommended value of 201 kip-in (22.7 kNm), with the highest average moment being almost two-thirds of that value, indicating that center bending could be more demanding than rail seat bending (5). This agrees with the previous survey, which suggested that center cracking of concrete crossties was more commonly seen in the field (4).

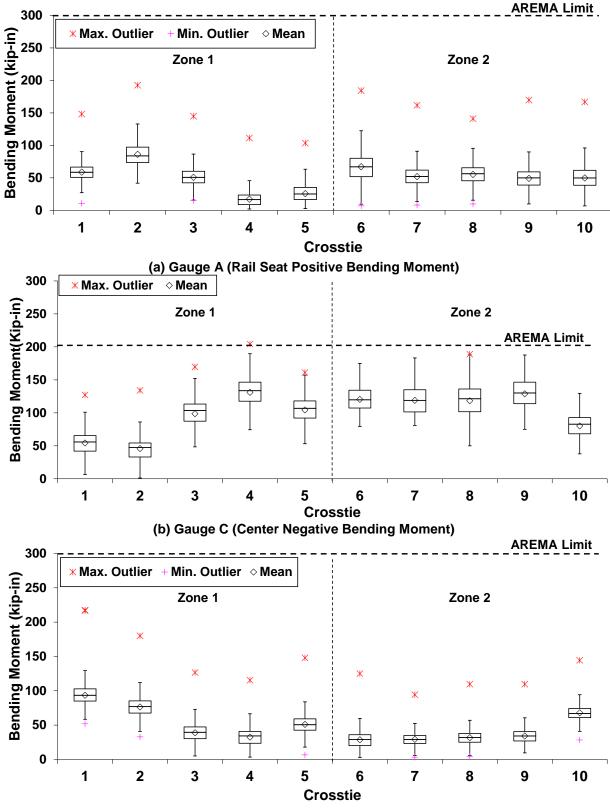
(c) Gauge E (Rail Seat Positive Bending Moment) FIGURE 7 Box-and-Whisker Plots of Measured Bending Strains

Each point in Figure 6 represents a value averaged from thousands of data. To visualize the distribution of measured bending moments of each crosstie over time, box-and-whisker plots were developed (Figure 7) for each crosstie.

The top line of the box represents the 75th percentile bending moment (Q3). The middle line is the median bending moment. The bottom line of the box represents the 25 percentile bending moment (Q1). The interquartile range (IQR), found as Q3 minus Q1, can provide an estimate of the variability of the data set – the greater the IQR, the higher the variability. The upper whisker shown in Figure 6 is the limit for upper outliers, which are defined as data points greater than Q3 plus 1.5 times the IQR (or (Q3 + 1.5*IQR)) (*12*). Similarly, the lower whisker is the limit for lower outliers, which are defined as data points smaller than Q1 minus 1.5 times the IQR (or (Q1 – 1.5*IQR)) (*12*).

As can be seen in Figure 7, moment distributions for crosstie centers and rail seats are quite different. To be more specific, both rail seats had more occurrences of outliers than crosstie centers. These outliers are hypothesized to be the result of high impact loads caused by flat wheels. The presence of more rail seat outliers suggests that rail seat bending is more sensitive to wheel defects than center bending. In addition, center bending moments appeared to be more variable, since they had larger IQRs than rail seat bending moments. This indicates that center bending is more sensitive to support conditions than rail seat bending.

The values of the center bending moment outliers are closer to the AREMA recommendations than the rail seat bending moment outliers. It should be noted that Crosstie 4's center bending moment outliers exceeded the AREMA recommended design value twice. That is, of the 38,954 loaded axles that passed over the crosstie, only two axles induced center bending moments over the AREMA recommendation of 201 kip-in (22.7 kNm). The probability of exceedance was calculated to be 0.005% for Crosstie 4 and 0.0005% for all 10 instrumented crossties. Both of the probabilities were considered to be insignificant, thus indicating that the bending of the crossties at this location would only cause center moments to exceed the recommended values under very rare circumstances or if the support conditions were to vary more than they already had. Besides that, Crosstie 4 appeared to have no distinct center cracks that would constitute a failure per Code of Federal Regulations (CFR) 213, the Federal Railroad Administration (FRA) Track Safety Standards (TSS) *(13)*. Therefore, even though center bending moments exceeded the design limit for Crosstie 4, it still served its functionality. It is also more evident in Figure 7 (a) and (c) that AREMA might overestimate the flexural demand on rail seats, as all the outliers of rail seat bending moments were below the AREMA imit.

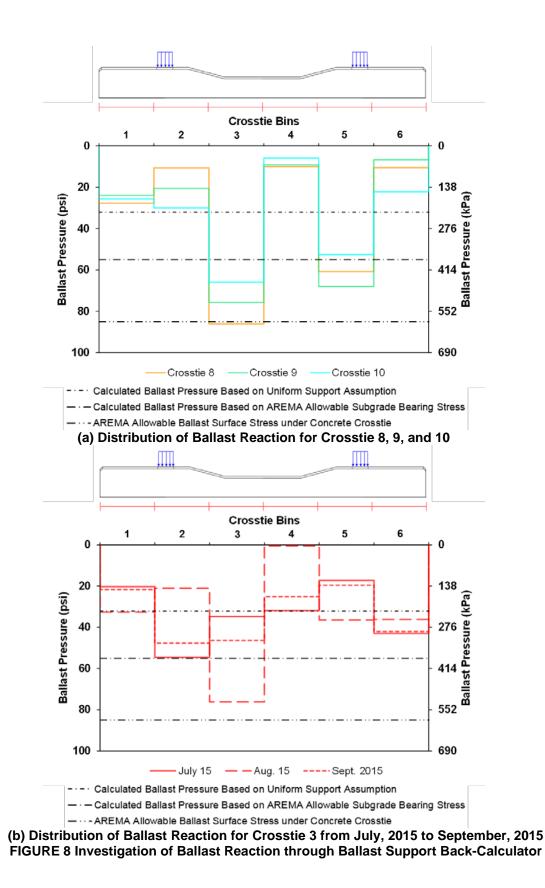
Although it is difficult to visually inspect the ballast support condition, the ballast reaction along the bottom of the crosstie can be calculated using the ballast support back-calculator. Figure 8 shows the resultant distribution of ballast support when wheels passed over the crosstie and induced a rail seat load of approximately 18 kips on each rail seat. The vertical axis is in reverse order, indicating a larger magnitude of ballast reaction (in pressure) when the bar extends further down to the bottom of the graph. For instance, in Figure 8 (a), Crosstie 8 experienced its highest ballast reaction of 86 psi (592 kPa) at Bin 3 and its lowest ballast reaction of 10 psi (69 kPa) at Bin 4. If the support condition was assumed to be uniform, then the ballast pressure would be 32 psi (221 kPa) for all bins, and this value is represented as the top black dashed line labelled "Uniform Ballast Pressure" in both Figure 8 (a) and (b). The middle black dashed line represents the ballast pressure when the subgrade stress reaches the allowable value that AREMA recommends (25 psi (172 kPa)) (5). This ballast pressure was calculated based on the Talbot Equation using the allowable bearing stress of subgrade, assuming a typical ballast depth of 12 in (30 cm), and a typical subballast depth of 6 in (15 cm) (5). AREMA recommends 85 psi (586 kPa) as the allowable ballast surface stress for concrete crossties, and this value is represented in the bottom dashed line

(Figure 8).

As can be seen in Figure 8, support conditions varied from crosstie to crosstie (Figure 8 (a)) and as tonnage increased (e.g. from month to month) (Figure 8 (b)). Figure 8 (a) shows that the ballast reaction below the crossties can vary though the crossties are only 24 in (61 cm) apart from one another. The greatest difference occurred at Bin 2, where there was a 48% difference in reaction between Crosstie 8 and 9, and 31% between Crosstie 9 and 10. In Figure 8 (b), a distribution of ballast support for Crosstie 3 was selected from each month for 3 months starting in July, 2015, and differences between reaction forces were observable at every bin. Bin 4 exhibited an extreme case, where in August, 2015, the reaction decreased to nearly zero, indicating a gap was created between the crosstie bottom and the ballast surface within the bin, when a particular wheel passed over the crosstie.

It is noticeable that in both Figure 8 (a) and (b), the reaction of some bins exceeded the ballast pressure calculated based on the allowable subgrade bearing stress. If this exceedance continued to occur, it could lead to subgrade bearing capacity failure. In Figure 8 (a), the ballast reaction in Bin 3 of Crosstie 8 exceeded the allowable ballast surface stress. If this exceedance happened frequently, it could cause the accelerated deterioration of ballast within those bins, and even ballast crushing. Track geometry defects could also develop due to these higher ballast pressures. Therefore, certain maintenance

FIGURE 8 Investigation of Ballast Reaction through Ballast Support Back-Calculator

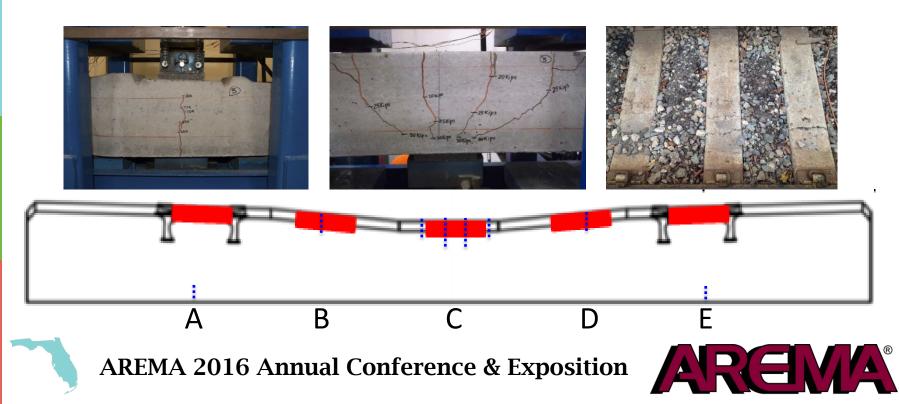
Crosstie Instrumentation

- 5 surface strain gauges installed on each crosstie:
 - Rail seat gauges (to measure rail seat positive bending)
 - Center gauge (to measure center negative bending)
 - Intermediate gauge (to measure asymmetric loading or support)

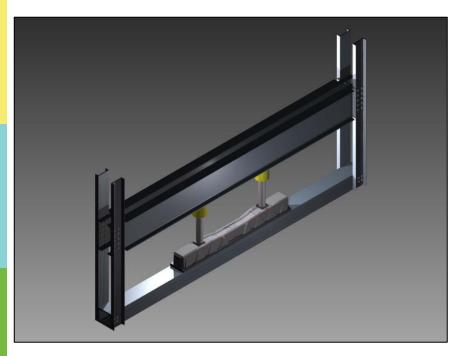
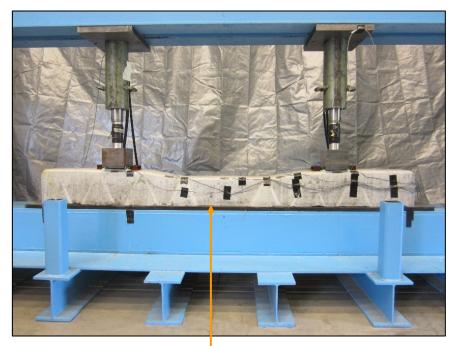
Laboratory Experimentation Equipment

• Loading frame - Static Load Testing Machine (SLTM)

• Supporting rubber pads

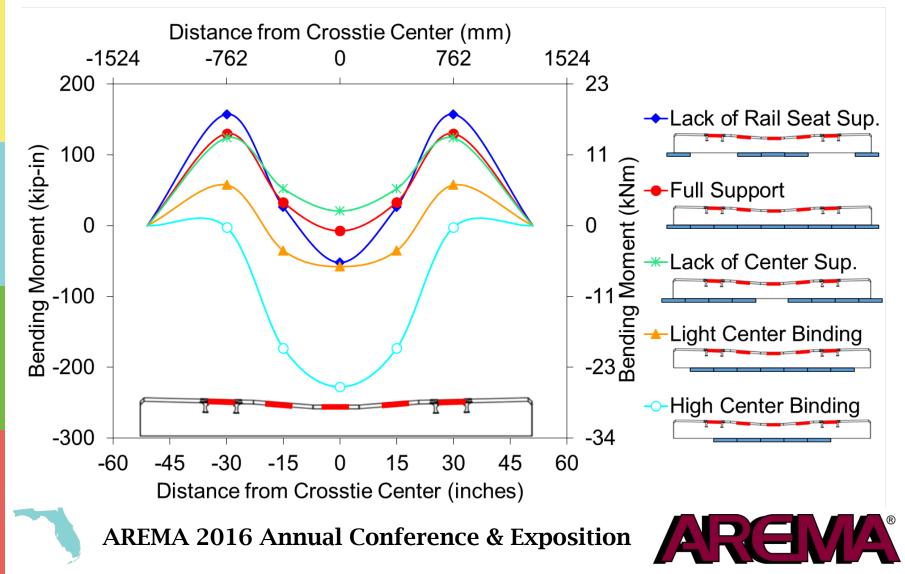
Flexural Performance under Different Support Conditions

Rail Seat Load: 20 kips (89 kN), Healthy Crosstie

Laboratory Experimentation: Preliminary Conclusions

- Small amounts of center binding can result in large differences in center moment:
 - 241.2 kip-in change for high center binding (at center)
 - 78.6 kip-in change for light center binding (at center)
- Rail seat moments are less sensitive to changes in support:
 33.4 kip-in change for lack of rail seat support (at rail seat)
- Center negative cracks are more likely than rail seat positive cracks and support conditions play a major role in the crosstie performance

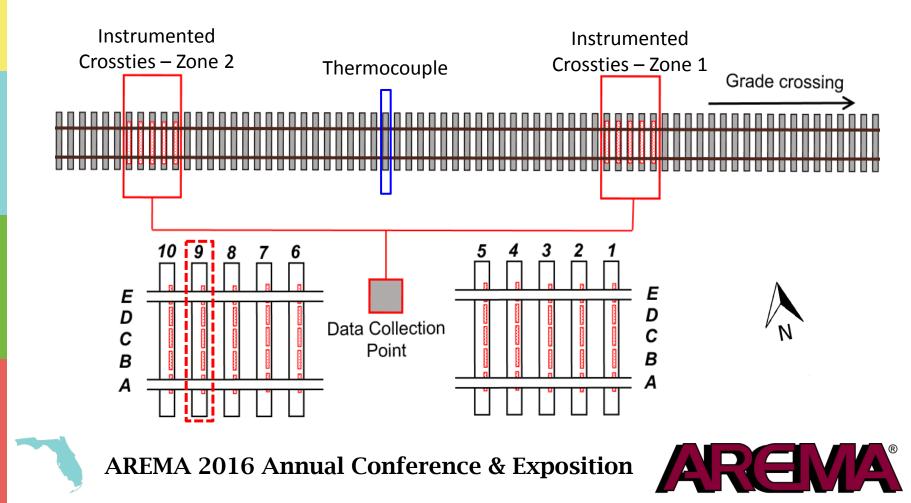
Field Site Layout

- Site split into two zones of five crossties each
- Concrete surface strain gauges installed on 10 crossties

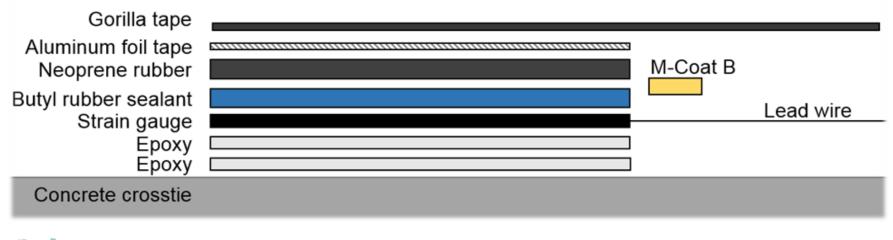
Instrumentation Protection Plan

- Surface strain gauges are delicate sensors and must be protected
- Potential types of damage:
 - Mechanical damage impacts or pressures caused by train passes or maintenance activities
 - Moisture damage ingress of water can cause wire shorts and failures

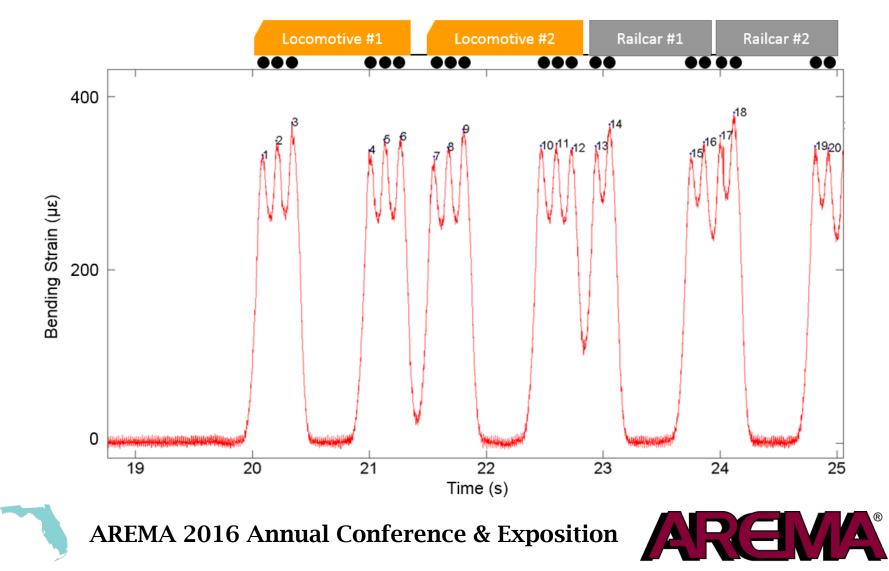
Example Strain Signal (Gauge C)

• Strain peaks correspond to loaded axles

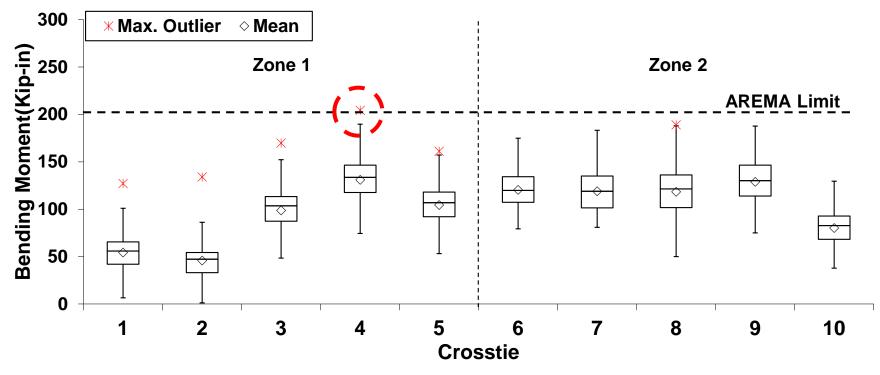
Box Plot for Center Negative Bending Moment (Gauge C)

- However, only 2 of 38,954 loaded axles exceeded the AREMA limit
 - 0.005% exceedance probability for Crosstie 4 and 0.0005% for all 10 crossties

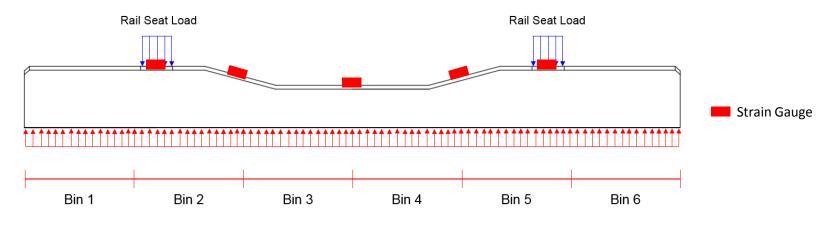
2-D Crosstie Bending Model

- Assume rail seat load is uniformly distributed across rail seat
- Divide the crosstie into 6 bins:
 - Each bin consists a percentage of total reaction force
- 9 inputs:
 - Known bending moments from 7 locations
 - 2 approximated rail seat loads
- 2 boundary conditions:
 - Force equilibrium (sum of all bins should be close to 1)
 - Value of each bin should not be negative

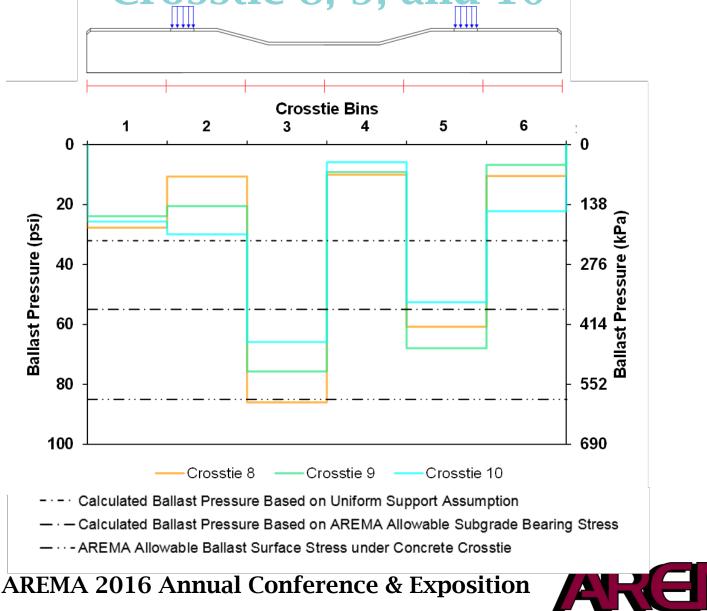
Distribution of Ballast Reaction for Crosstie 8, 9, and 10

Ballast Pressure Limit States

- Ballast pressure calculated based on uniform support condition: 32 psi
- AREMA allowable ballast surface stress under concrete crossties: 85 psi
- Ballast pressure calculated based on AREMA allowable subgrade bearing stress (25 psi) using Talbot equation: 55psi
