Degradation Mechanisms of Concrete Due to Water Flow in Cracks of Prestressed Railroad Sleepers under Cyclic Loading

Abstract: Visual inspection and field experience from concrete railroad sleepers (crossies) provide evidence that cyclic loading of train axles accelerates their degradation in areas of high precipitation. Because prestressing forces close flexural cracks after every load application, this repetitive motion generates water flow within cracks. In this study, multiple mechanisms are systematically investigated through laboratory experimentation to understand the deterioration of concrete in cracked prestressed beams exposed to moisture and under cyclic loading. Results identified abrasion as the leading degradation mechanism. High hydraulic pressures, cavitation, and leaching damage are also investigated but seem less likely to govern this problem. DOI: [10.1061/\(ASCE\)MT.1943-5533.0004144](https://doi.org/10.1061/(ASCE)MT.1943-5533.0004144). © 2022 American Society of Civil Engineers.

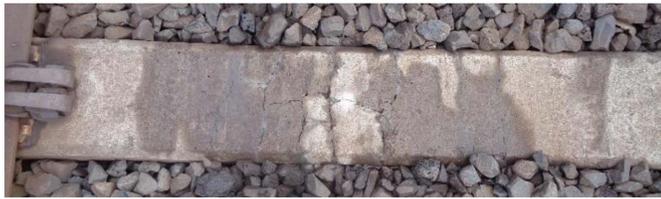
Fig. 1. Center-cracked pretensioned concrete sleeper after precipitation event.

Water flow in cracks may be an important factor in accelerating flexural distress in pretensioned concrete beams subjected to loading conditions similar to railroad sleepers (crossies). Field observations indicate that cracked sleeper deterioration is accelerated in locations with high precipitation (Fig. 1).

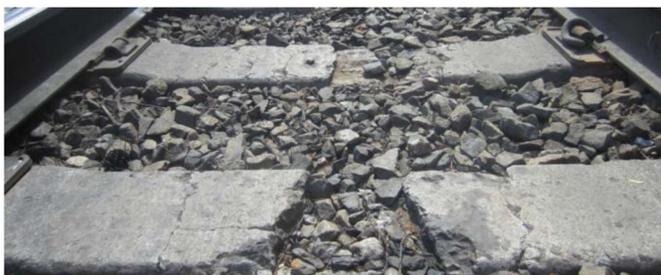
Fig. 3. Observation of severe expansion of flexural cracks.

When prestressed concrete beams crack in flexure, the cracks formed are narrow and are sometimes referred to as hairline cracks. This type of cracking is typical in standard laboratory tests and is only visible when loads are applied because of the resistance exerted by internal prestressing forces. Nevertheless, concrete sleepers in the field develop cracks that are significantly more severe than those in the laboratory environment, sometimes leading to a loss of concrete cover (Fig. 3).
