THE EFFECT OF SERVICE LOADING ON THE BENDING STRENGTH
OF CONCRETE TIES

INTERIM REPORT
OCTOBER 1981

1. Report No. FRA/TTC-81/11		2. Government Accession No.		3. Recipient's Catalog No.	
4. Title and Subtitle The Effect of Service Loading on the Bending Strength of Concrete Ties				5. Report Date October, 1981

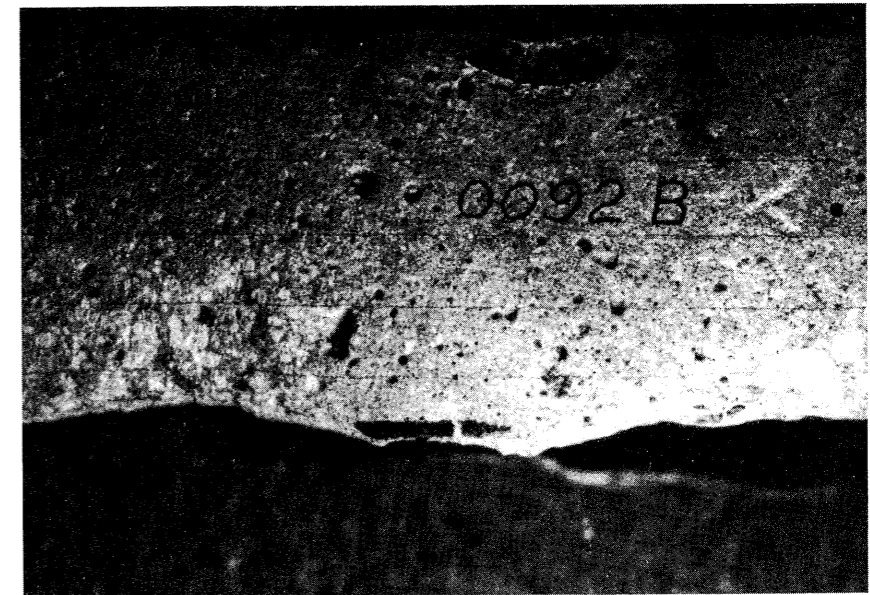
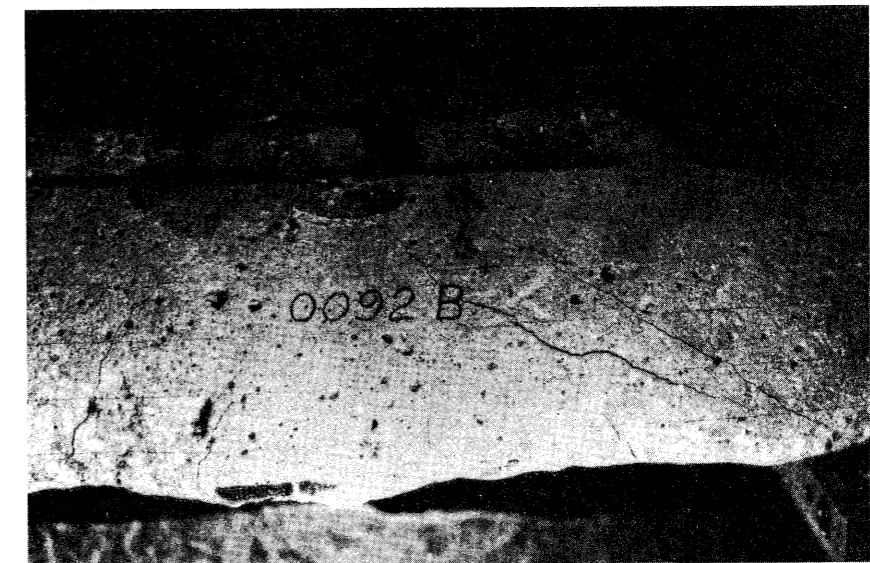
Before test

After ultimate load

FIGURE A-6. RAIL SEAT TEST OF USED TYPE B TIE.

Photos of typical tie failure modes are shown in figures A-4 through A-7.
