EXPERIMENTAL MEASUREMENT AND FINITE ELEMENT ANALYSIS OF SCREW SPIKE FATIGUE LOADS

Matthew G. Dick
David S. McConnell
Hans C. Iwand
Rail Sciences, Inc.

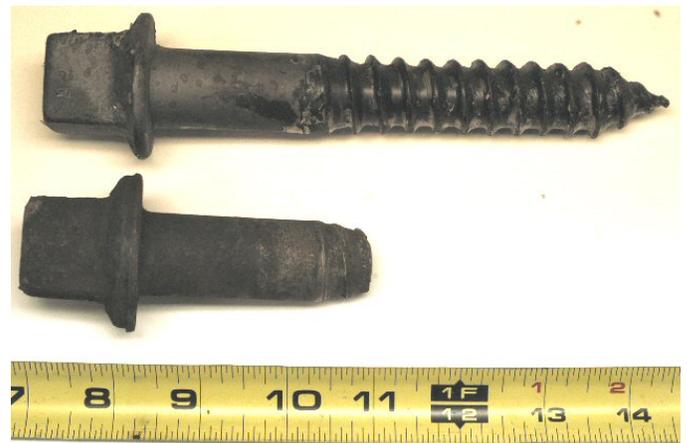
Screw spikes fail due to bending fatigue from rail vehicle lateral wheel loads. New and failed screw spikes are shown in

Figure 1. Overview of new and failed screw spikes.

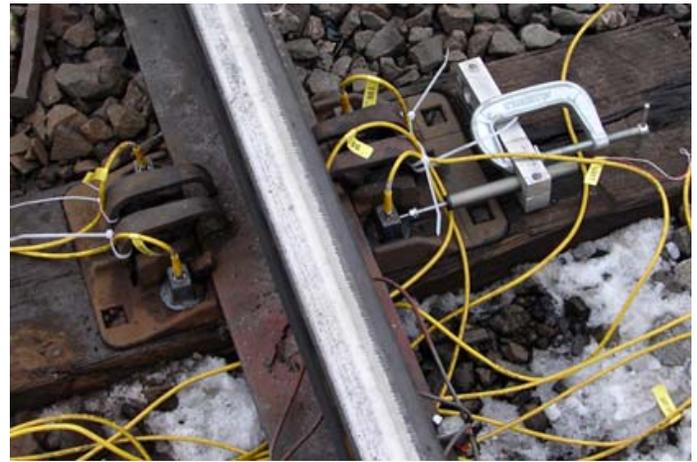
Figure 5. Overview of fully instrumented tie plate.
