*RMAE Engineering*

FAST INSTRUMENTED CROSSTIES

PROPERTY OF U. S. GOVERNMENT  
DEPARTMENT OF TRANSPORTATION  
TRANSPORTATION TEST CENTER

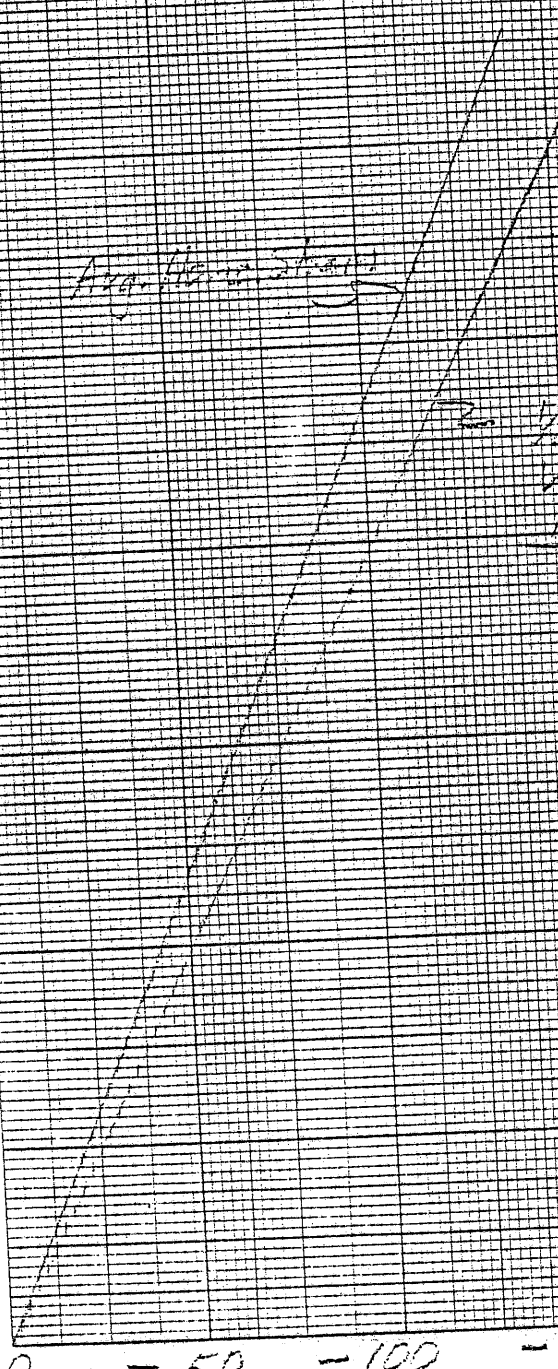
Positive Bending Moment  $M_1$  Ticks Kips

1/2 Bridge A1-D-9 (A End, Outside Rail Seat, Bottom)

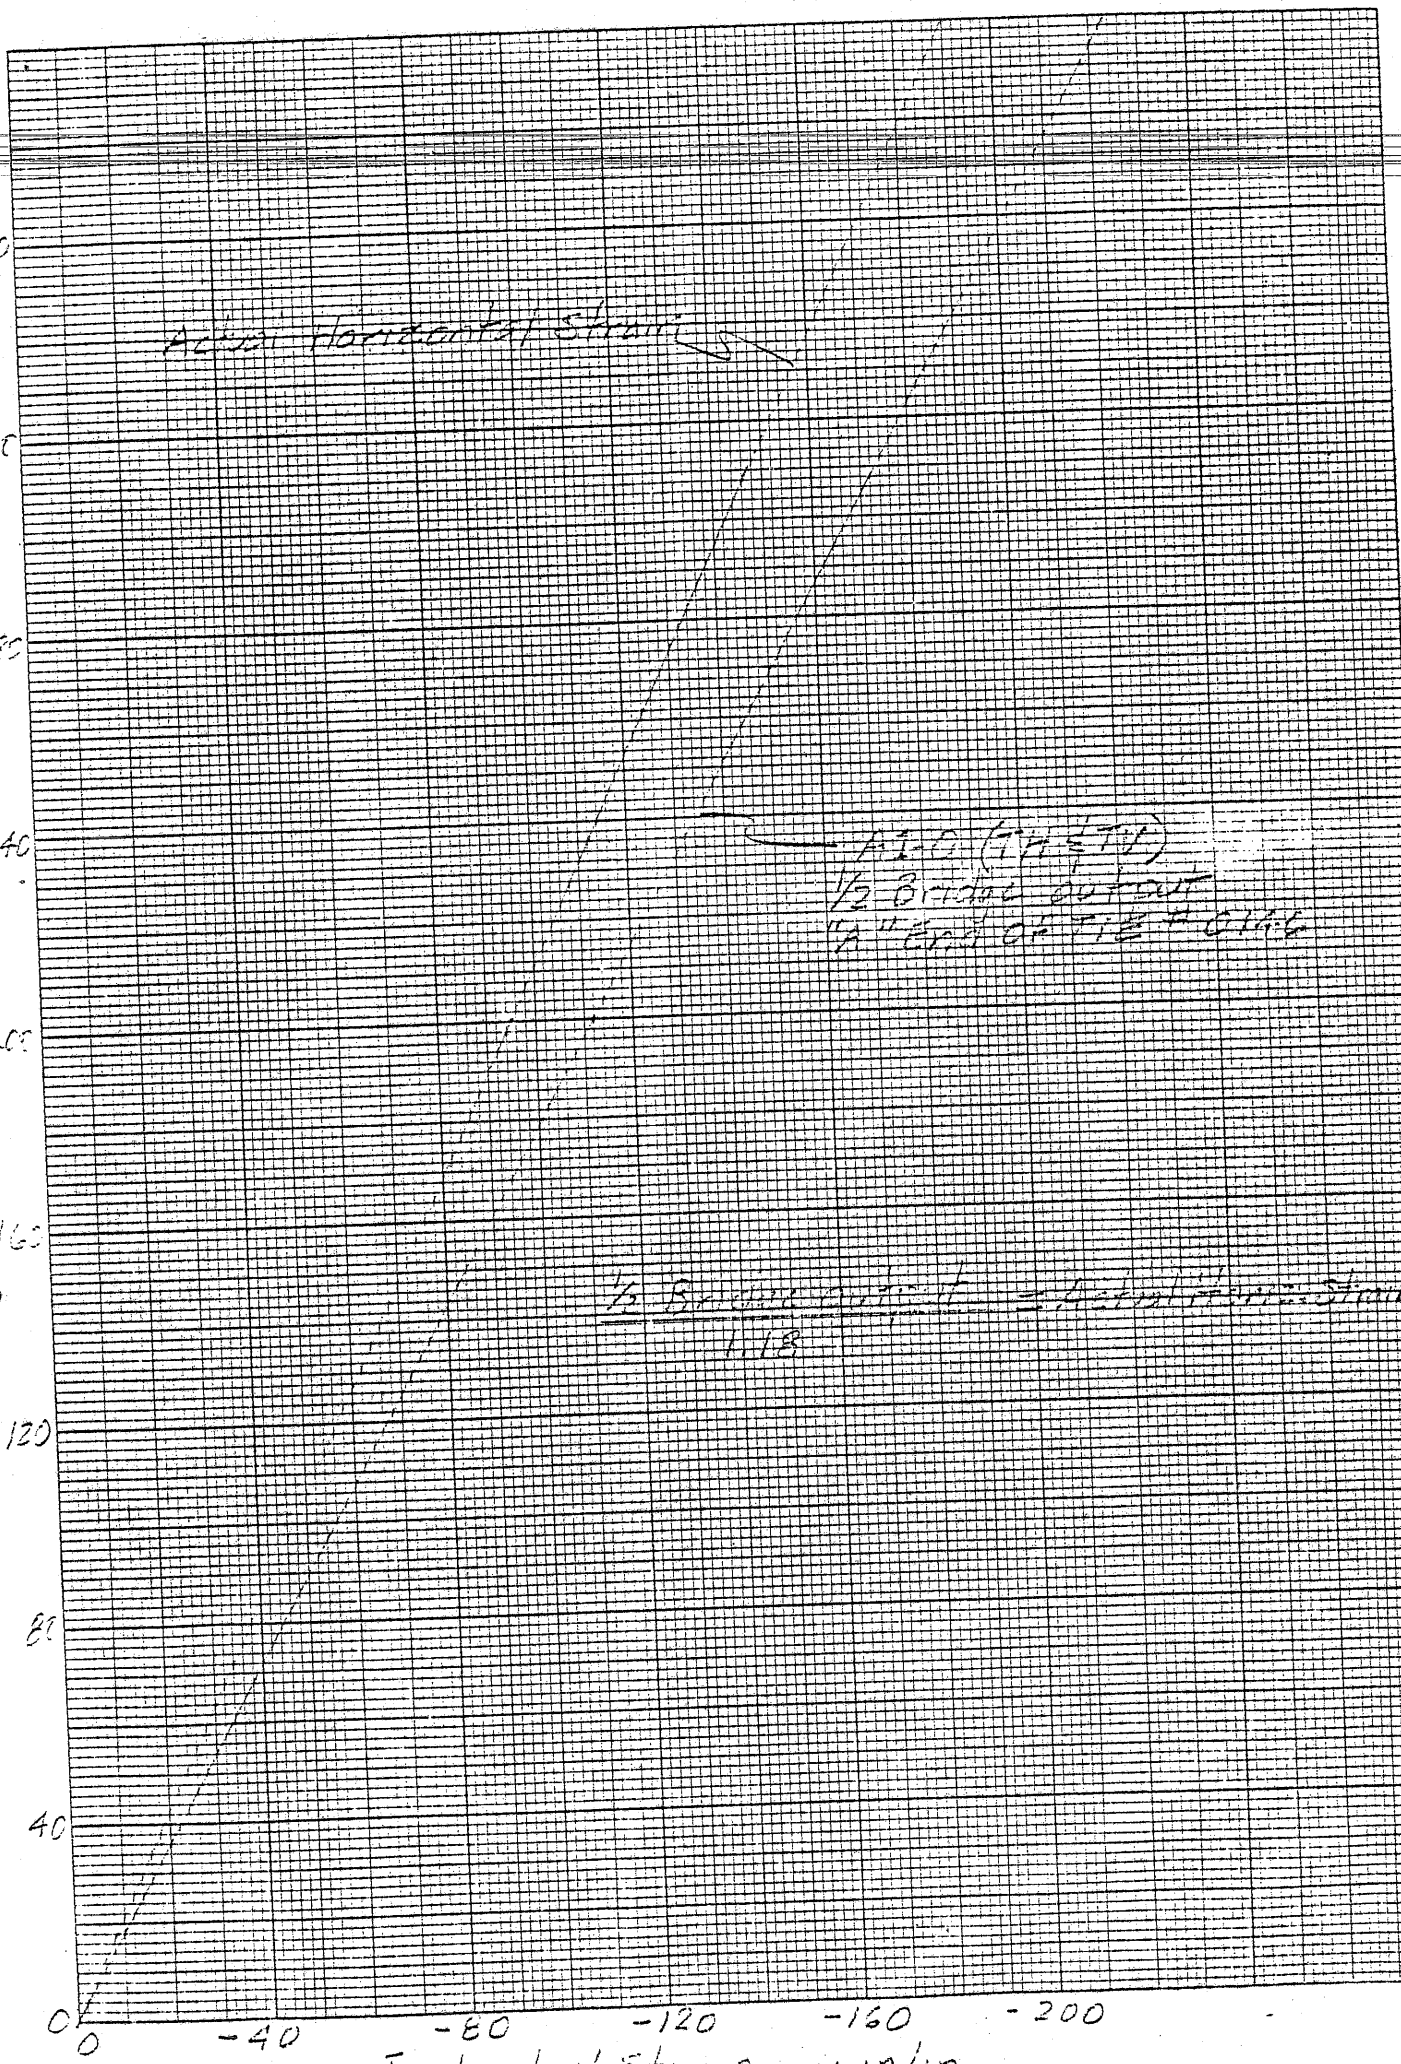
$M=0$  (TIE IN)  
 $\frac{1}{2}$  Bridge output  
 $\frac{1}{4}$  " END OF TIE # 0196

$\frac{1}{2}$  Bridge output = Actual Strain  
1.18
