Federal Railroad  
Administration

RR 20-24 | November 2020

# TIMBER CROSSTIE SPIKE FASTENER FAILURE INVESTIGATION: FIELD EVALUATION OF AN ALTERNATIVE FASTENER

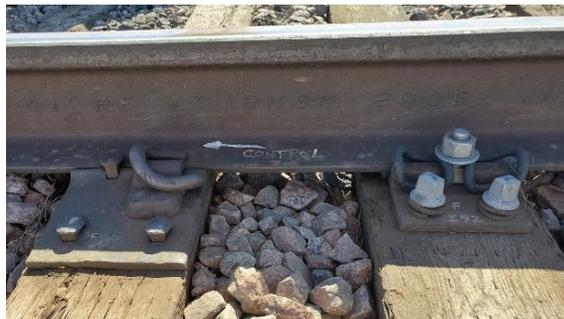
**Figure 1. Transition between control fastener (left) and alternative fastener (right) at TTC's FAST**

Section 25, this track segment has a history of spike failures. The control zone fastener type is commonly found in North American heavy haul track and consisted of 20 crossties, e-clips, and cut spikes. The test zone consisted of an alternative fastening system with 30 crossties, tension clamps, and screw spikes with spring washers. The test setup included installing new ties at every third tie location. All other ties were in good, used condition. [Table 1](#) provides select details of each fastening system, while [Figure 1](#) shows the installed systems. Each spring washer is expected to apply between 4,000 and 7,000 lb. of preload.
