Performance of Elastic Fasteners on an 8-Degree Curve in Revenue Service

Rafael Jimenez and Dingqing Li, TTCI
Russell McDaniel, Norfolk Southern

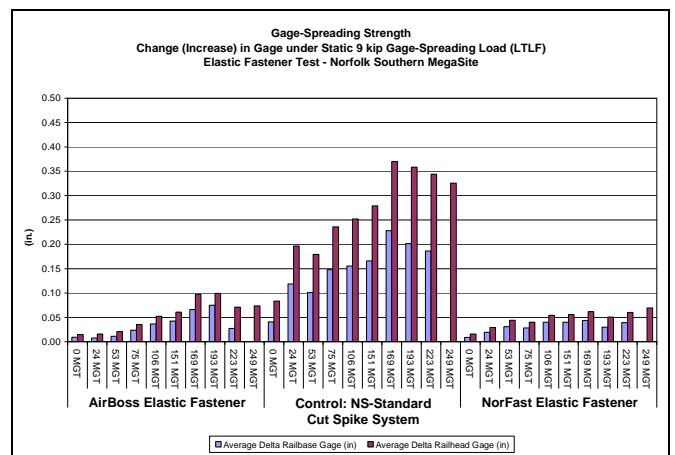
Figure 2 shows the gage strength degradation test results for the three zones using a lateral track loading fixture (LTLF). After 250 MGT, the gage strength of the two elastic fastener test zones was more than 3 times stronger (less gage widening) than that of the control zone with the NS-standard 18-inch plate and cut spike system. The LTLF test, which applies the gage spreading load at the neutral axis of the rail, indicates the cleats may provide some increased resistance to lateral tie plate translation.

Figure 2. Gage Strength Degradation Data showing the Significant Benefit of the Elastic Fasteners Tested over the Standard Cut Spike System

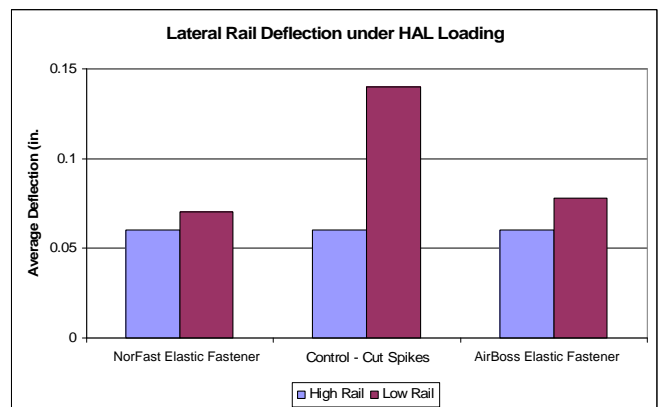
Given that the test zone is exposed to underbalance train operating conditions, higher loading and therefore larger deflections are expected on the low rail. Such was the case in the cut-spiked subzone, where the deflection measured on the low rail was almost twice that measured on the low rail of the elastic fastening system zones. Figure 5 shows that the two elastic fastening systems provided similar resistance to the dynamic gage-spreading forces at both rails where measured deflections ranged between 0.06 and 0.08 inch.²

Figure 5. Lateral Railhead Dynamic Deflection under HAL Coal Car Loading

Lateral railhead deflections resulting from the dynamic loading introduced by passing HAL coal cars were measured early in the test. Each of the subzones was fitted with a pair of transducers to capture the high and low railhead deflections.

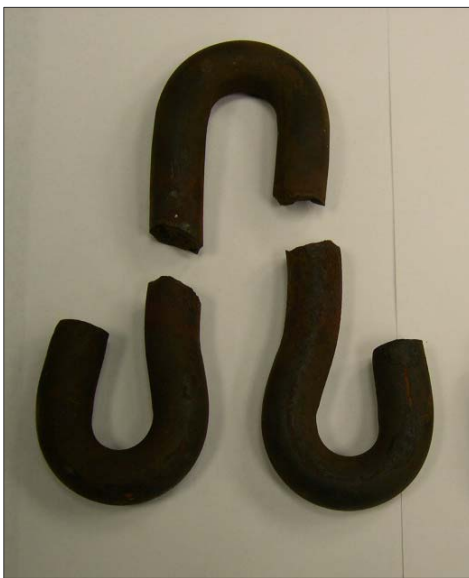
After 70 MGT of service, two of the 360 NorFast rail clips installed were found fractured.³ The fractures occurred under the rail clip keeper portion of the tie plate, where it was difficult to detect by typical visual inspection, as Figure 6 shows.

Figure 6. Parts of a NorFast Rail Clips Fractured at 70 MGT

Because of similar rail clip breakage (nine of 260), after 455 MGT at FAST, a laboratory study was conducted on samples taken from the two ongoing in-track tests at the eastern mega site and at FAST to determine if this type clip should be removed from service testing. The results of the laboratory study indicated that no such action was necessary.⁴ In total, 11 rail clips in the NorFast elastic fastener test zone broke or fell out during the mega site test. Four of the 11 clips broke at a low rail load station installation, where the ties were not properly tamped resulting in severe vertical displacement (pumping) under traffic. The average lateral load on the low rail resulting from traffic was about 20,000 pounds according to load station data. In the AirBoss zone, four rail clips were bent as a result of being struck by track maintenance machinery.

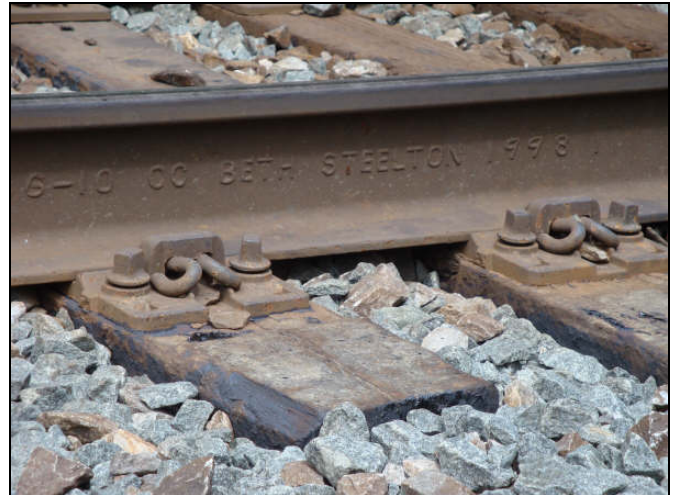
The bottom surface of the NorFast system plates had cleats that were designed to enhance gage-widening restraint. The cleats prevented the plates from seating tightly into the tie during installation. After some traffic, when the cleats were seated into the wood fibers, a gap (about ¼ inch) between the bottom of the screw spike head and the tie plate was created giving the appearance that the screw spikes were uplifting, as Figure 7 shows. Test operators decided not to cinch down the small gap to avoid over tightening and these gaps did not increase throughout the test. The effect of the cleats on the tie surface under the plates was not determined.

Figure 7. Gap between the Screw Spike Head and Tie Plate after the Tie-Bottom Cleats seated into the Wood Fibers

- The cleats, designed for gage restraint on the bottom of the NorFast plates, prevented the plates from seating into the ties during the installation. When the plates seated after some traffic, a small gap developed between the bottom of the screw spike head and the top of the plate. The gaps did not increase during the test. The lateral track loading fixture test, which applies the gage spreading load at the neutral axis of the rail, indicates the cleats may provide some increased resistance to lateral tie plate translation.
