# Effect of Missing or Broken Fasteners on Gage Restraint of Concrete Ties

Dingqing Li and Rafael Jimenez

## Summary

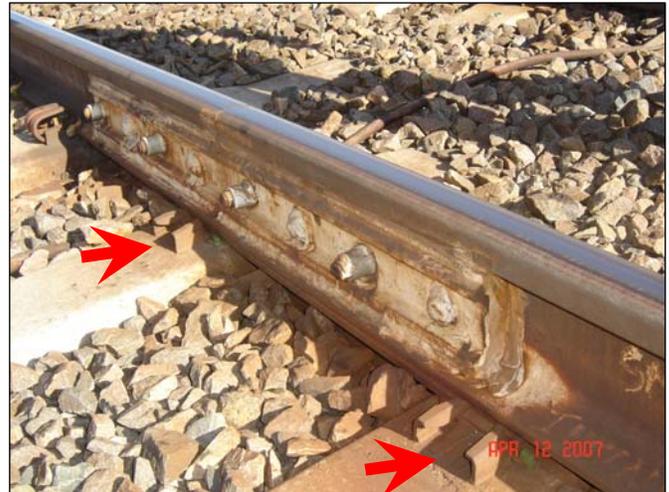
Under HAL train operations it is inevitable that some rail fastener components, such as clips and insulators, will break or become loose over time (Figure 2 shows an example). As such, there are questions concerning how track integrity or gage restraining capability by rail fasteners may be compromised as a result of failed or missing fasteners and how different parts of a fastener system can affect gage restraint (gage strength). Answers to these questions provided by actual field testing and measurements may help railroads develop and optimize their track maintenance practices.

**Figure 2. Example of Missing Fasteners in Revenue Service**

At FAST, the concrete tie track that was tested uses a Fastclip type of fastener system (Figure 1) and is part of a section of tangent track. At the revenue service western mega site located near Ogallala, Nebraska, the concrete tie track uses a SAFELOK® clip type of fastener system (Figure 2). Tests were conducted on both tangent and curve track locations. At FAST and in revenue service, all the tracks tested are classified as FRA Class 4 and are designed for HAL train operations.

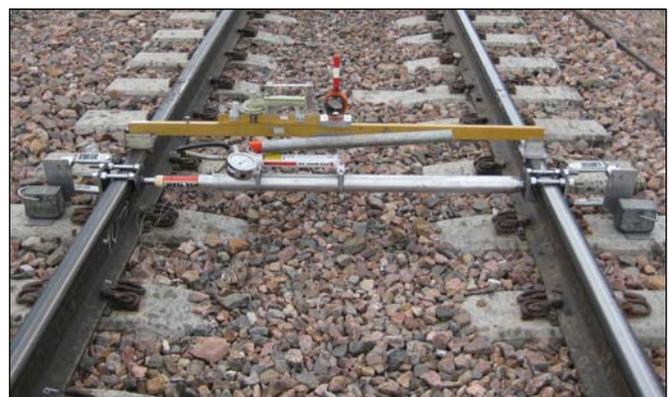
Figure 3 shows a light track loading fixture (LTLF) used to measure gage strength. At each test location, a gage widening force of 9,000 pounds was applied to the gage face 5/8 inch from the top of the railhead. Lateral rail deflections were measured at the head and base of both rails. For the given gage widening test load, higher deflections correspond to lower gage strength.

**Figure 3. LTLF for Gage Strength**
