Evaluation of the longitudinal restraint, uplift resistance, and long-term performance of high-density polyethylene crosstie rail support system using static and cyclic loading

Proc IMechE Part F:
J Rail and Rapid Transit
2017, Vol. 231(8) 835–849
© IMechE 2016
Reprints and permissions:
sagepub.co.uk/journalsPermissions.nav
DOI: 10.1177/0954409716647094
journals.sagepub.com/home/pif

Ibrahim Lotfy and Mohsen A Issa

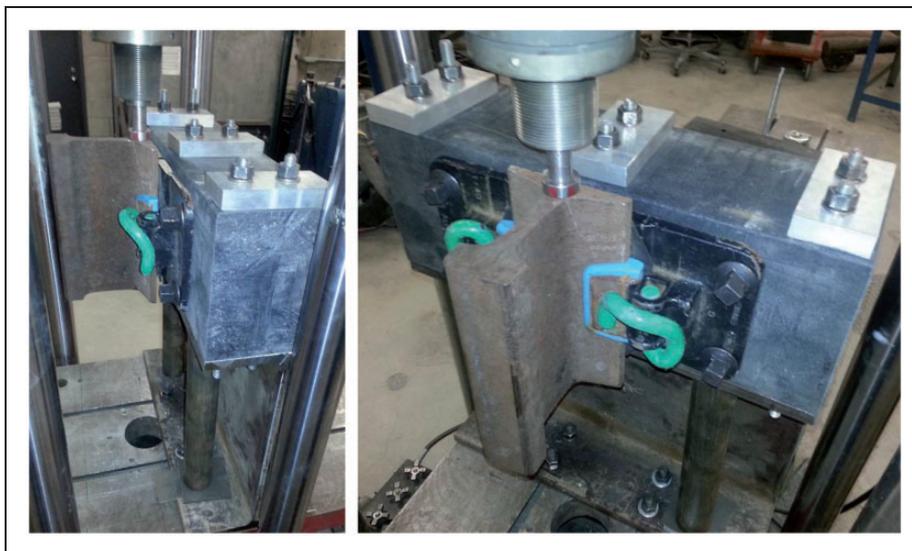
Figure 3. Longitudinal restraint test setup.

Figures 2 and 3 illustrate the longitudinal restraint test schematics and configuration.

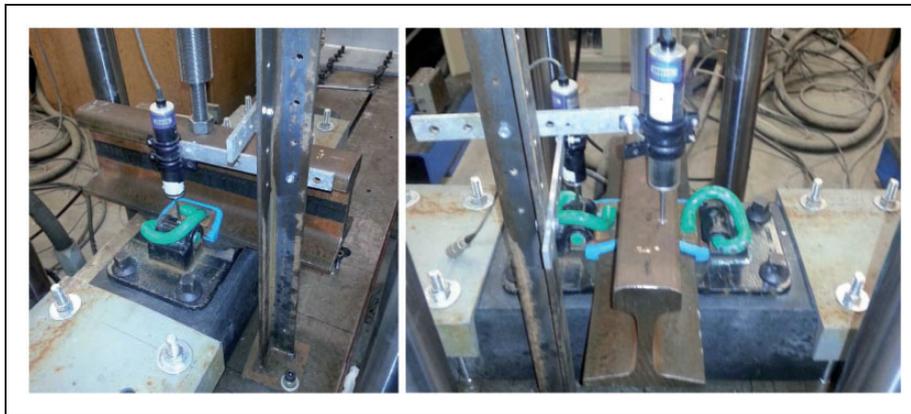
Figure 7. Fastener uplift test setup.

pullout resistance was already investigated in previous tests,¹⁸ this test will enable the assessment of the fastening clips pullout resistance as well as the identification of the contributions of the screw spikes and the fastening clips to the pullout resistance of the entire system. For this test, the crosstie specimens were cut into 3 ft (0.91 m) long segments and the rail was cut into a 20 in. (50.8 cm) long segment. The complete rail and fastening system assembly was installed using the recommended setup D predrilled pilot holes as mentioned earlier.¹⁸ Two steel channels section were used in order to fix the specimens to the testing bed when applying the vertical uplift loading. A 20 in. (50.8 cm) rail segment was cut and machined specifically for this test setup. The rail segment was drilled and taped from the top and then a threaded rod was installed to enable the application of tensile uplift forces. Two linear variable displacement transducers (LVDTs) were installed to monitor both the railhead and the steel bearing plate vertical displacements. The railhead displacement indicates the total uplift of the system while the steel bearing plate displacement provides an indication of the screw spikes pullout only without the fastening clip contribution. This scheme enables the identification of the contribution of both components to the overall system uplift resistance. Five specimens were tested at room temperature. Figures 6 and 7 illustrate the test configuration.

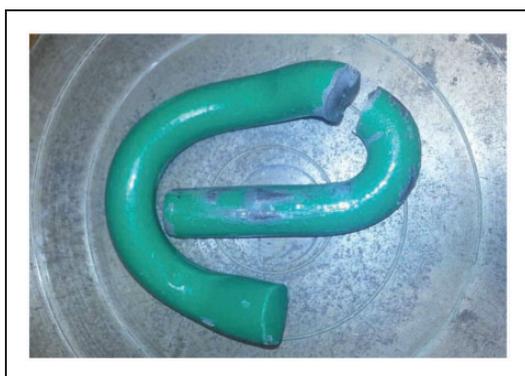
Figure 8. Failure of the fastening clip.

fracture of the clips shown in Figure 8. The response of the fastening clips was similar to the normal compliance of steel with two distinct phases: elastic and plastic. The first separation load occurred at or shortly after the yielding of the clips. After unloading, most of the deflection was recovered, with a small

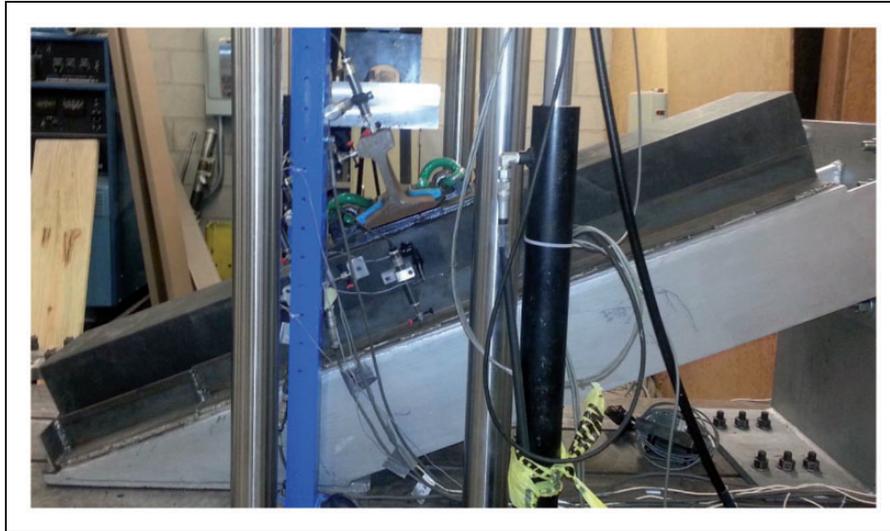
Figure 12. Test setup.

illustrated in Figure 11 and depicted in Figures 12 and 13. The LVDTs were used to monitor the deformations in the specimens: railhead vertical (designated as “Rail vrt”) and horizontal deformations (designated as “Rail Hrzt”), steel bearing plate vertical deformation (designated as “Plate Vrt”), crosstie’s

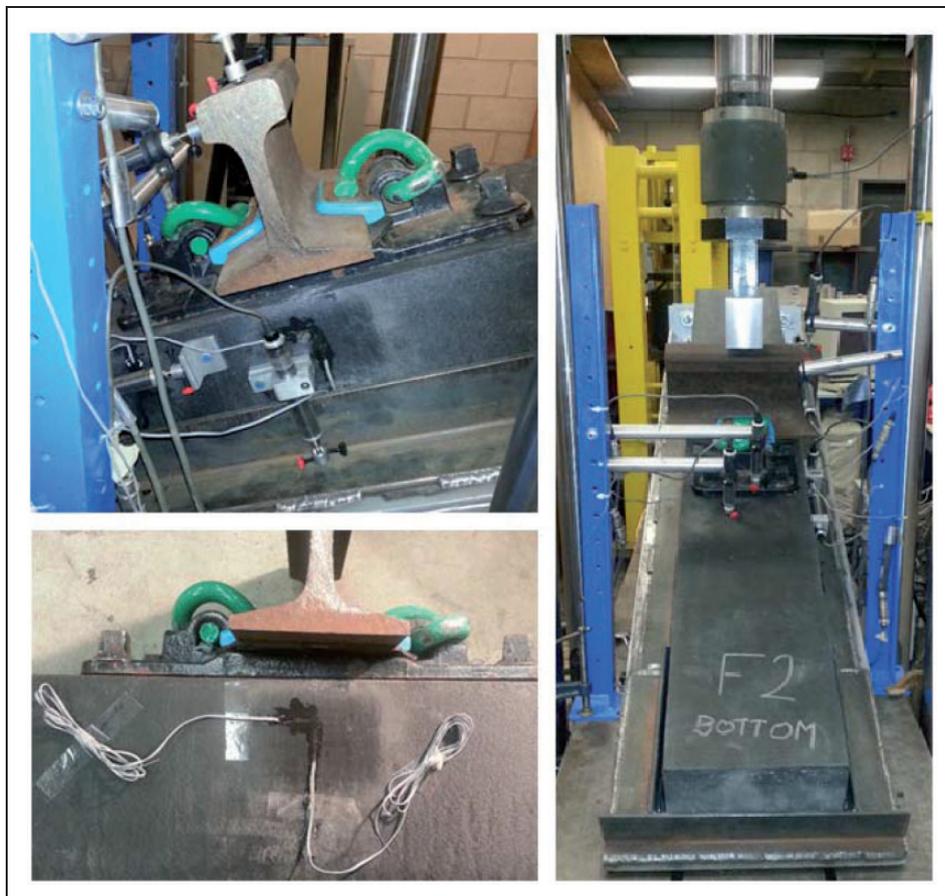
Figure 13. Test instrumentation and strain gauge installation.
