MADE ELASTIC

Broken spikes created by elastic fastening systems

By Marcus Dersch, Cameron Stuart, Arthur de O. Lima, and Riley Edwards, Contributing Authors

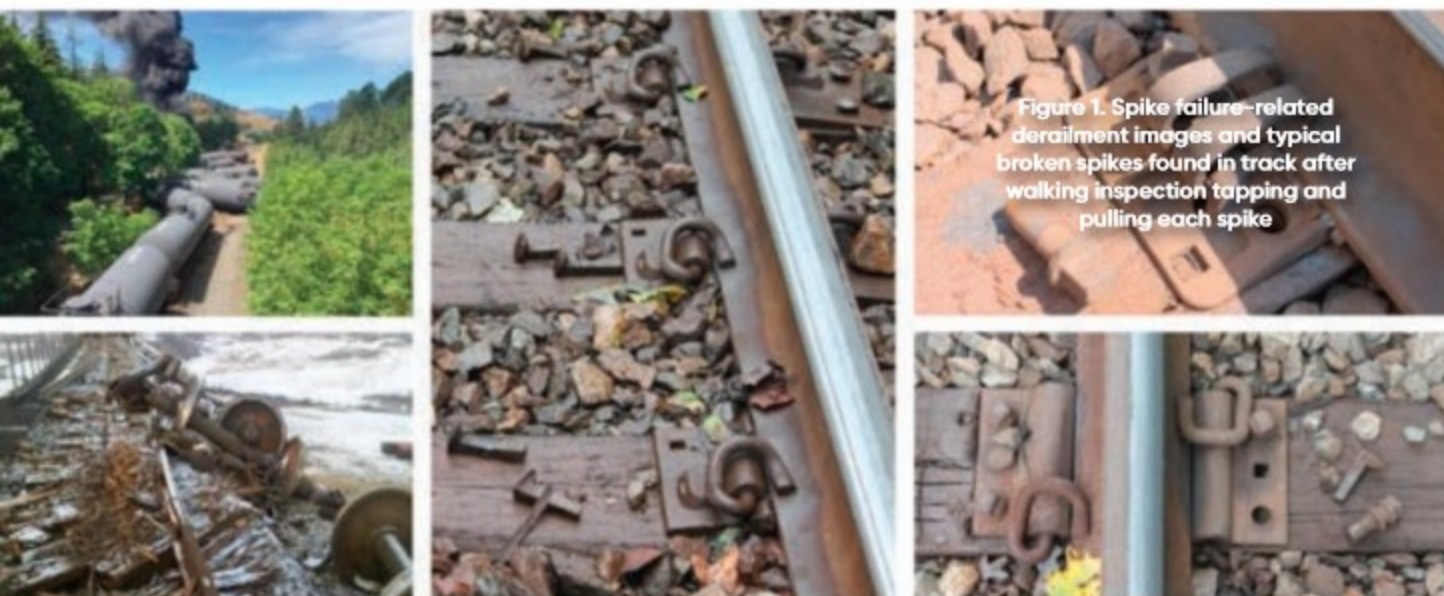
Figure 1. Spike failure-related derailment images and typical broken spikes found in track after walking inspection tapping and pulling each spike

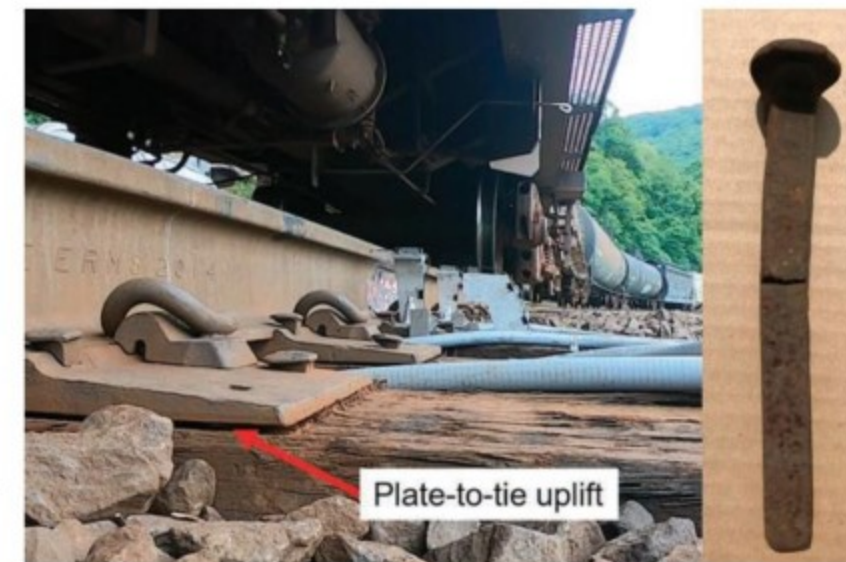
Figure 2. Examples of plate-to-tie uplift and of damaged spike.

The research data and analysis reveal that these spikes are failing due to fatigue from longitudinal loads transferred to the spikes through the elastic fastening system. This longitudinal load is in addition to the lateral load carried by the spikes and is made worse due to the loss of friction between the plate and crosstie from uplift forces ahead of loaded wheels (Figure 2).

the load-carrying capacity of the elastic fastening system. Elastic fasteners clamp the rail to the tie plate and spikes clamp the tie plate to the crosstie. Vertical rail uplift forces ahead of and behind loaded wheels can degrade spike clamping performance, resulting in plate uplift (loss of friction), excessive spike loads, and eventual spike fatigue failure. Timber crosstie strength also influences spike stress. Timber crossties are approximately 10 times weaker across the grain (i.e., longitudinal load direction) than with the grain (i.e., lateral load direction). When the timber crushes, the spike stress increases.

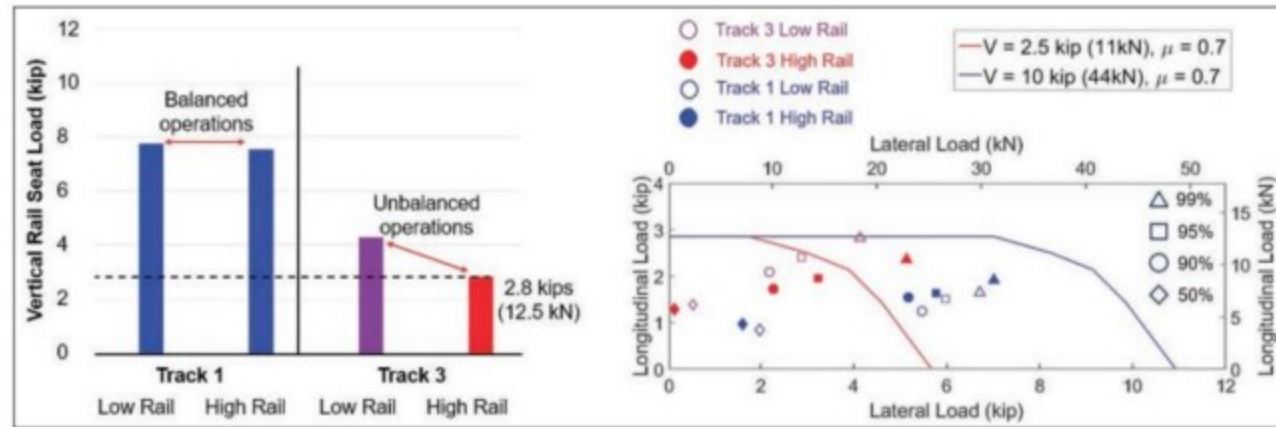
Figure 4. Median vertical rail seat load data (left). The effect of train balance speed on spike loads and failure thresholds (right).

Data revealed underbalance speed train operation on Track 3, reducing the vertical rail load on the high rail and thus reducing plate-to-tie friction. Track 1 operations are near balance speed, resulting in more even loads between low and high rails (Figure 4, left). Combining

these field data with modeling failure thresholds (Figure 4, right) illustrates the impact of unbalanced operation on spike failures.

The two lines represent the modeled spike failure thresholds for Track 1 (blue) and Track 3 (red) based on a combined lateral and longitudinal loading condition. The data points are field data from Track 1 (blue) and Track 3 (red). The points represent the 50th, 90th, 95th, and 99th percentile lateral and longitudinal field loading data. All Track 1 data are contained within the boundaries of the blue line—indicating that forces are below the failure threshold. Meanwhile, some Track 3 high rail datapoints extend beyond the boundaries of the red line—forces exceed the failure threshold. The unbalanced operating condition on Track 3 unloads the high rail, reducing

the plate-to-tie friction and transferring excessive loads to the spikes.

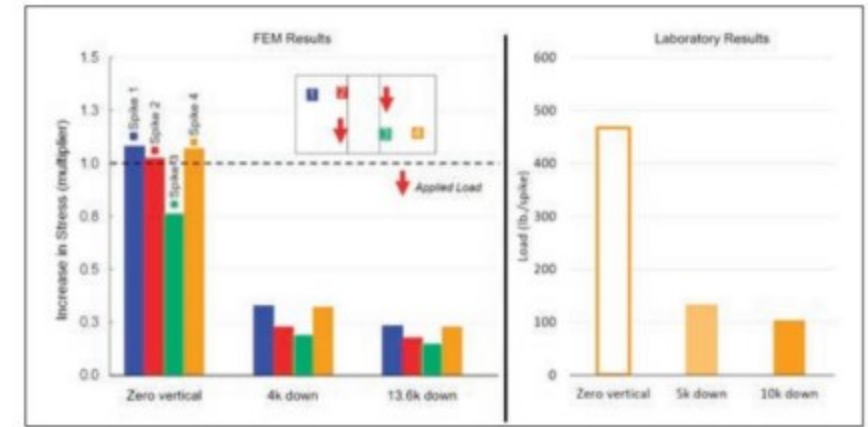
Figure 6. Effect of plate hold-down force on spike stresses—modeling (left) and laboratory (right).

Figure 6 illustrates the importance of the plate-to-tie hold-down force in reducing spike stresses. The left graphic shows the model data comparing the relative impact of hold-down force on spike stress in a four-spike plate arrangement loaded to 2,500 lb. Spike stresses are much higher with zero hold-down force and much lower with 4,000 lb of hold-down force. Stress levels did not change appreciably with higher hold-down force. Laboratory test data confirm the modeling results and the influence of vertical load (Figure 6, right). The hold-down force ensures that plate-to-tie friction is helping the fastening system carry the train loads. This friction can reduce spike stresses by up to 80%.

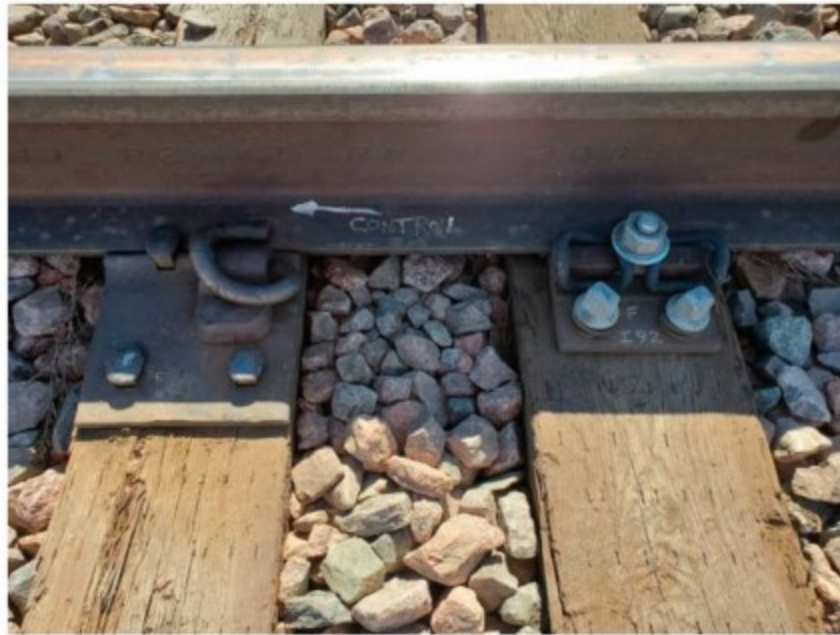
Figure 7. Transition between control zone (left) and test zone (right) at TTC FAST, 2019-2020.

The test was conducted in a track section with a history of spike failures and consisted of a 20-tie control zone with cut spike fastening systems adjacent to a 30-tie test zone with a screw spike/spring washer system (Figure 7). The test accumulated 170 MGT under FAST train loading.

TTCI conducted periodic visual inspections to document the performance of the fastening systems, the results of which are displayed in Table 2. The control zone accumulated six broken spikes during the test, while the test zone had none. The control zone showed evidence of plate movement, spike uplift, and cross-tie skew. The test zone had no indication of plate movement and had minimal cross-tie skewing. There was very minor spring washer loosening in three locations after 60 MGT and additional loosening after 170 MGT, indicating the likely need for periodic fastening system maintenance. These results confirm the positive effect of plate-to-tie friction in reducing spike stresses.
