Dynamic Responses of Bridge Approach Concrete Ties after the Applications of Polyurethane Injection, Stone Blowing and Under-Tie Pad Remedial Measures

June 16, 2016

Crosstie & Fastening System
Symposium

Mitigation of Differential Movement at Railway Transitions for US High Speed Passenger Rail and Joint Passenger/Freight Corridors

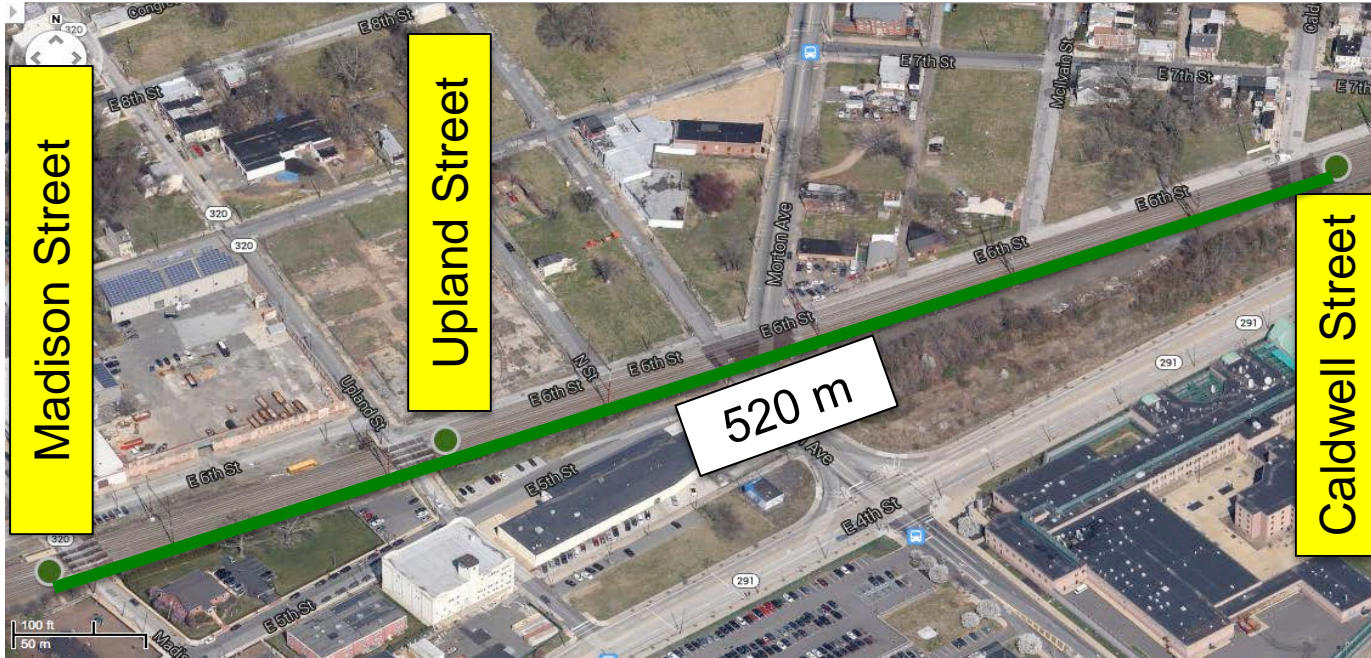
Three Bridge Approaches at Chester, PA Site

AMTRAK
NEC
ACELA
Passenger
Trains
110 mph
(177 km/h)

**Recurring bridge approach
settlement and geometry problems**

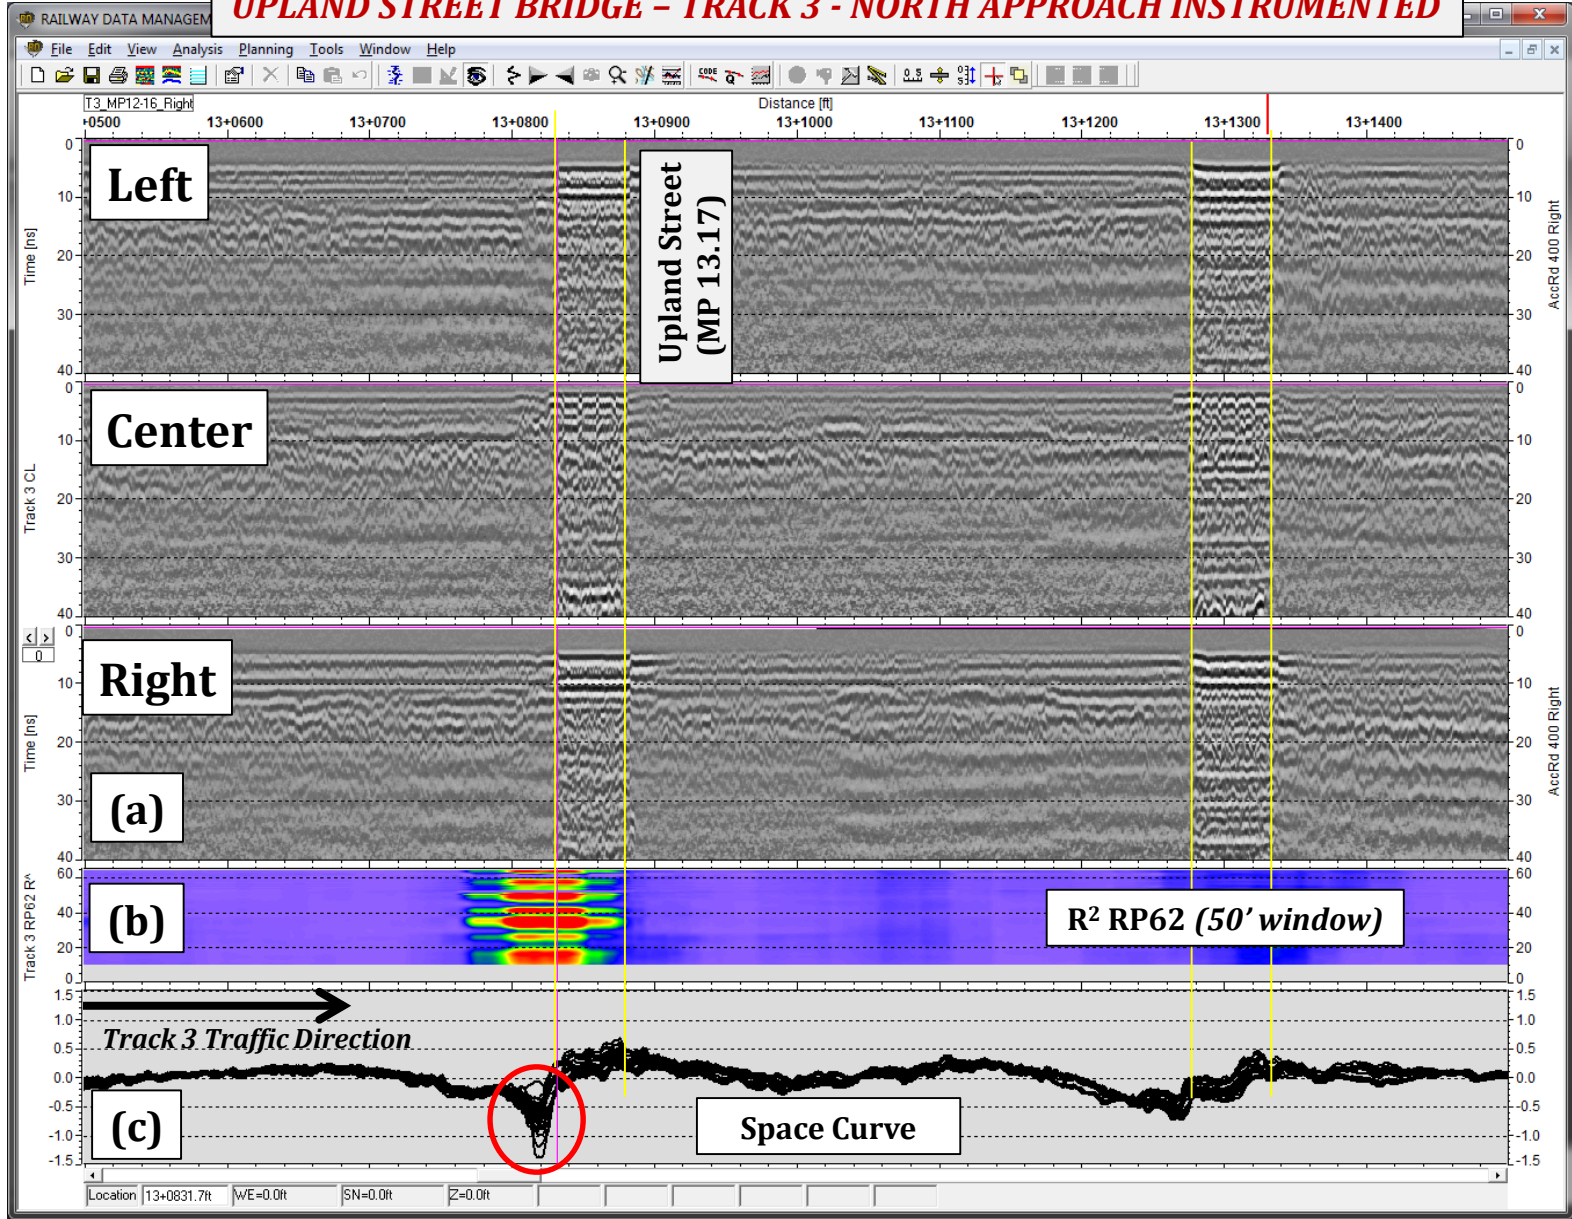
UPLAND STREET BRIDGE - TRACK 3 - NORTH APPROACH INSTRUMENTED

Installed **Multidepth Deflectometers (MDDs)** at 3 Bridge Approaches

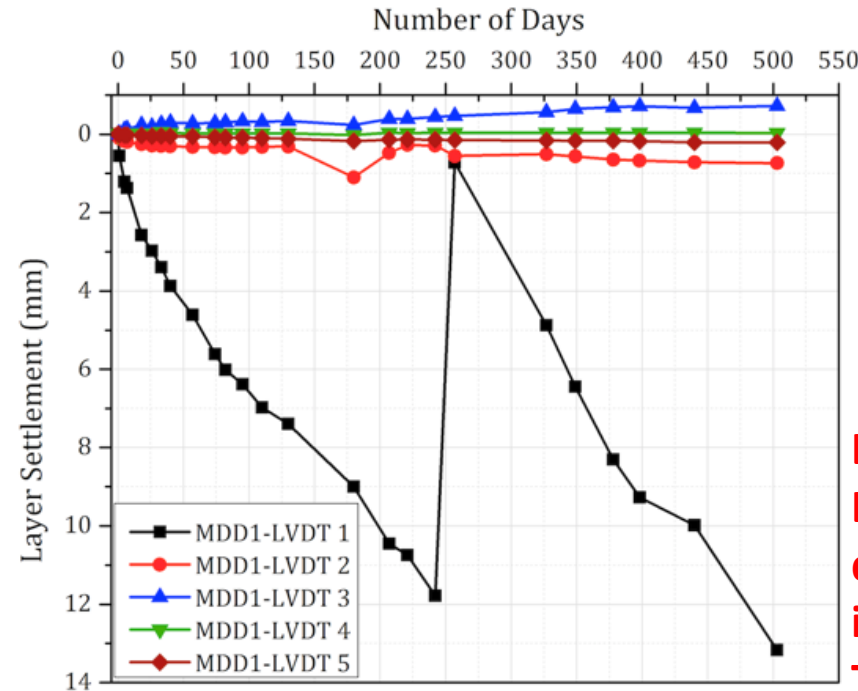
Upland Street
15 ft. from North Abutment

Layer Settlement Trends for Upland and Madison Street Bridge Approaches

Layer 1 or LVDT 1 displacement is the primarily The crosstie deformation

- Ballast movement at both approaches – Major factor contributing to track settlement
- Remedial measures targeted at reducing ballast settlement would likely lead to favorable performance

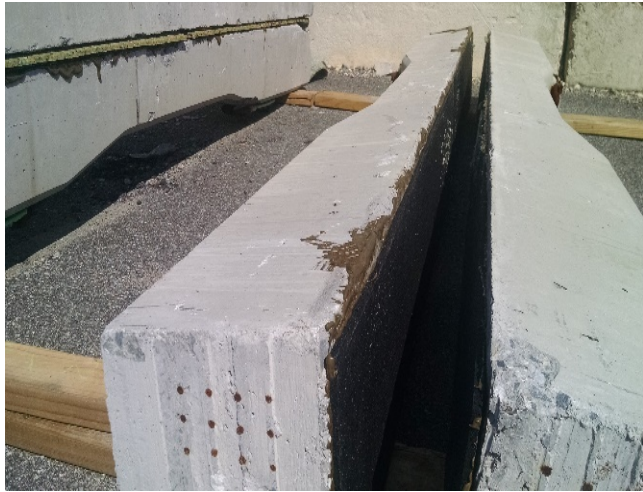
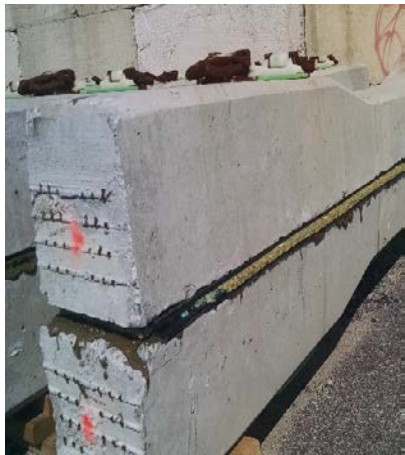
UTP Installation Effort

Without Under-Tie Pads **With Under-Tie Pads**

- UTP Manufacturer: [Pandrol-CDM Track/Novitec](#)
- A block of 30 ties were installed on the Upland Street bridge south approach (Track 2)
 - Approach represents train entering the bridge from the embankment
- Work was performed with a pre-approved 36-hour outage
 - Start: 10:00 PM on Friday, 29 August 2014
 - End: 12:00 AM on Saturday, 30 August 2014
- A pre-constructed concrete tie track panel was placed in the track

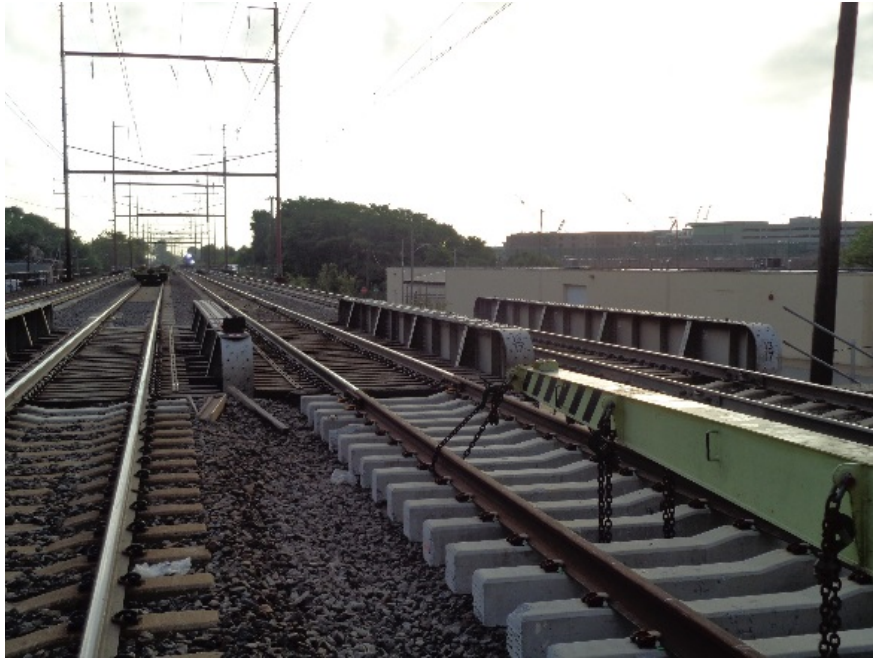
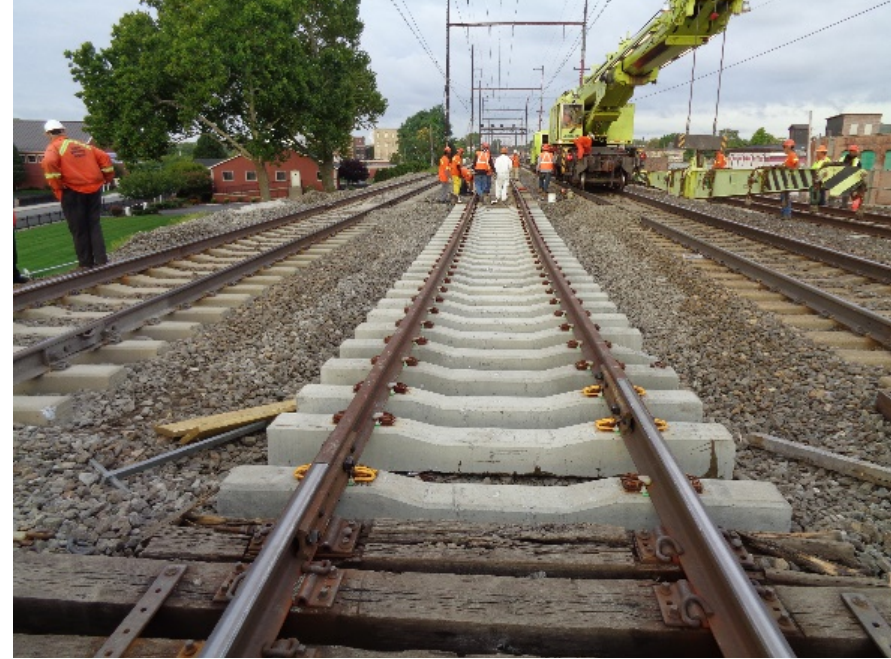
Under Tie Pad Track Panel Installation: Aug. 28-29, 2014

30 Tie Track Panel with Installed UTPs under New Ties

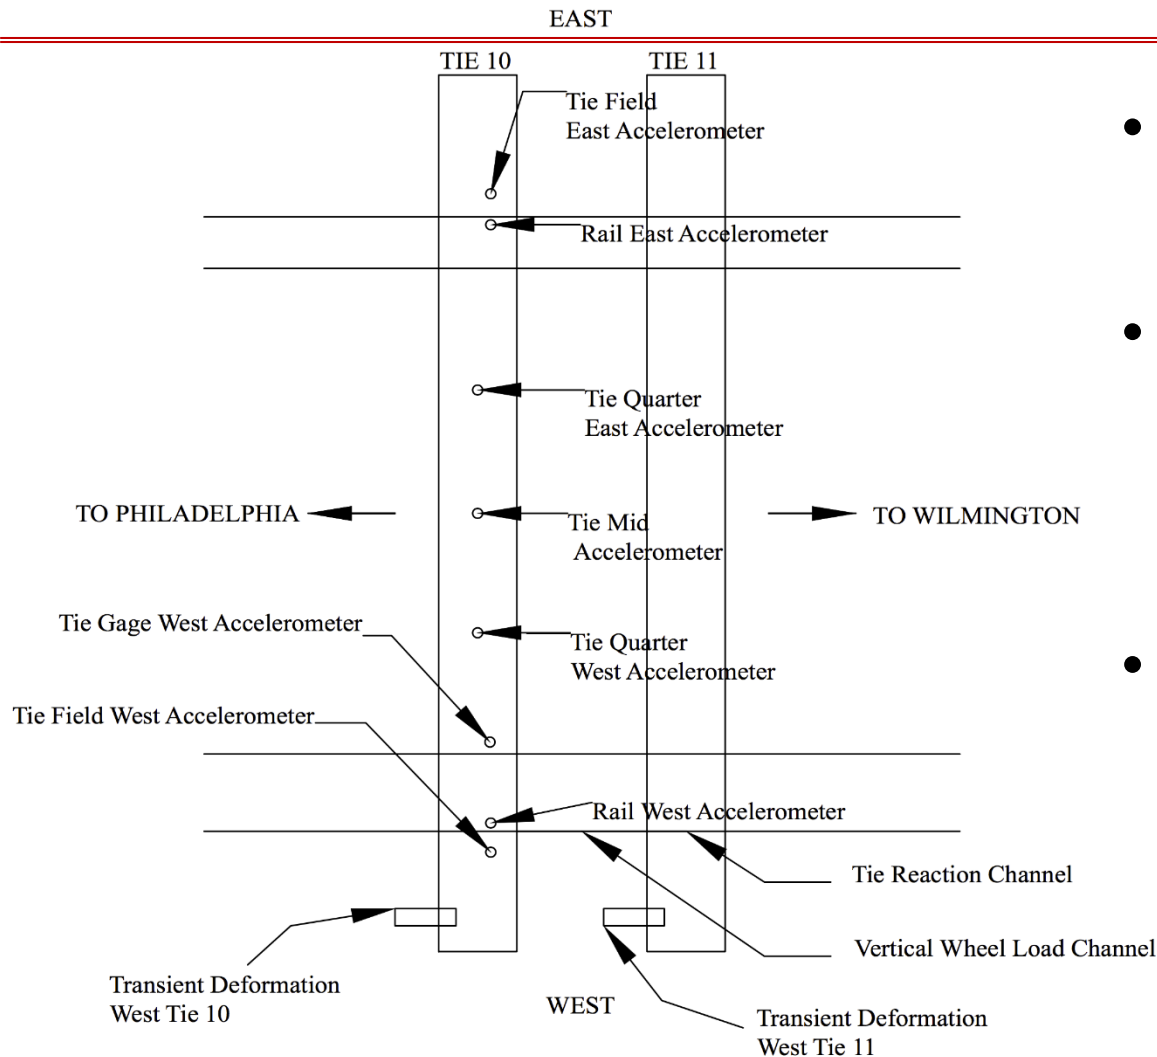
- Instrumentation mounted on the 10th and the 11th tie from the abutment
- Accelerations and displacement time histories of ties were recorded under the passage of **Acela Express** trains
- Accelerations were measured with **accelerometers**; Displacements were measured with a **calibrated cantilevered metal strip** mounted with **strain gauges**

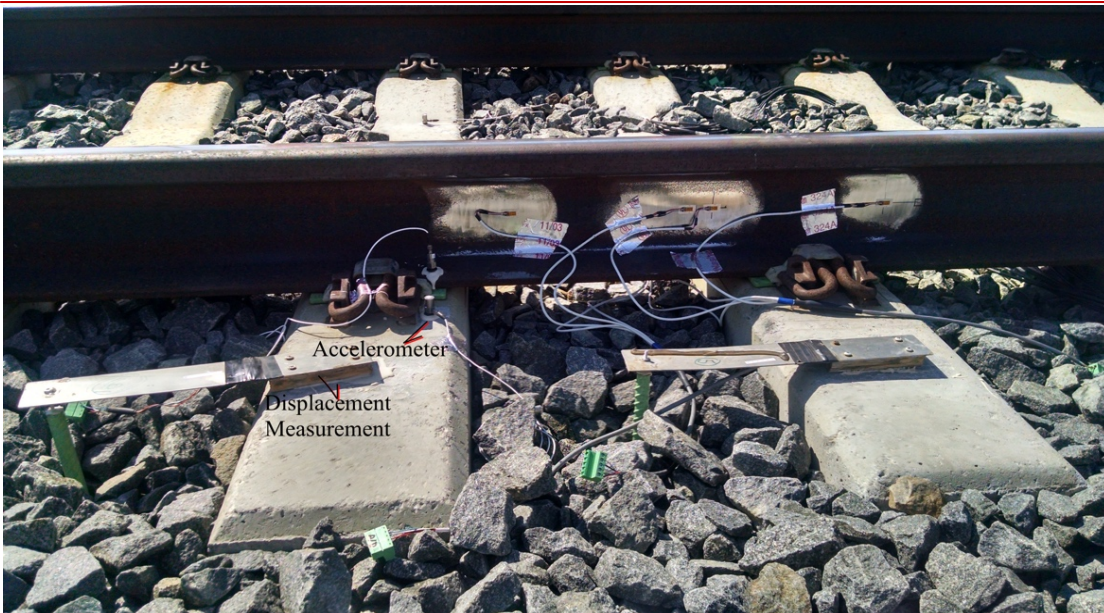
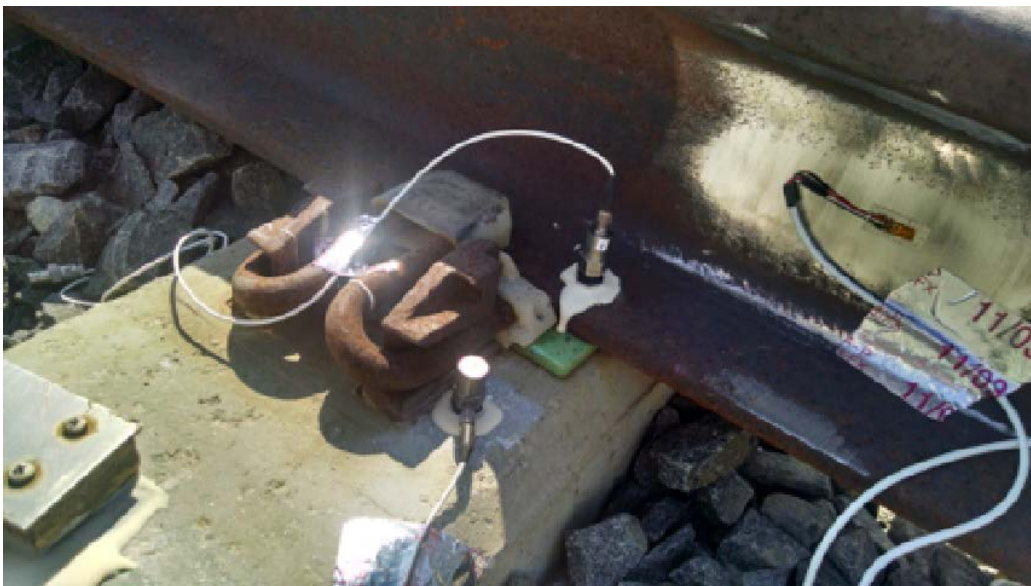
- Note that unlike the MDDs, this set-up for displacement measurement **can measure transient displacements of the ballast layer only!**
- This is **acceptable** as analysis of the MDD data has shown the **ballast layer to be the primary contributor** to the total transient (as well as permanent) deformations

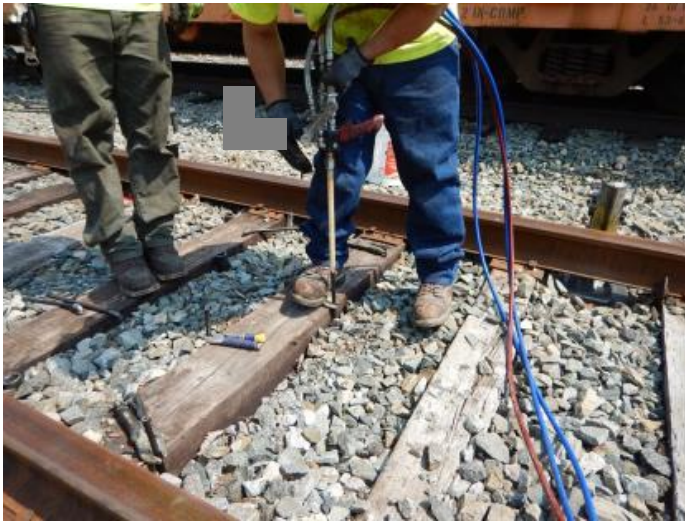
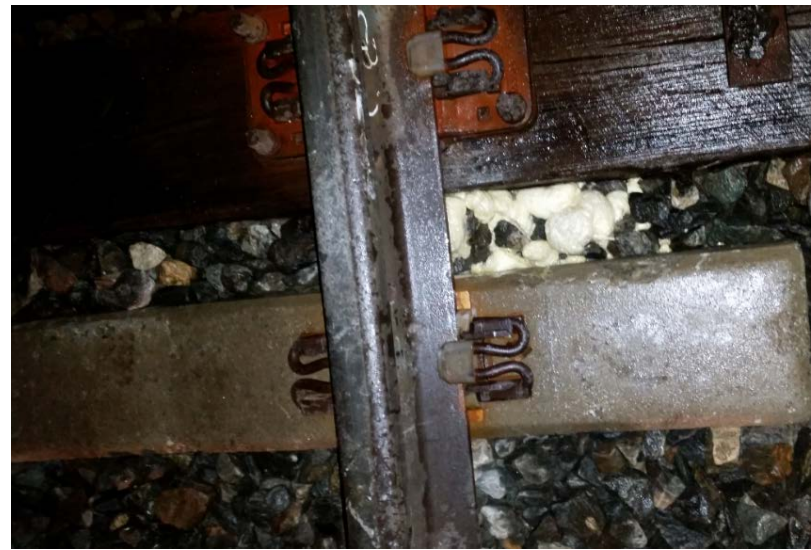
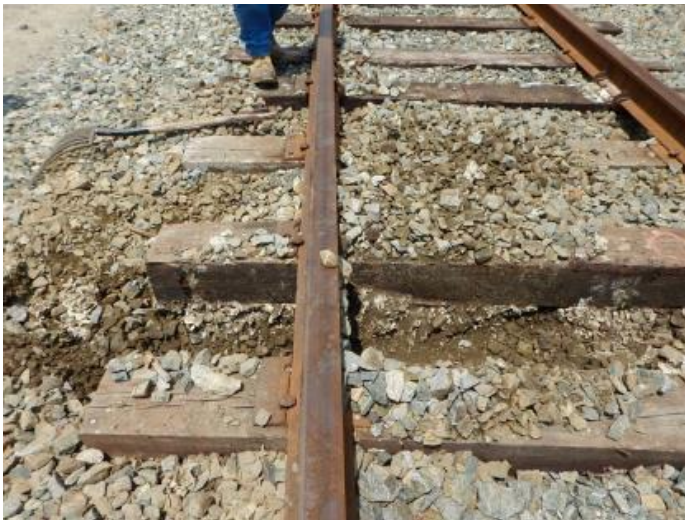
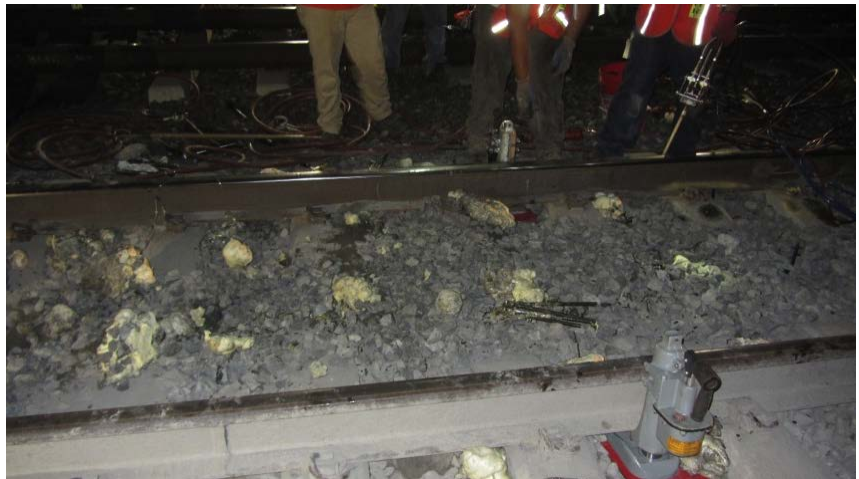
Photographs Showing Grout Injection and Expansion through Injection Ports

- Chemical grouting at Upland Street bridge approach was carried out on July 17, 2014
- Grout Properties
 - Density: 240 kg/m³ (15 pcf)
 - Compressive Strength:
 - 5516 kPa (800 psi) @ 0% strain
 - 1380 kPa (2000 psi) @ 10% Strain
 - Tensile Strength: 1,034 kPa (150 psi)

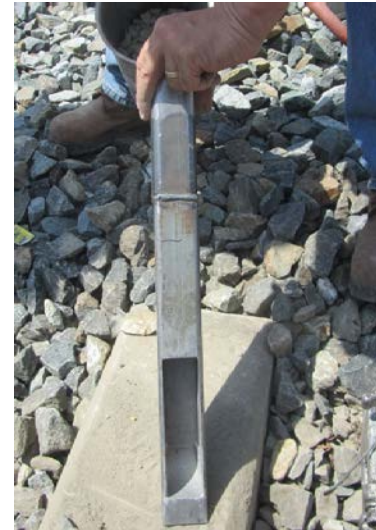
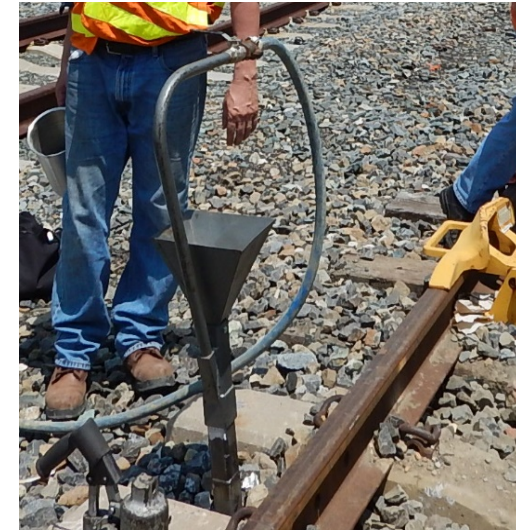
Selig and Waters, 1994

A	Initial condition
B	Ties raised
C	Stoneblowing tubes driven next to tie
D	Compressed air used to blow stones
E	Stoneblowing tubes withdrawn
F	Ties lowered to rest on freshly inserted stone

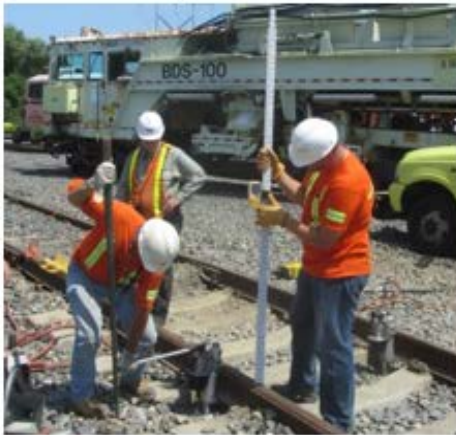
Surveying of Track to Establish Top-of-Rail Profile

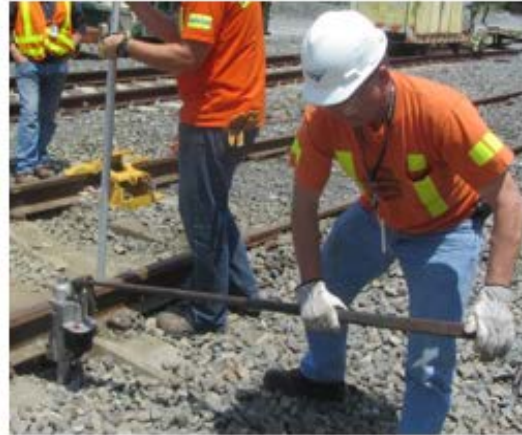
Jacking of Track to Pre-Determined Level

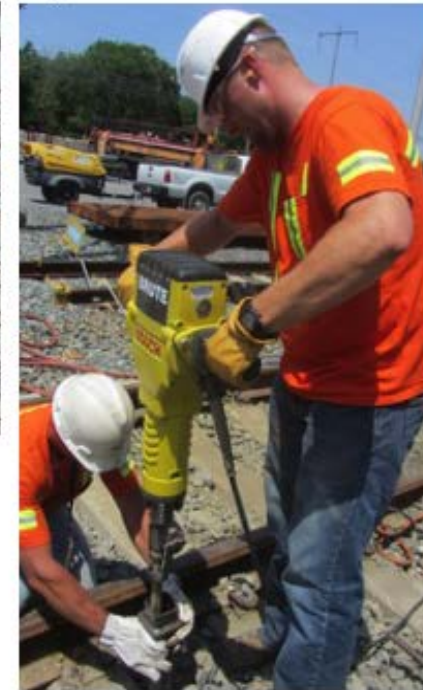
Driving Injector Tube Adjacent to Tie

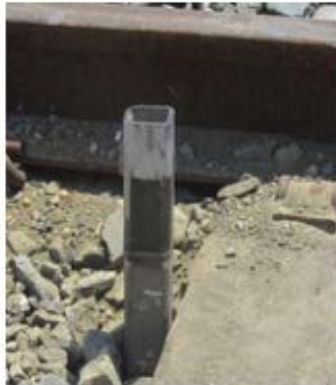
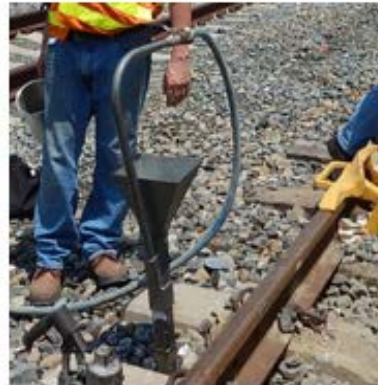
Injector Tube Driven Into Ballast Adjacent to Tie

Injection Chute with Air Connection Mounted on Top of the Injector Tube

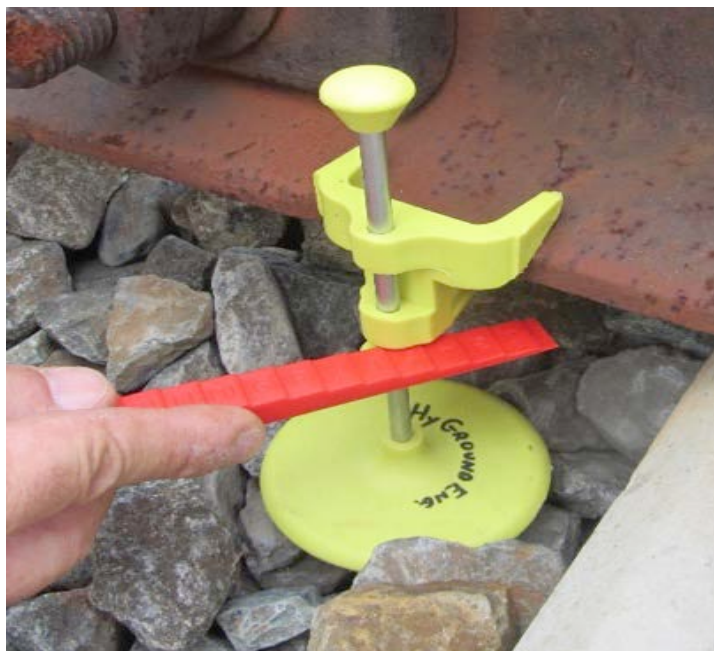
Measurement of Voids
Underneath Ties Using Void
Meters

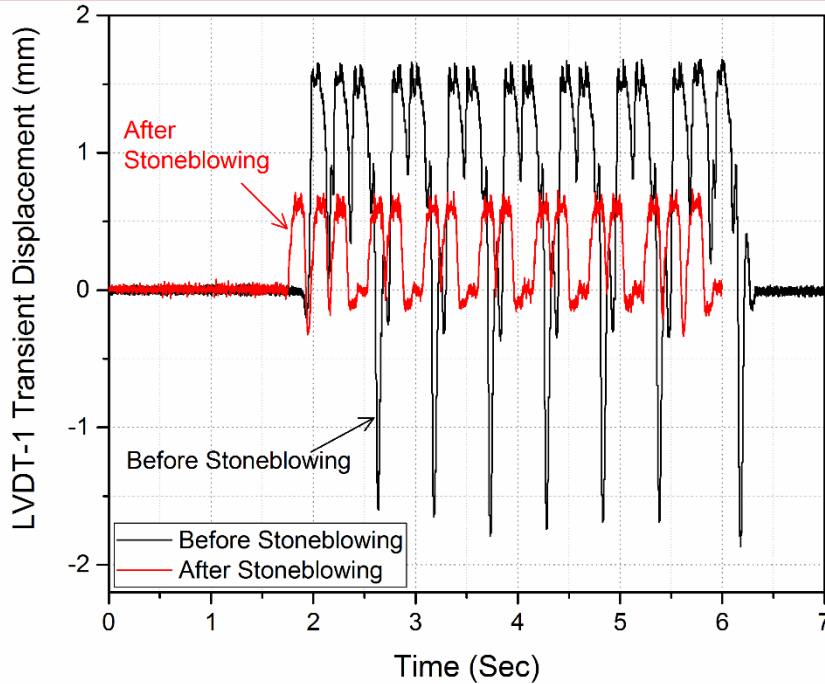
Effect of Stoneblowing on Transient Response and Track Geometry Data

- *Significantly reduced transient deformations for the top layer were recorded shortly after stoneblowing*
- *Track space curve shows elimination of the downward dip through the stone injection*
