## Investigation of Ballast Degradation and Fouling Trends using Image Analysis

**M. Moaveni, Y. Qian, H. Boler, D. Mishra and E. Tutumluer**

**Department of Civil and Environmental Engineering**

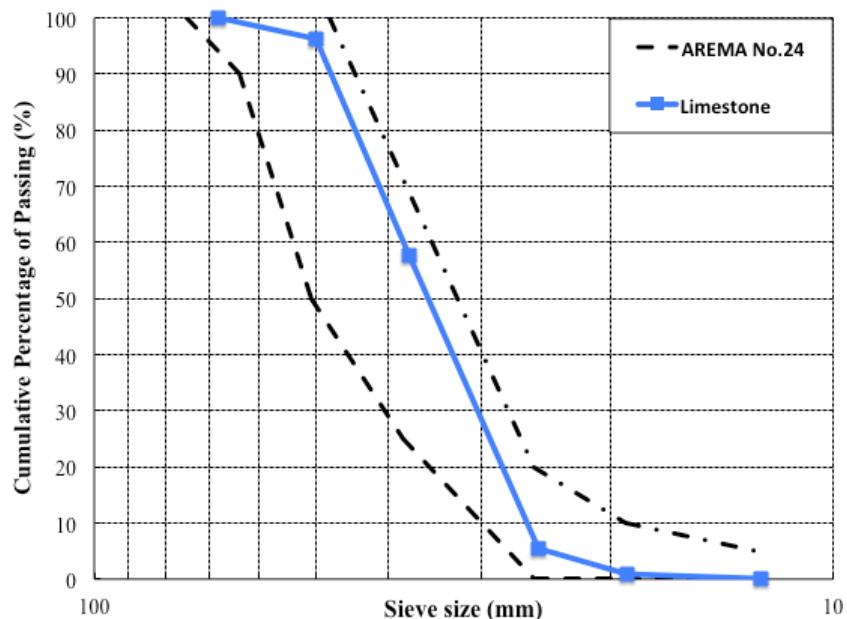
The ballast material used in the laboratory was a 100% crushed limestone, which followed AREMA No. 24 gradation requirements as illustrated in Figure 1. Ten kilograms of virgin ballast material were placed in the LAA test drum together with 12 steel balls. The drum was set to rotate on the average 50 turns per minute and for each run the drum rotated 125 times. After finishing every 125 turns, the drum was allowed to stand still for about 10 minutes to let dust settle before the tested material was poured out. All particles above 25.4 mm or 1.0 in. sieve size were also brushed to collect dust and fine material before sieving. The rest of the materials (passing 25.4 mm or 1.0 in. sieve) were carefully sieved using a DuraShake™ type rotation aggregate sifter so that loss of fine materials was minimized. Materials passing each sieve size were then collected and placed on a blue background placed on the floor to take photos. The outlined procedure was repeated until the specimen reached FI of 40, which corresponds to a heavily fouled ballast condition certainly requiring maintenance activities in the track. Note that the same specimen was always used in LAA test drum, which required 12 individual turns at 125-turn intervals.

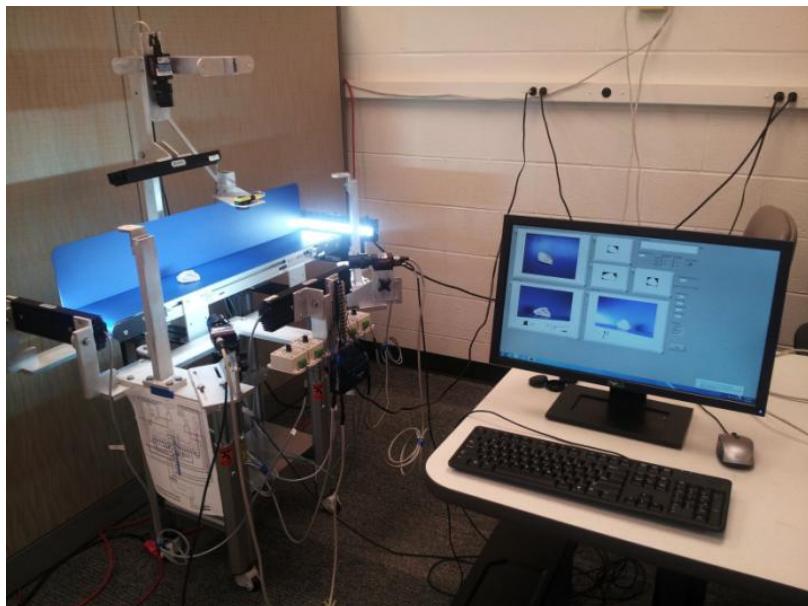
Figure 2: Enhanced-University of Illinois Aggregate Image Analyzer (E-UIAIA)

Recently, an enhanced, second generation UIAIA has been designed and manufactured at the University of Illinois with many improvements over the old system. Figure 2 illustrates this new system showing an aggregate particle with three orthogonal views captured using high resolution progressive scan digital color cameras. These views are used to quantify imaging based FER, AI, and STI morphological indices. Unlike the old version of UIAIA, which was limited to taking black and white images, the new system is equipped with three high resolution (1,292 x 964 pixels) Charge Coupled Device (CCD) progressive scan cameras to capture digital color images of aggregate particles. An advanced color thresholding scheme is utilized in Enhanced-UIAIA (E-UIAIA) to scan and process color images of different types of mineral aggregate. Four LED illumination lights with dimmer controls assist the operator to achieve the best contrast and sharpest possible aggregate images by optimizing camera light gains as well as minimizing shadows. An enhanced calibration adjustment interface also makes it possible to change the spatial resolution corresponding to the size of aggregate particle scanned by using the variable focal length of the camera lenses. After the calibration process, “saved configurations files” are used to determine accurate sizes and shape property indices for each batch of aggregate particles.

During the LAA tests, aggregate particles larger than 9.5 mm or passing 3/8-in. sieve were hand picked to perform image analyses using the E-UIAIA. This step was conducted to determine imaging based quantifications of particle size and shape indices as well as recording the change in shapes after each step of the 125-turns.

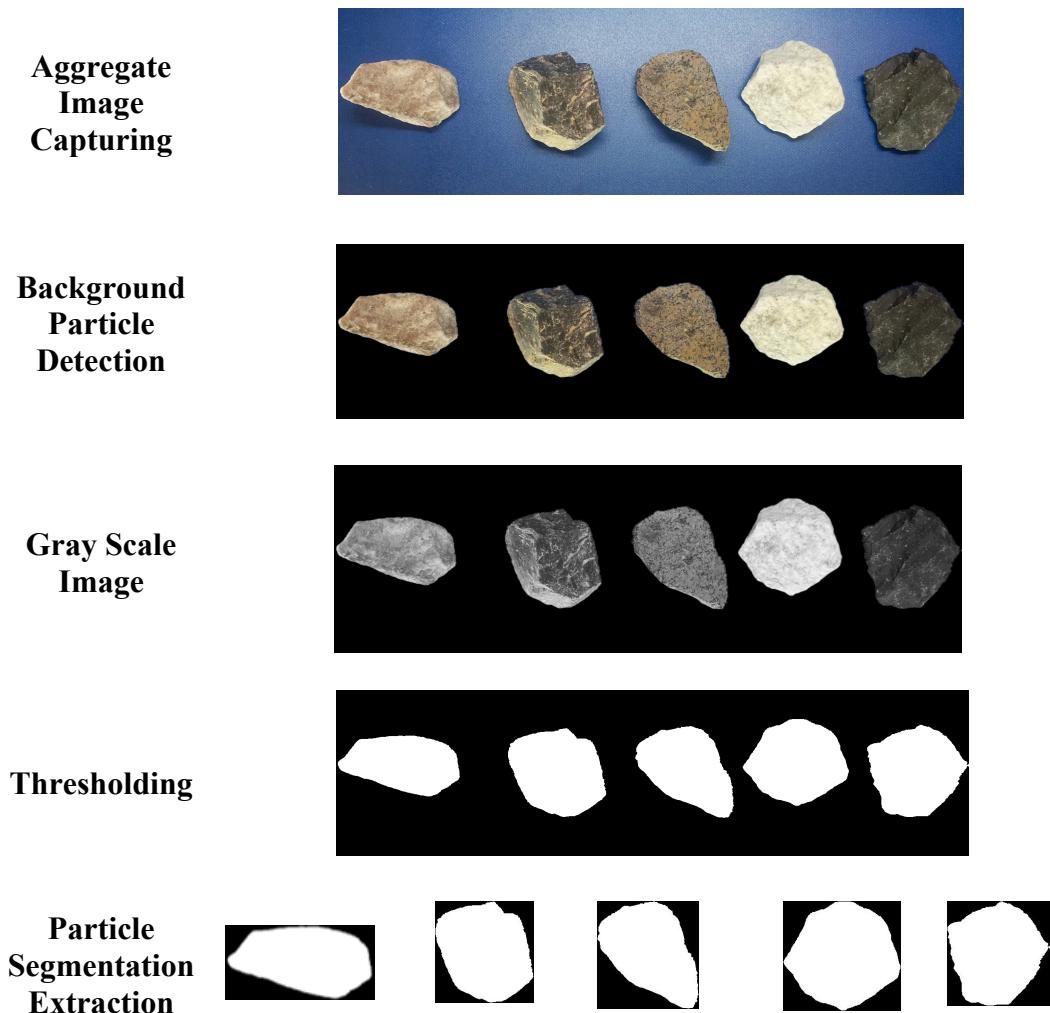
Figure 3: Description of image segmentation algorithm using MRF approach

Image segmentation is the process of partitioning a digital image into multiple sets/classes of pixels (“superpixels”). Each segmented set/class should correspond to a well-defined object or a coherent region in the image [10]. In the current research study, aggregate image analysis and segmentation techniques are used to combine a Markov Random Field (MRF) approach for modeling, graph cut for optimization and user interaction for enforcing hard constraints [11,12,13]. The ultimate objective is segmenting the images into foreground and background regions, while the connected components of the foreground need to be determined. Each such connected component is a single particle or a small cluster of particles. The segmentation algorithm examines each row in the image and finds the intervals of foreground pixels and cluster intervals from adjacent rows. Each cluster is hence a connected component thus corresponds to a single particle. An illustration of the process is shown in Figure 3 for different color coarse aggregate particles segmented into smaller single-particle images.

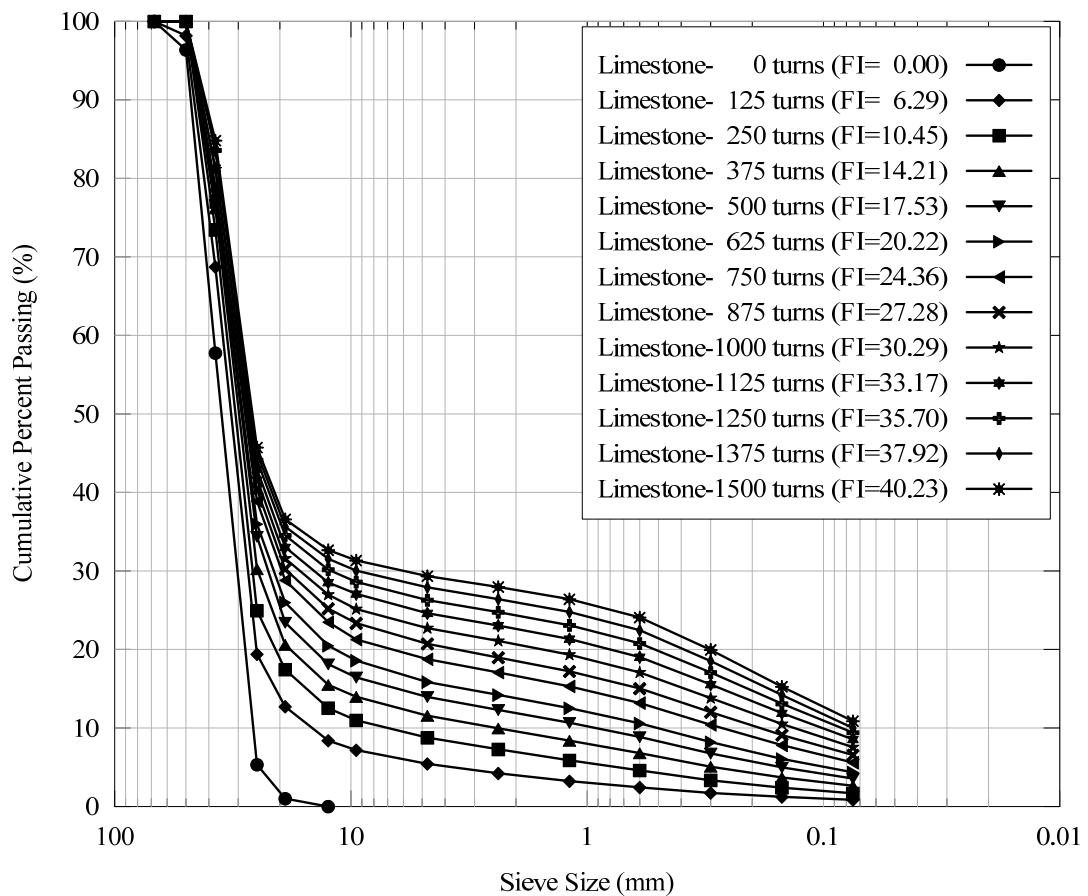
Figure 4: Degradation of limestone ballast during LAA test

Sieve analysis results and the determined degradation patterns in terms of change in particle size distributions during LAA test are presented in Figure 4, which clearly shows how the ballast gradation changed from a uniform to a well-graded gradation in time. Additionally, Fouling Index (FI) values associated with each 125 revolutions has been reported. Figure 3 therefore confirms how the FI values increased gradually for each set of 125-turns. Since virgin ballast materials are more susceptible to abrading sharp corners and edges of the crushed particles, breakage of the large sized particles mostly happened in the early stages of the experiment. With the number of turns increasing in LAA runs, those particles that did not break due to the impact loads gradually became much more rounded due to loosing their sharp corners as well as possessing smoother textures due to abrasion of surfaces and edges.

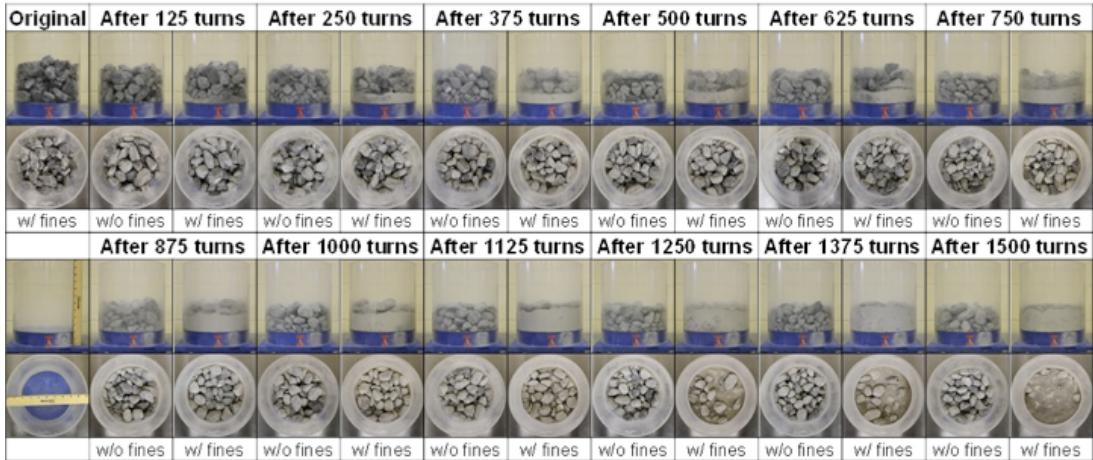
Figure 6: Visual description of limestone degradation during LAA test

To investigate particle contact and particle packing characteristics, the test specimen collected after each set of 125-turns of LAA test drum was placed into a cylindrical Plexiglas with dimensions of 25.4 cm (10.0 in.) in diameter and 25.4 cm (10.0 in.) in height. Figure 6 presents the side and top views of aggregate packing photos taken at different number of LAA drum turns. It should be noted that for each stage of the LAA test, there are two sets of images presented for “with” and “without” the particles smaller than 9.5- mm size.

The fine materials accumulated from the bottom to fill all the voids are created by fewer large particles all the way to the top when FI value of 40 are finally reached at 1500 turns. This observation confirms what Selig and Waters [2] found as the limit of heavily fouled ballast that should no longer be used in the field. Furthermore, a comparison of the height of the virgin ballast sample to that of the sample at 1500 LAA turns clearly shows how the ballast layer starts to settle down as the number of revolutions increases.

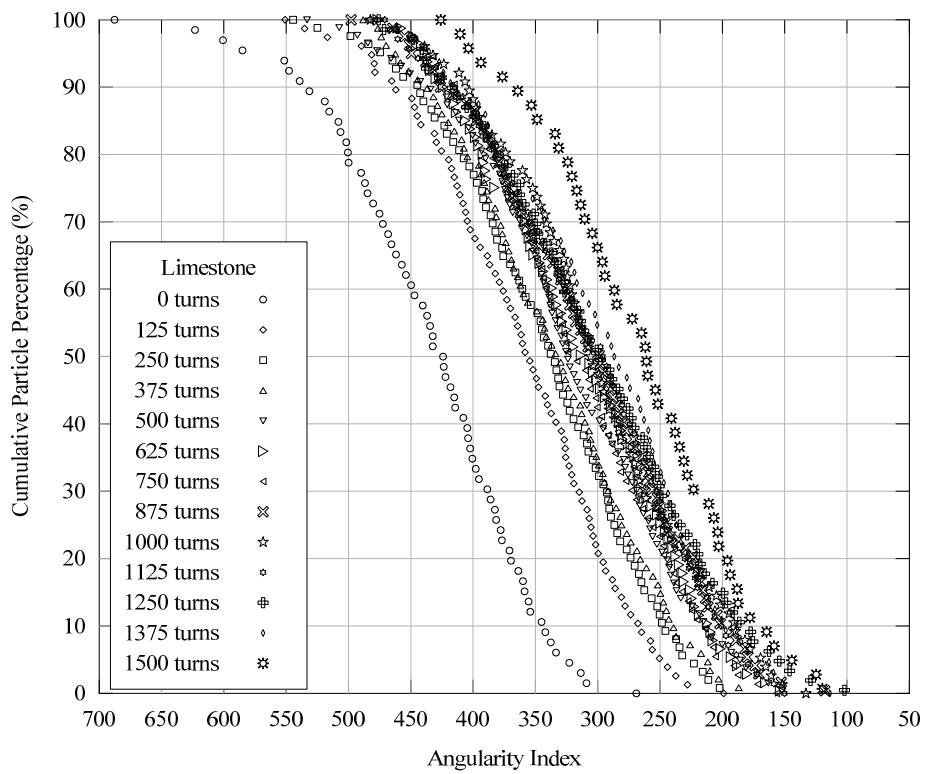
Figure 7: Limestone Angularity Index (AI) values determined during LAA test

Ballast degradation during the LAA test not only changes the particle size distributions but also influences the shapes of individual aggregate particles. Figure 7 presents the AI distributions of particles measured in the scale of 0 to 720 using E-UIAIA. Similar to the grain size distribution concept, the overall degradation trends of AI changes in time with the increasing number of LA Abrasion turns (see Figure 7). The AI values of limestone ballast decreases as the number of LAA turns increases gradually. The gap between any two curves illustrates how much the AI has changed.

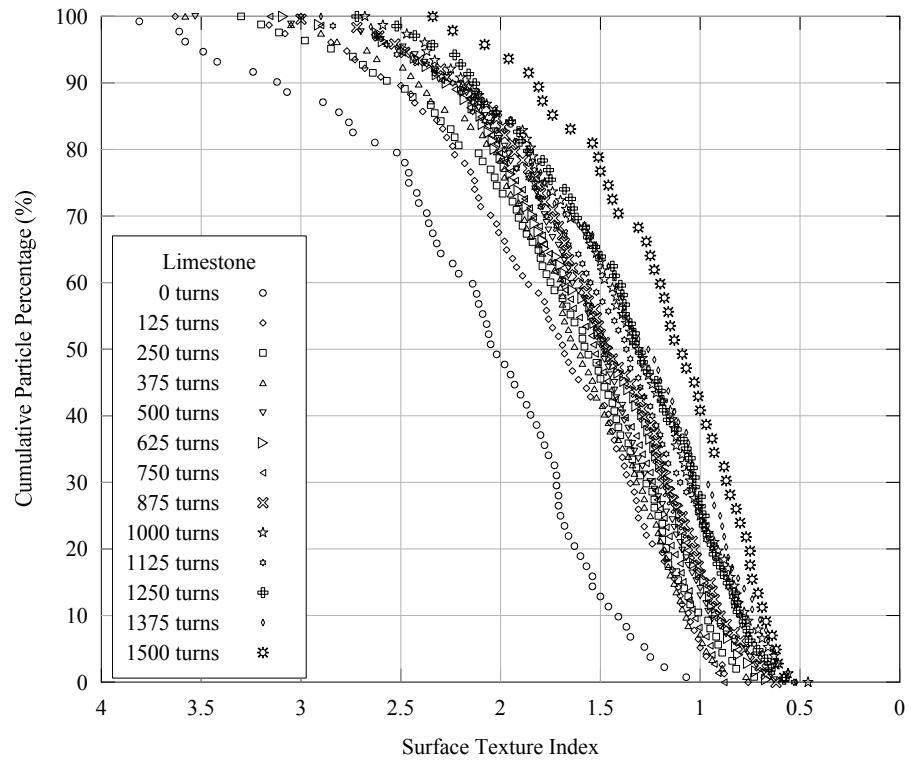
Figure 8: Limestone Surface Texture Indices (STI) determined during LAA test

Figure 8 shows STI distributions in the scale of 0 to 4 in which each point represents the ballast surface texture value for a particle and each curve captures STI distribution for all the particles after a certain number of drum turns. The gap between any two curves illustrates how much the STI has changed.

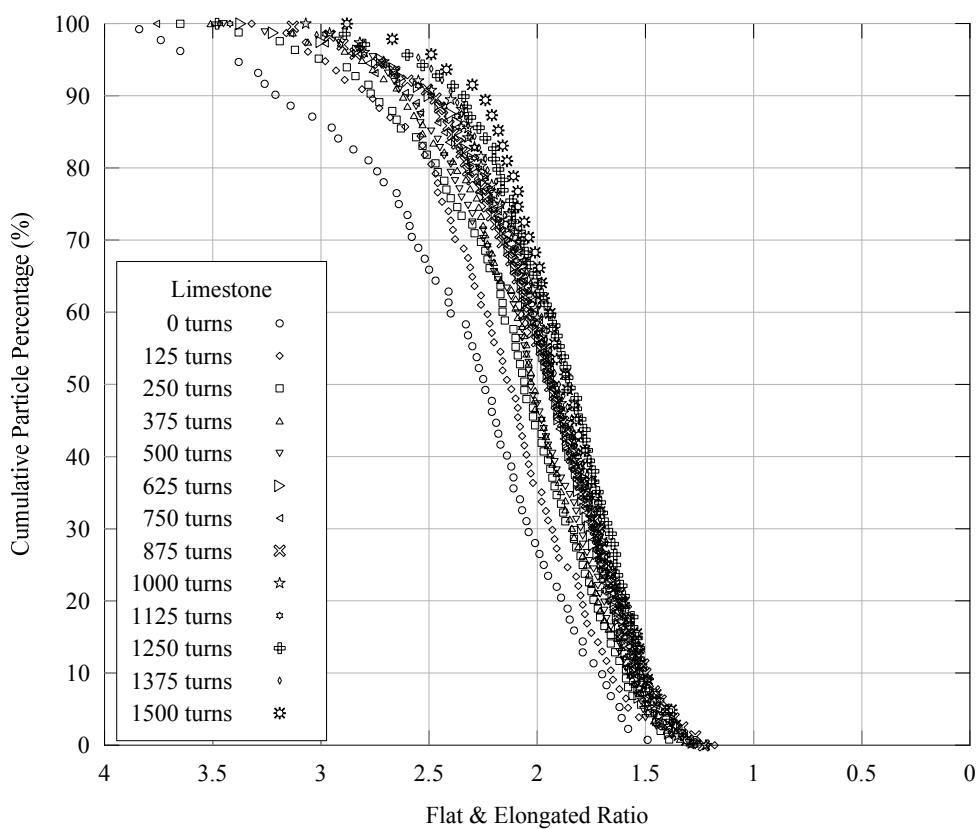
Figure 9: Limestone Flat & Elongated ratios determined during LAA test

Figure 9 presents the changes in the Flat & Elongated (F&E) ratio distributions. Different from the AI and STI index trends, F&E ratio distributions changed from the initial wider range values to much narrower range values, which means that particles tended to become a certain uniform shaped towards more cubical by eliminating some of the more flat and elongated particles after exposed to abrasion and breakage.

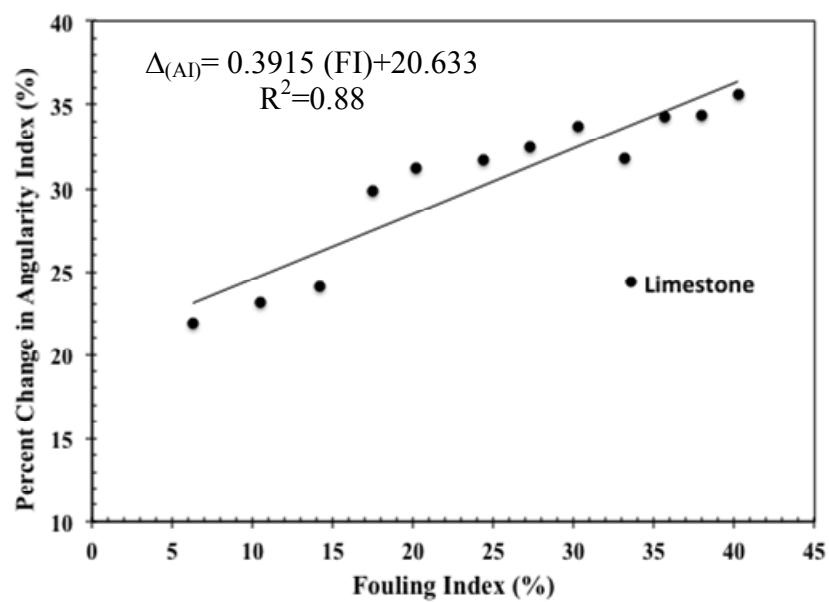
Figure 10: Percentage change in angularity (AI) and fouling (FI) indices

Because both ballast fouling and shape property changes are due to particle abrasion and breakage from the LAA test, the next step was to investigate how the change in FI values would correlate to changes in aggregate particle shape indices quantified by the E-UIAIA. Indeed, Figure 10 shows a strong correlation between the percentage change in average AI values and FI with a coefficient of determination  $R^2$  of 88%.

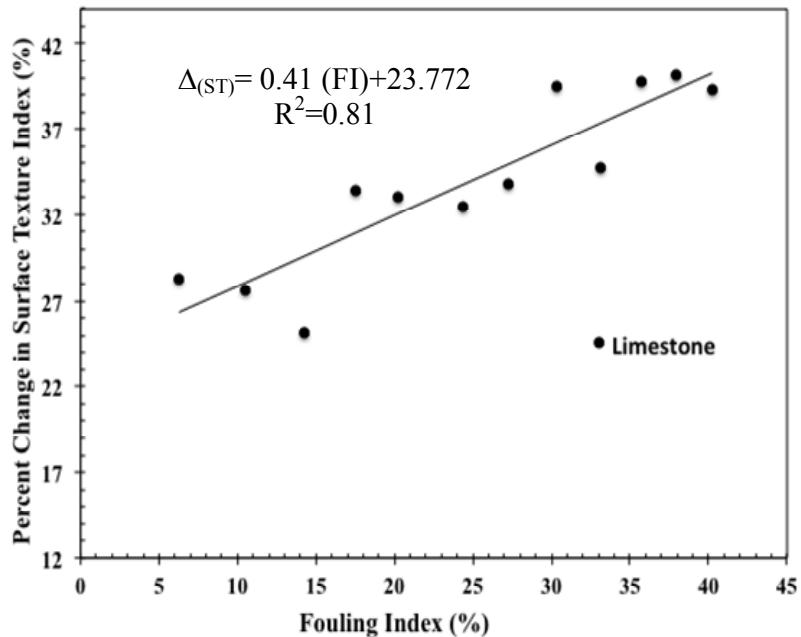
Figure 11: Percentage change in surface texture (STI) and fouling (FI) indices

Similarly, Figure 11 presents a strong correlation between the percentage change in average STI values and FI this time with a coefficient of determination  $R^2$  of 81%. Such trends confirm that there is a definite connection between ballast fouling and the overall reduced angularity and surface texture of the aggregate particles found in old used ballast in the field.

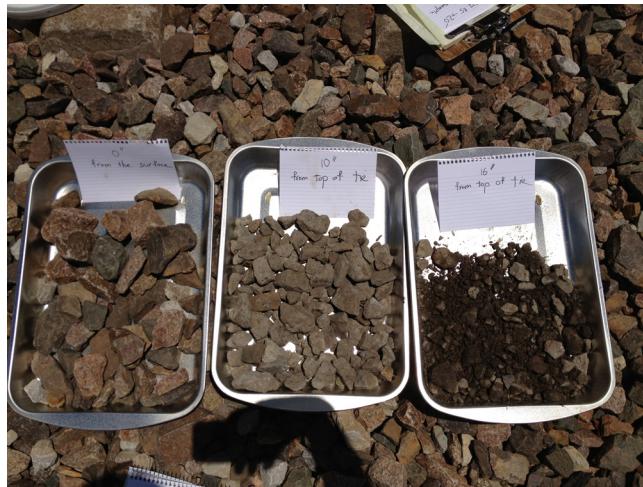
Figure 12(a): Aggregate samples collected at the surface (left), 8-in. (20.3-cm) (middle), and 16-in. (40.6-cm) (right) ballast depths

To evaluate the performance of the field imaging and segmentation methods developed in this study, aggregate samples were collected at different ballast depths from a mainline freight railroad in Mississippi. Figure 12(a) shows the aggregate samples collected at the surface as well as 8-in. (20.3 cm) and 16-in. (40.6 cm) ballast depths. Figure 12(b) is a photo of the sampling track location showing clean ballast on top and gradually fouling ballast with depth. The shape properties of the ballast aggregate particles were measured using the field imaging/segmentation and the laboratory E-UIAIA methods described in this paper to investigate the effects of train loading and the resulting ballast deterioration levels with depth.

It should be noted that both methods could successfully detect the gradual demise in the aggregate size with ballast depth due to degradation and particle breakdown under repeated train loading. The particles sampled from the 8-in. (20.3-cm) depth have slightly higher F&E ratios as determined by the two methods. The measured AI

and STI values indicate somewhat increasing trends with ballast depth, which can be explained with the size reduction and breakage of older ballast under train loading. Interestingly, as the aggregate size gets smaller with depth, these more recently crushed particles at greater depths possess higher angularities and rougher surfaces. This observation confirms the findings from LAA testing in the lab to simulate the ballast degradation.
