## EFFECTS OF BALLAST DEGRADATION ON PERMANENT DEFORMATION BEHAVIOR FROM LARGE-SCALE TRIAXIAL TESTS

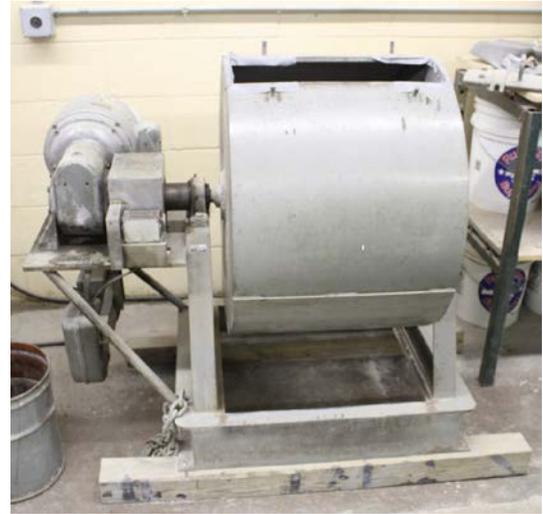
The ballast material used in the laboratory was a 100% crushed limestone, which adequately met AREMA No. 24 gradation requirements. Approximately 10 kilograms of clean ballast materials were placed in the LA abrasion drum (see Figure 1) together with 12 steel balls, which are typically used in the LA abrasion test (AASHTO T 96 or ASTM C 131).

Figure 1. Photo of Los Angeles (LA) abrasion test equipment

The drum was set to rotate on the average 50 turns per minute and for a total drum turns of 1,500 times to reach the fully fouled condition with a Fouling Index (FI) of 40. After finishing 1,500 turns, the drum was allowed to stand still for 10 minutes to let dust settle before the tested material was poured out. In order to minimize loss of fine materials, both the inside of the drum and the steel balls were carefully hand brushed after the test. All particles above 25.4 mm or 1.0 in. sieve were also brushed to collect dust and fine material before sieving. The outlined procedure was repeated until enough materials were generated for conducting large-scale triaxial tests and all the generated degraded ballast material were evenly mixed before preparing the triaxial test specimens. Further details on generating degraded ballast material through LA abrasion tests have been provided elsewhere [7]. The gradations of clean and

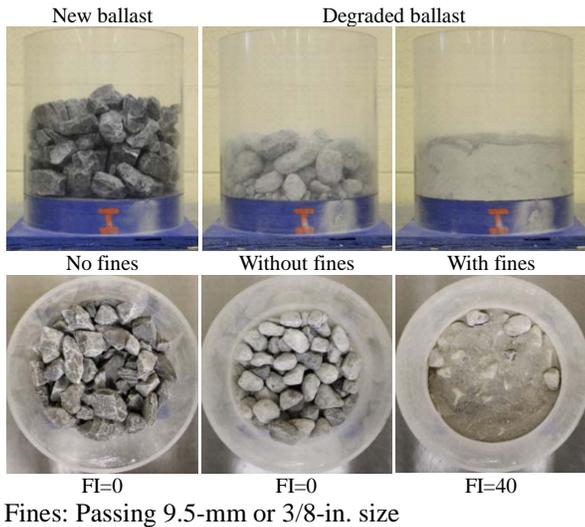
It is not obvious how to relate gradation information to ballast layer functional characteristics and the governing mechanisms that would impact ballast layer structural and drainage behavior. To investigate particle contact and particle packing characteristics before and after degradation, approximately 10 kilograms of ballast material obtained from the before and after 1,500 turns in LA abrasion tests were poured into an acrylic chamber with dimensions of 25.4 cm (10.0 in.) in diameter and 25.4 cm (10.0 in.) in height. Figure 3

presents the side and top views of aggregate packing photos taken before and after degradation with the corresponding FI values. Photos of the degraded ballast without fines are also shown in Figure 3 for comparison. It is clearly seen that after 1,500 turns, the same weight (ten kilograms) of degraded ballast occupied less volume as compared to the new ballast in the acrylic chamber. However, for the same weight of degraded ballast, the specimen height remained nearly the same with or without fine particles as shown in Figure 3. Basically, the fine particles generated during degradation occupied the voids created by the large particles. As FI approached 40, nearly all the voids created by the large particles were filled with fine particles.

Figure 3. Photos of side and top views of aggregate packing

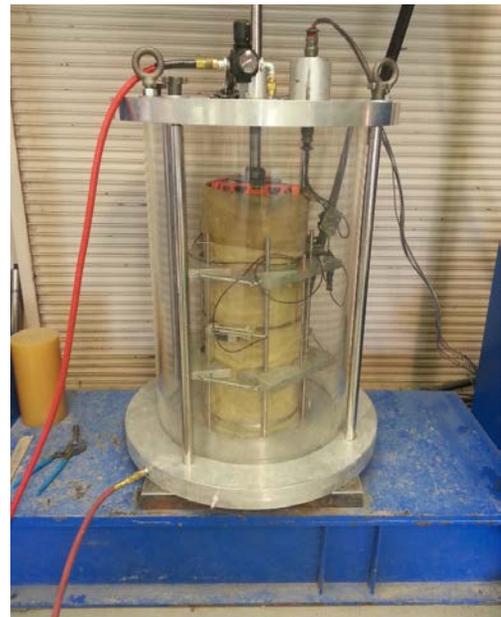
A large scale triaxial test device has recently been developed at the University of Illinois for testing specifically ballast size aggregate materials (see Figure 5). An internal load

cell (Honeywell Model 3174) with a capacity of 89 kN (20 kips) is placed on top of the specimen top platen. Three vertical LVDTs are placed around the cylindrical test sample at 120-degree angle between each other to measure the vertical deformations of the specimen from the three different side locations. Other details about the large-scale triaxial test device have been provided elsewhere [9].

Figure 5. Photo of University of Illinois Ballast Triaxial Tester
